# **ADDENDUM NO. 2 TO ASBESTOS ABATEMENT SPECIFICATIONS**

**Asbestos Abatement Prior to Renovations  
@  
Levey Middle School**

# NESHAPs ASBESTOS INSPECTION REPORT

**Glenn W. Levey Middle School**  
25300 West Nine Mile Road  
Southfield, Michigan 48033

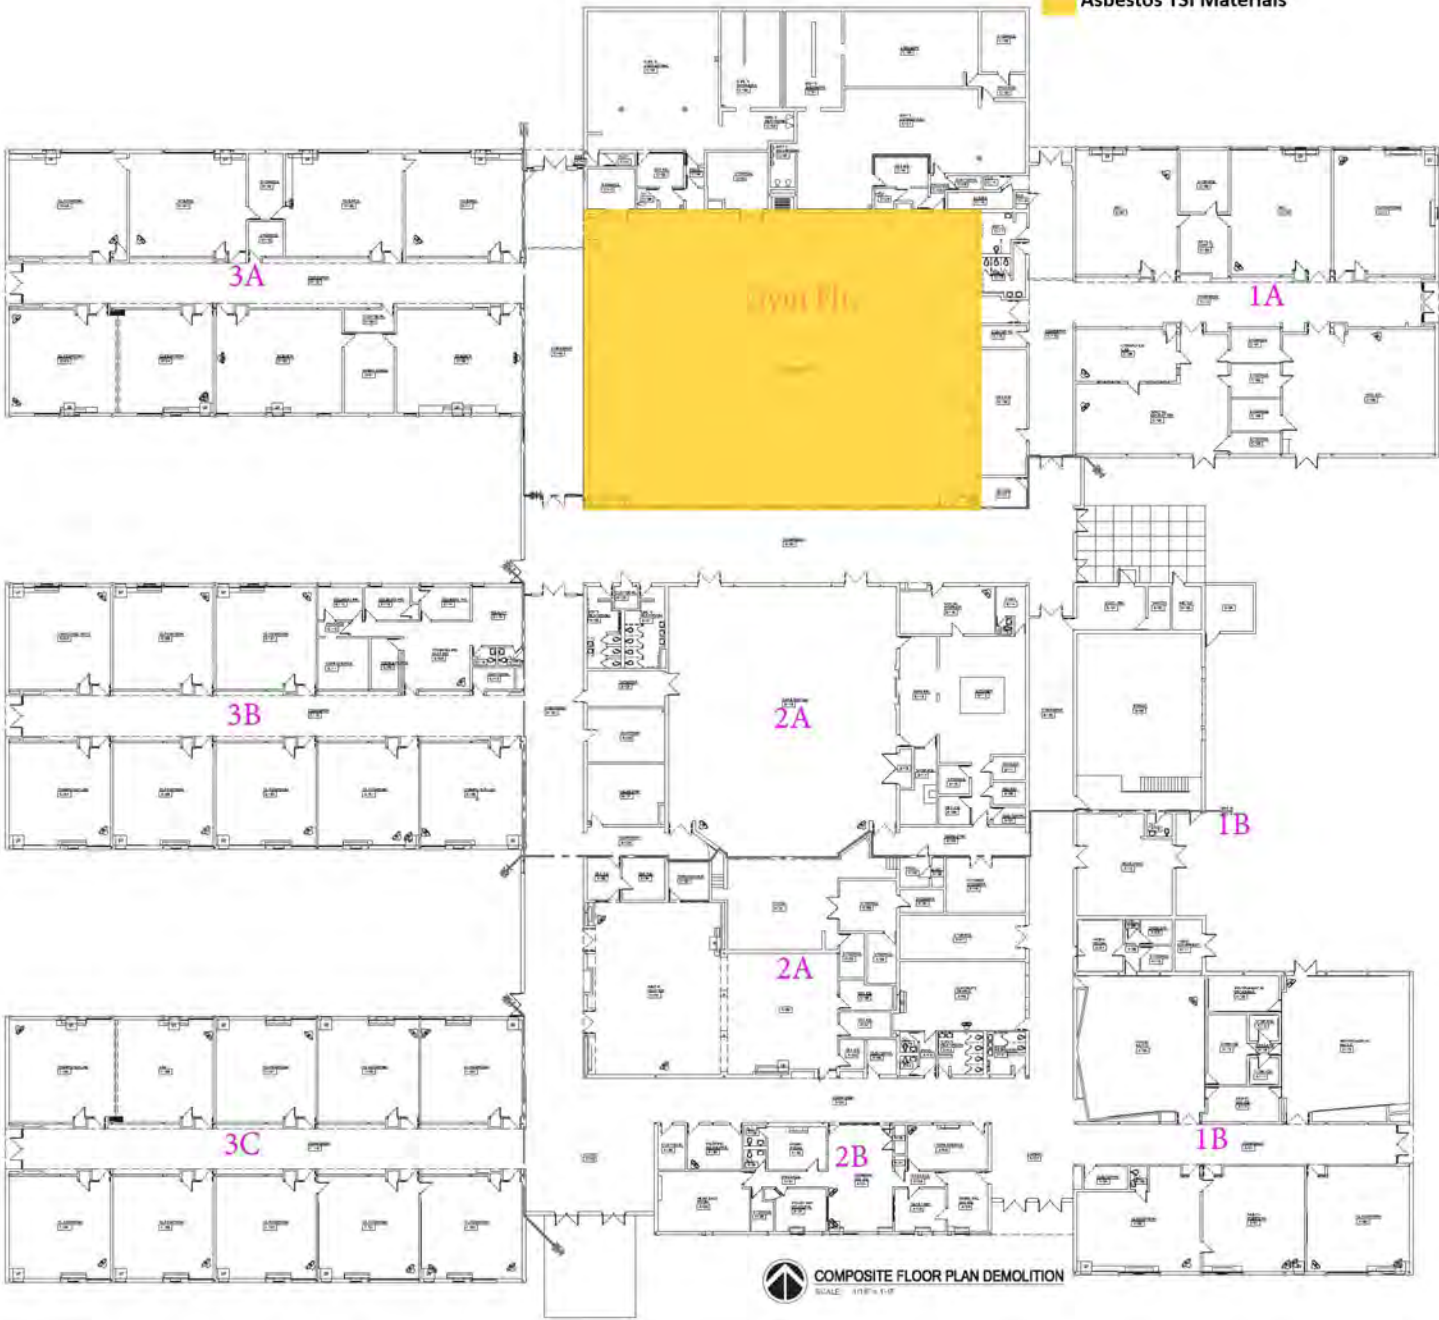
**SHEET NUMBER**  
**AD2.10**

## Asbestos TSI Materials

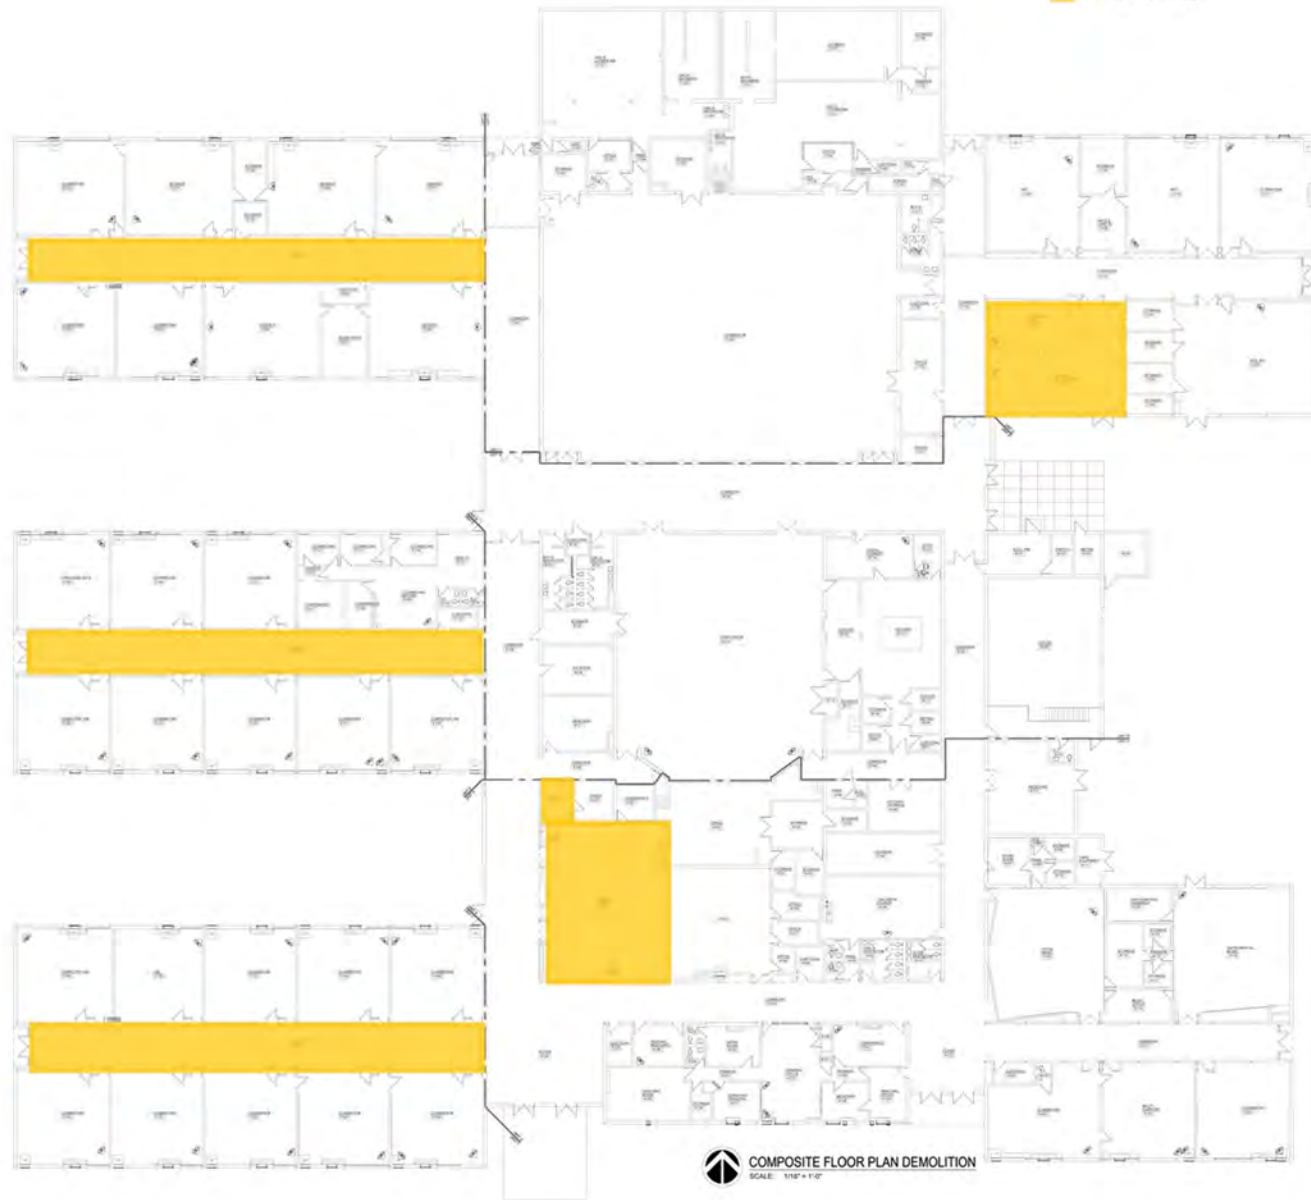
ACM Flooring
