SCHOOL DISTRICT OF
WASHBURN

FACILITY Assessment

June 27, 2023

School District of Washburn Middle School and High School
305 West 4th Street
Washburn, WI 54891

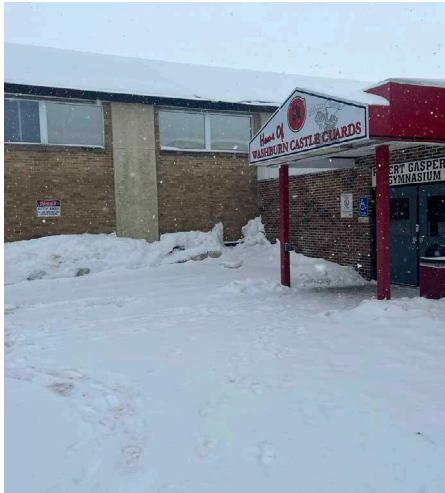
Parking Lot/Near Door 25

Sub-Category	Element	Condition	Priority	Details	Recommendation
Drainage	Parking Lot/ Near Door 25	Poor	I	Drainage in the area immediately outside of door 25 shows signs of ponding and sediment deposits due to improper drainage.	Reconstruct parking lot with stormwater management system.
Drainage	Door 23 Area	Poor	I	Drainage pattern flows across foundation at west facade and leads to step down at door 23, likely causing water issues. Regrade entire area for positive drainage away from door and foundation.	Improve site drainage.
Drainage	Door 26 Area	Poor	I	Drainage in the area immediately outside of door 26 shows signs of negative drainage towards entrance.	Regrade and consider retaining wall to achieve positive drainage.
Drainage	Door 20 Area	Poor	I	Drainage from scupper above door 20 has scoured and eroded the ground below creating negative drainage toward the building foundation.	Improve site drainage by adding fill and armoring ground with riprap rock.

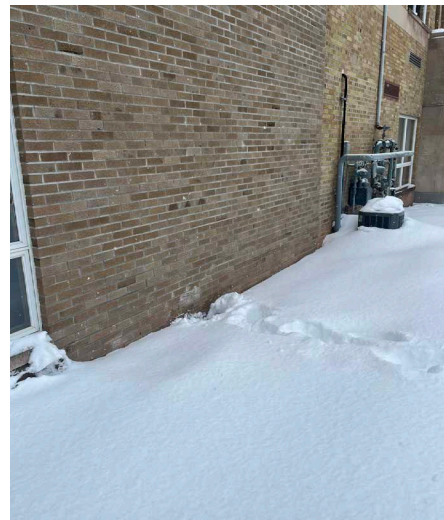
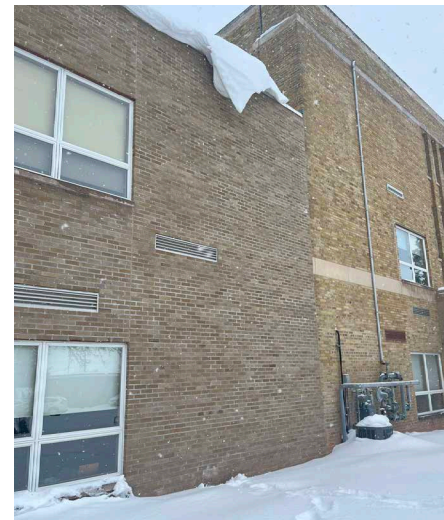
Drainage	Southern Facade Between Doors 20 + 21	Poor	I	Drainage from roof scupper has scoured and eroded the ground below and has created negative drainage toward the building foundation.	Improve site drainage by adding fill and armoring ground with riprap rock mulch.
Drainage	Door 21 Area	Poor	I	Drainage from scupper above door 21 has scoured and eroded the ground below and have created negative drainage toward the building foundation.	Improve site drainage by adding fill and armoring ground with riprap rock mulch.

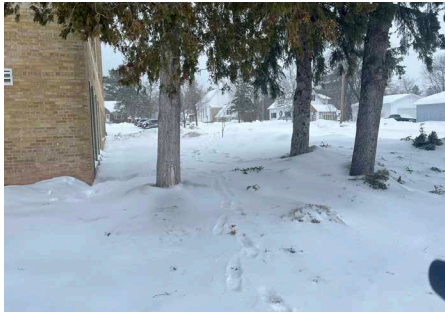
Sub-Category	Element	Condition	Priority	Details	Recommendation
Drainage	Southeast Corner of Building	Fair	2	Due to snow conditions, reviewers were unable to observe whether there is proper drainage to move water away from the building.	Ensure positive drainage away from building. Regrade if necessary.
Grounds Turf	Tree Pruning	Poor	1	Trees and branches are overgrown and damaged.	Prune out damaged limbs and hazard branches. Ensure branches do not rub on each other.
Grounds Turf	Tree Pruning	Poor	1	Branches show signs of Black Knot Fungus which may spread to other trees if left unchecked.	Prune trees immediately.
Grounds Turf	Gymnasium	Fair	3	There is a safety issue related to snow falling off the barrel roof when people are walking along the side of the building at ground-level.	Install foundation plantings serving as a safety buffer to prevent people from being too close to building when snow falls from barrel roof. This can be accomplished by saw cutting and removing existing pavement. Add shrub foundation plantings.

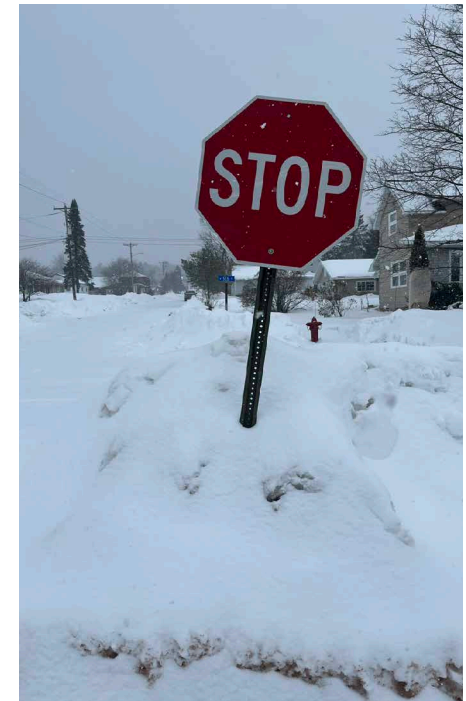
Vehicle Routes	Stop Sign at Northwest Parking Lot Entrance	Poor	2	Stop sign shows damage from snow removal and is out of plumb.	Reinstall sign.
Vehicle Routes	Pavement Striping	Fair	3	Pavement markings are fading.	Restripe parking areas.
Vehicle Routes	Pavement + Curbing/ Throughout Site	Fair	2	Due to weather conditions at the time of the site visit, the existing pavement and curbing throughout the site was not evaluated.	Reevaluate pavement and curbing in the spring.
Vehicle Routes	Street Sign/West 4th Street Near Solar Array	Poor	1	The street sign is missing.	Replace missing street sign.

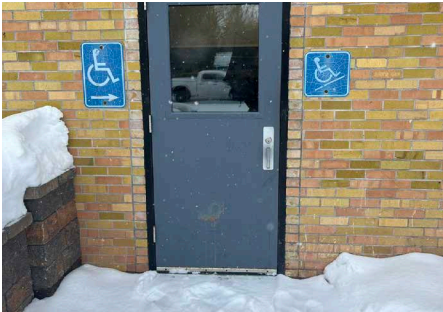
Sub-Category	Element	Condition	Priority	Details	Recommendation
Pedestrian Routes	Door 22	Poor	1	The door lacks a push button for accessibility and is therefore not ADA-compliant.	Install an automatic door and push button system.
Other Site Civil	Storage Shed at 4th Avenue Alley	Fair	3	Paint is peeling or missing.	Prepare and repaint shed.
Other Site Civil	Trash Enclosure	Poor	2	Trash enclosure structure is warped and showing signs of deterioration. Gate is difficult to operate due to inadequate design.	Replace trash enclosure.
Other Site Civil	Paint/Garden Shed	Fair	3	Paint is peeling or missing.	Prepare and repaint shed.
Other Site Civil	Hoop House	Poor	1	Hoop house vent on west side is damaged and should be replaced. There is a tear in plastic of hoop house on south east side.	Repair and replace damaged elements.
Other Site Civil	Paint + Threshold/ Door 25 Area	Fair	1	Paint is cracked and peeling on awning posts. Door threshold is not ADA-compliant as it exceeds the maximum height of one-half inch for accessibility.	Perform routine maintenance on metal posts. Mud jack or replace sidewalk.

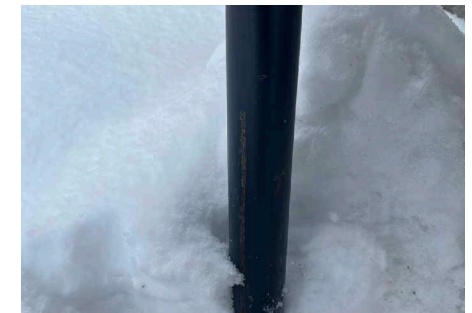
Railing/Door 20 Area

Middle School/High School	Site/Civil	OtherSite/Civil	20230227_BH53				Door 20 Area	Fair	2	Scratches and chips in railing paint are beginning to rust.	Prepare and repaint railing.	1	LS	\$500	\$500			\$763.69	2	\$	-	\$	764	\$	-
Middle School/High School	Site/Civil	OtherSite/Civil	20230227_BH54				Door 21 Area	Fair	2	Scratches and chips in railing paint are beginning to rust.	Prepare and repaint railing.	1	LS	\$500	\$500			\$763.69	2	\$	-	\$	764	\$	-
Middle School/High School	Site/Civil	OtherSite/Civil	20230227_BH55				Monument Sign	Fair	2	Paint is worn on wood elements of monument sign.	Prepare and repaint sign.	1	LS	\$500	\$500			\$763.69	2	\$	-	\$	764	\$	-
Middle School/High School	Architectural/Structural	ExteriorRoof	no pic				Area A	Fair	3	The roof consists of a fully adhered ethylene propylene diene terpolymer (EPDM) rubber membrane. It is approximately 10 years old. The average useful service life is 20 years.	Perform regular maintenance.	18,000	SF	\$0	\$0		No pricing.	\$0.00	3	\$	-	\$	-	\$	-

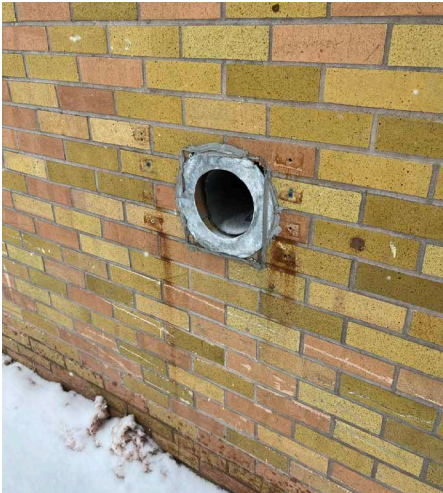
Missing Vent Cover/West Facade Near Door 23

Sub-Category	Element	Condition	Priority	Details	Recommendation
Exterior Walls	Missing Vent Cover/ West Facade Near Door 23	Poor	1	Vent of unknown origin is missing vent cover.	Replace vent cover.
Exterior Walls	1942 Original Building Brick	Poor	1	Large portions of the brick are discolored and spalling due to moisture intrusion. The mortar is heavily damage throughout.	Perform exterior masonry repairs including repointing.
Exterior Walls	1948 Addition Brick	Fair	2	The 1948 addition features a common brick bond. No brick face damage was observed. Minor staining is evident to the west of the high school entrance.	Perform minor masonry repairs above and to the west of the high school entrance.
Exterior Walls	1954 Addition (Gym) Brick/Plaster	Poor	1	There is evidence of limited repointing done in the past. However, large portions of the brick are damaged, specifically on the upper north wall and west entrance. The mortar is missing in spots. The stucco material is missing from the west stack and moisture intrusion appears to be occurring at column locations throughout addition.	Perform exterior masonry repairs including repointing.

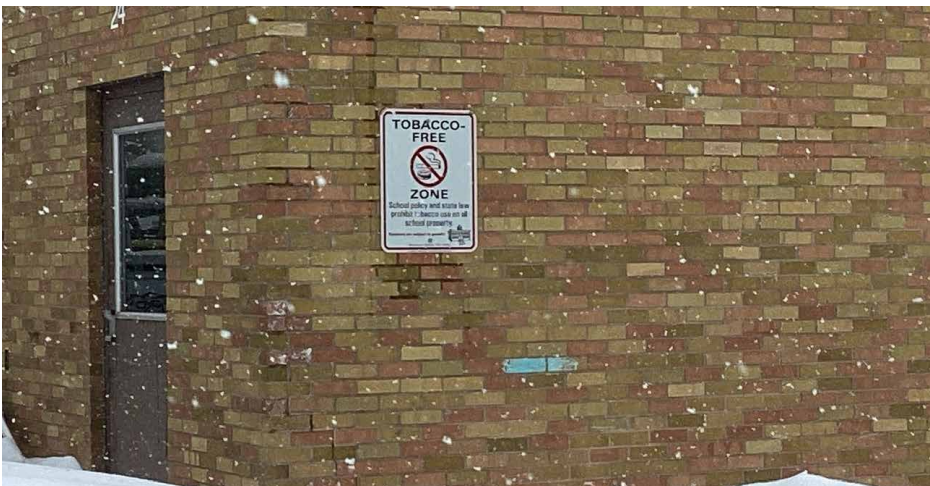
Exterior Walls	1972 Addition Brick	Fair	2	There is minor mortar deterioration at the northwest corner of the building. Damage from snow removal equipment is evident along the west wall. Water intrusion was reported inside the building along the west wall of the science room.	Perform exterior masonry repairs including tuckpointing. Further investigate the water intrusion issues that are ongoing.
Exterior Walls	1987 Addition Brick	Fair	2	The mortar has evidence of efflorescence on the south wall due to moisture infiltration.	Perform exterior masonry repairs including tuckpointing.

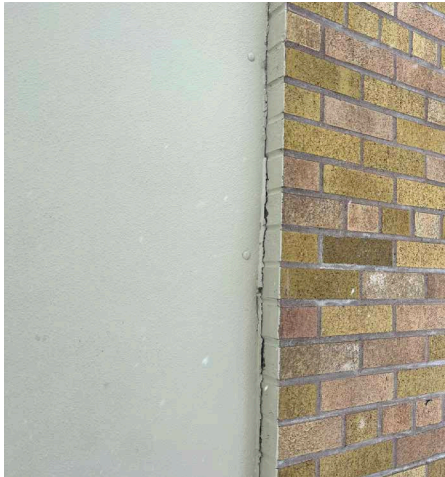
Sealants

Sub-Category	Element	Condition	Priority	Details	Recommendation
Exterior Walls	Sealants/Throughout	Poor	1	Exterior sealants throughout the building are cracking and have lost flexibility.	Remove and replace exterior sealants.
Exterior Windows	Windows/ Throughout	Poor	1	Windows throughout the building are double-pane glass with aluminum frames. Older portions of the building feature glass block windows. Moisture penetration was apparent throughout. Most of the operable windows were difficult to open/close.	Replace windows.
Exterior Doors	Doors, Frames,+ Hardware/ Throughout	Fair	2	Exterior doors and frames have corrosion. The original gym entrance doors are not being utilized as the main entrance to the gym any longer. The number of doors could be reduced and still keep code required exit.	Replace corroded exterior doors, frames, and hardware.
Exterior Other	Window Opening Lintels/Original Building	Poor	2	Many of the original window opening lintels are heavily corroded. The corrosion appears to be the worst on the accent windows and the third floor openings.	Prepare and repaint lintels throughout. Replace in cases where lintels appear wavy or are delaminated.

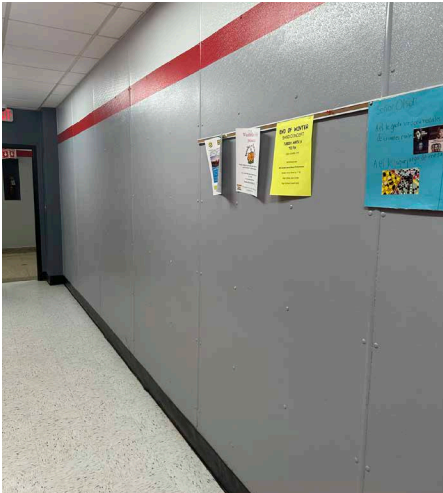
Sub-Category	Element	Condition	Priority	Details	Recommendation
Interior Walls	Walls	Fair	2	Walls are a combination of masonry, gypsum board, or fiberglass reinforced plastic (FRP), and while functional they give an outdated and worn look to spaces.	Refinish masonry and gypsum board walls and replace restroom floor and wall tile to refresh spaces.
Interior Walls	Display Cases/ Branding/Corridors	Poor	2	Most corridors lack quality display cases of student work. Materials and branding is inconsistent.	Increase the quantity of visual display cases in corridors. Replace corridor flooring, wall, and ceiling finishes to be consistent.
Interior Walls	Interior Signage/ Branding	Poor	2	Interior signage and branding is missing, worn, or outdated.	Replace room signage and incorporate branding into public spaces.
Interior Doors	Interior Doors	Poor	2	Many interior doors are original and damaged.	Replace doors.

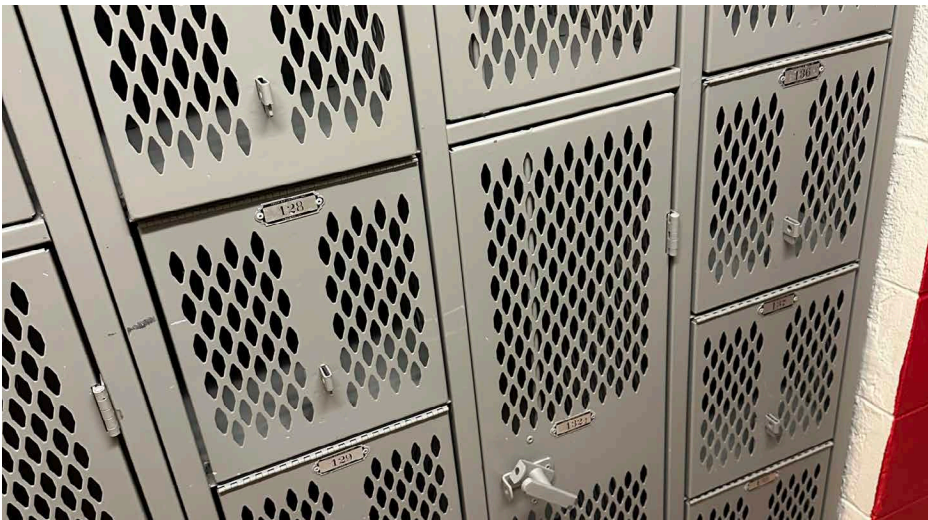
Interior Other	Lockers	Poor	1	Student and athletic lockers are outdated, worn, and have exceeded their useful service life.	Replace lockers.
Interior Other	Drinking Fountains	Poor	1	Some drinking fountains are not dual-height for accessibility.	Replace drinking fountains, including one with a bottle filler.
Interior Other	Window Treatments	Poor	2	Window treatments are outdated and worn.	Replace window treatments with manual roller shades.
Interior Other	Wood Trim	Poor	2	Original wood trim is aging and outdated.	Re-finish existing wood trim.
Interior Other	Freezer and Cooler Enclosures/Kitchen	Poor	1	The freezer and cooler enclosures are original and are damaged.	Replace enclosures.

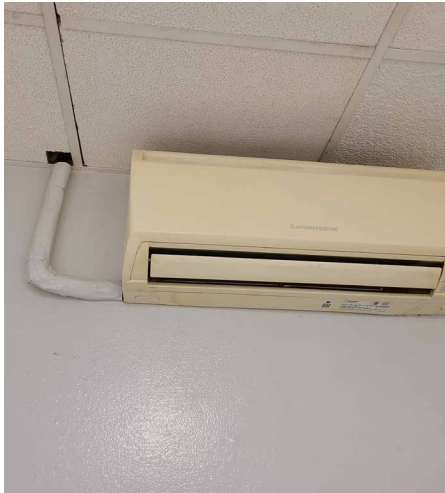
Mini-split, Washer + Dryer/Kitchen

Sub-Category	Element	Condition	Priority	Details	Recommendation
Heating Cooling	Mini-split, Washer and Dryer/Kitchen	Fair	3	Kitchen office has a mini-split heating and cooling system serving it. A washer and dryer are in the office corner. The dryer is near the exterior wall but must verify venting goes to outside.	Verify dryer vent length meets requirements and route directly outside, not into other ductwork if not already.
Heating Cooling	First Floor HVAC/1942	Poor	I	Building area served by gravity exhaust with pneumatic controlled dampers and classroom unit ventilators. There is no cooling or dehumidification. There is no exhaust in restrooms. Equipment was installed in the 1980s and is at the end of its useful life in terms of maintenance and controls operation.	Demolish existing systems/controls. Replace existing systems with new central air handling unit (AHU), ductwork and diffusers. New exhaust fan in restrooms, new DDC Controls.

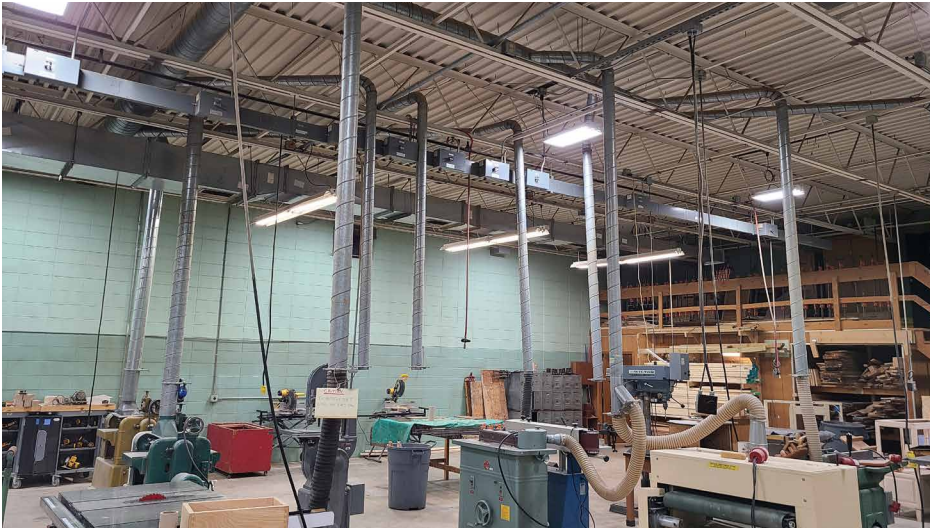
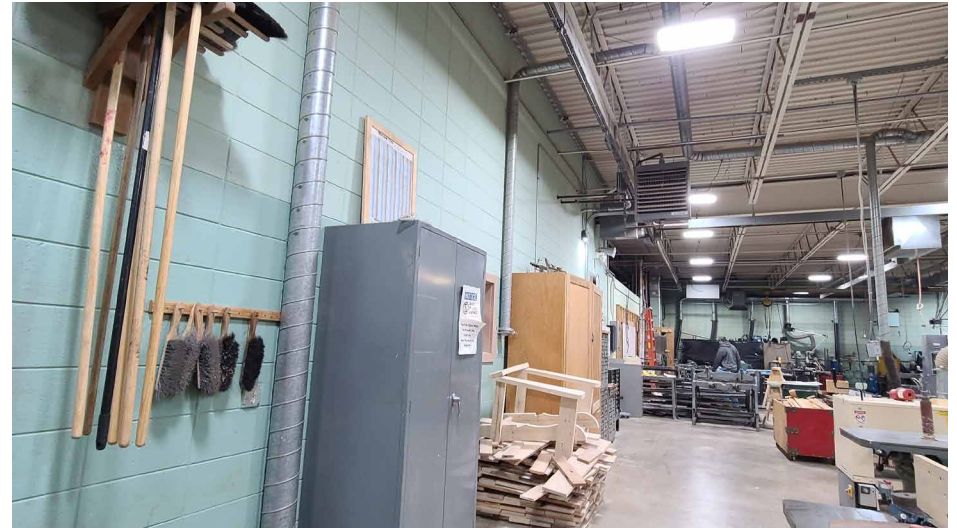
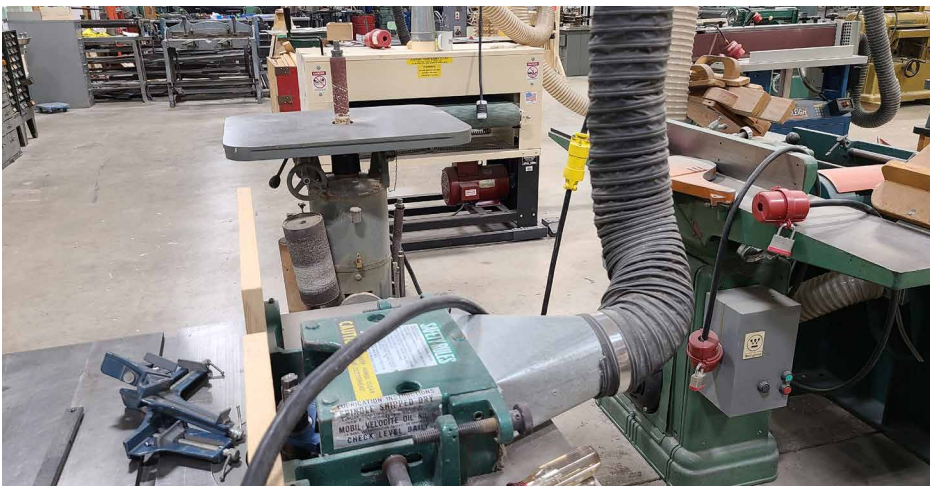
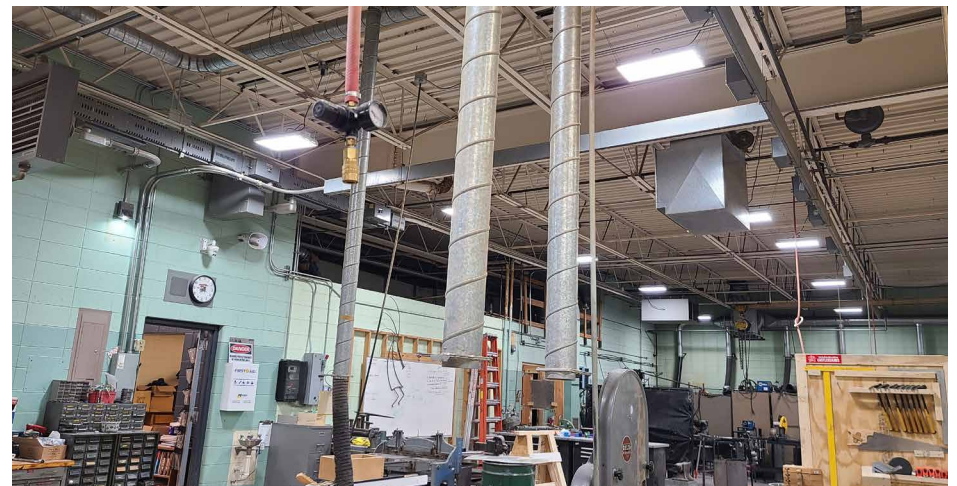
Heating Cooling	Second Floor HVAC/1972 Technical Education	Fair	2	Dust collector was installed in 1982. Ductwork in space was observed to be clean and well maintained and shall remain in service. Welder exhaust was reported by teacher to be undersized. Welding system has good flexible connections but needs a more powerful fan for fume capture.	Replace Reznor brand roof top unit (RTU), dust collection system, air cleaner and weld fume exhaust. Ductwork in space shall remain in service.
Heating Cooling	Second Floor HVAC/1987	Poor	I	Area is served by gravity exhaust with pneumatic controlled dampers and classroom ducted fan coil units. There is no cooling or dehumidification. There is no exhaust in restrooms. Equipment was installed in the 1980s and is at the end of its useful service life in terms of maintenance and controls operation.	Demolish existing HVAC systems. Provide new air handler and exhaust to meet code. Route new laundry exhaust duct.

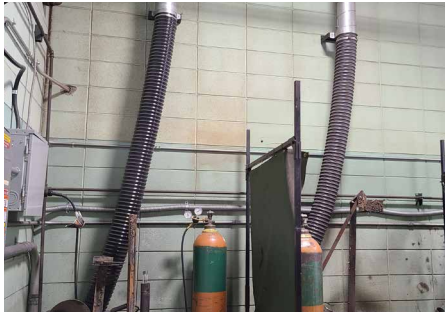
Sub-Category	Element	Condition	Priority	Details	Recommendation
Other Mechanical	240/Technology Education	Fair	2	Staff reported the fan to be slightly underpowered for the quantity of welding booths that are connected. Utility set fan is noisy and disruptive.	Provide new roof-mounted fan and ductwork through existing penetration.
Other Mechanical	Walk-In Freezer and Cooler/Kitchen	Poor	1	Walk in freezer and cooler are original per staff (1972). Floors are rotted out. Water and moisture is frozen under the floor. If freezer and cooler are shut off, the floor thaws and floods. Compressors are in tunnel below stairs and overheat due to lack of cooling.	Replace refrigeration system serving freezer and cooler. Cost to replace enclosure for new freezer and cooler, is provided in the architectural costs).
Other Mechanical	Emergency Gas Shut Off Valve 124/Science	Poor	1	The emergency gas shut off valve is in a locked box in the hallway. This is not code compliant and will need to be updated.	Update gas shut offs to include required manual valve at or near teachers station. Install emergency power off (EPO) switch under plastic cover at egress doorway.

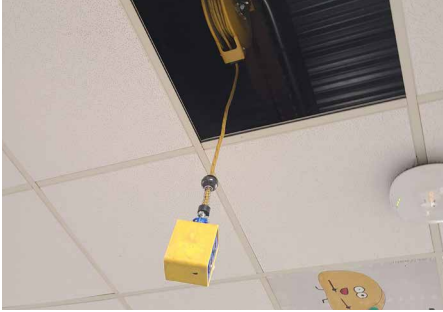
Power Cord Reels/Art Room

Sub-Category	Element	Condition	Priority	Details	Recommendation
Power Supply	Power Cord Reels/ Art Room	Poor	1	Power cord reels are hung from the structure and enter rooms through removed ceiling tiles.	Move cord reels below the ceiling tiles and re-install missing ceiling tile to maintain smoke separation.
Power Supply	Main Distribution Panel/ Concession Stand	Good	3	The main distribution panel is located in a small room adjacent to the concession stand. The 1,200 amp, Westinghouse brand panel was installed in 1994. The average useful life is 40 years. It appears to be adequately sized for the building.	Perform regular maintenance.
Power Supply	Switchboards/ Throughout Original Building + 1948 Addition	Poor	1	There are three Cutler-Hammer brand fusible switchboards located in the original building and 1948 addition. They appear to be original to construction. The average useful life is 40 years.	Replace with a switchboard that has circuit breakers.

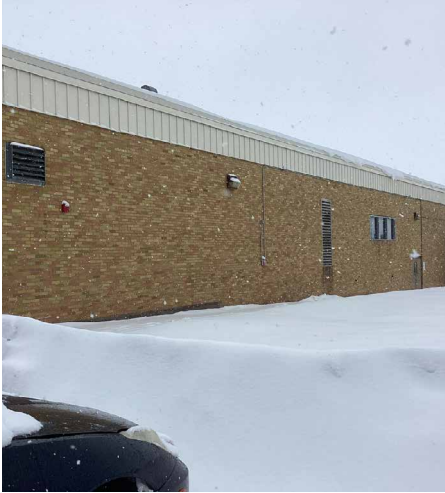
Building Exterior Lighting

Sub-Category	Element	Condition	Priority	Details	Recommendation
Exterior Lighting	Building Exterior	Poor	2	Some of the exterior building-mounted lighting fixtures are not LED. They appear to be high intensity discharge (HID) fixtures which provide poor light levels. Lighting at entrance canopies is not LED.	Replace with LED fixtures.
Exterior Lighting	Parking Lots	Poor	2	The parking lots have no lighting and rely on the building-mounted lights.	Install parking lot lighting.
Interior Lighting	LED Lighting/ Throughout	Fair	3	Approximately 90% of the lighting has been updated to LED. Lighting controls have not been updated.	Replace remaining non-LED fixtures and update lighting controls.
Interior Lighting	Stage Lighting	Poor	1	Performance lighting above the stage and dimming controls are outdated. There are extension cords used as permanent wiring, which does not meet code.	Replace performance lighting, dimming controls, and wiring.

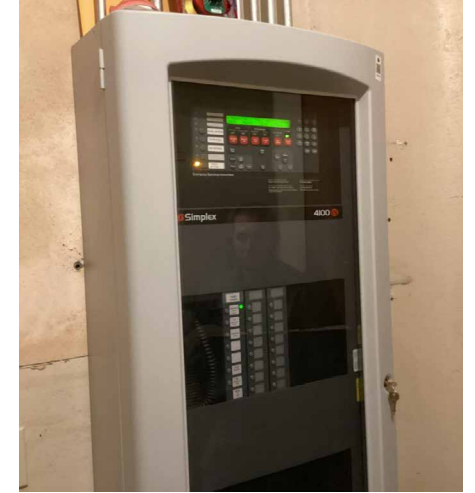
Fire Alarm Panel

Life Safety	Fire Alarm	Good	3	The fire alarm panel and associated devices were recently updated to voice notification.	Perform regular maintenance.
Life Safety	Emergency Lighting/ Throughout	Poor	1	Many of the emergency lighting fixtures appeared past their useful service life.	Replace emergency lighting system.
Life Safety	Paging System/ Throughout	Fair	2	The paging system is connected to the clocks, bells, and phone system. The main system controls are having issues. The speakers throughout the building are outdated.	Upgrade main system controls and speakers.
Security	Security Cameras/ Throughout	Fair	2	A network of Verkade brand security cameras are located throughout the building interior and exterior. They were installed around 2017. Coverage appears to be adequate. Cameras are programmed to detect intruders while building is unoccupied.	Perform regular maintenance.
