## Final Arborist Report

To: JMJ Team c/o Mike Dahlem  
Site: Fruitland Elementary – 1515 S Fruitland, Puyallup, WA 98371  
Re: Tree Inventory  
Date: April 23, 2025  
Project Arborist: George White,  
ISA Certified Arborist PN-8908A  
ISA Qualified Tree Risk Assessor  
Reviewed By: Charlie Vogelheim  
ISA Certified Arborist PN-9375A  
ISA Qualified Tree Risk Assessor  
Referenced Documents: The City of Puyallup Vegetation Management Standards, Administrative Policies and Procedures  
Tree Retention Plans Fruitland ES (JMJ Team, 3.25.2025)  
Preliminary Replanting Schedule (JMJ Team, No Date)  
Attached: Table of Trees  
Tree Site Map

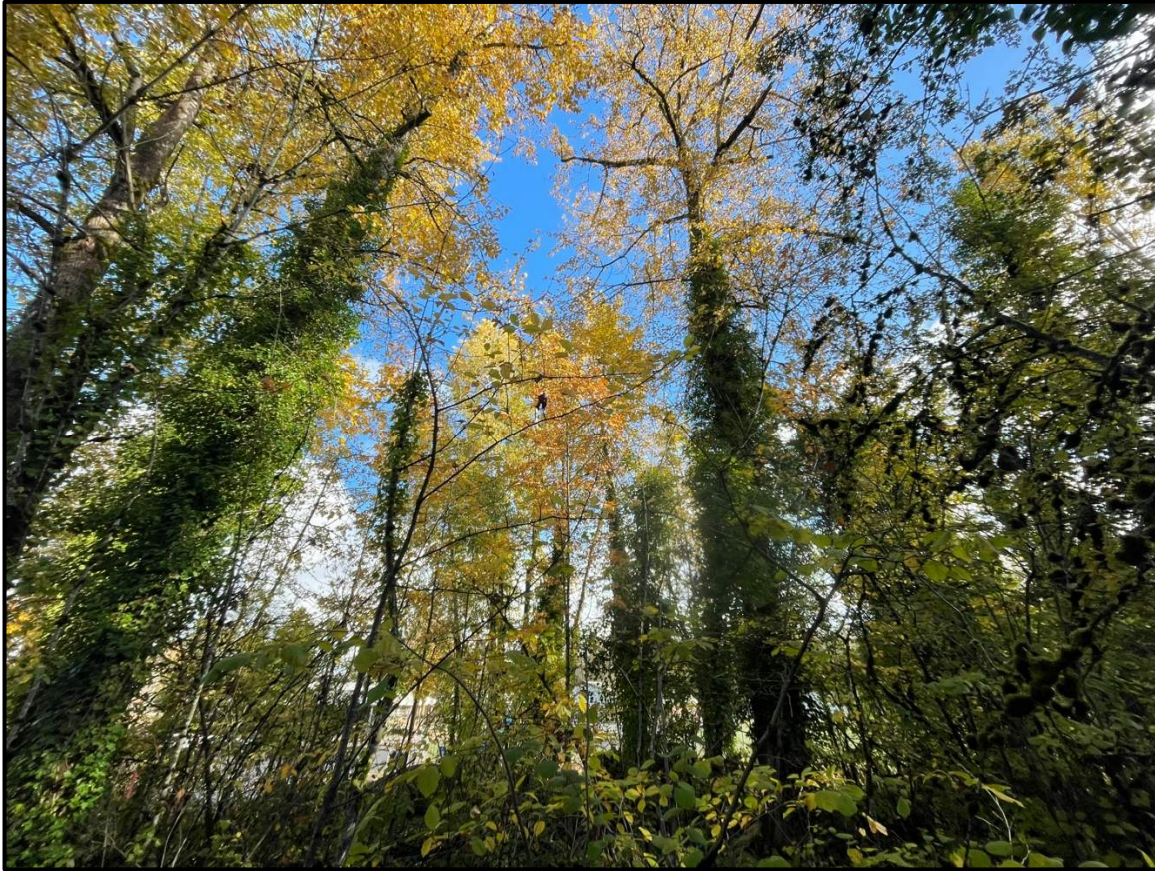
I noted several invasive plant species on site including Himalayan blackberry (*Rubus bifrons*), English ivy (*Hedera sp.*), English holly (*Ilex aquifolium*). English ivy was especially pervasive (Photo 2). Ivy can smother native vegetation, negatively impact tree health, and increase the likelihood of tree failure when allowed to climb into tree canopies. Invasive plants should be removed prior to development. At a minimum, ivy should be removed from tree trunks and pulled back 3 feet from the base of any tree.

**Photo 1.** Invasive English ivy is pervasive throughout the site. At a minimum, ivy that is climbing tree trunks should be severed and pulled back 3 feet from the trunk.

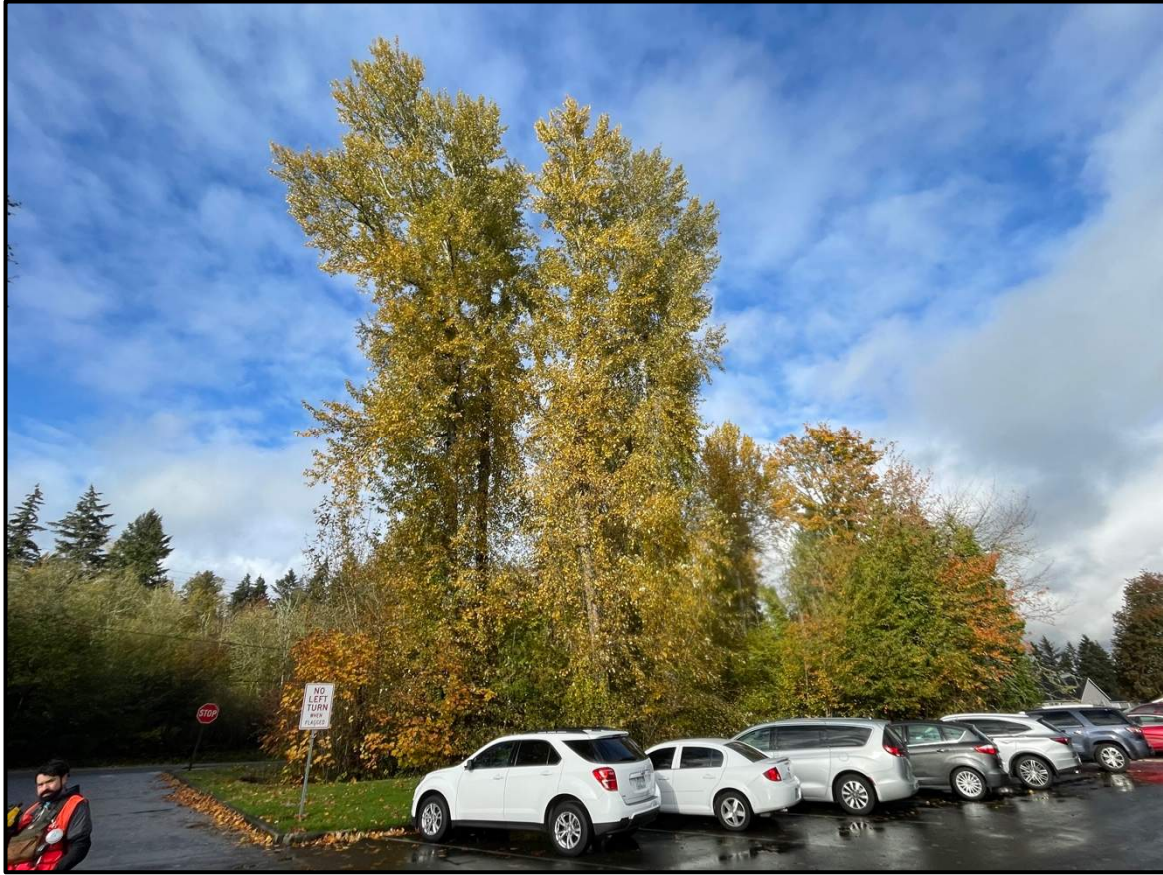
Trees on-site primarily consisted of native broadleaf species including Black cottonwood (*Populus trichocarpa*), bigleaf maple (*Acer macrophyllum*), Oregon ash (*Fraxinus latifolia*), Red alder (*Alnus rubra*) and native willow hybrids (*Salix spp.*). Other tree species included Douglas-fir (*Pseudotsuga menziesii*), wild cherry (*Prunus avium*) and Norway spruce (*Picea abies*).

**Photo 2.** Trees on-site are primarily large, native deciduous trees including several large black cottonwood trees.

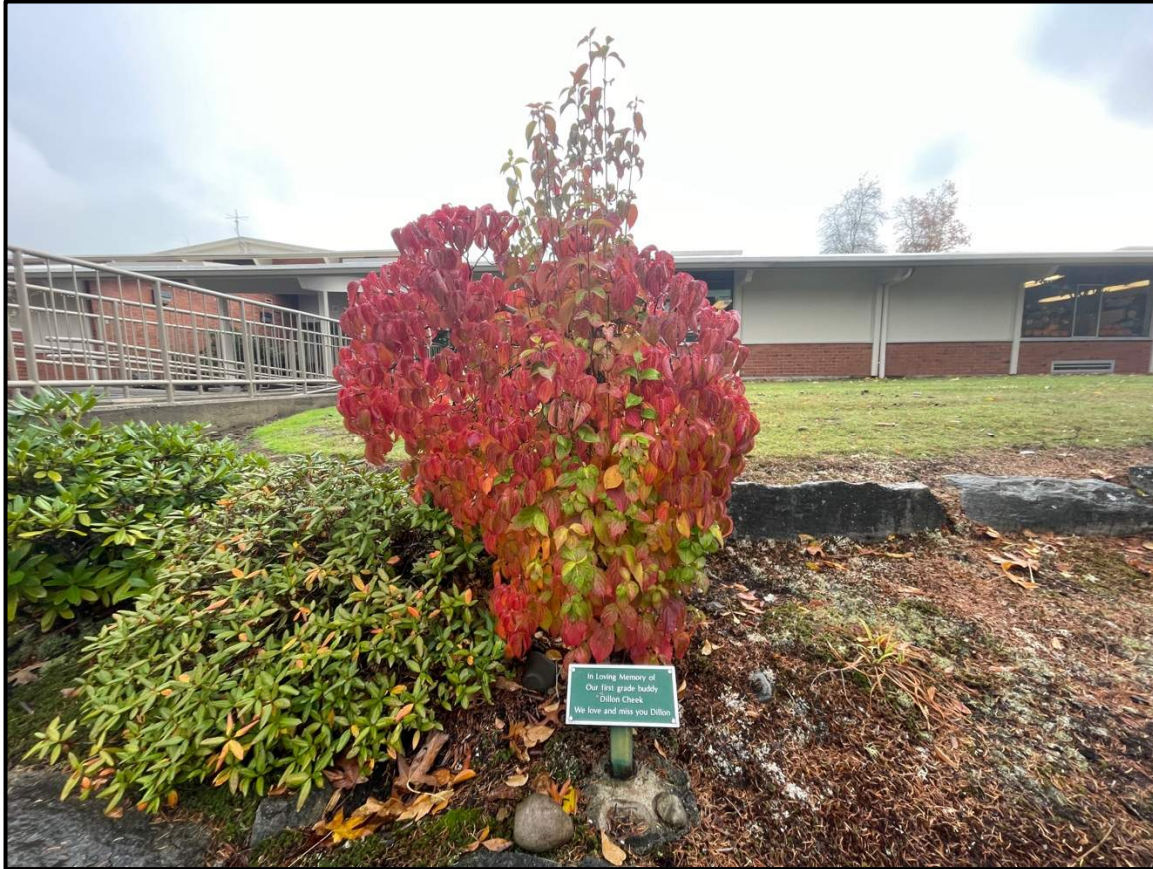
During our tree inventory I noted a small flowering dogwood tree near the entrance of the school that had been planted as memorial to a student (Photo 3). While this tree is not regulated it should be carefully protected during construction or be transplanted elsewhere.

**Photo 3.** A small dogwood tree that was planted as a memorial to a student. This tree should be protected during construction.

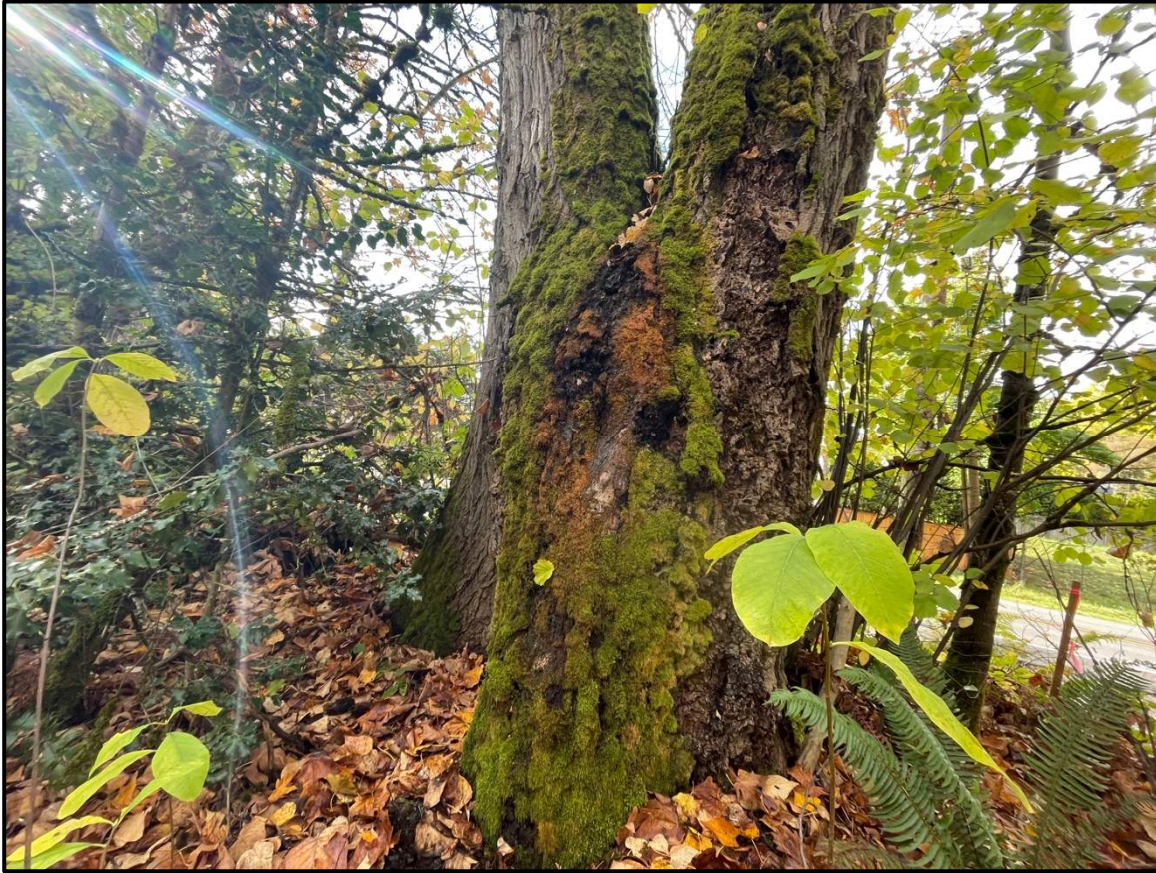
Tree 377 is a 55-inch black cottonwood tree located near the southwest corner of the site. This tree is codominant at 8 feet above grade with a narrow union (Photo 4). The base of this tree is conspicuously swollen and may indicate internal decay. The combination of codominant stems and the potential

internal decay increases the likelihood of failure. This tree has the potential to impact the S Fruitland roadway in the event of failure. I recommend performing an advanced risk assessment of this tree using a micro-resistance drill or sonic tomography if it is retained.

**Photo 4.** The base of tree 377 a 55-inch black cottonwood with a narrow, codominant union and swollen base. An advanced risk assessment of this tree is recommended.

| Tree ID | Scientific Name | Common Name | DSH (inches) | DSH Multistem | Health Condition | Structural Condition | Significant | Dripline (feet) | Critical Root Protection Zone (feet) | Proposed Action | Notes |
|---|---|---|---|---|---|---|---|---|---|---|---|
| 377 | <i>Populus trichocarpa</i> | Black cottonwood | 66.8 | | Good | Fair | - | 48 | 67 | Remove | Codominant at 8 feet with narrow union and included bark, significant reaction growth at base may indicate internal decay, advanced testing recommended |
