## **LIMITED ASBESTOS SURVEY**

**Mint Valley Elementary School  
2745 38<sup>th</sup> Avenue  
Longview, Washington**

Survey Date: March 19, 2025

Report Date: March 31st, 2025

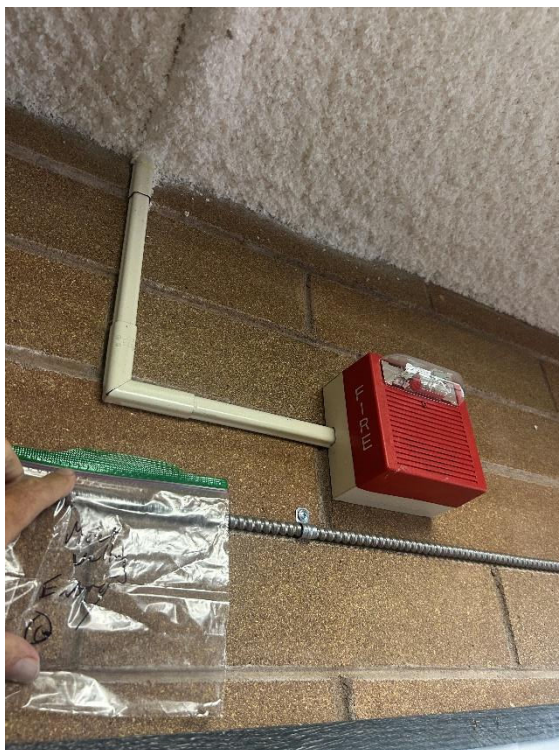
Fire system wall mount typical

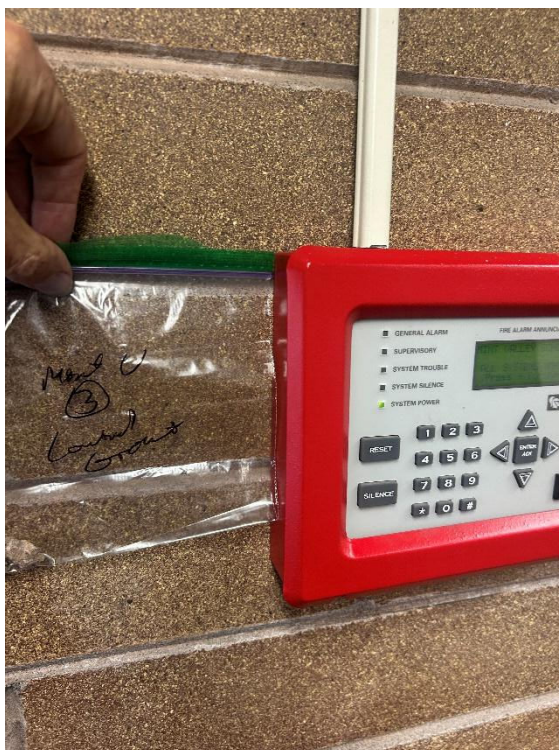
Sampling location

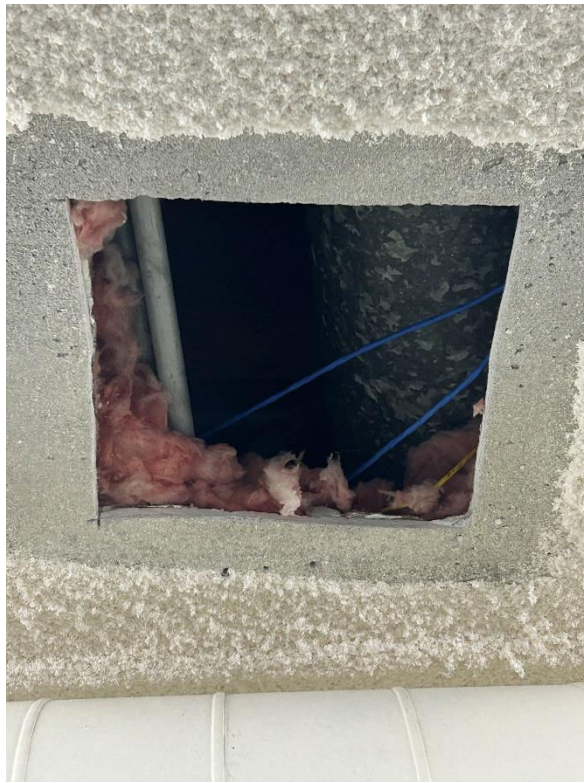
Ceiling area opening after HVAC upgrade

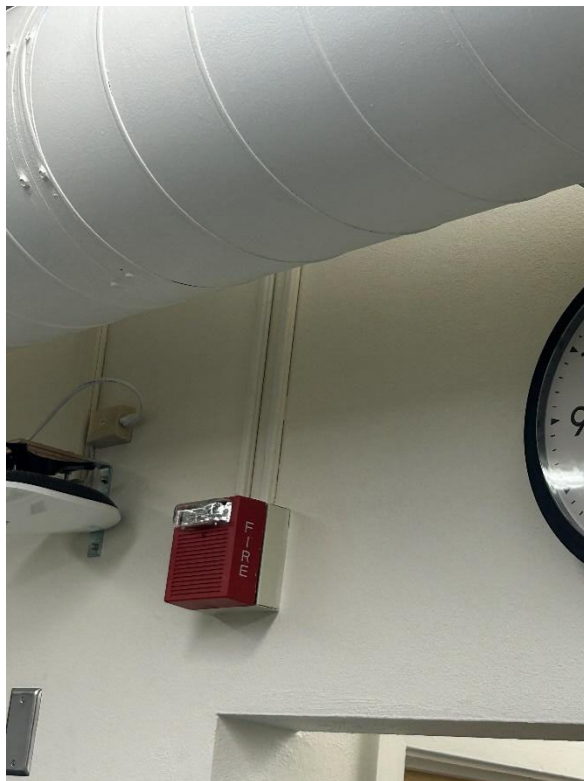
Sheetrock wall mount typical

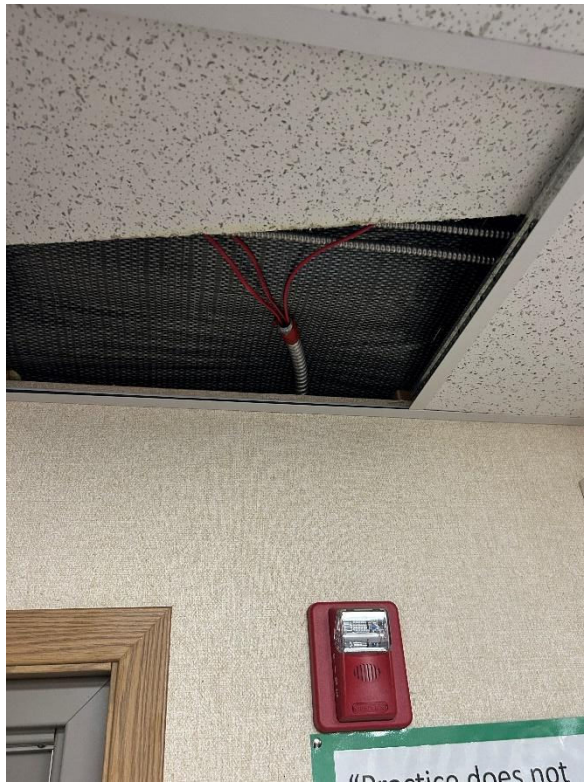
Ceiling tile drop down typical

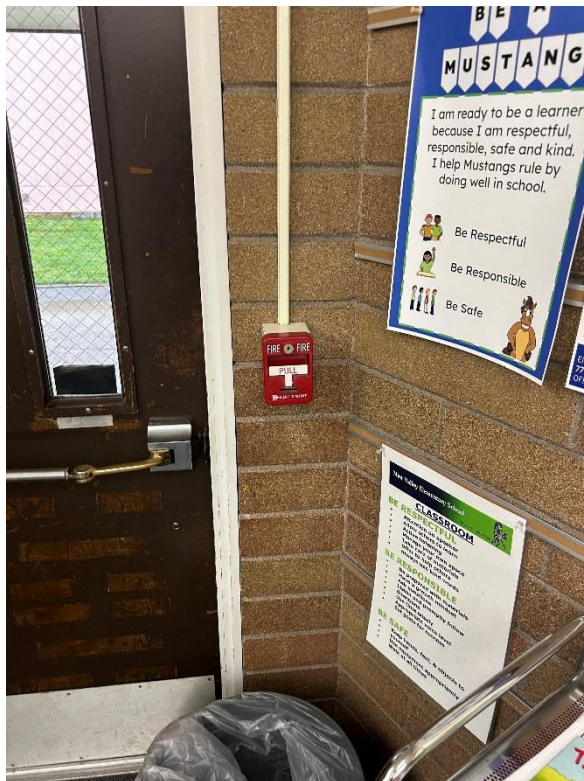
Interior brick mounts

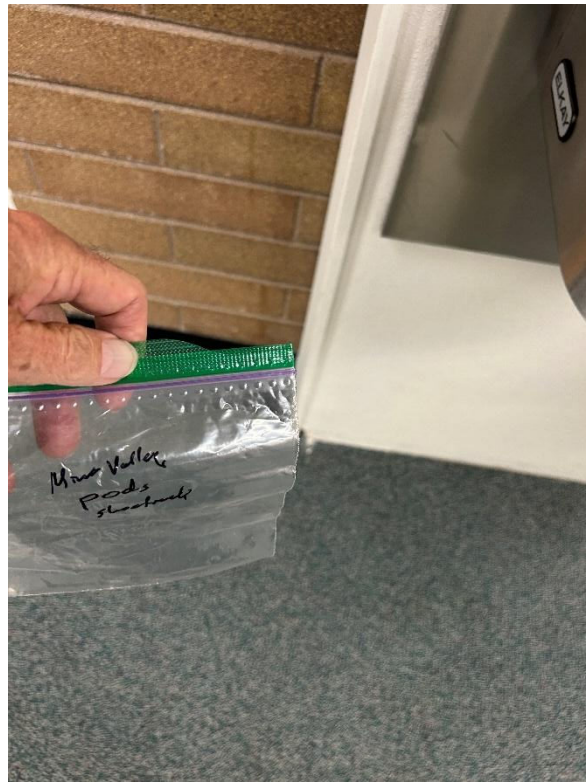
Sheetrock sample area
