# ADDENDUM

**Addendum #:** 1  
**Date:** May 7, 2025  
**Project #:** 2024-0014  
**Project Name:** Columbia Heights ES Reroof

## **LIMITED LEAD SURVEY**

## **LIMITED LEAD AND ASBESTOS SURVEY**

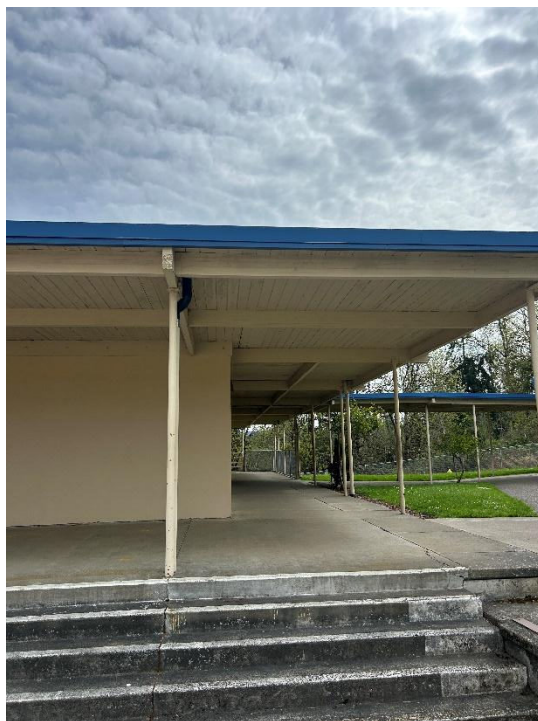
| Sample No. | Location | Material Description | Result (ppm) |
|---|---|---|---|
| CH-4 | Trim | Blue Paint | 4100 |

Exterior blue trim and breezeway

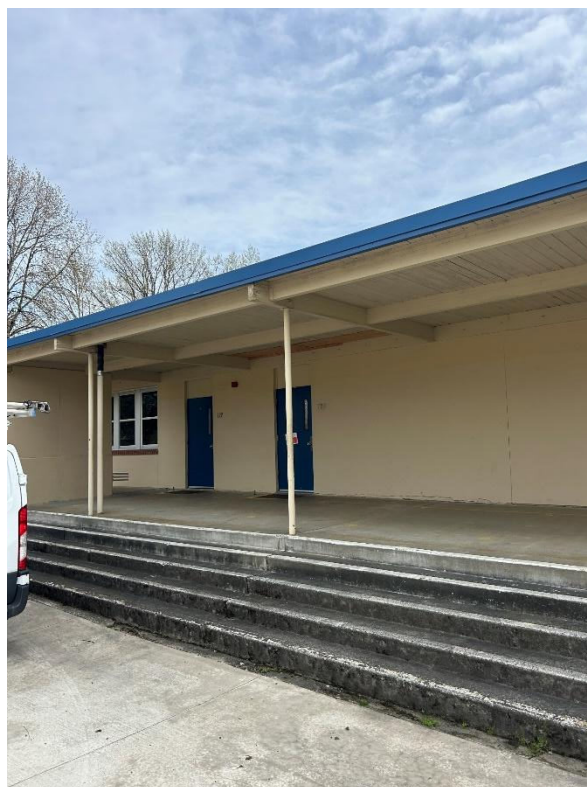
Ceiling area under roof eave

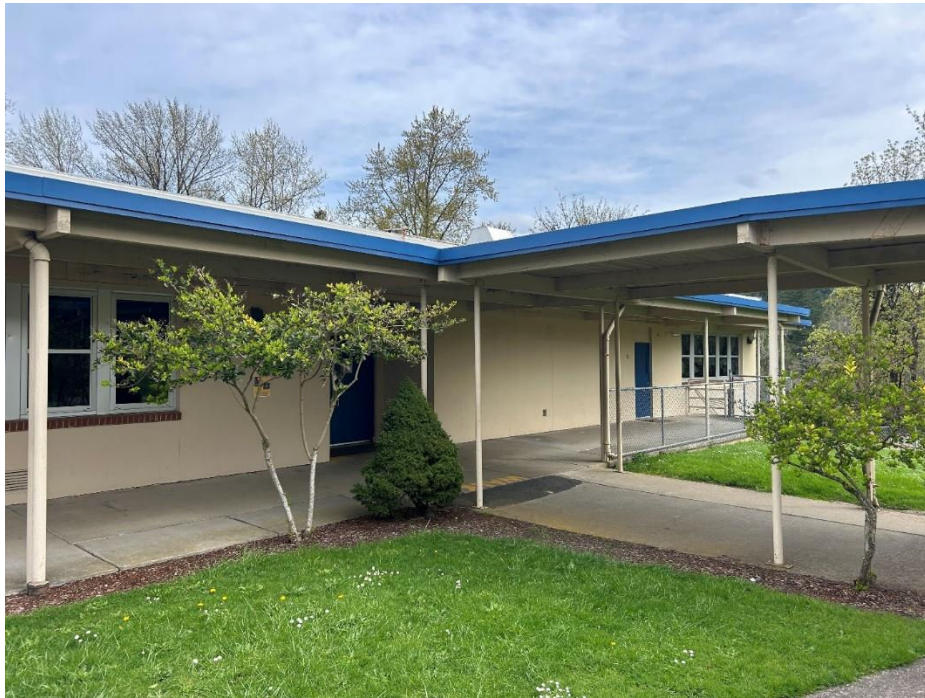
Interconnecting breezeway

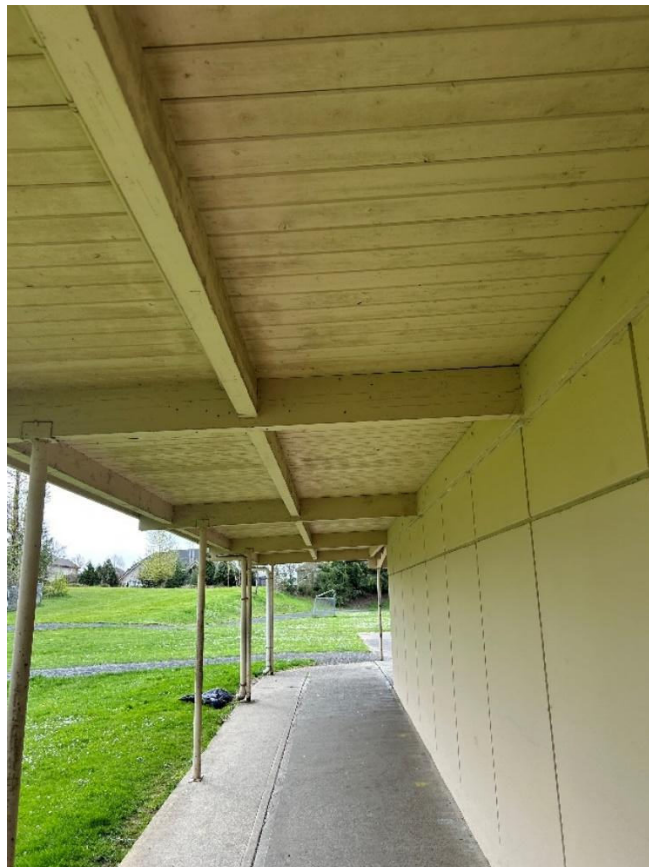
Sampling locations under eave

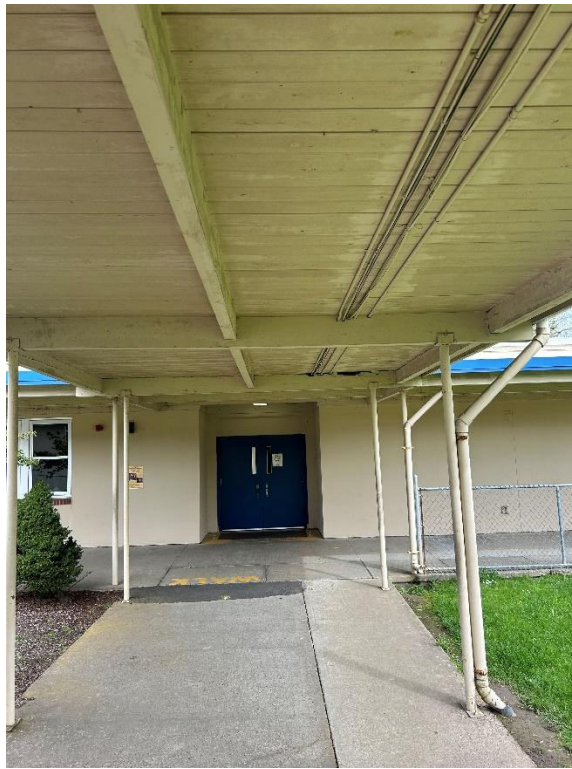
| Sample No. | Location | Material Description | Result (ppm) |
|---|---|---|---|
| CH-5 | Gutter Metal Downspout | Yellow Paint | 3300 |

The paint found on metal pillars and downspouts and trim was noted to have elevated levels of lead in paint. However, none of these values were above the EPA definition of lead in paint levels of 5000ppm.

Metal downspout sampling locations

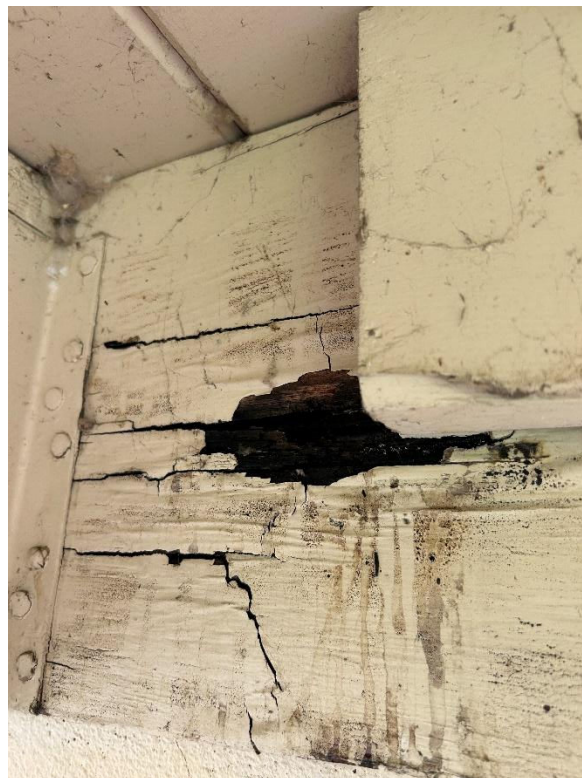
Wood coating in poor condition

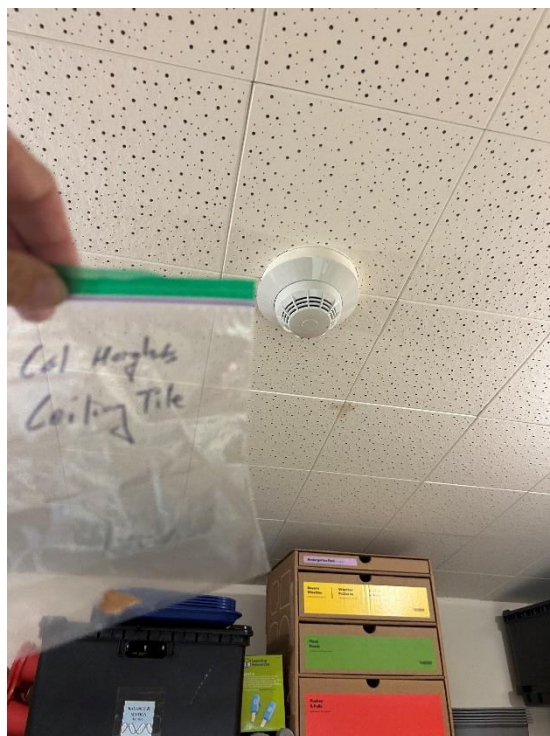
Ceiling tile typical location

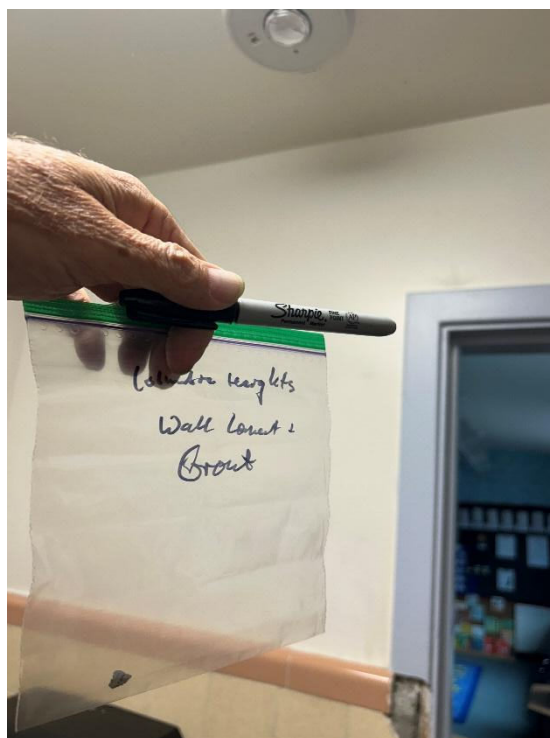
Wall sampling location

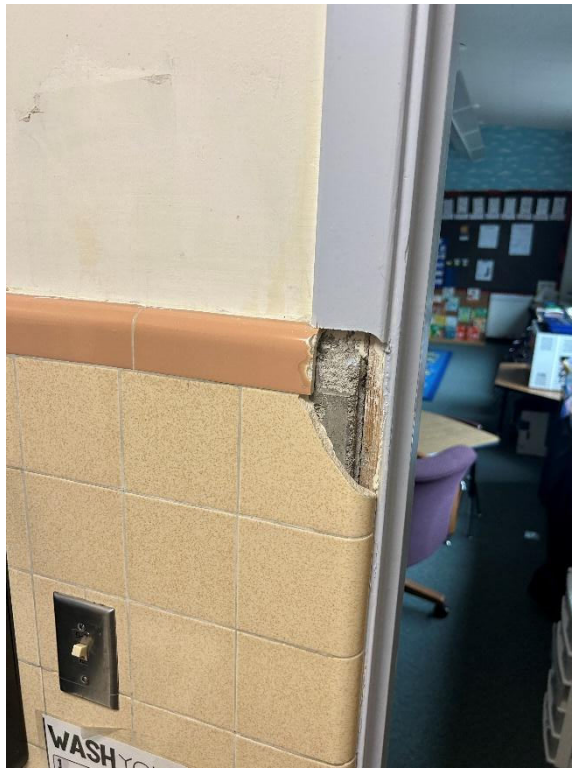
Concrete and grout sampling location

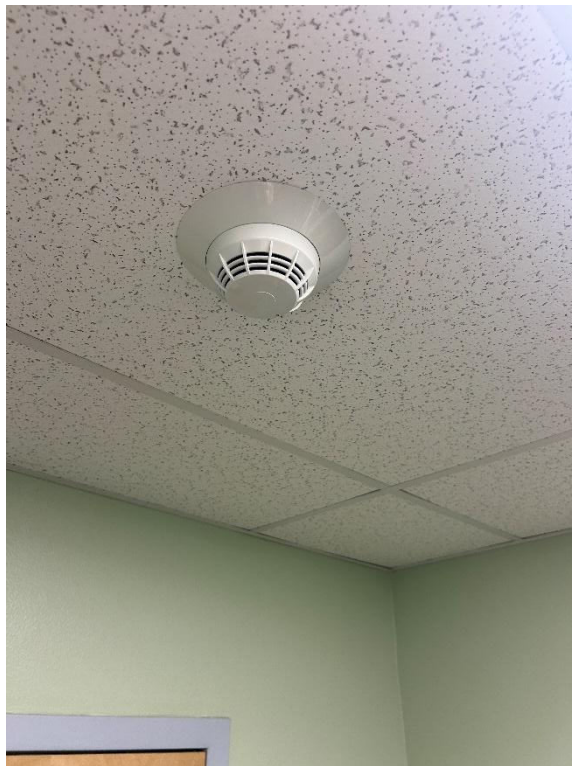
Different tile drop down sampled

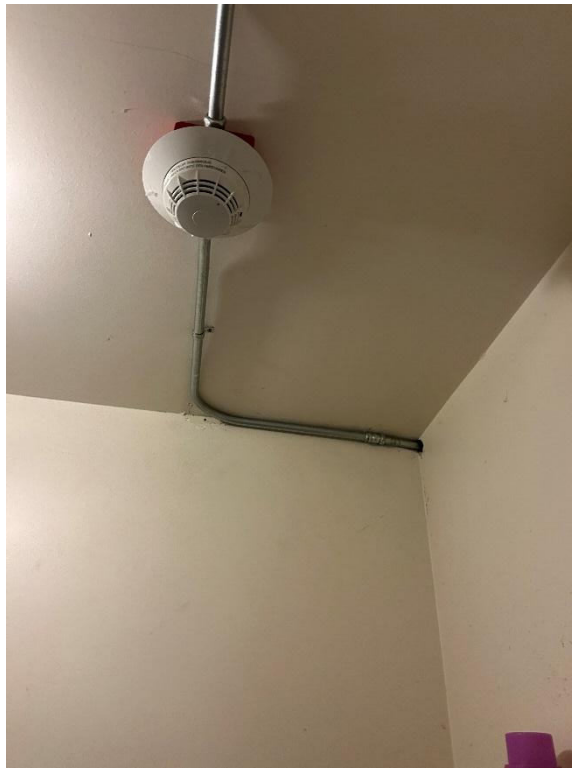
Concrete plaster sampling

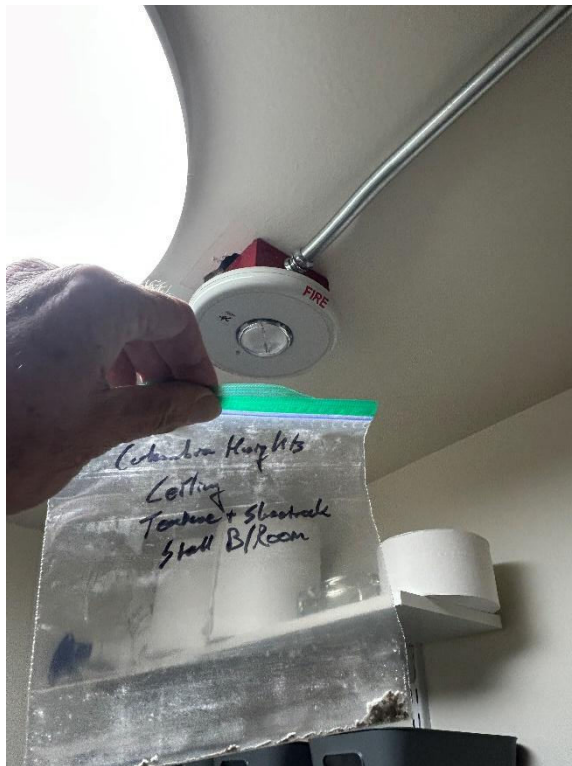
Typical fire sensor sampling location
