DeKalb County School District/Leased/Charter

# The GLOBE Academy at Heritage School

## School Assessment Report

May 20, 2016

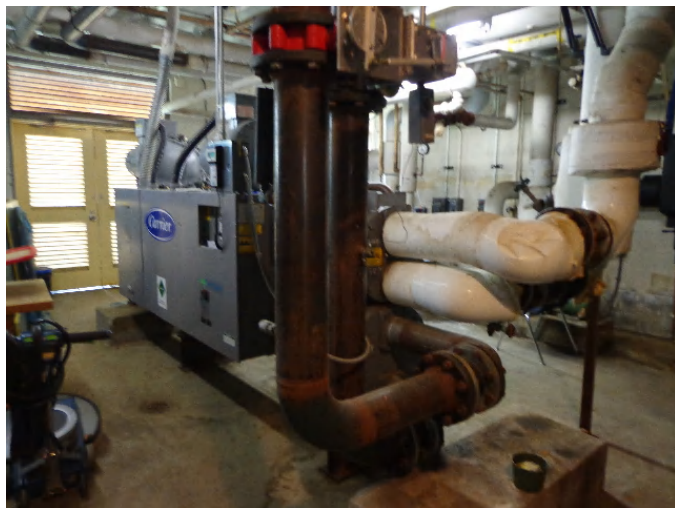
#### System: D3030 - Cooling Generating Systems

**Distress:** Missing

**Notes:** The mechanical room is housing a water cooled chiller and is missing a refrigerant leak detection system, including an audible and visual alarm and mechanical ventilation to the exterior incase of leakage per code requirements.

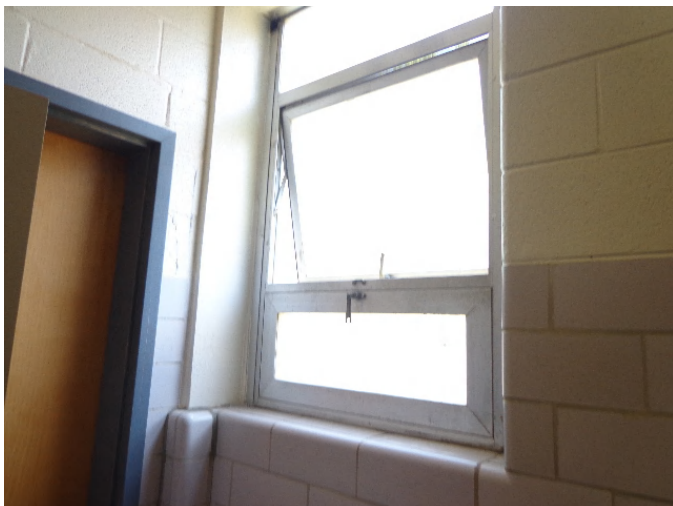
**System: B2020 - Exterior Windows**

**Distress:** Beyond Service Life

**Notes:** The aluminum frame, operable, single pane windows are aged, rusted, not energy efficient, and should be replaced. The windows reportedly leak in a couple of classrooms.

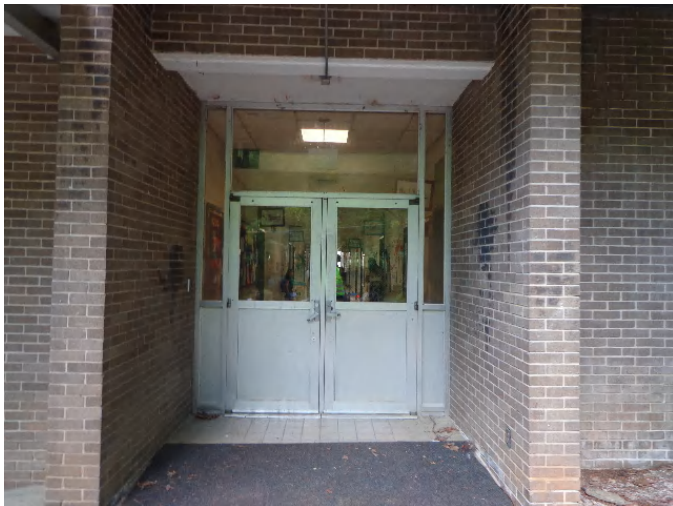
### **System: B2030 - Exterior Doors**

**Distress:** Beyond Service Life

**Notes:** The original exterior doors are aged, inefficient, and should be replaced.

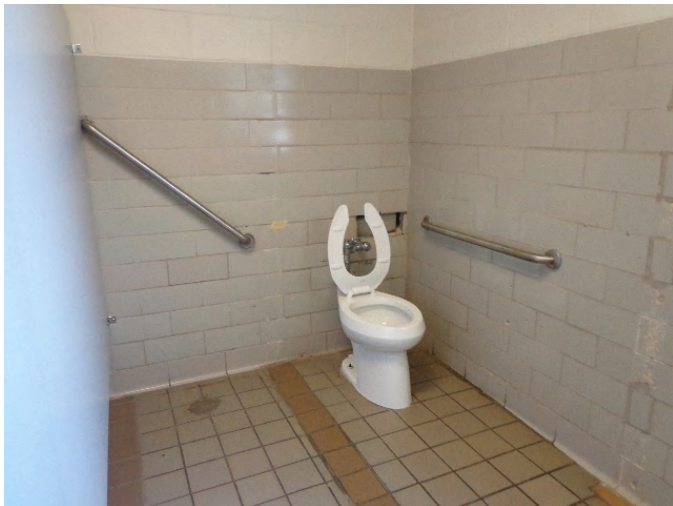
### **System: C1030 - Fittings**

**Distress:** Beyond Service Life

**Notes:** Fittings, including toilet partitions and signage, are aged, inadequate, in marginal condition, and should be replaced. Grab bars and room signage are not ADA compliant. Some handrails at stairs are not ADA-compliant.

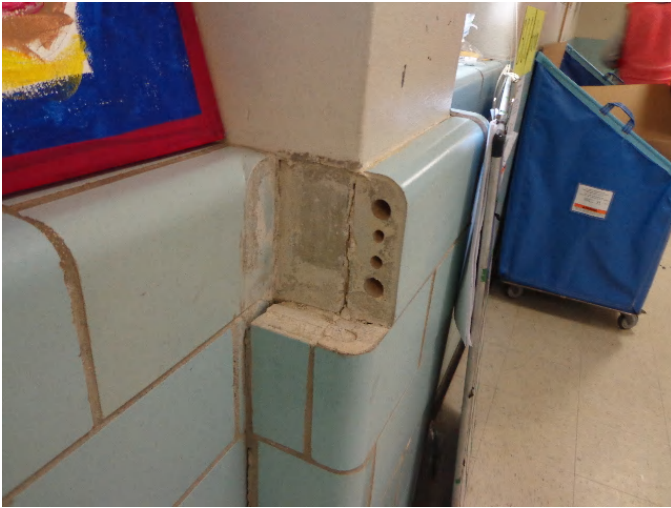
**System: C3010 - Wall Finishes - Ceramic & Glazed**

**Distress:** Beyond Service Life

**Notes:** The ceramic tile wall finishes are original construction, with many sections are damaged and patched, and should be scheduled for replacement.

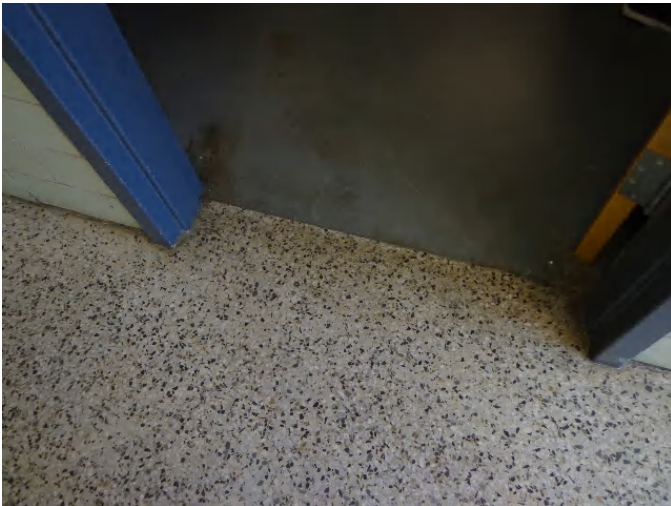
**System: C3020 - Floor Finishes - Epoxy**

**Distress:** Beyond Service Life

**Notes:** The epoxy flooring is aged, worn, and should be replaced.

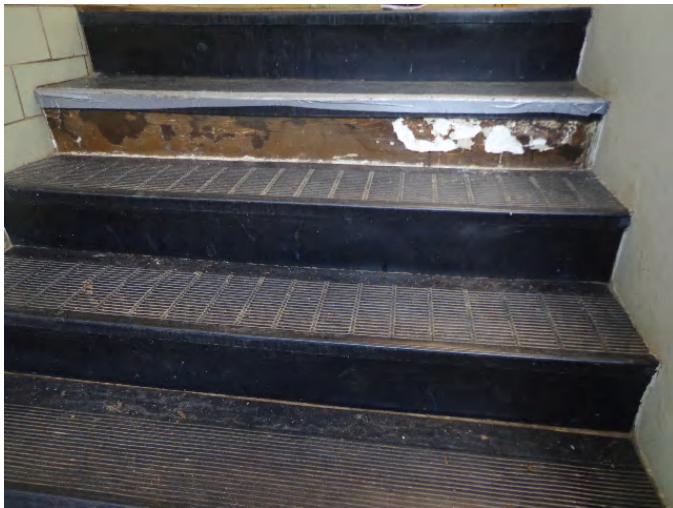
**System: C3020 - Floor Finishes - Rubber**

**Distress:** Beyond Service Life

**Notes:** The rubber flooring on the stairs is aged, damaged and worn, and should be replaced.

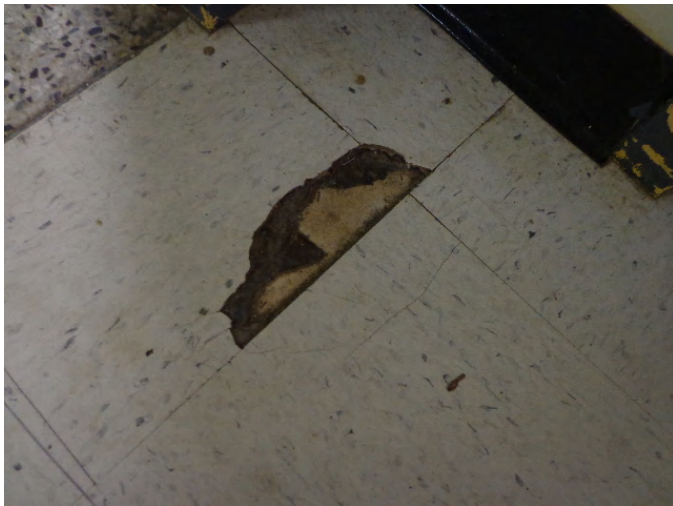
**System: C3020 - Floor Finishes - VCT**

**Distress:** Beyond Service Life

**Notes:** The VCT flooring is aged, cracked, and worn, and should be replaced.

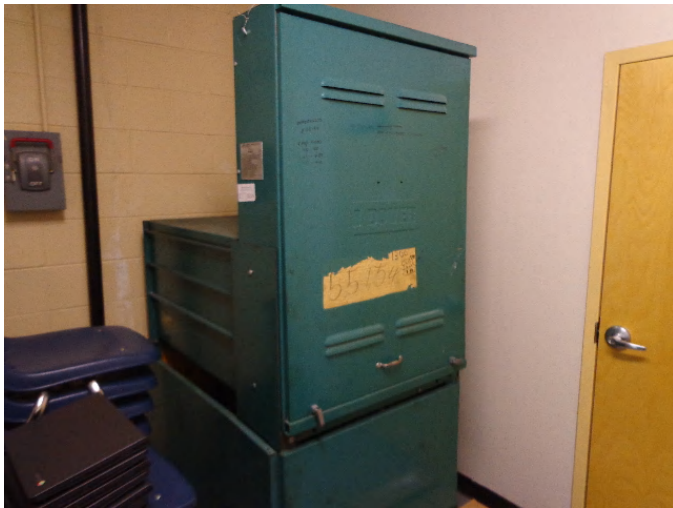
**System: D1010 - Elevators and Lifts**

**Distress:** Beyond Service Life

**Notes:** The elevator is original construction, not ADA-compliant, and should be scheduled for replacement.

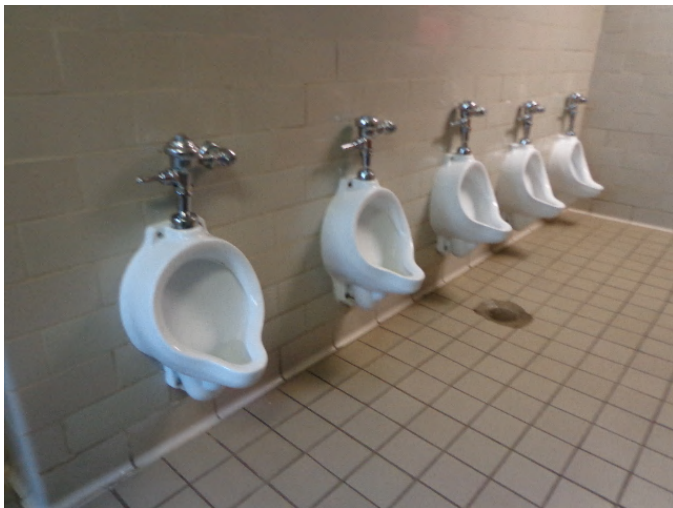
**System: D2010 - Plumbing Fixtures**

**Distress:** Beyond Service Life

**Notes:** The plumbing fixtures are beyond their expected service life and should be replaced.

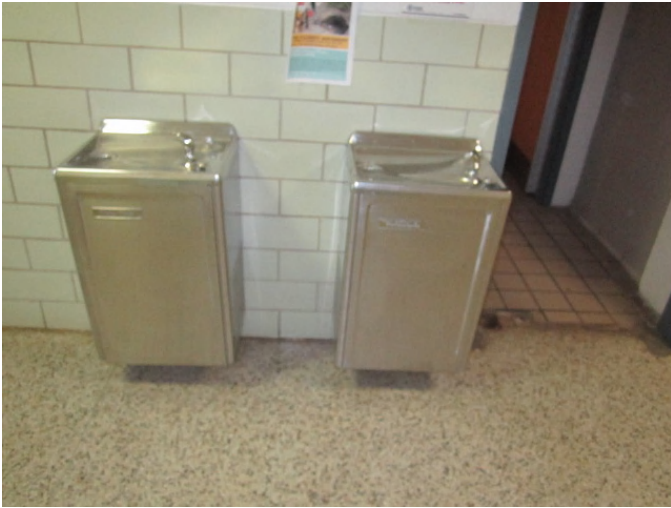
**System: D2010 - Plumbing Fixtures**

**Distress:** Needs Remediation

**Correction:** Remove/replace drinking fountain w/recessed ADA compliant drinking fountain

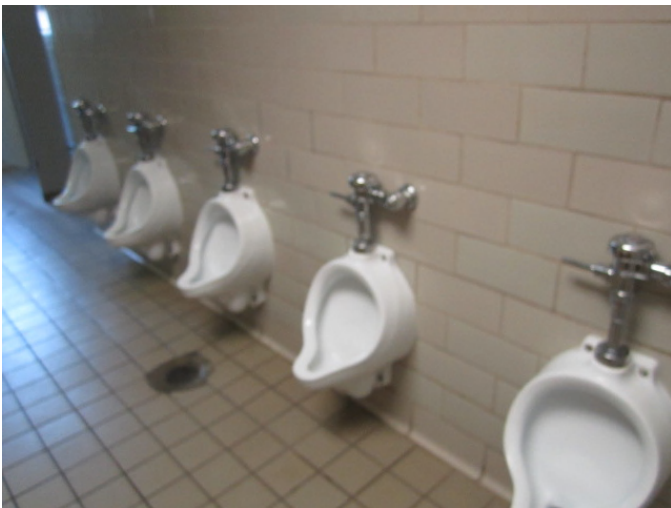
**System: D2020 - Domestic Water Distribution**

**Distress:** Beyond Service Life

**Notes:** The domestic water distribution system is beyond its expected service life and should be scheduled for replacement.

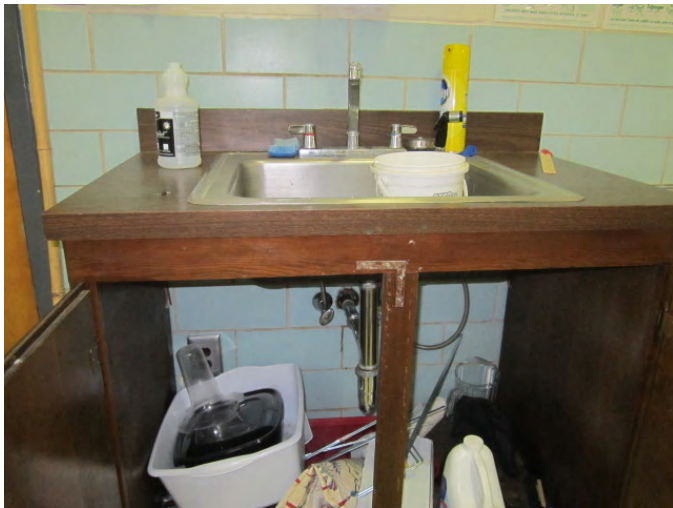
**System: D2030 - Sanitary Waste**

**Distress:** Beyond Service Life

**Notes:** The sanitary waste system is beyond its expected service life and should be scheduled for replacement.

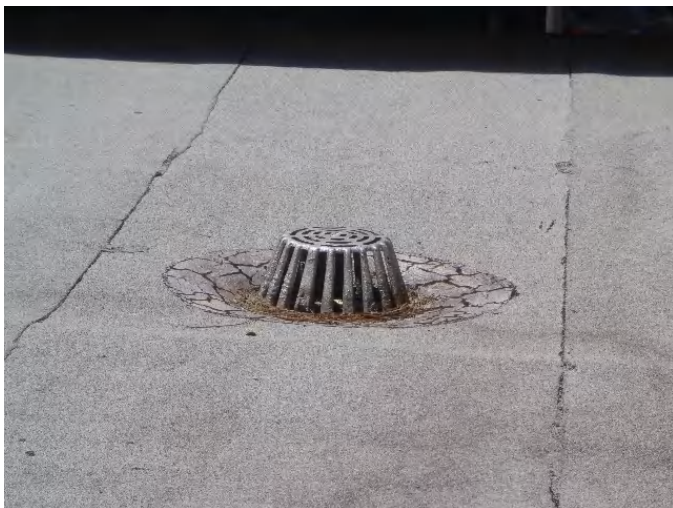
**System: D2040 - Rain Water Drainage**

**Distress:** Beyond Service Life

**Notes:** Rainwater drainage system is beyond its expected service life and should be scheduled for replacement.

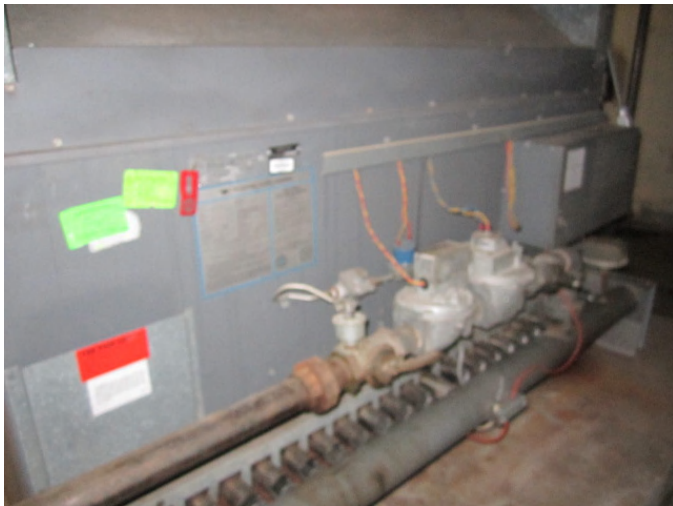
**System: D2090 - Other Plumbing Systems - Natural Gas**

**Distress:** Beyond Service Life

**Notes:** The natural gas service is beyond its expected service life and should be scheduled for replacement.

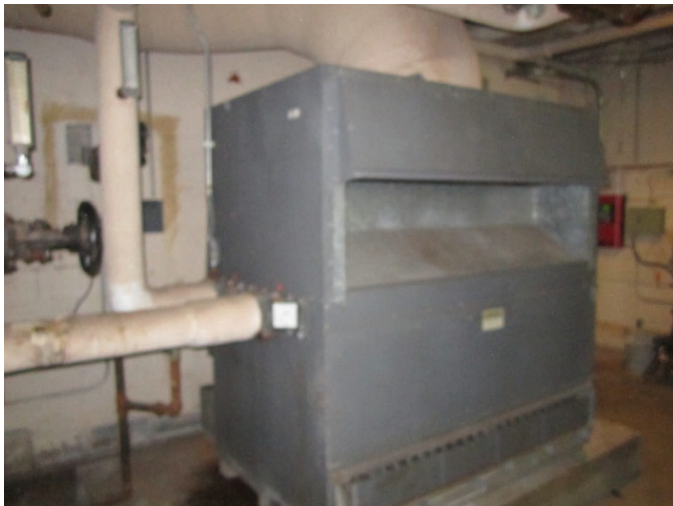
**System: D3020 - Heat Generating Systems**

**Distress:** Beyond Service Life

**Notes:** The original boiler is beyond its expected service life and should be scheduled for replacement.

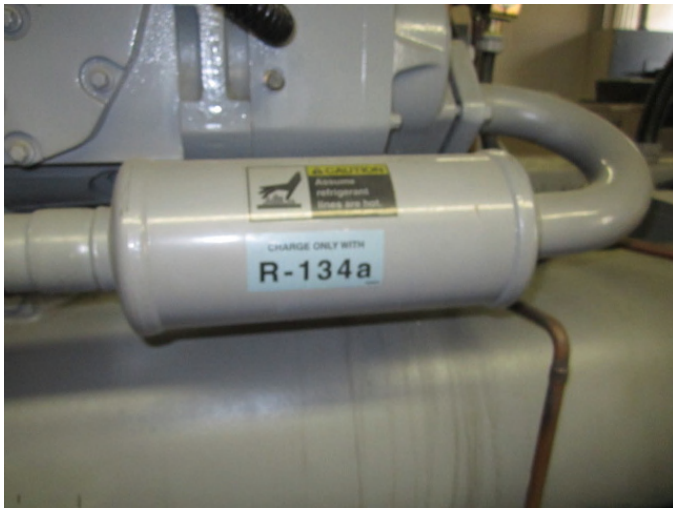
**System: D3040 - Distribution & Exhaust Systems**

**Distress:** Missing

**Notes:** Indoor chiller is lacking refrigerant leak detection and related purge ventilation, which is required per code.

**Correction:** Replace roof mounted exhaust fan, 8500 CFM exhaust fan

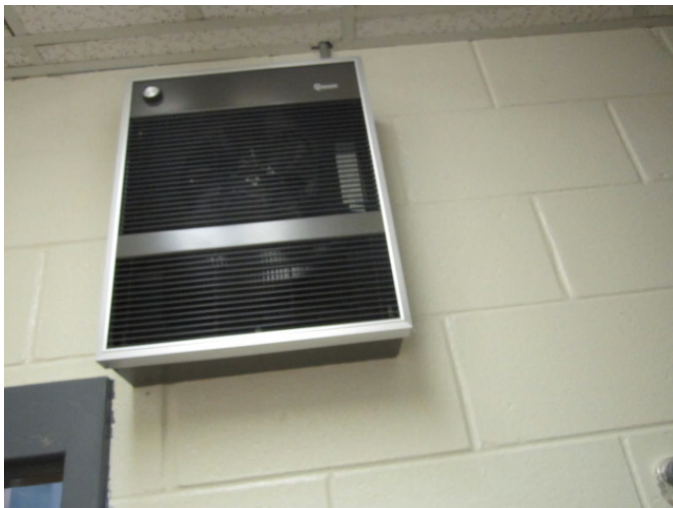
**System: D3050 - Terminal & Package Units**

**Distress:** Beyond Service Life

**Notes:** Terminal and package units are beyond their expected service life and should be scheduled for replacement.

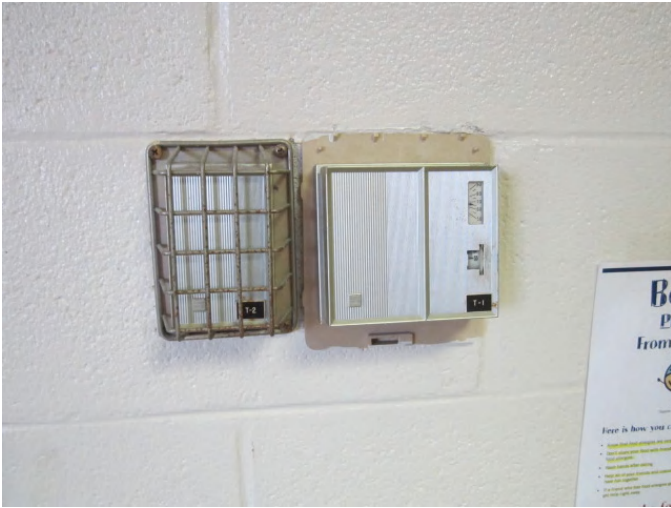
**System: D3060 - Controls & Instrumentation**

**Distress:** Beyond Service Life

**Notes:** Controls and instrumentation are beyond their expected service life, inadequate, and should be scheduled for replacement.

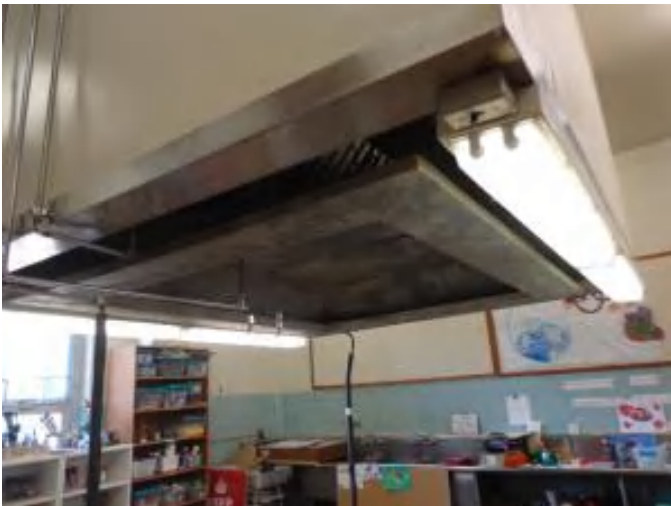
**System: D3090 - Other HVAC Systems/Equip - Kitchen Hood**

**Distress:** Beyond Service Life

**Notes:** The original kitchen hood and exhaust system is aged and should be replaced.

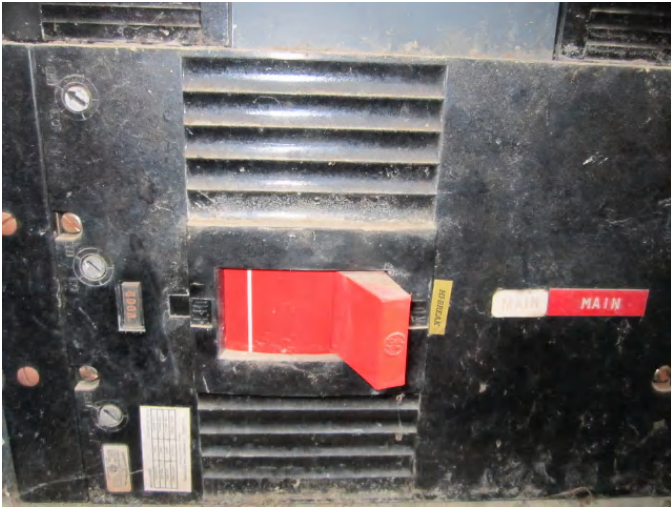
**System: D5010 - Electrical Service/Distribution**

**Distress:** Beyond Service Life

**Notes:** The electrical service/distribution system is beyond its expected service life, inadequate, and should be scheduled for replacement.

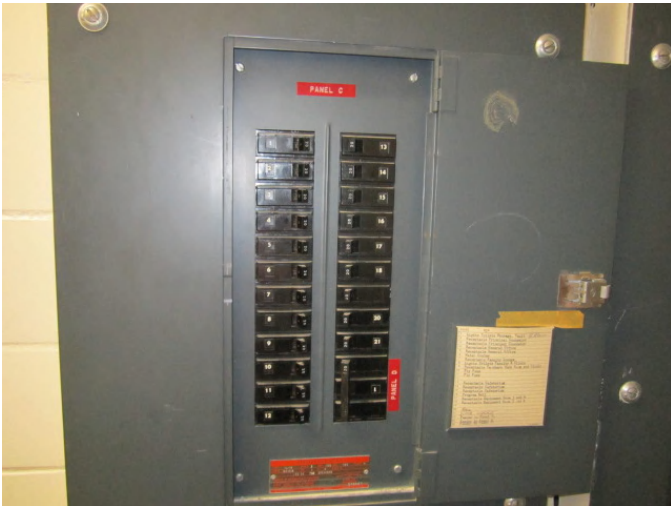
**System: D5020 - Branch Wiring**

**Distress:** Beyond Service Life

**Notes:** Branch wiring is beyond its expected service life, inadequate, and should be scheduled for replacement. Electrical outlets are not GFI in wet areas.

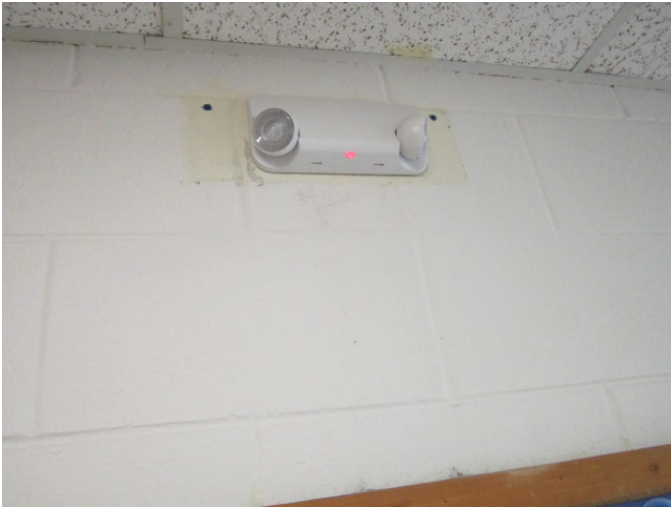
### **System: D5020 - Lighting**

**Distress:** Beyond Service Life

**Notes:** Lighting is beyond its expected service life, inefficient, and should be scheduled for replacement.

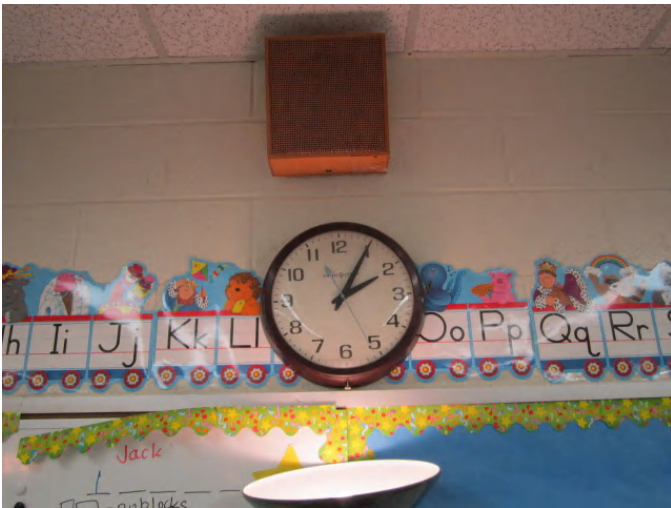
### **System: D5030 - Communications and Security - Clock & PA Systems**

**Distress:** Beyond Service Life

**Notes:** Clock and PA systems are beyond their expected service life and should be scheduled for replacement.

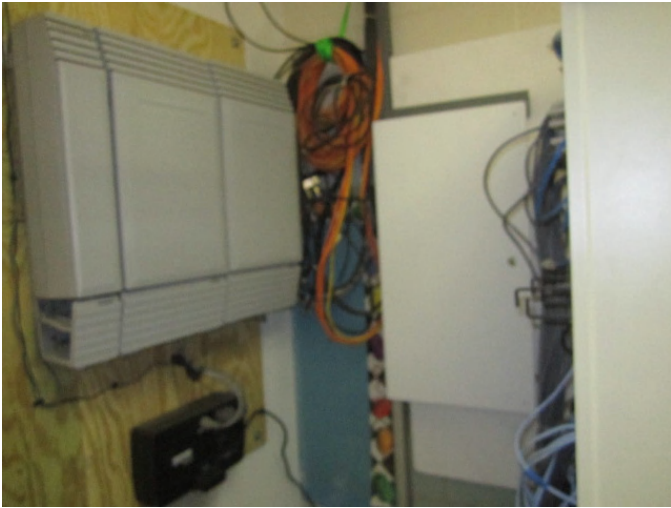
**System: D5030 - Communications and Security - Data Systems**

**Location:** Throughout Building  
**Distress:** Beyond Service Life  
**Category:** Deferred Maintenance  
**Priority:** 3 Priority  
**Correction:** Renew System  
**Qty:** 35,132.00  
**Unit of Measure:** S.F.  
**Estimate:** \$107,820.00  
**Assessor Name:** Eduardo Lopez  
**Date Created:** 08/13/2015

**Notes:** Data systems are beyond their expected service life and should be scheduled for replacement.

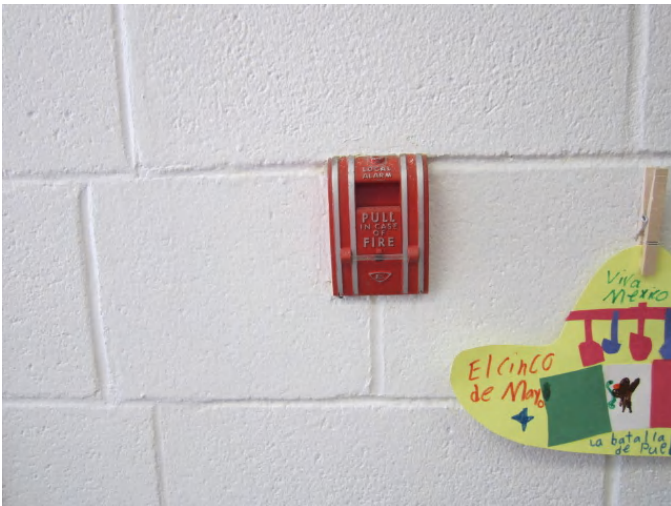
**System: D5030 - Communications and Security - Fire Alarm**

**Location:** Throughout Building  
**Distress:** Beyond Service Life  
**Category:** Deferred Maintenance / Accessibility Code Compliance  
**Priority:** 3 Priority  
**Correction:** Renew System  
**Qty:** 35,132.00  
**Unit of Measure:** S.F.  
**Estimate:** \$47,534.00  
**Assessor Name:** Eduardo Lopez  
**Date Created:** 04/11/2015

**Notes:** The fire alarm system is beyond its expected service life, not ADA-compliant, and should be scheduled for replacement.

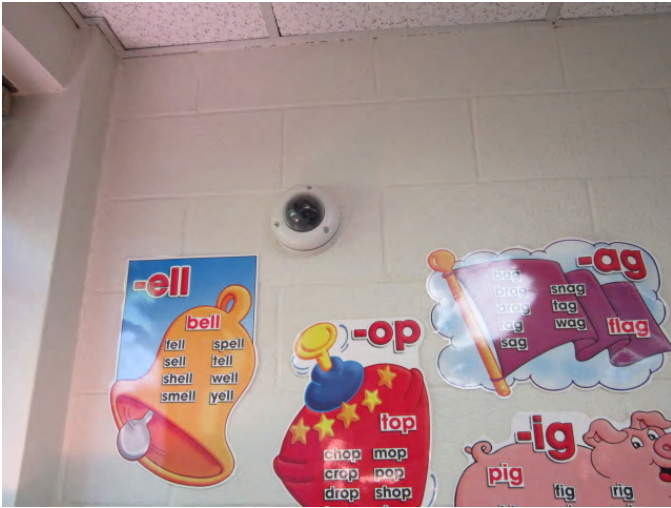
**System: D5030 - Communications and Security - Security & CCTV**

**Distress:** Beyond Service Life

**Notes:** The security and CCTV system is beyond its expected service life, does not perform adequately, and should be scheduled for replacement.

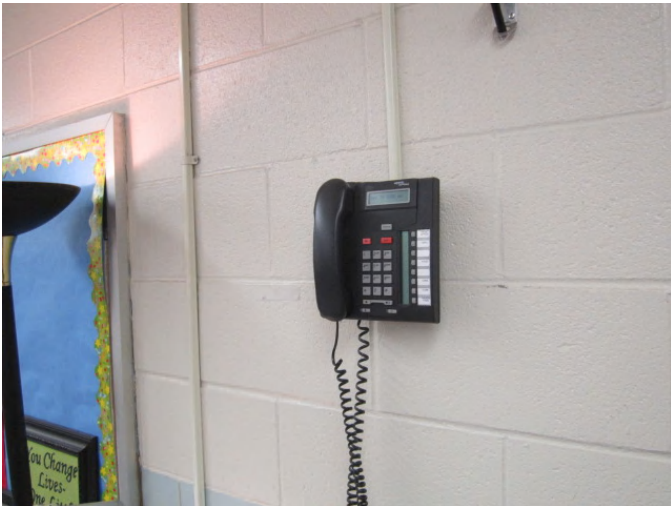
**System: D5030 - Communications and Security - Telephone**

**Distress:** Beyond Service Life

**Notes:** The telephone system is beyond its expected service life and should be scheduled for replacement.

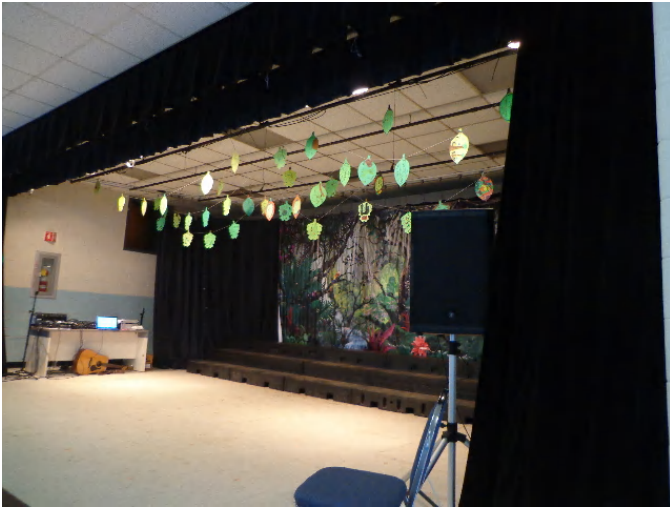
**System: E1020 - Institutional Equipment**

**Distress:** Beyond Service Life

**Notes:** Institutional equipment, such as theater and stage equipment, is aged and should be replaced.

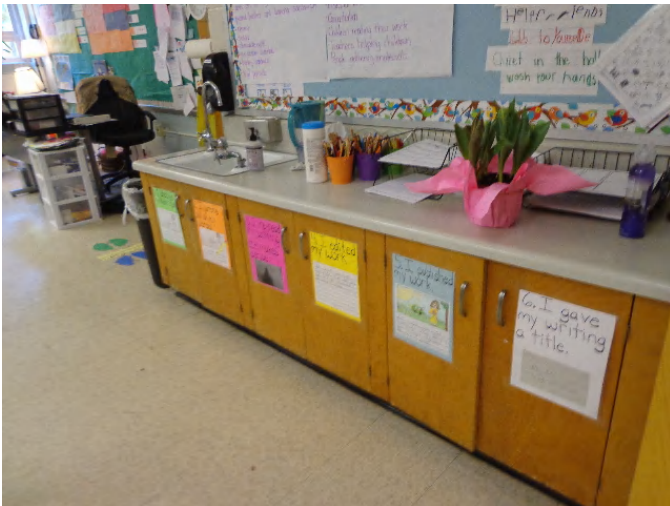
**System: E2010 - Fixed Furnishings**

**Distress:** Beyond Service Life

**Notes:** Fixed furnishing, such as fixed casework and window treatment, are beyond their expected service life and should be scheduled for replacement.

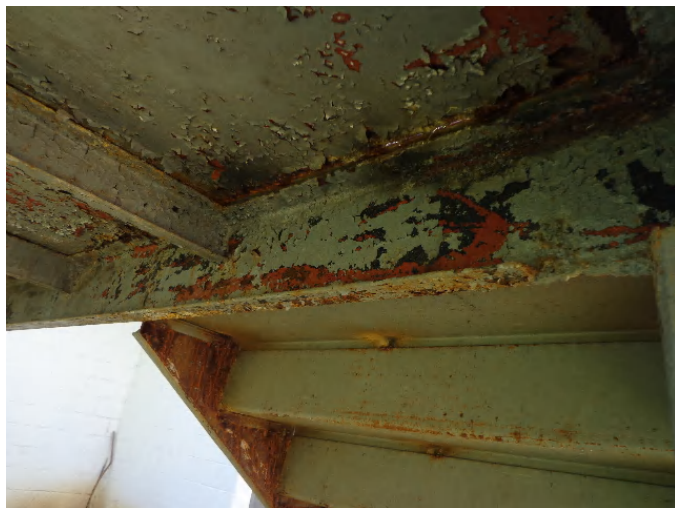
**System: F1010 - Special Structures**

**Distress:** Beyond Service Life

**Notes:** Ramp between buildings is aged, in deteriorating condition, rusting, and should be replaced.

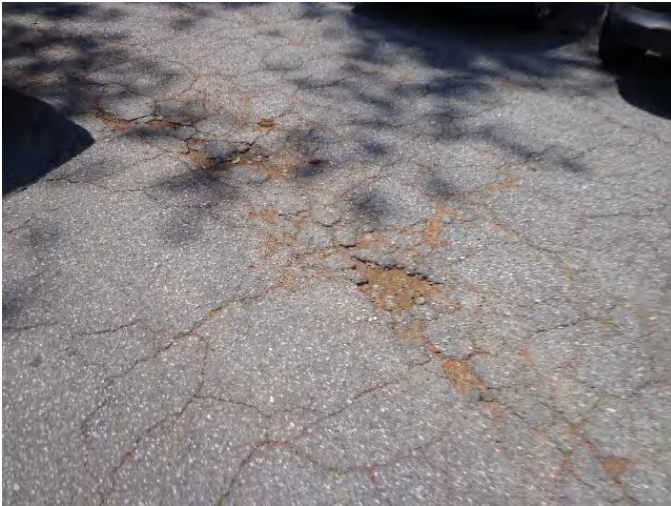
#### System: G2010 - Roadways

**Distress:** Beyond Service Life

**Notes:** The roadways are aged, with many cracks, and should be re-surfaced.

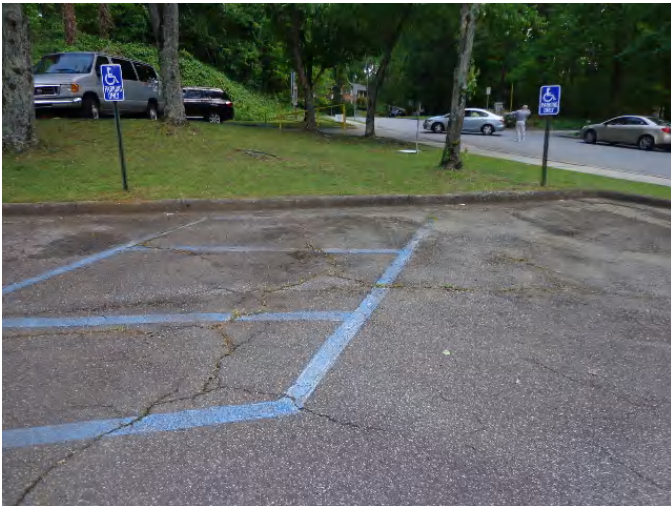
#### System: G2020 - Parking Lots

**Distress:** Beyond Service Life

**Notes:** The parking lot is aged, with many cracks, and should be re-surfaced and re-striped. Add signage directing people to accessible parking and accessible building entrance.

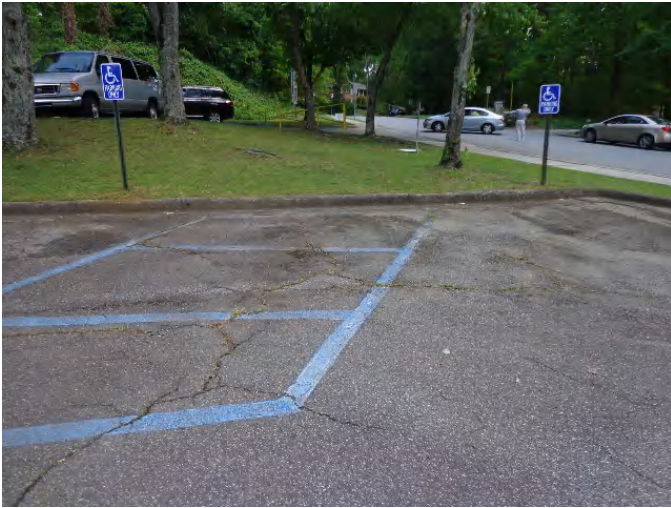
**System: G2020 - Parking Lots**

**Distress:** Missing

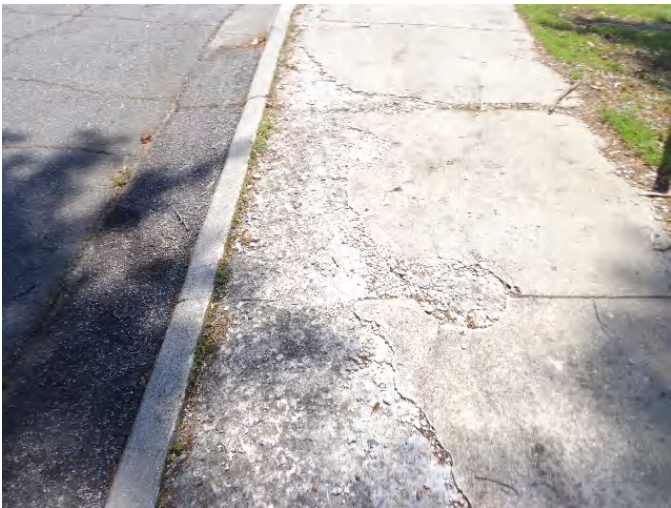
**System: G2030 - Pedestrian Paving**

**Distress:** Beyond Service Life

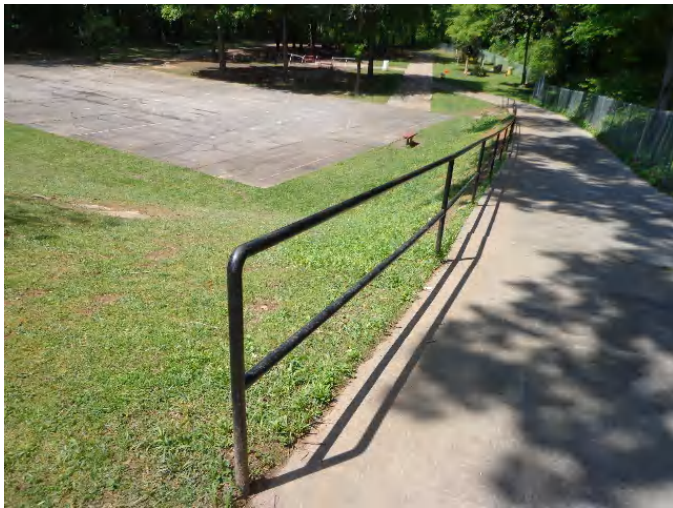
**System: G2030 - Pedestrian Paving**

**Distress:** Inadequate

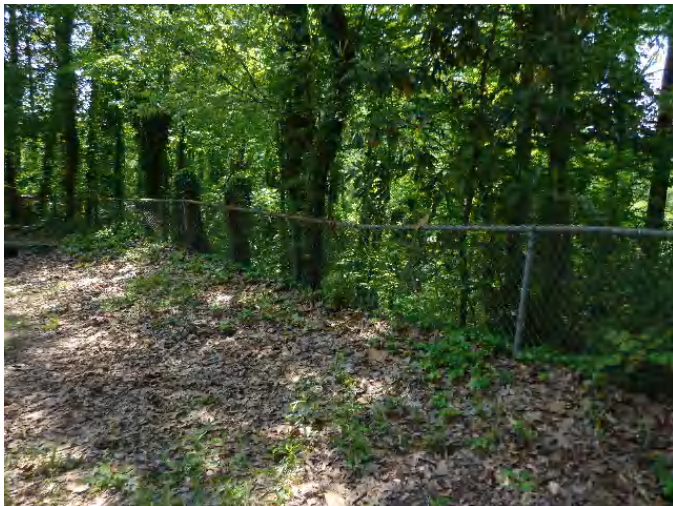
**System: G2040 - Fencing & Guardrails**

**Distress:** Beyond Service Life

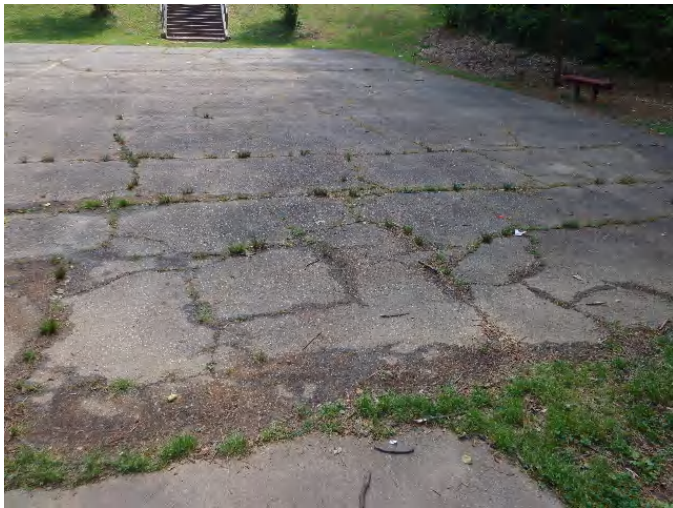
**System: G2040 - Hard Surface Play Area**

**Distress:** Beyond Service Life

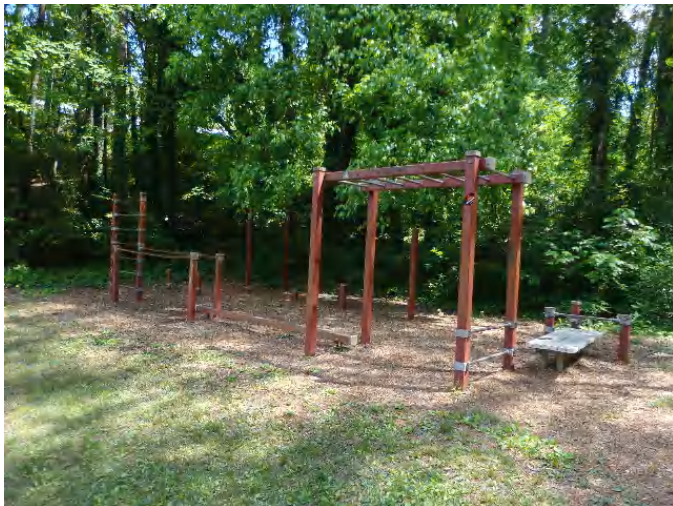
**System: G2040 - Playing Field**

**Distress:** Beyond Service Life

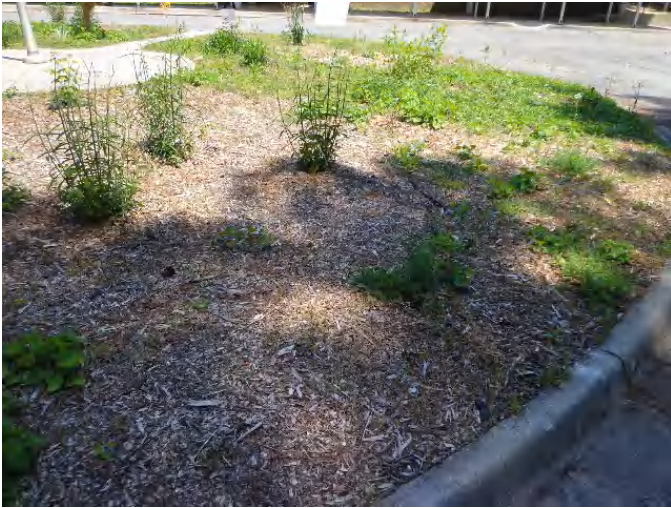
**System: G2050 - Landscaping**

**Distress:** Beyond Service Life

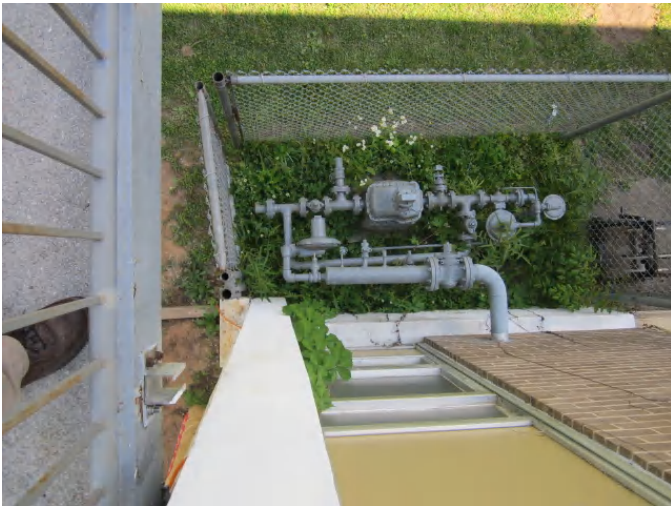
**System: G3060 - Fuel Distribution -Nat Gas**

**Distress:** Beyond Service Life

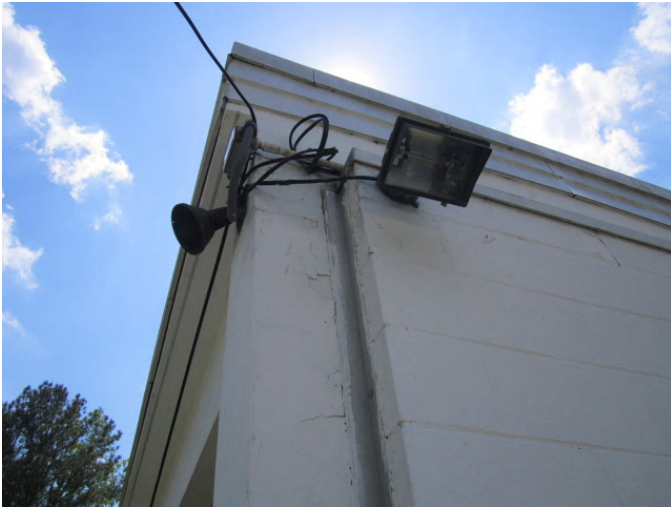
**System: G4020 - Site Lighting**

**Distress:** Beyond Service Life

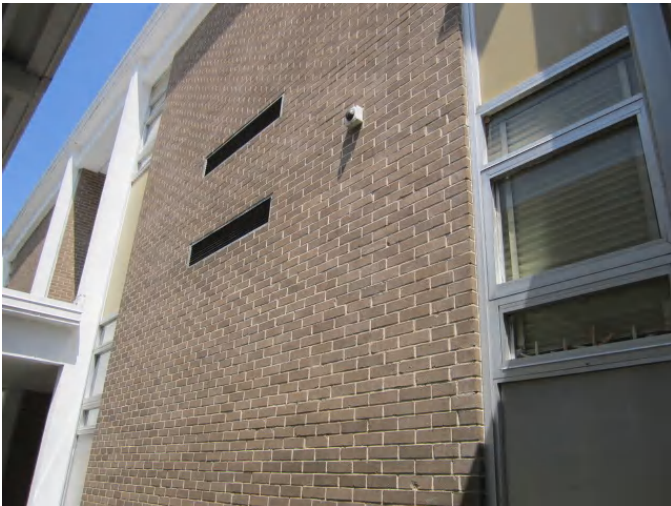
**System: G4030 - Site Communications & Security**

**Distress:** Beyond Service Life
