**DeKalb County School District/Middle Schools**

# **Lithonia Middle**

## **School Assessment Report**

**May 20, 2016**

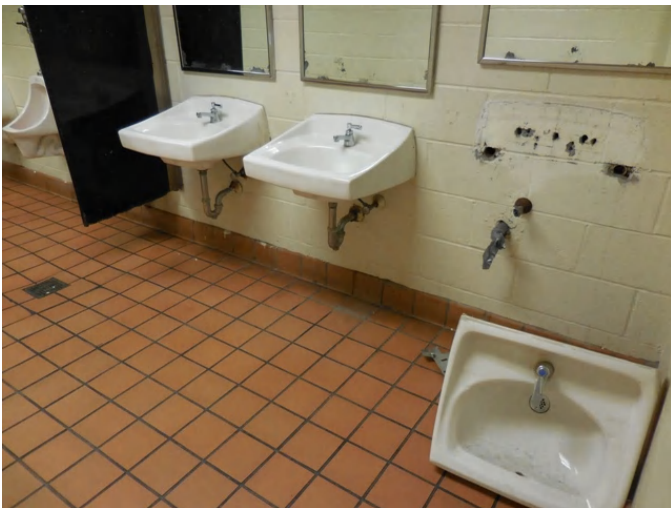
**Location:** Mens Restroom

**Distress:** Damaged

**Notes:** Lavatory sink is broken in the men's restroom and should be replaced. SPLOST project 119-422 to provide hall restroom renovations.

**Correction:** Replace lavatory, vitreous china

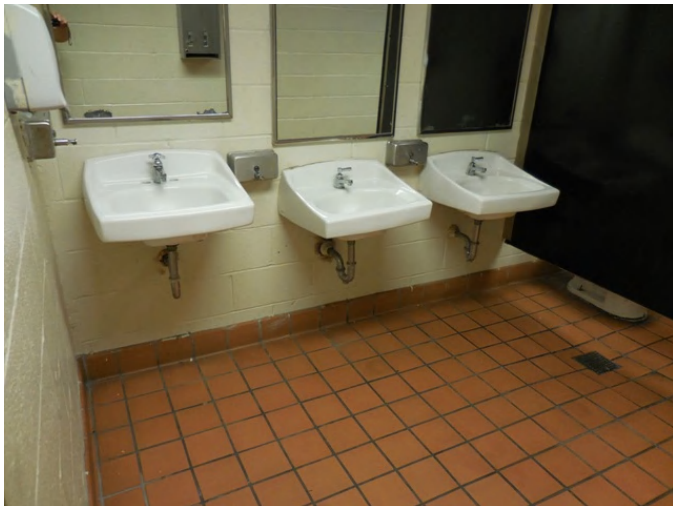
**Location:** Restrooms

**Distress:** Missing

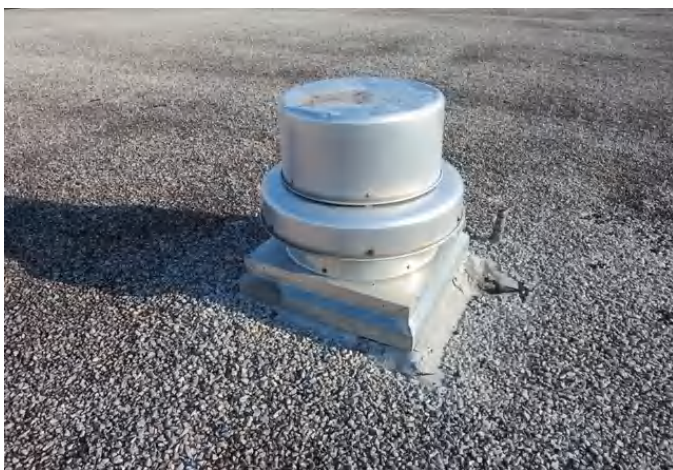
**Location:** Roof

**Distress:** Damaged

**Notes:** Exhaust units have been vandalized, resulting in no exhaust circulation in the restrooms throughout the building. System should be scheduled for replacement and measures should be take to prevent unauthorized access to the roof.

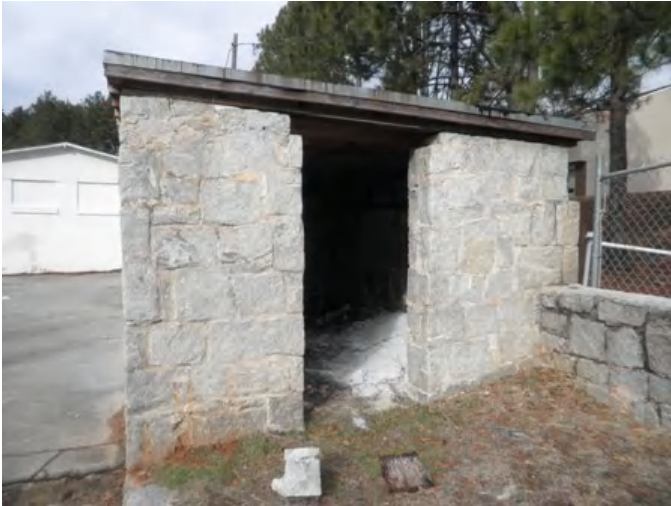
**Location:** Exterior Wall

**Distress:** Missing

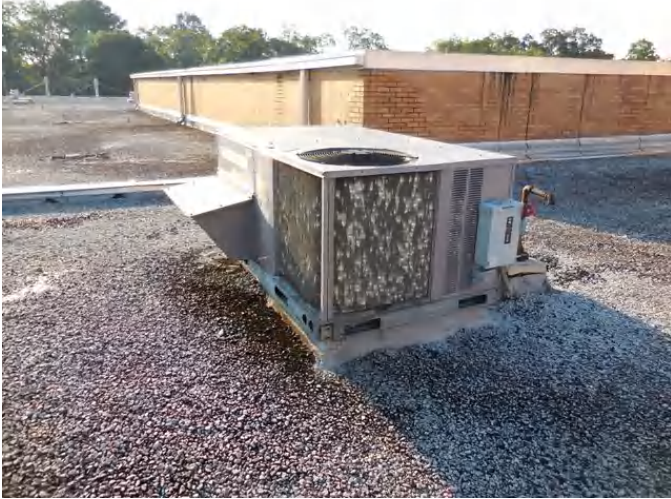
**Location:** Roof  
**Distress:** Damaged  
**Category:** Deferred Maintenance  
**Priority:** 3 Priority  
**Correction:** Renew System  
**Qty:** 124,627.00  
**Unit of Measure:** S.F.  
**Estimate:** \$2,538,901.00  
**Assessor Name:** Sam Mandola  
**Date Created:** 08/13/2015

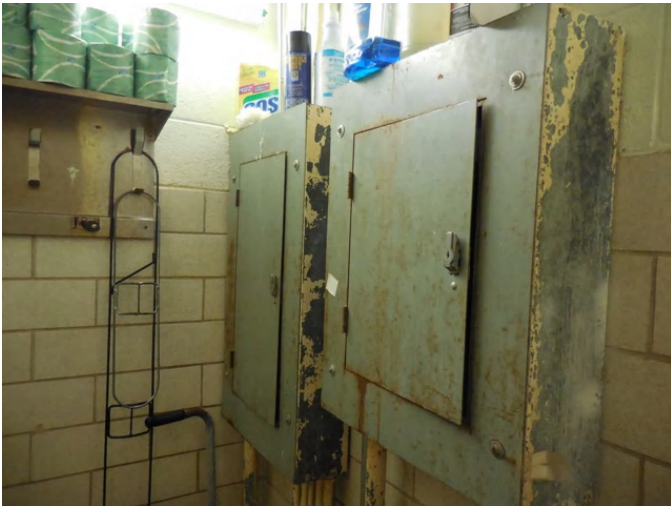
**Location:** Throughout Building  
**Distress:** Beyond Service Life  
**Category:** Deferred Maintenance  
**Priority:** 3 Priority  
**Correction:** Renew System  
**Qty:** 124,627.00  
**Unit of Measure:** S.F.  
**Estimate:** \$758,106.00  
**Assessor Name:** Eduardo Lopez  
**Date Created:** 08/13/2015

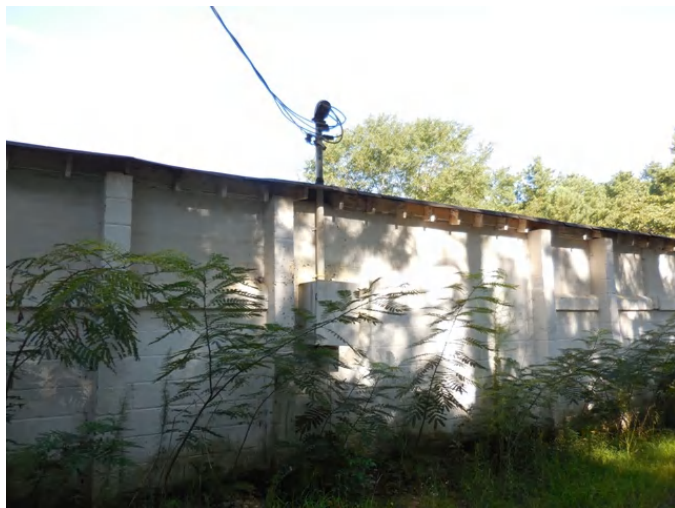
**Location:** Throughout Building  
**Distress:** Beyond Service Life  
**Category:** Deferred Maintenance  
**Priority:** 3 Priority  
**Correction:** Renew System  
**Qty:** 1,125.00  
**Unit of Measure:** S.F.  
**Estimate:** \$3,787.00  
**Assessor Name:** Eduardo Lopez  
**Date Created:** 04/11/2015

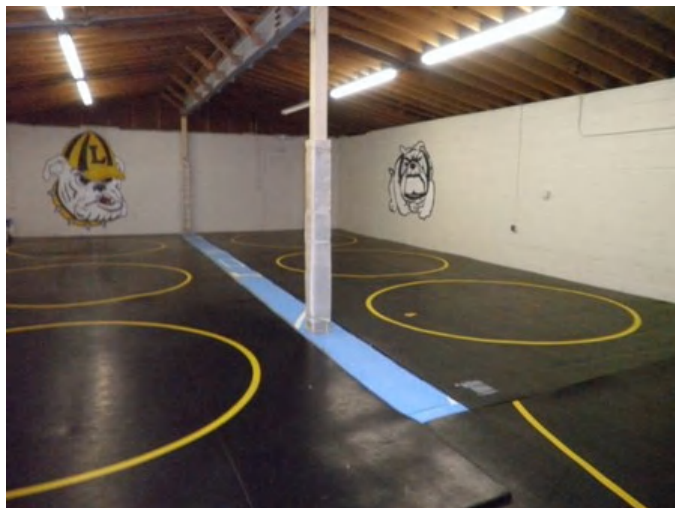
**Location:** Throughout Building  
**Distress:** Beyond Service Life  
**Category:** Deferred Maintenance  
**Priority:** 3 Priority  
**Correction:** Renew System  
**Qty:** 1,125.00  
**Unit of Measure:** S.F.  
**Estimate:** \$15,555.00  
**Assessor Name:** Eduardo Lopez  
**Date Created:** 04/11/2015

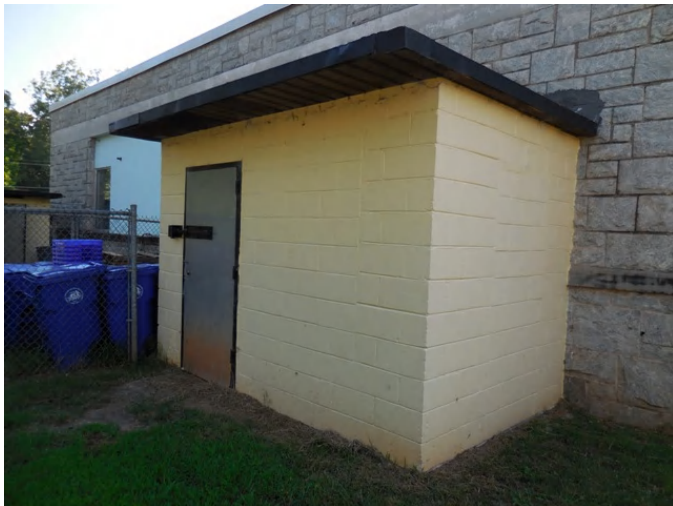
**Location:** Exterior Wall  
**Distress:** Beyond Service Life  
**Category:** Deferred Maintenance  
**Priority:** 3 Priority  
**Correction:** Renew System  
**Qty:** 77.00  
**Unit of Measure:** S.F.  
**Estimate:** \$440.00  
**Assessor Name:** Sam Mandola  
**Date Created:** 09/16/2015

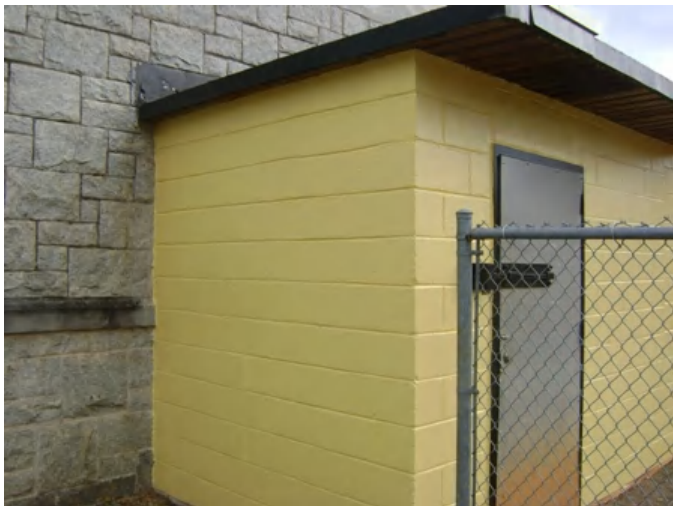
**Location:** Roof  
**Distress:** Beyond Service Life  
**Category:** Deferred Maintenance  
**Priority:** 3 Priority  
**Correction:** Renew System  
**Qty:** 77.00  
**Unit of Measure:** S.F.  
**Estimate:** \$1,422.00  
**Assessor Name:** Sam Mandola  
**Date Created:** 04/11/2015
