# DRUID HILLS HIGH SCHOOL MODERNIZATION REPORT

## MODERNIZATION REPORT

The Modernization Report catalogs facility deficiencies in the current facility. Deficiencies are classified as follows:

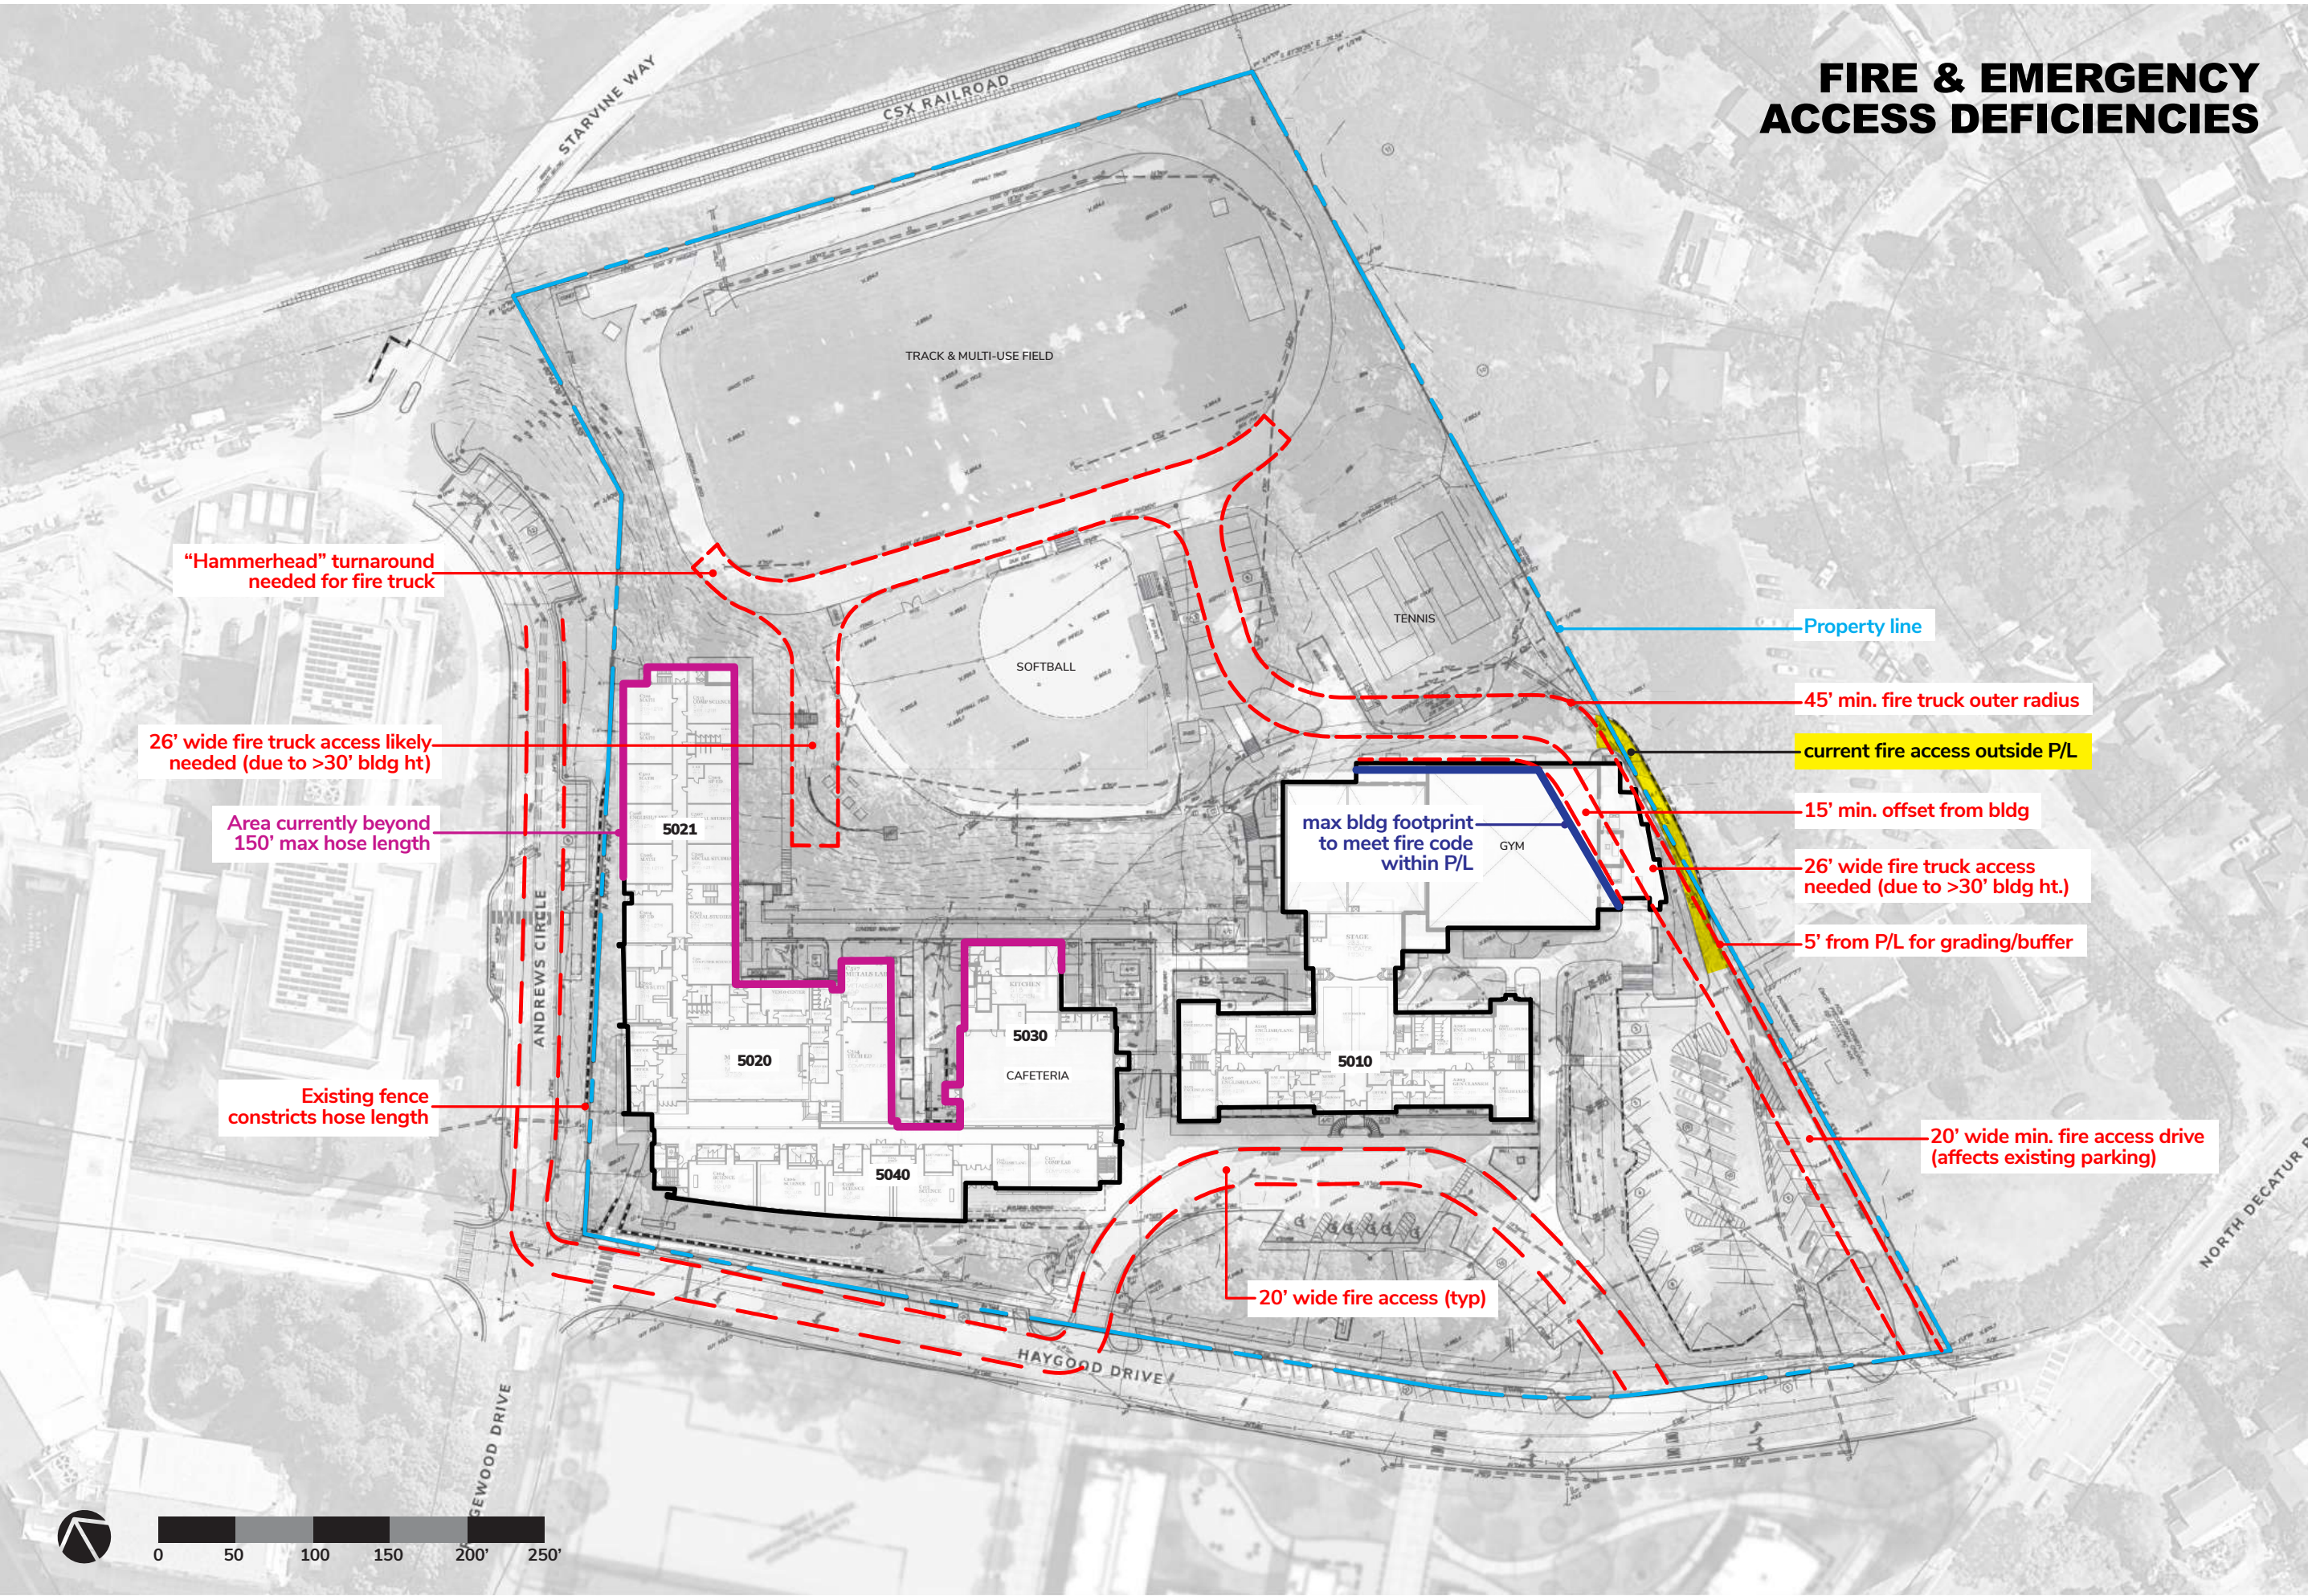
# FIRE & EMERGENCY ACCESS DEFICIENCIES

"Hammerhead" turnaround needed for fire truck

26' wide fire truck access likely needed (due to >30' bldg ht)

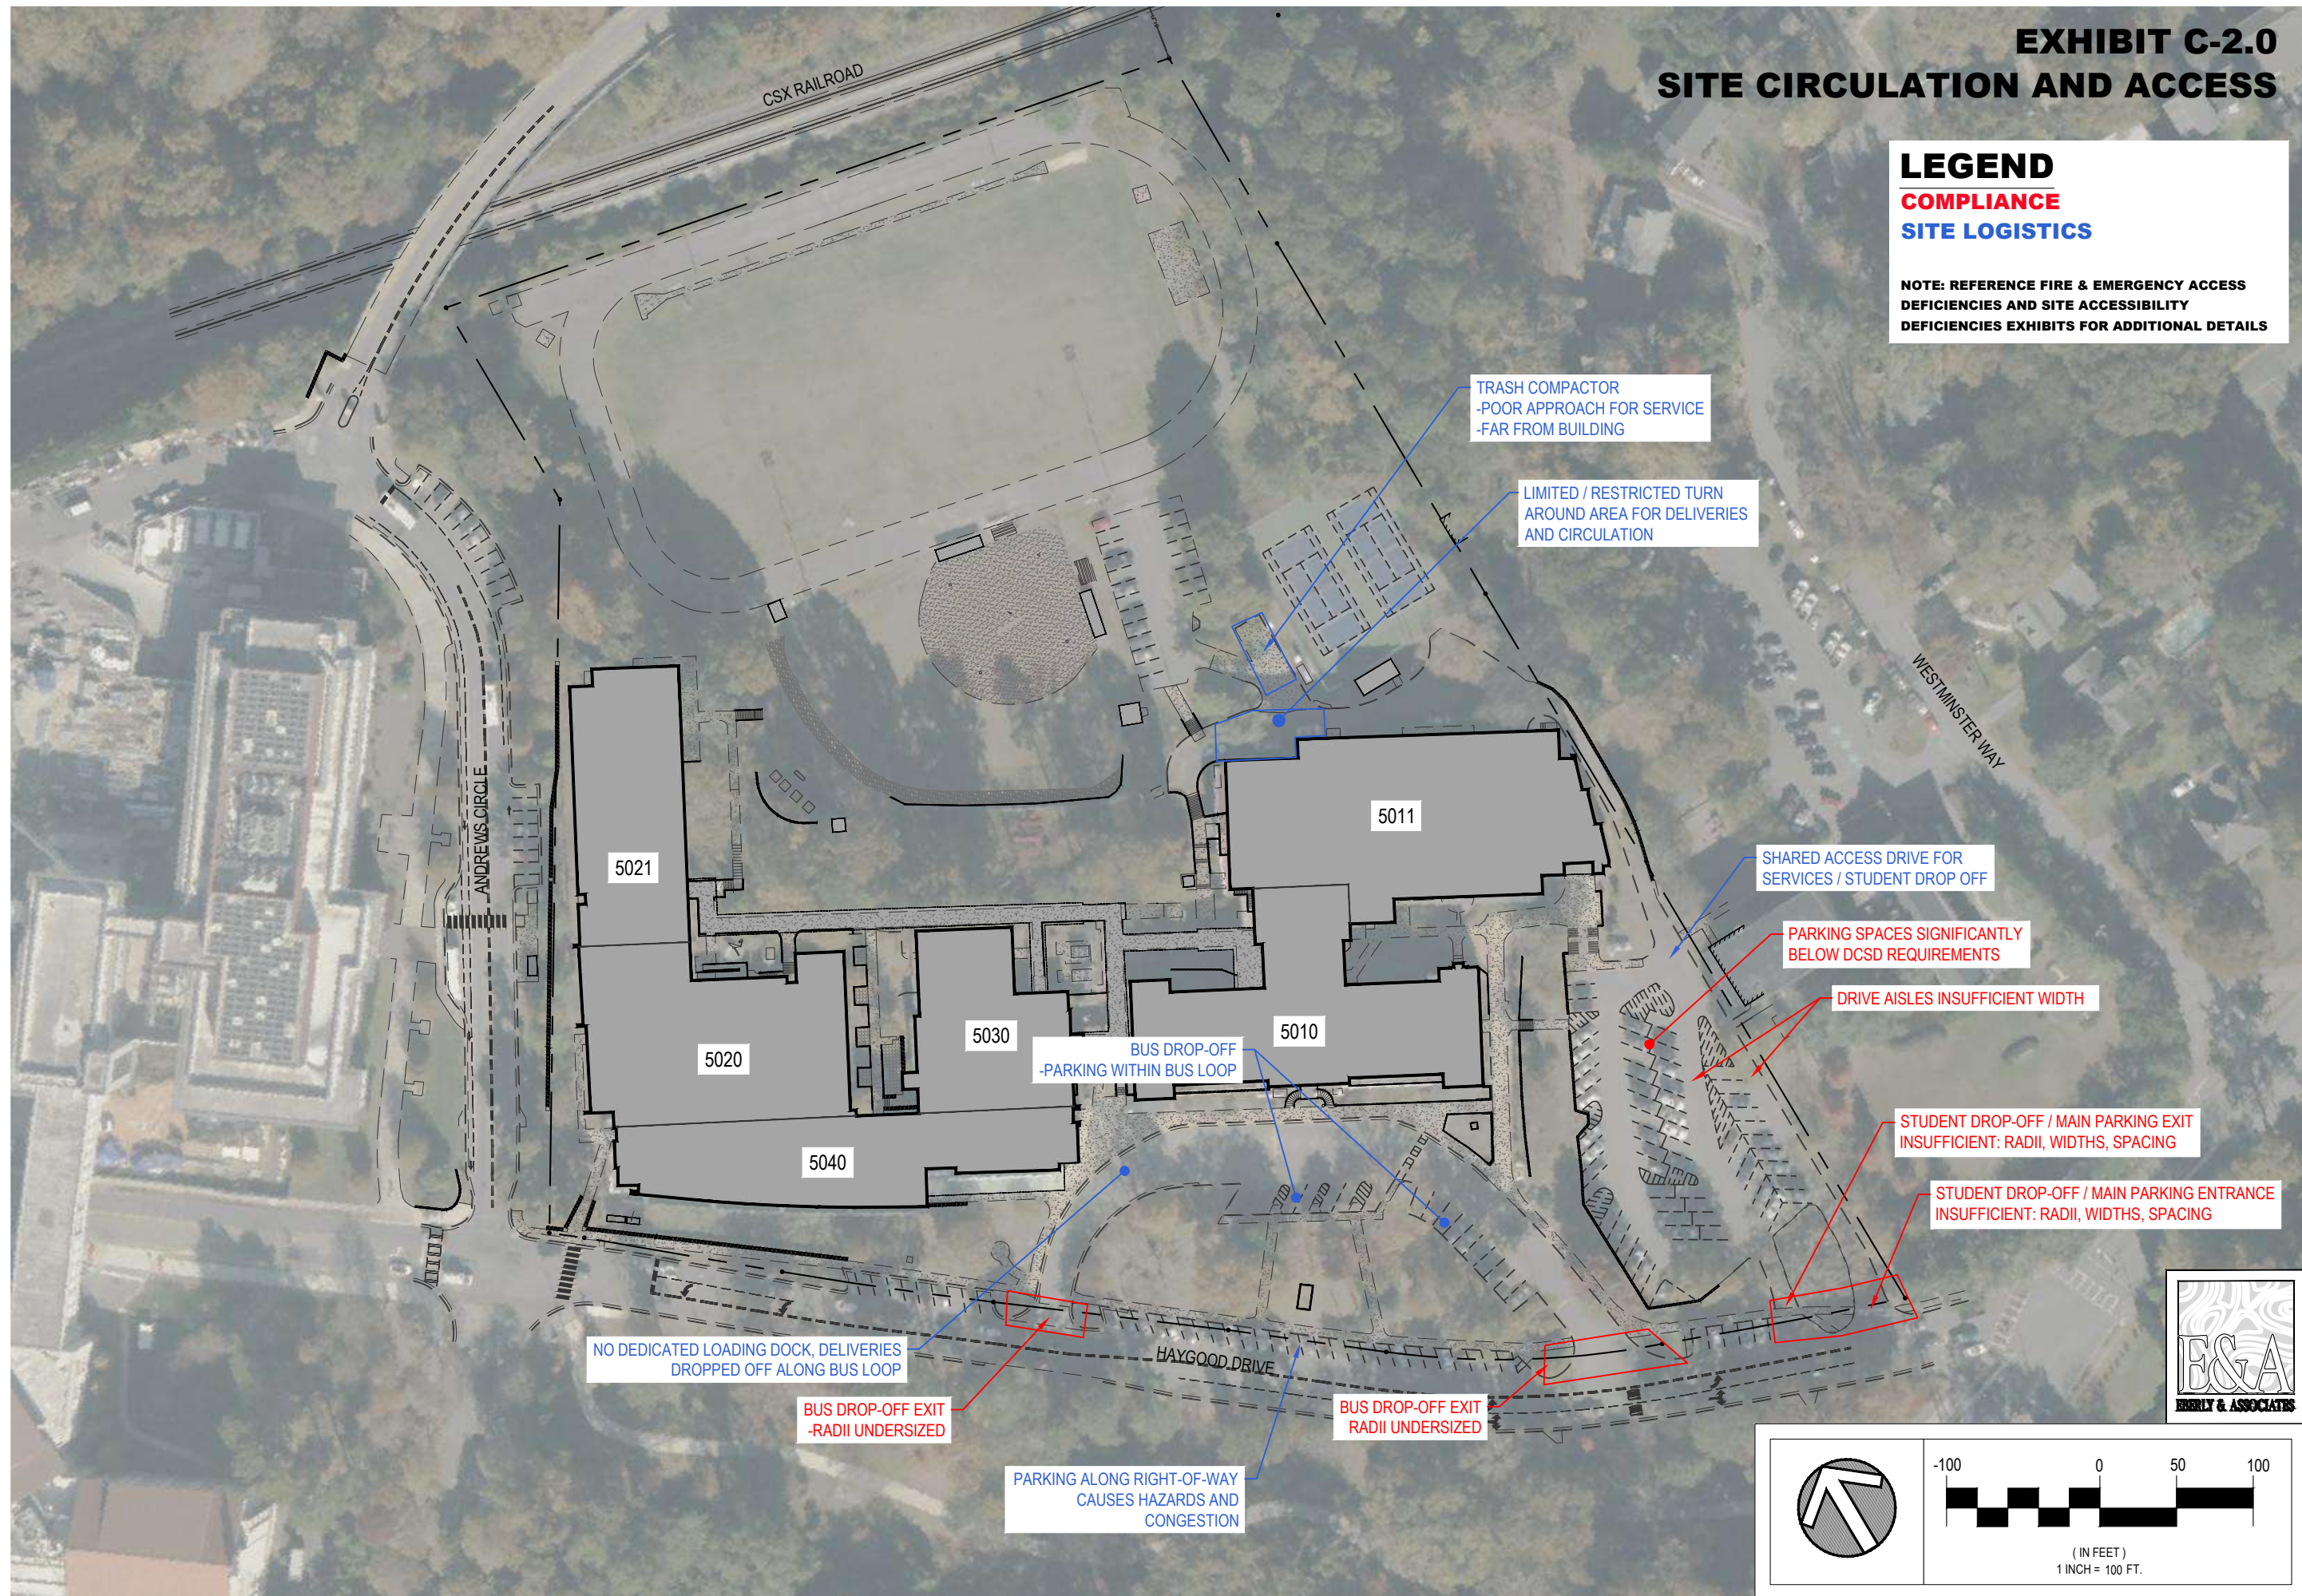
**EXHIBIT C-3.0**

EXACT AGE OF WATER & SEWER LINES UNKNOWN DUE TO MISSING AS-BUILTS, BUT IT APPEARS THAT PORTIONS OF WATER, SEWER, ELECTRICAL AND STORM FROM ORIGINAL 1927 CONSTRUCTION MAY EXIST ON SITE.

8" SEWER LINE (±1927)  
-NO RECORDS INDICATE RENOVATION  
OR REPLACEMENT TO LINE

STORM STRUCTURES WITHIN  
FIELD PLAY AREA POSE  
TRIPPING AND INJURY HAZARD

EXISTING DROP INLET IN POOR  
CONDITION & FULL OF DEBRIS

POOR DRAINAGE CONDITIONS  
WITHIN COURTYARD

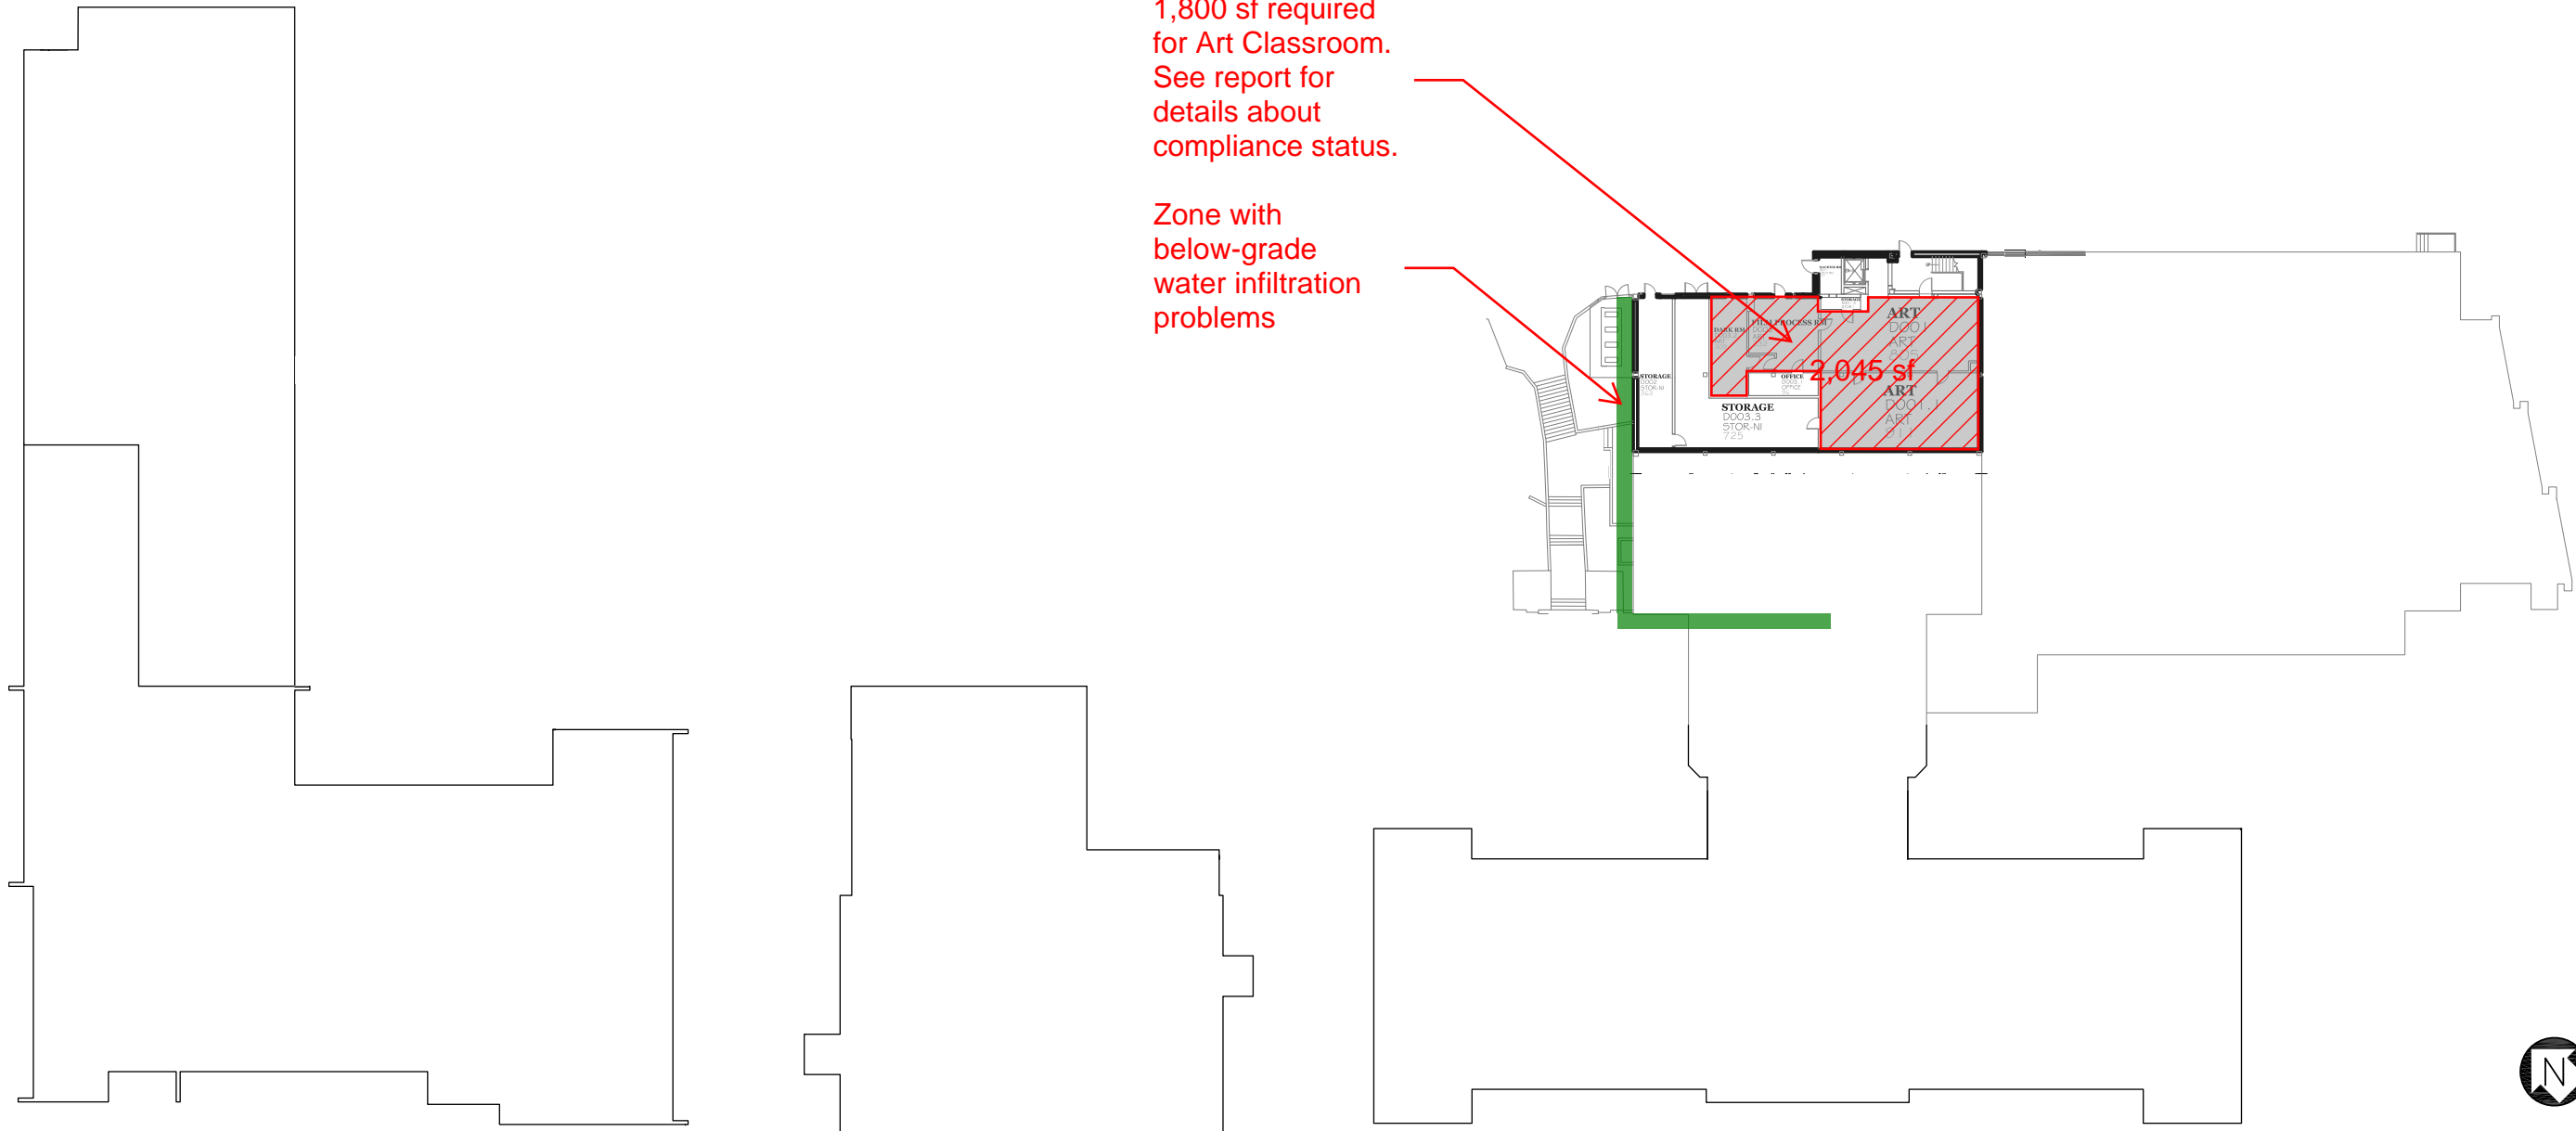
Zone with below-grade water infiltration problems

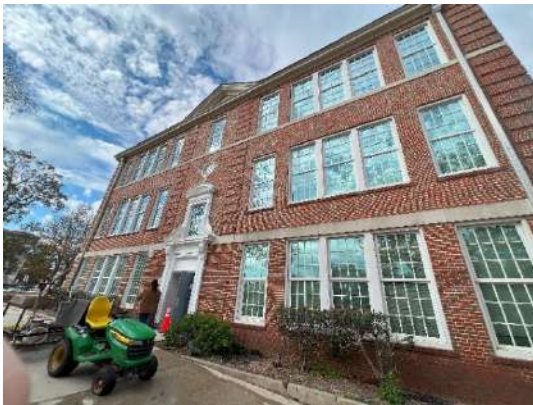
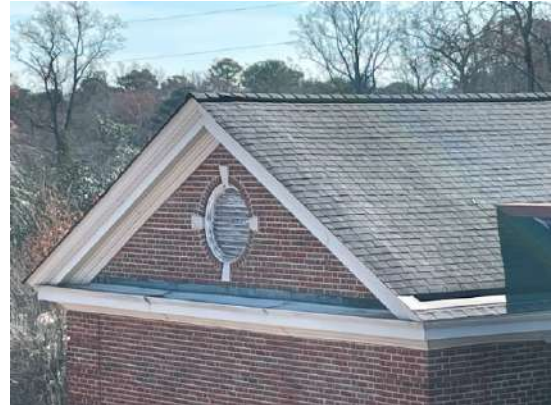
1. The round wood louvers are experiencing peeling paint and appear to have rotten areas. Replace the four round louvers with more durable material.
2. Windows should be checked and caulked if necessary, but are otherwise in good condition.

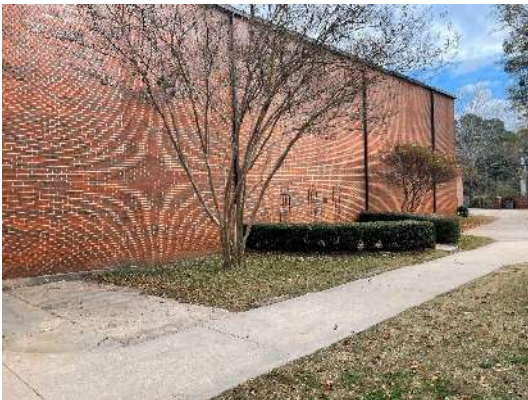
1. There has been and is evidence of former moisture infiltration along this wall of the gym and classrooms below. This entire wall should be excavated and waterproofed to below the foundations.

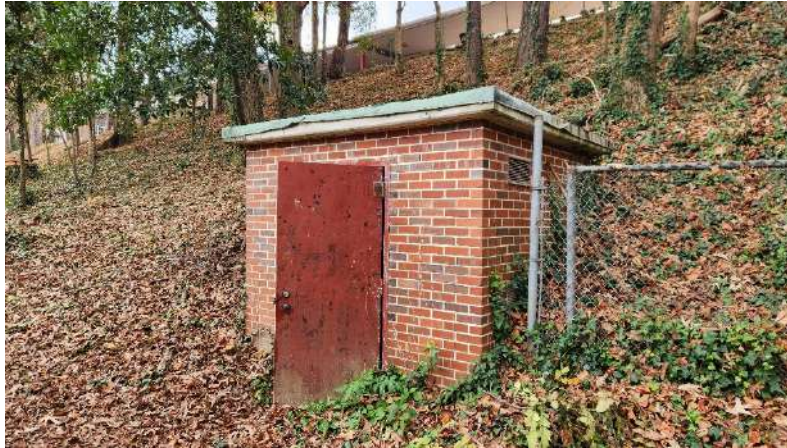
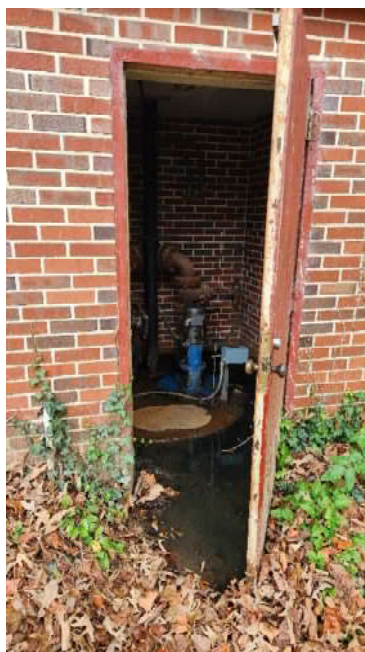
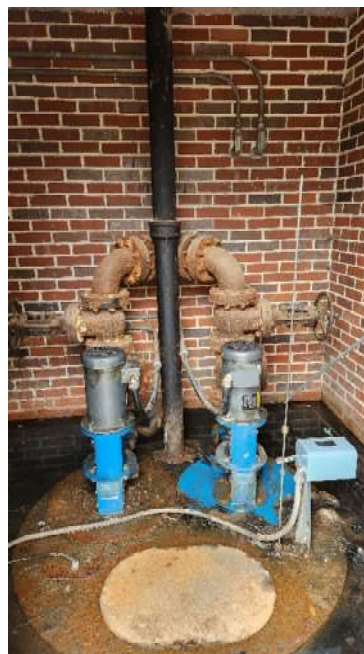
2. Near the lit station there is a large underutilized space with old gym equipment and a stone wall. This area has poor drainage and was observed to have standing water during rain events. Large rain events may have sewage contamination in this area. Unmaintained equipment could be considered hazardous to users and visitors.

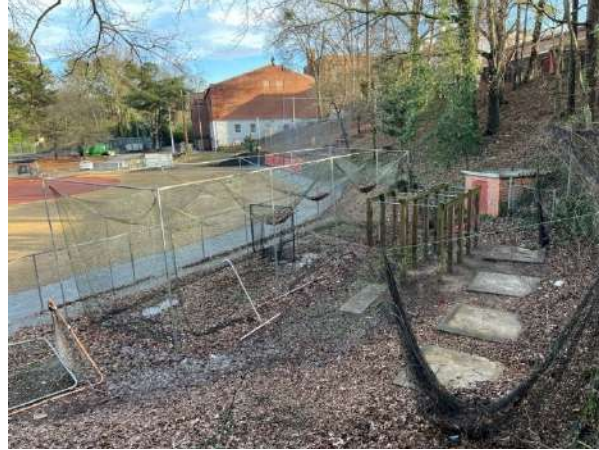
3. Bleachers are placed along the slope near the softball field. **This bleacher area does not have ADA access.**
4. Along the central covered walkway, three outdoor spaces house large mechanical equipment. **The equipment is loud and significantly decreases the quality and useability of outdoor space.**
5. At the front of the campus, there are many picnic tables that are in a mulched landscape area. This area is highly used by students, teachers, staff, and visitors and does not have full ADA access.

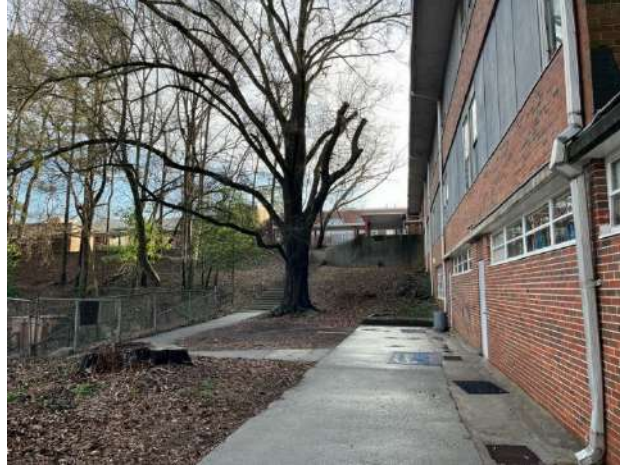
- b. Several trees have been cut down and large stumps have been left in place. In some locations, the stumps are a tripping hazard in the walkways.
- 3. The courtyard space between buildings 5030 and 5020 includes severe erosion, poor drainage, clogged area drains/catch basins and destabilized landscape. This space has high usage during cafeteria hours based on the number of picnic tables and amount of wear of the site space. The space has 10 picnic tables that hold 8 people per table – roughly accommodating about 80 students. This space also serves as site circulation for the campus with high foot traffic and therefore mud and erosion. This deteriorated landscape clogs area drains and catch basins.

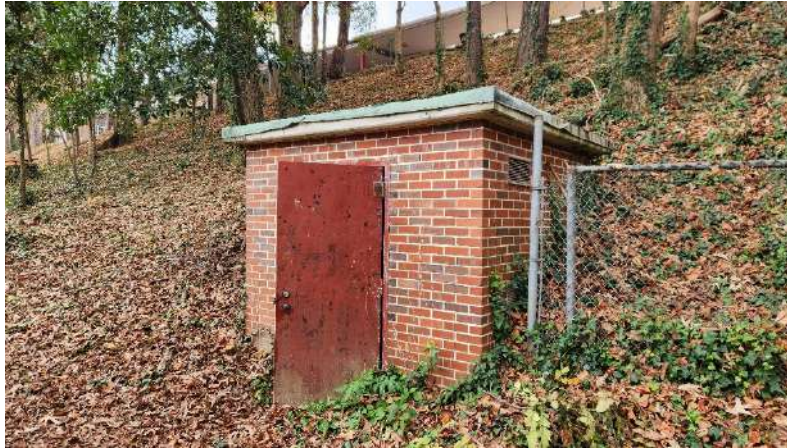
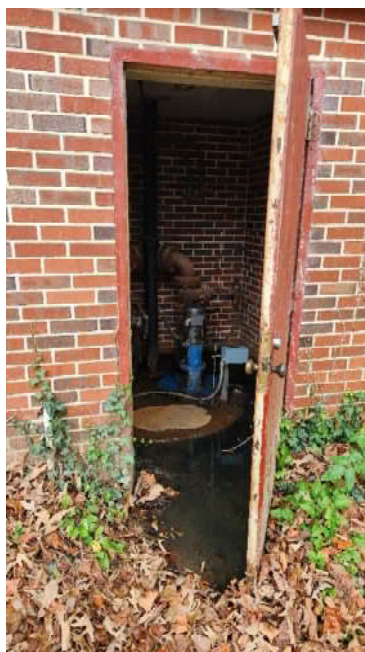
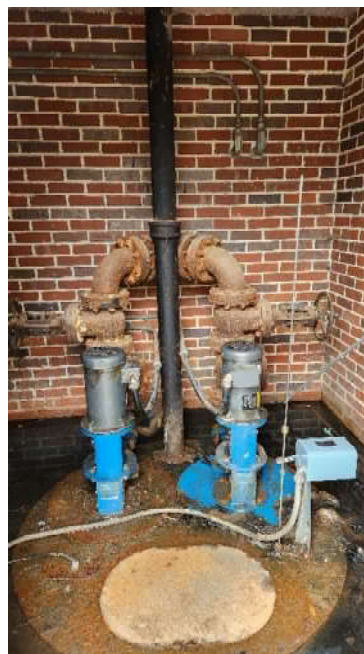
2. Near the lit station there is a large underutilized space with old gym equipment and a stone wall. This area has poor drainage and was observed to have standing water during rain events. Large rain events may have sewage contamination in this area. Unmaintained equipment could be considered hazardous to users and visitors.

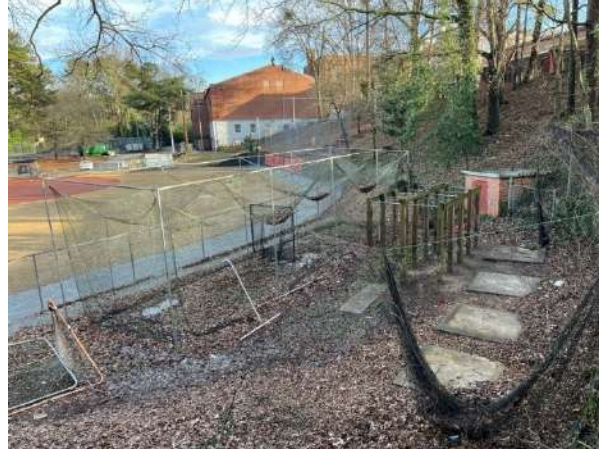
3. Bleachers are placed along the slope near the softball field. **This bleacher area does not have ADA access.**
4. Along the central covered walkway, three outdoor spaces house large mechanical equipment. **The equipment is loud and significantly decreases the quality and useability of outdoor space.**
5. At the front of the campus, there are many picnic tables that are in a mulched landscape area. This area is highly used by students, teachers, staff, and visitors and does not have full ADA access.

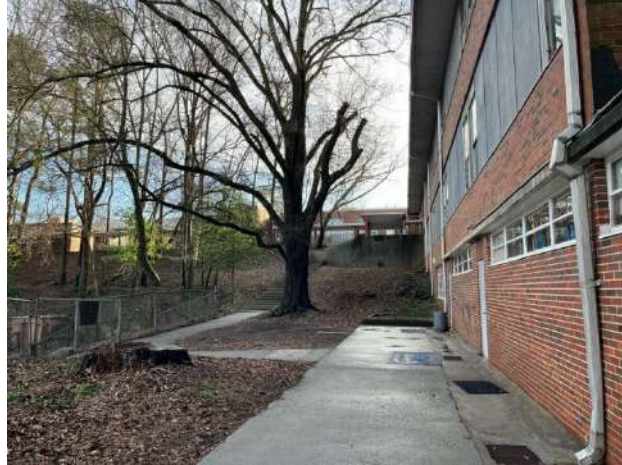
- b. Several trees have been cut down and large stumps have been left in place. In some locations, the stumps are a tripping hazard in the walkways.
- 3. The courtyard space between buildings 5030 and 5020 includes severe erosion, poor drainage, clogged area drains/catch basins and destabilized landscape. This space has high usage during cafeteria hours based on the number of picnic tables and amount of wear of the site space. The space has 10 picnic tables that hold 8 people per table – roughly accommodating about 80 students. This space also serves as site circulation for the campus with high foot traffic and therefore mud and erosion. This deteriorated landscape clogs area drains and catch basins.

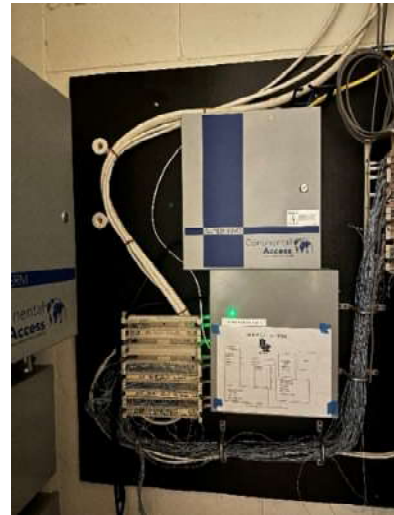
3. Existing Intercom/Clock system is in fair condition. Parts are becoming obsolete, and system should be replaced due to age within the next 5 years.
  - Scope: Throughout the building 5011.
  - Correction: Replace with new system based off DCS standards.

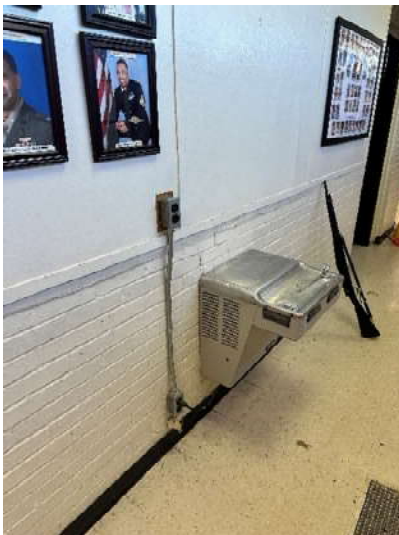
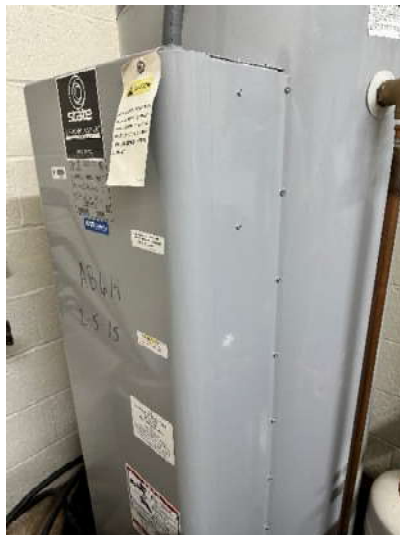
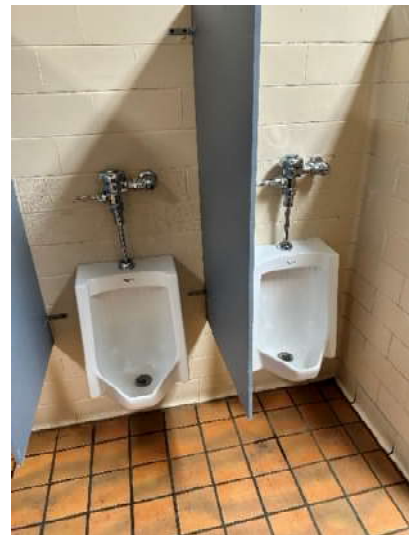
1. Building is fully sprinkled. Fire risers are in good condition.
  - Scope: Throughout the entire Building 5020.
  - Correction: None
2. Drinking Fountain does not meet DCS standards.
  - Scope: Building 5020 – Corridor
  - Correction: Replace with Hi/Lo fixture with bottle filler to match DCS standards.
3. Electric water heater was manufactured in 2015. Water heater was in good condition with no visible signs of rust or issues.
  - Scope: Building 5020 – Storage Room
  - Correction: Drain water heater to clean annually.
4. Plumbing restroom fixtures were in fair condition with no signs of visible leaks.
  - Scope: Building 5020 – Gang Restrooms
  - Correction: None

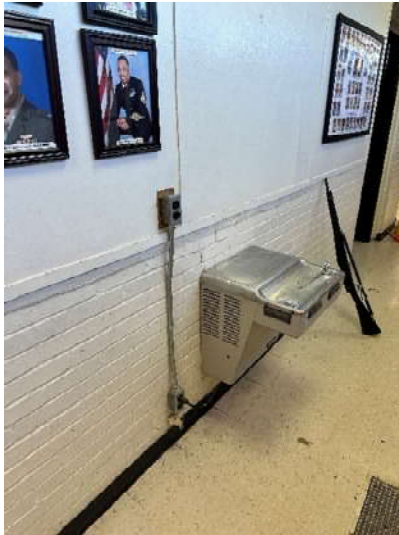
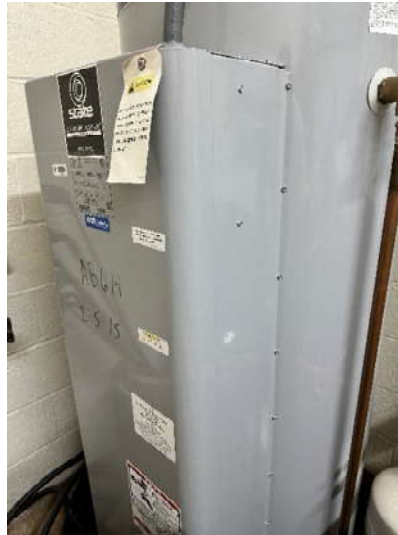
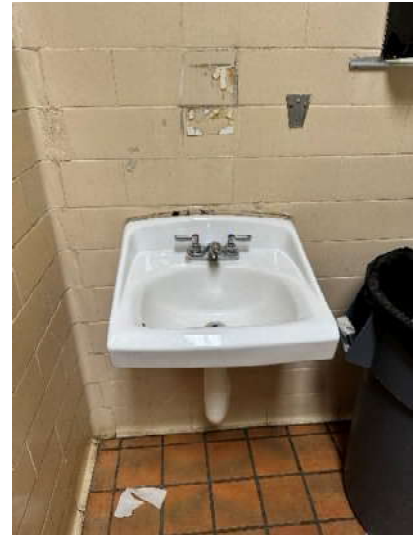
1. Building is sprinkled; however, areas might be lacking coverage. Entrance to Building 5021 from interior courtyard is not sprinkled.
  - Scope: Throughout the entire Building 5021.
  - Correction: Provide coverage to areas not sprinkled. Check existing suppression piping for leaks. Visible leaks were observed on a number of ceiling tiles.
2. Drinking Fountain does not meet DCS standards.
  - Scope: Building 5021 – Corridor
  - Correction: Replace with Hi/Lo fixture with bottle filler to match DCS standards.
3. Electric water heater was manufactured in 2015. Water heater was in good condition with no visible signs of rust or issues.
  - Scope: Building 5021 – Storage Room
  - Correction: Drain water heater to clean seasonally.
4. Custodial mop sink is in poor condition.
  - Scope: Building 5021 – Custodial Room
  - Correction: Replace fixture with new.

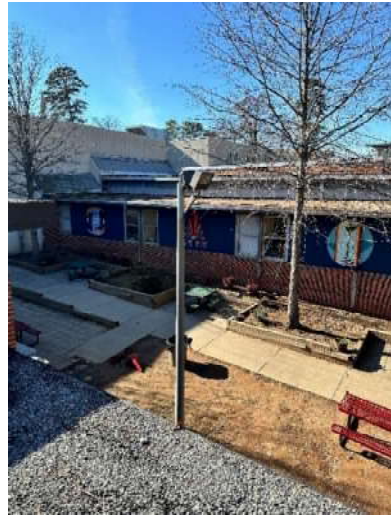
4. Exterior lighting is outdated.
- Scope: Building 5030 – Canopy/Exterior
  - Correction: Replace with LED fixtures and updated lighting controls per DCS standards.

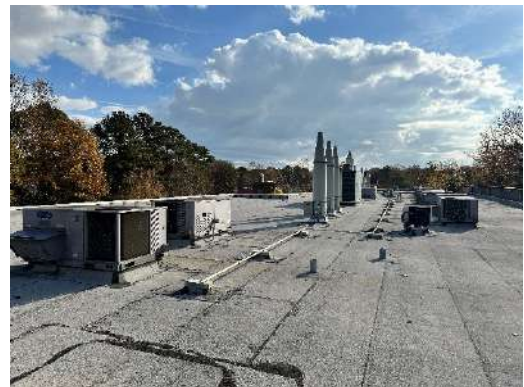
1. DX Minisplit units were not operating.
  - Scope: Building 5040 – IDF Room(s)
  - Correction: Replace Minisplits with new to avoid server racks from overheating.
2. BAS controls are becoming obsolete. Not all buildings are on the same BAS front-end as Building 5010.
  - Scope: Throughout Building 5040
  - Correction: Replace BAS controls system.
3. DX Rooftop Gas Heat Units were manufactured and installed in 2009. Units are at life cycle.
  - Scope: Building 5040 – Roof
  - Correction: Replace DX Rooftop Units.
4. Vektor high-plume exhaust fans are in fair condition. Equipment was manufactured and installed in 2009.
  - Scope: Building 5040 – Roof
  - Correction: Replace exhaust fans.
5. Energy Recovery Unit (8000 cfm) was installed in 2009 and is in fair condition.
  - Scope: Building 5040 – Roof
  - Correction: Plan for replacement within the next 5 years.

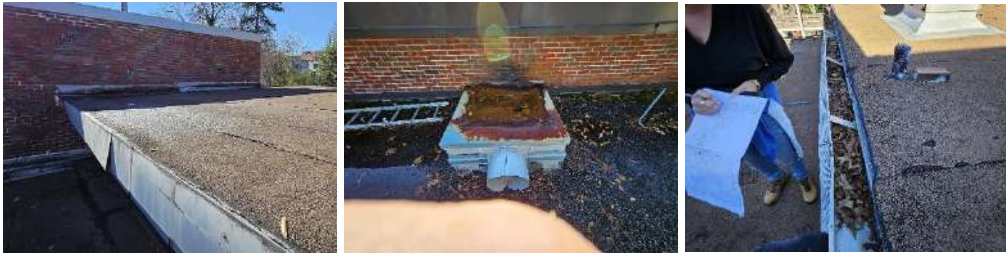
5. Deteriorated curb covers.
  - Scope: Occurs in multiple locations.
  - Correction: Remove and replace.
6. Severely damaged expansion joint.
  - Scope: Occurs in multiple locations.
  - Correction: Remove and replace.
7. Deteriorated flashing sealants.
  - Scope: Occurs in multiple locations.
  - Correction: Remove and replace.

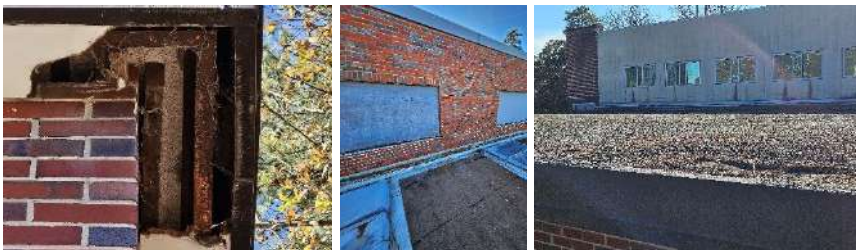
1. Deteriorated sealants.
  - Scope: Occurs in multiple locations.
  - Correction: Replacement of existing.
2. Cracked and missing mortar.
  - Scope: Occurs in multiple locations.
  - Correction: Replacement of existing.
3. Deteriorated sealants at wall openings and control joints.
  - Scope: Occurs in multiple locations.
  - Correction: Remove and replace.
4. Soffit damage from moisture intrusion damage.
  - Scope: Occurs in multiple locations.
  - Correction: Remove and replace.
5. Deteriorated window opening components.
  - Scope: Window units and temporary covering which have been placed over some windows.
  - Correction: Remove and replace.
6. Brick and stucco façade cracks and staining
  - Scope: Occurs in multiple locations.
  - Correction: Replacement of existing.

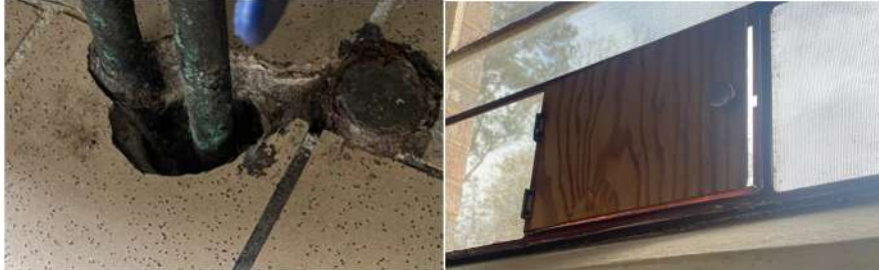
3. Rusted galvanized legs on prep table.

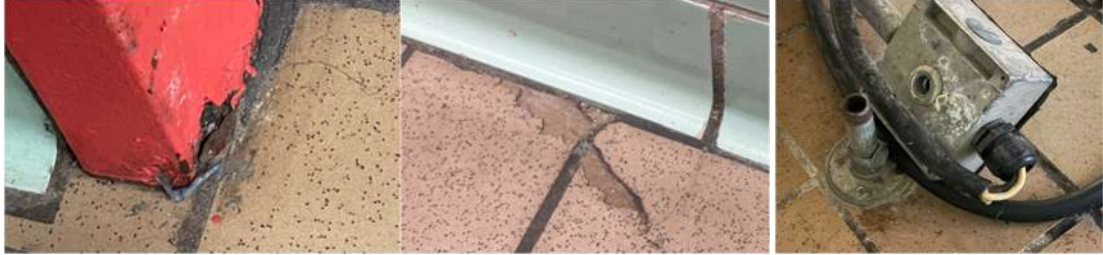
6. Cracked tiles, rust on door frames, and exposed wires.
