HUTTEBALL  
+ OREMUS  
architecture

# 2021 FACILITY ASSESSMENT

## GRANITE FALLS SCHOOL DISTRICT

Spring 2021

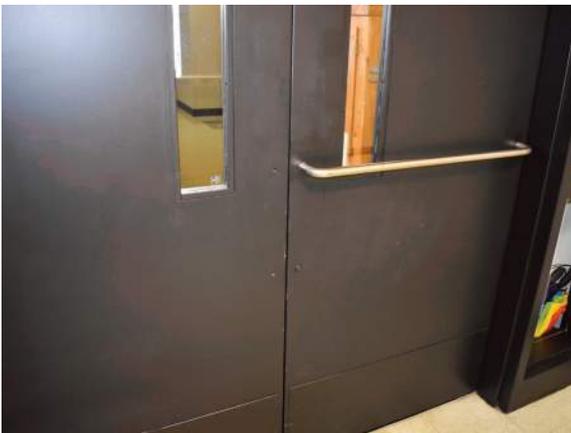
▲ Missing door hardware at entry door.

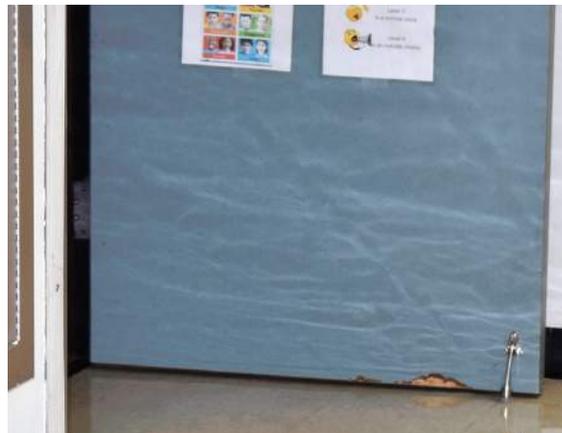
▲ Plastic laminate facing at interior door is beginning to show signs of age.

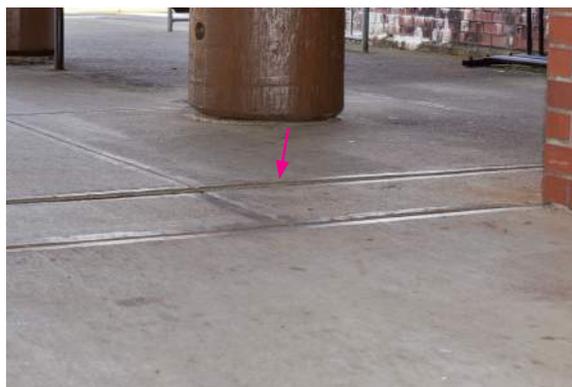
▲ Raised lip in concrete paving at main entry.

- > Monitor asphalt surfaces for deterioration.
- > Monitor concrete paving 'lip' at main entry.

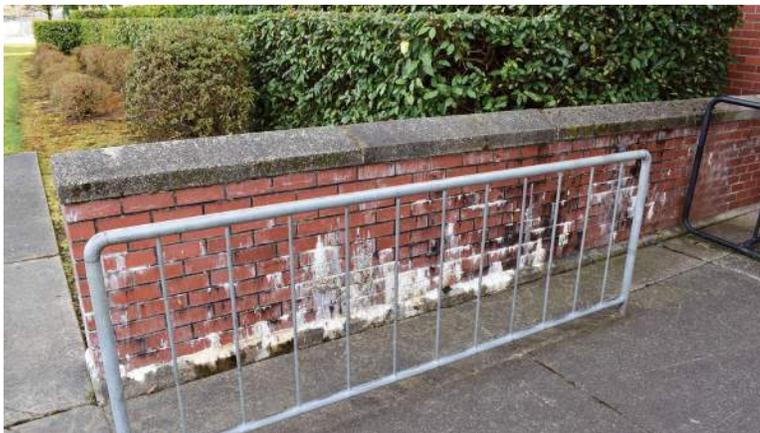
▲ Efflorescence at entry wall

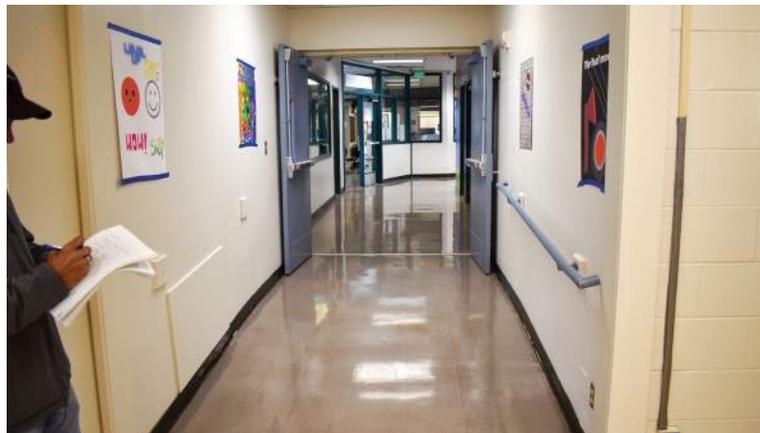
▲ Handrail is missing at the left side of the ramp to the commons. Handrail is deformed and should be re-secured or replaced at right side of ramp.

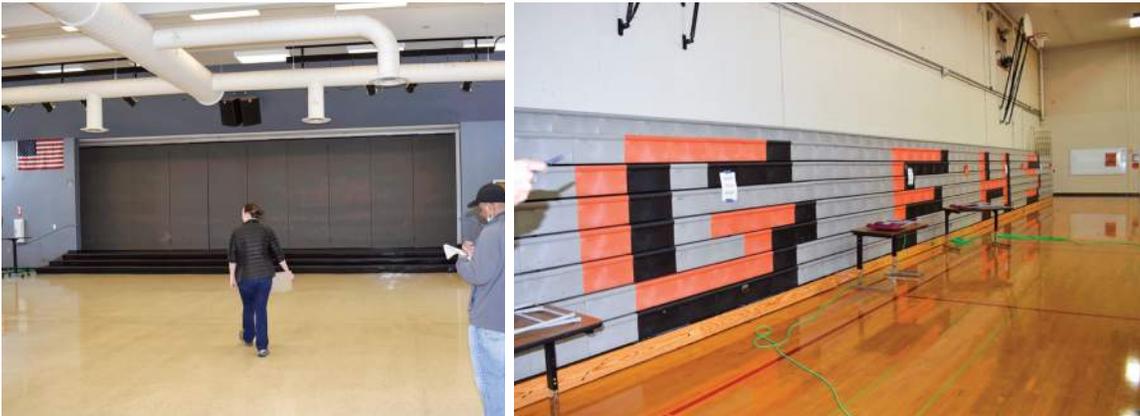
The beam supporting the operable partition dividing the stage from the commons has sagged, rendering the operable partition non-functional. Due to its inability to function as a performance space, the stage has been turned over to custodial storage and offices, and the surround curtains were removed. If this teaching space is deemed necessary, consult with an engineer to replace the wood support beam with a steel beam.

⚠ Stage operable partition is no longer functional. ⚠ Bleachers in the middle school still read "GFHS".

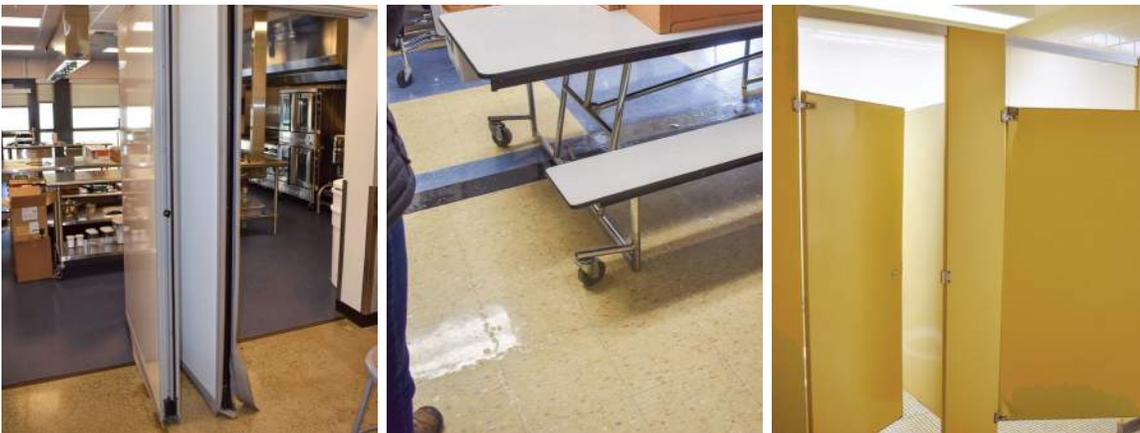
⚠ Slipped seals at operable partitions in STEAM building. ⚠ Bubbling in VCT at Multipurpose Building. ⚠ Dented toilet partitions in the Multipurpose Building.

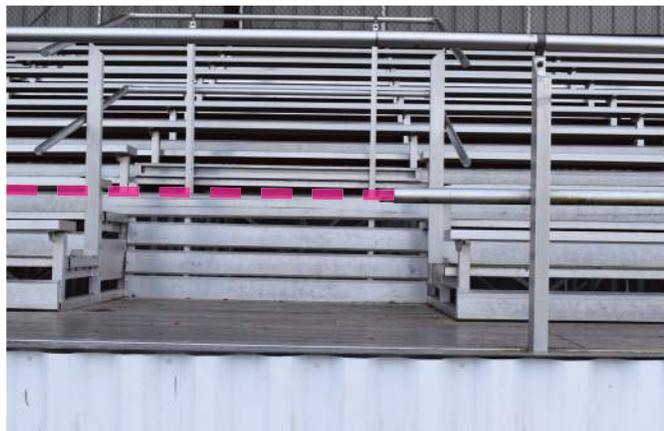
▲ Middle school grandstand. Dashed line showing ▲ Missing section of guardrail at middle school grandstand.  
location of missing guardrail.

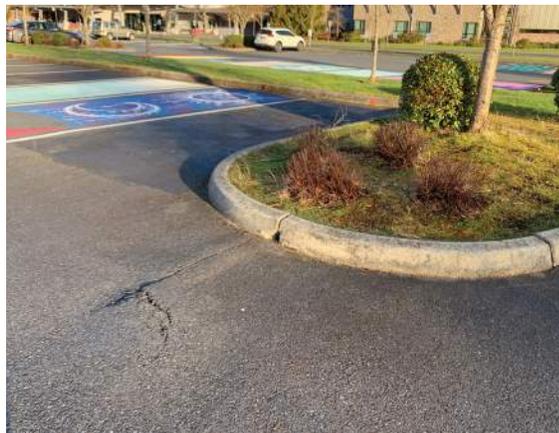
▲ Cracks in asphalt, presumably due to root growth.

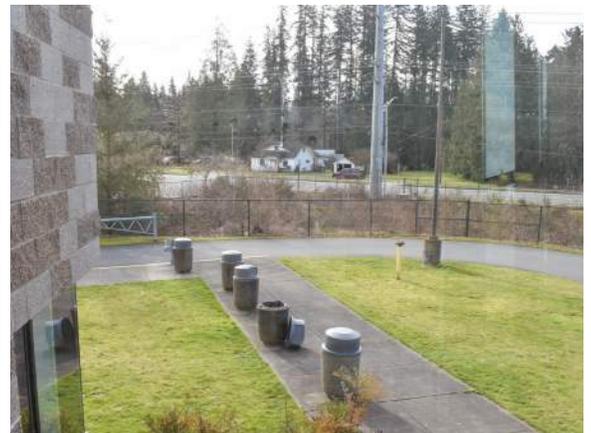
▲ Trash cans being used as vehicular bollards at the southwest corner of the high school.

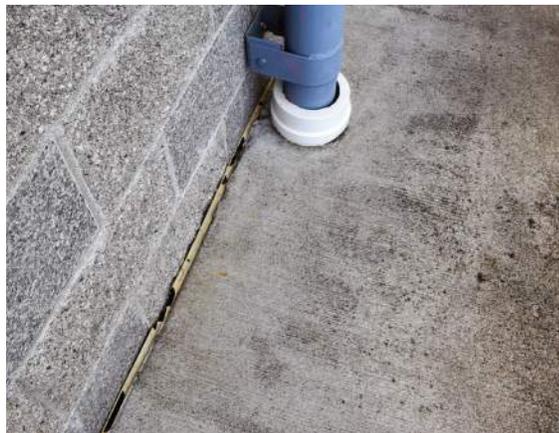
The sealant at expansion joints in the rear courtyard has deteriorated and is missing entirely in many locations next to the building. When not sealed, these concrete expansion joints become an area where dirt and debris can collect, and water can run under slab causing heaving, cracking, and displacement in the concrete. All joints should be cleared of debris and aged sealant, and re-sealed.

▲ Sealant has deteriorated, or is missing at expansion joints along the face of building.

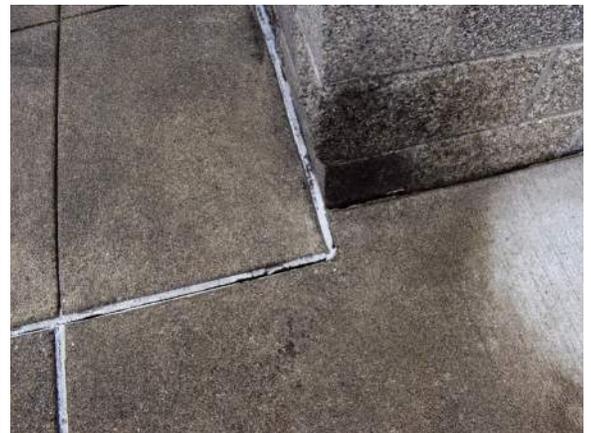
▲ Sealant has deteriorated, or is missing at expansion joints along the face of building and across the plaza.

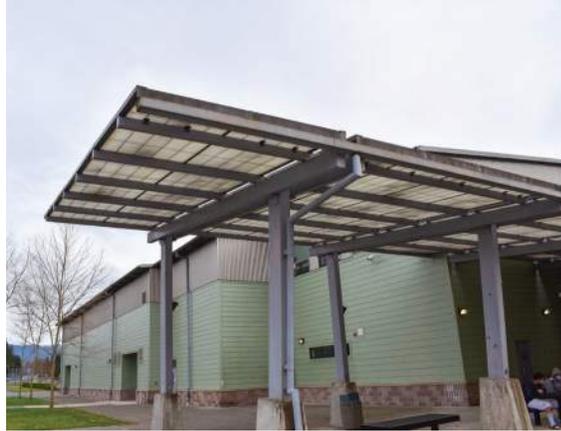
▲ Debris build up on rear translucent panel canopy.

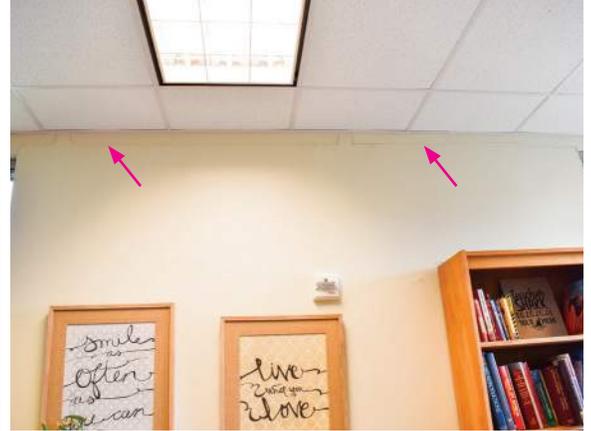
▲ Crack at exterior wall of Classroom B219.

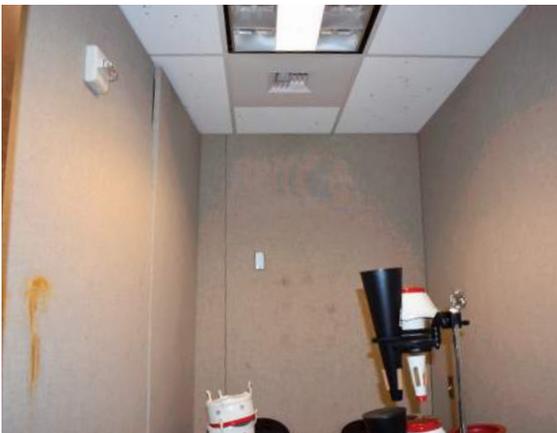
⚠ Damage at ceiling and acoustical wall panels in practice room.

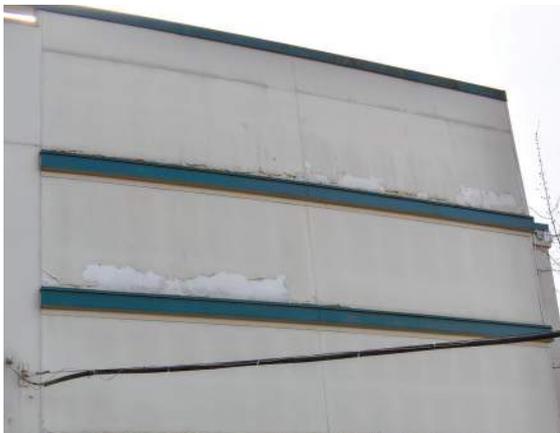
▲ Damage to fiber cement panels at the Crossroads / Administration building.

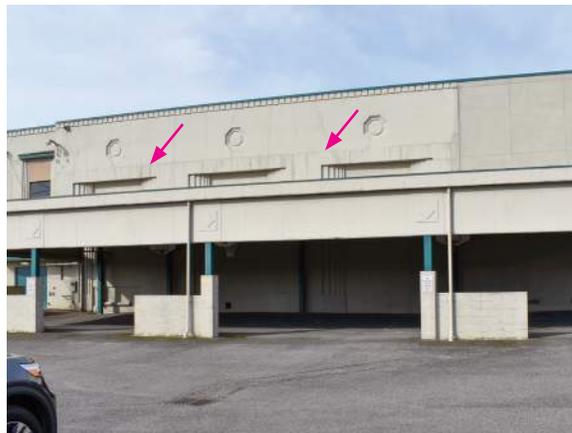
▲ Significant cracking in stucco at south side of the gymnasium.

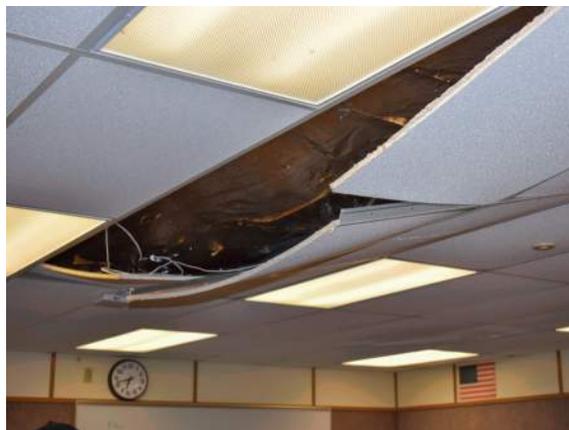
▲ Broken ceiling support system at Portable P4.

R1.20	Continue to correct leaks in piping above ceiling.					X	
R1.21	Repair broken ceiling suspension system at Portable P4, and replace damaged ceiling tiles.					X

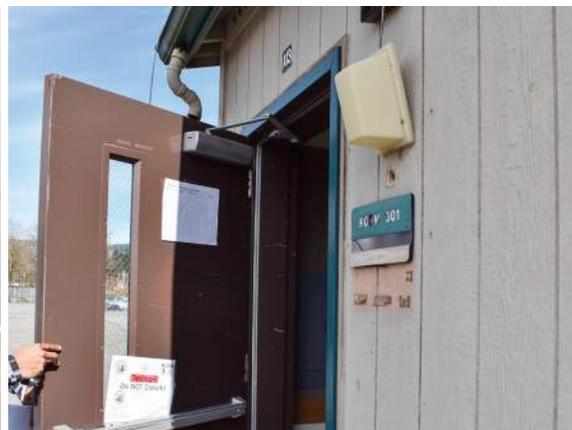
▲ Secure exterior light fixture at Portable P4.

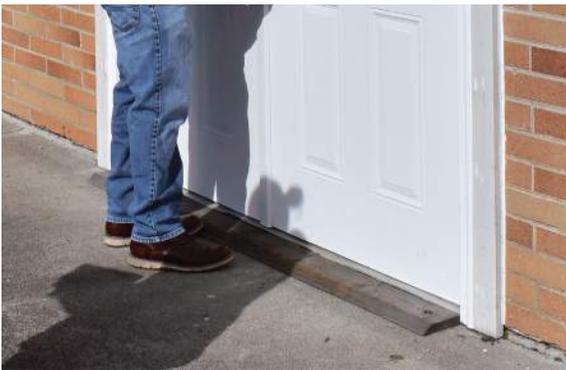
▲ *Modify exterior door threshold to allow for equipment to wheel in & out of space.*

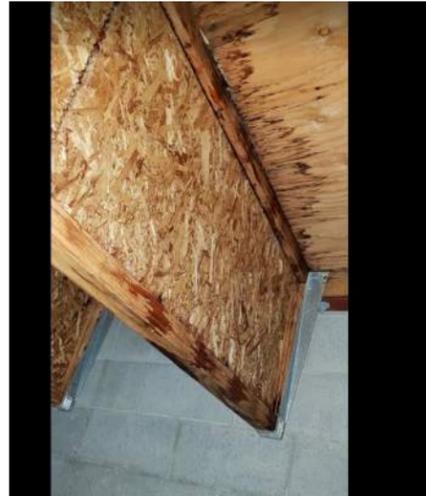
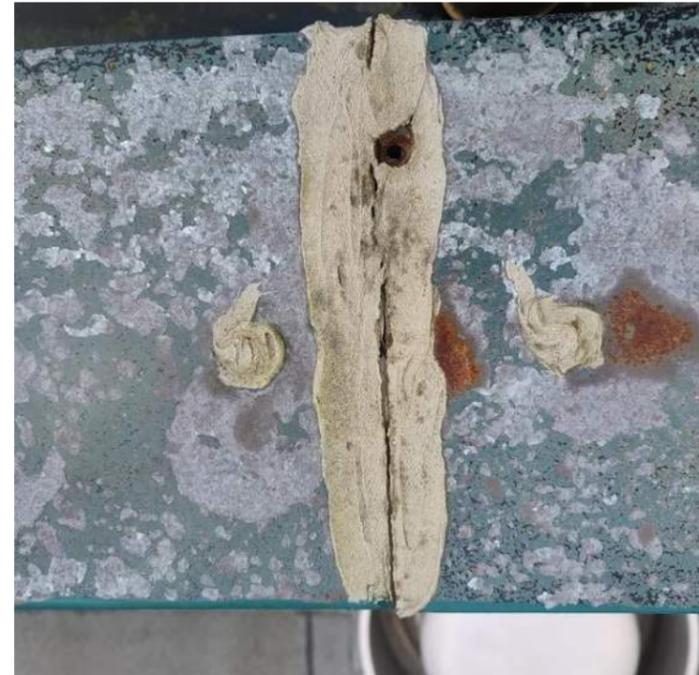
Signs of long term water intrusion can be found right below the roof deck. This amount of exposure can lead to rotted decking and eventually major structural members. These issues bring a major cost increase to any roofing project, especially when the roof section is 40 feet in the air.

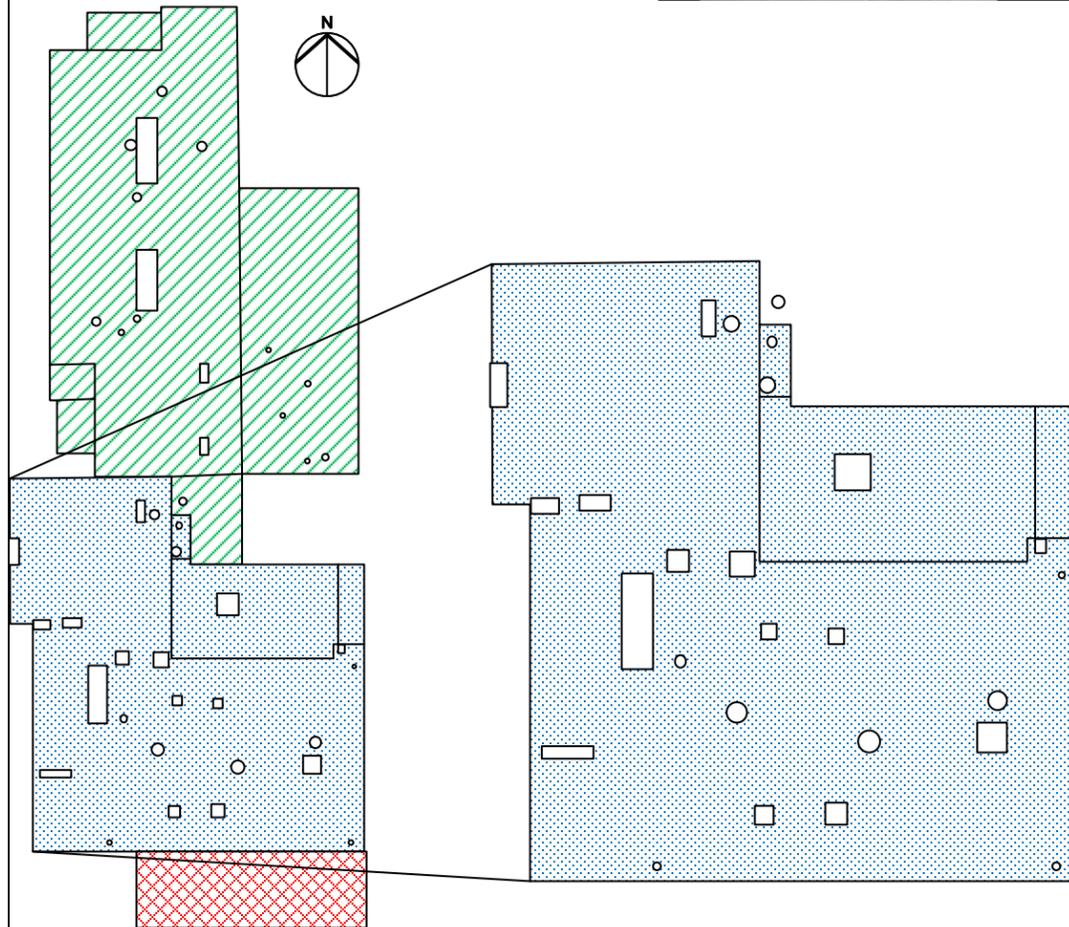
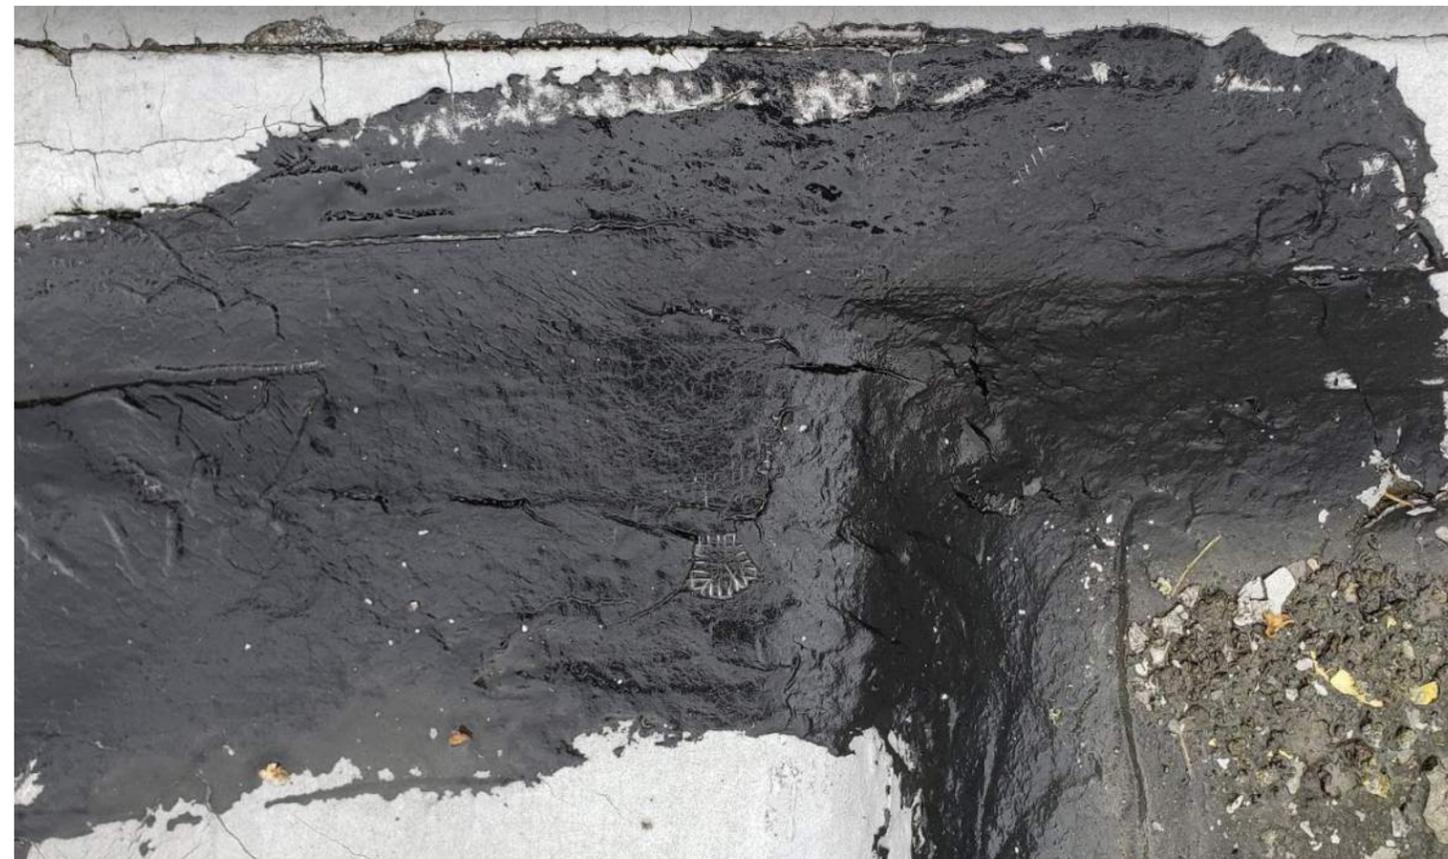
The roofing system on this section of the building is at the point of failure. I could hear the multi-ply membrane crunch under foot as I inspected the roof areas. The membrane's reinforcement scrim can often be seen in most of the crucial details and the drain sumps are literally "coming apart at the seams" as seen in the photo below. The coping details have been repaired over and over and are now missing fasteners, leaving openings in the cap. The existing curbing is low to the roof line, making a re-roofing project difficult. I'd like to not again that this roof section(at least the gymnasium) is not insulated.

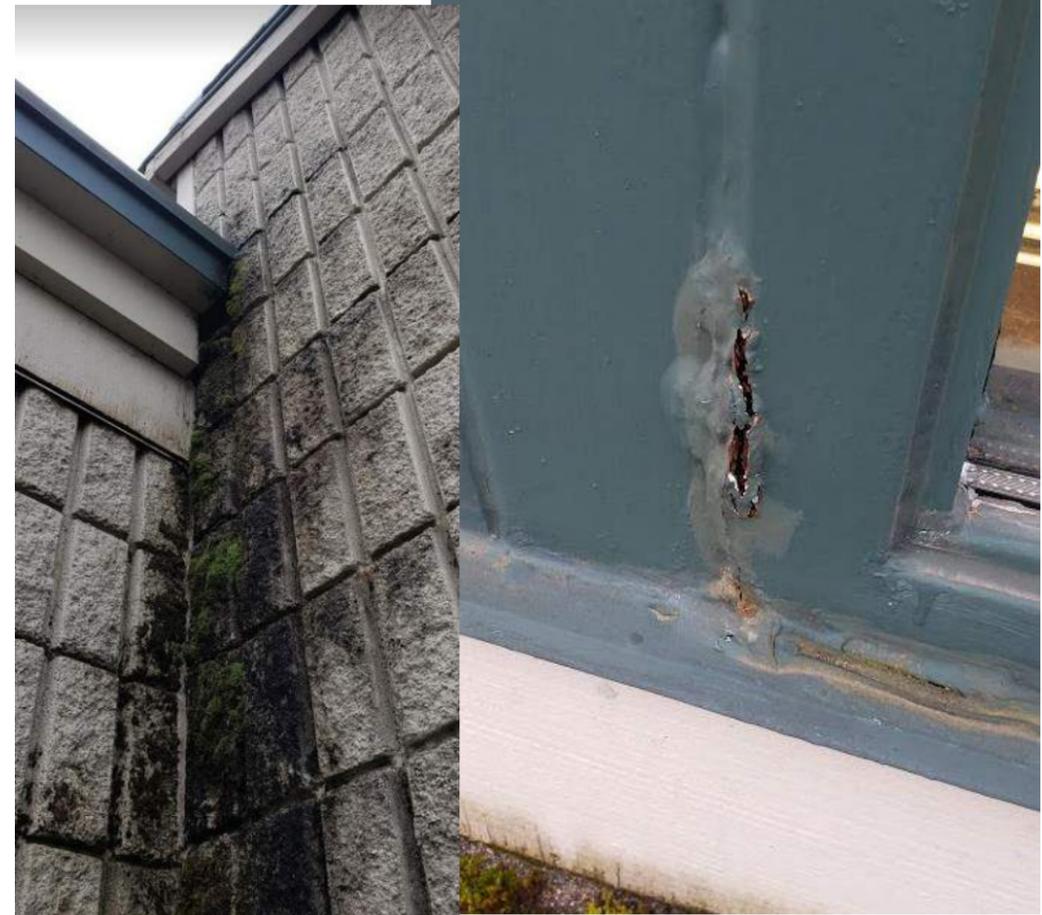
The other concern I found during my inspection is the the rusting metal framing around the windows at the peak of the roof.

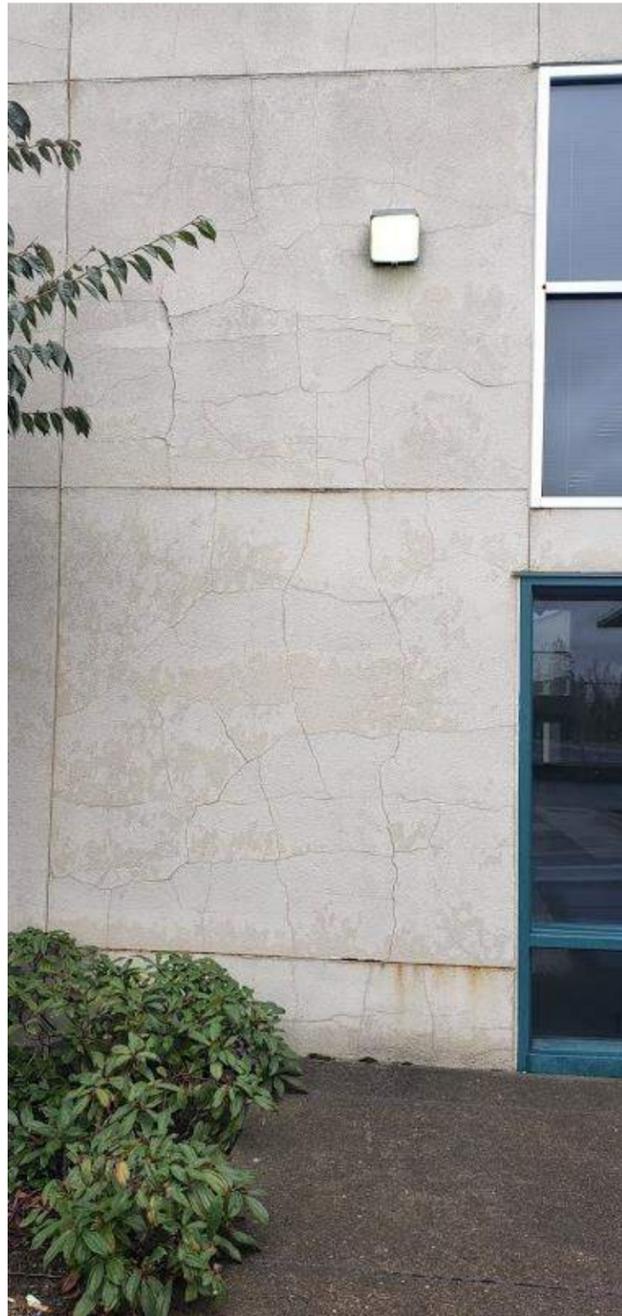
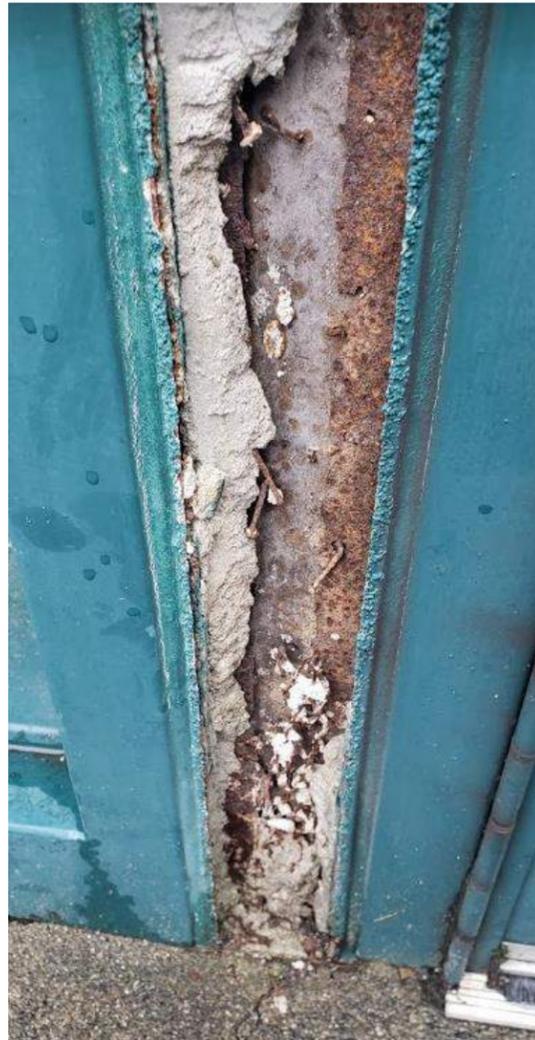
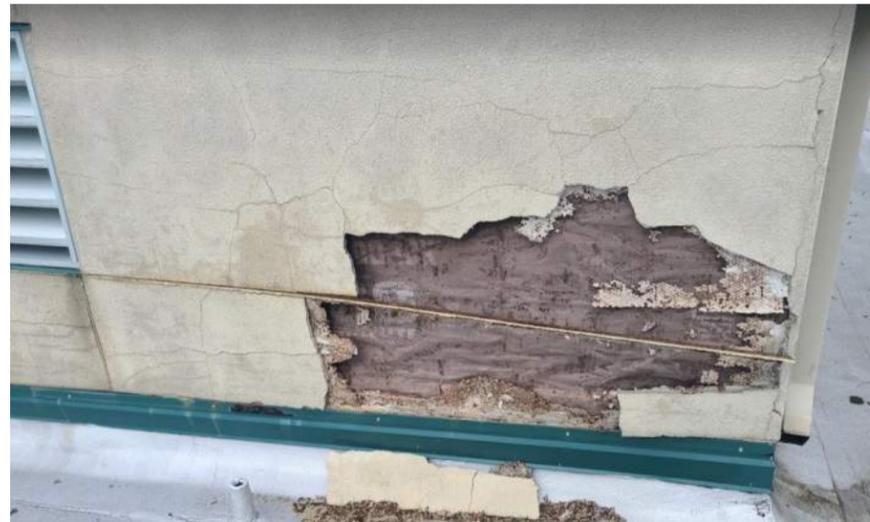
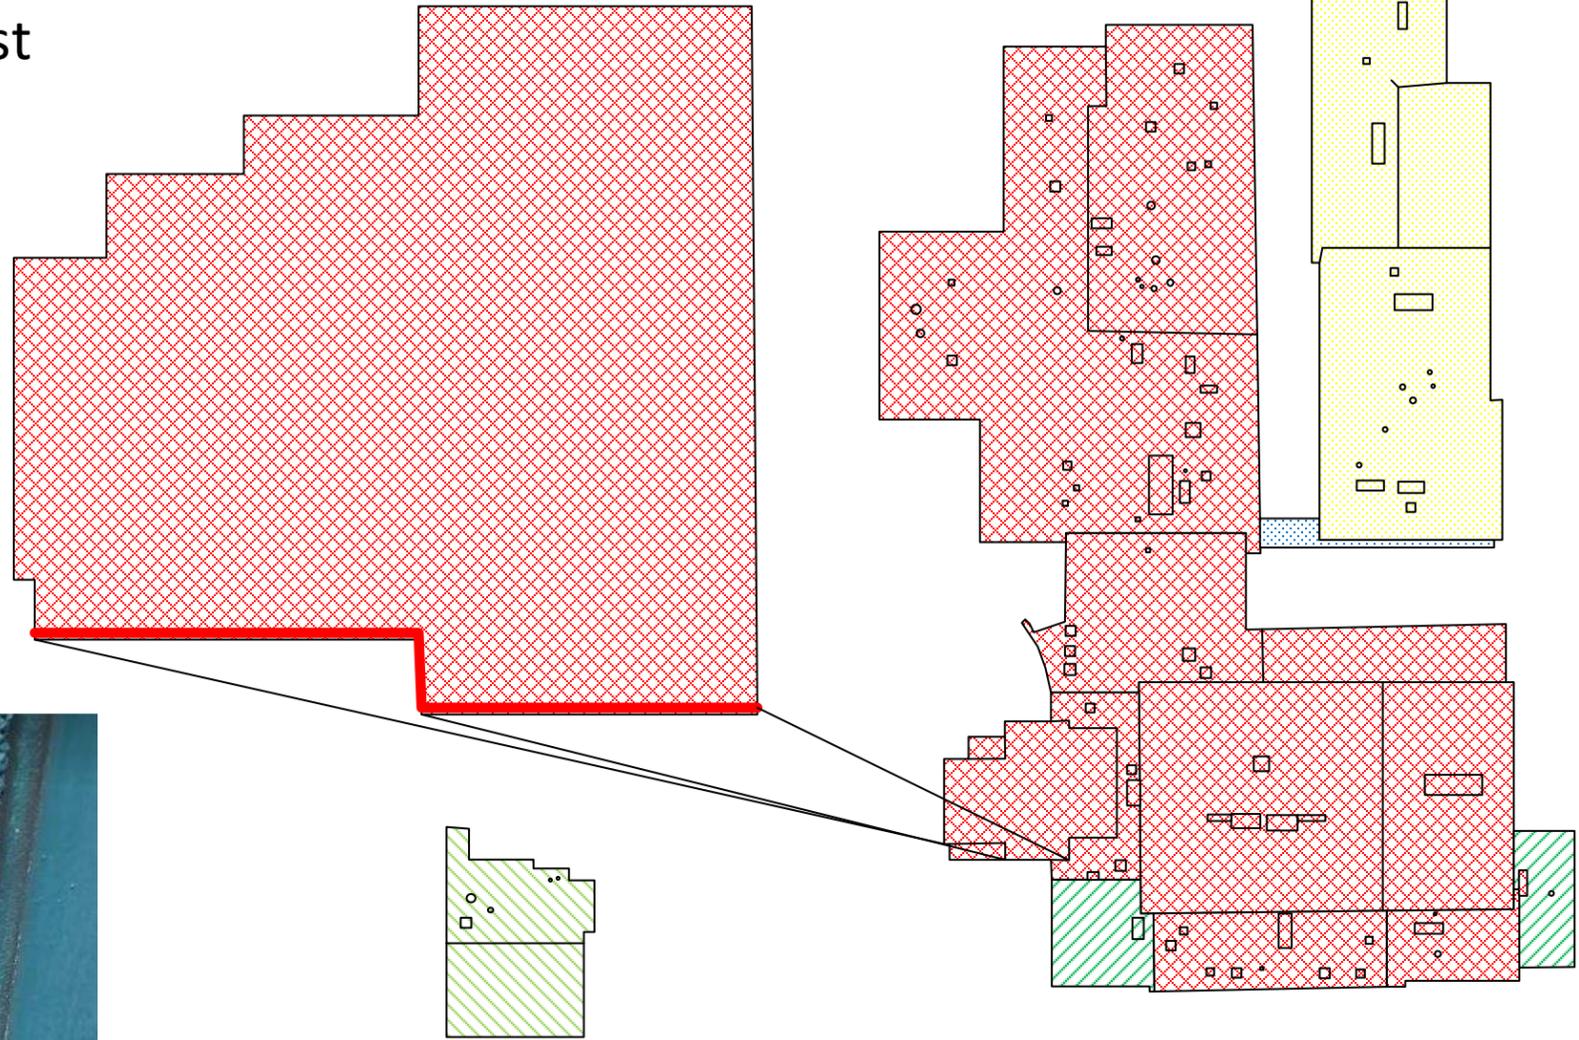
# Stucco Wall at the Southwest Entrance of the School

The Stucco wall at the southwest entrance of the Middle School is deteriorating. Students have pulled a section of the wall away in one area, but the real concern is if this material falls on a student closer to the entrance. We recommend replacing the stucco or removing it and going back with Hardie panels to attempt to match the look.

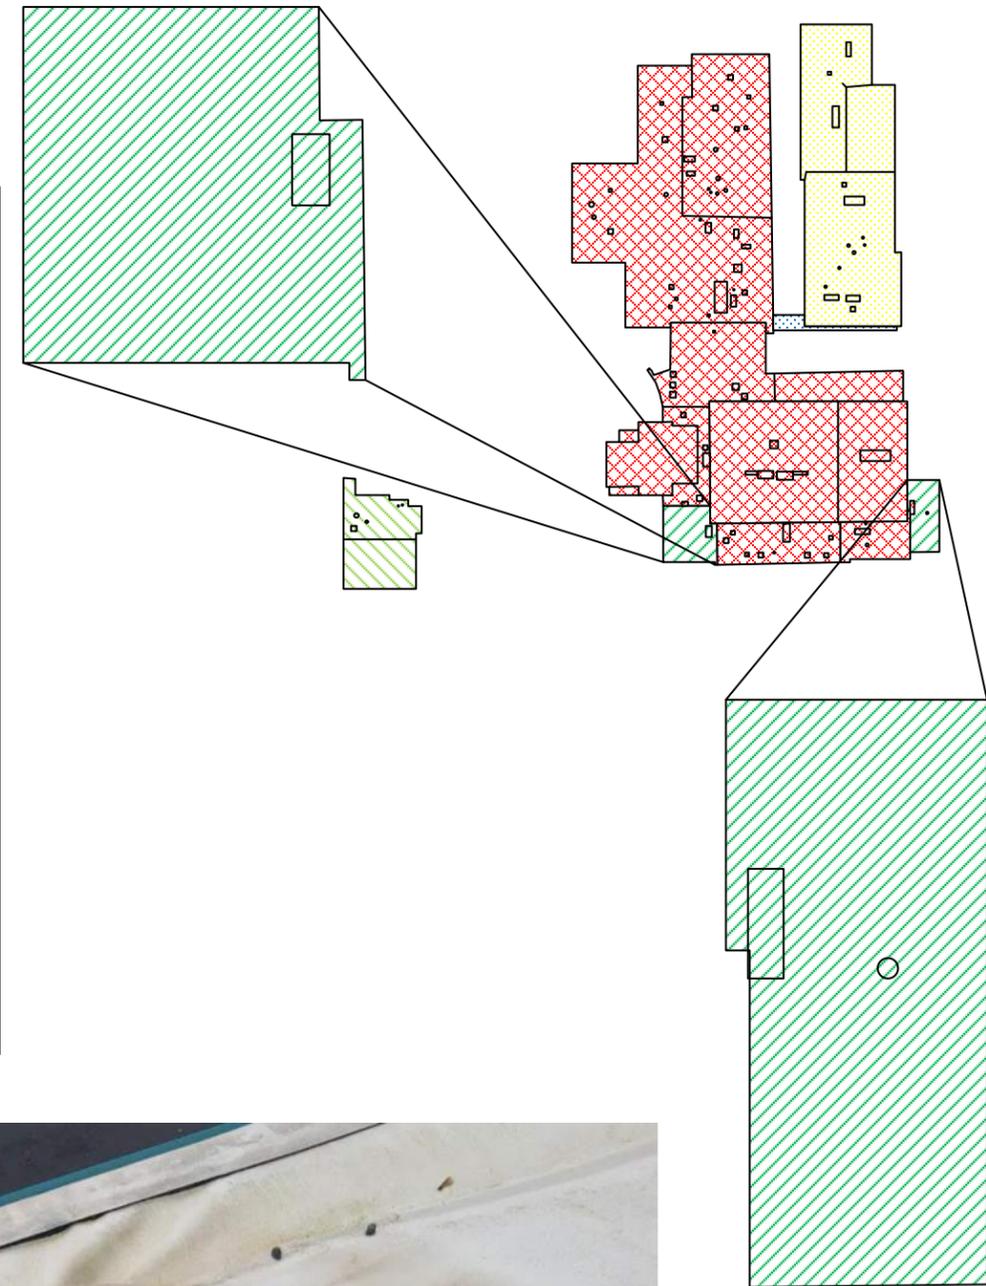
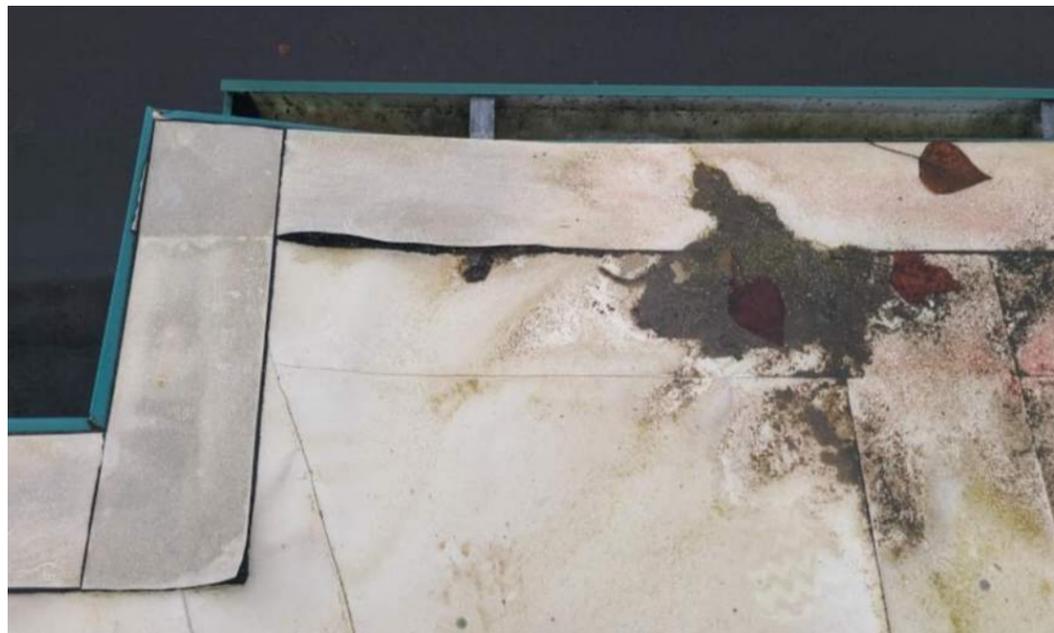
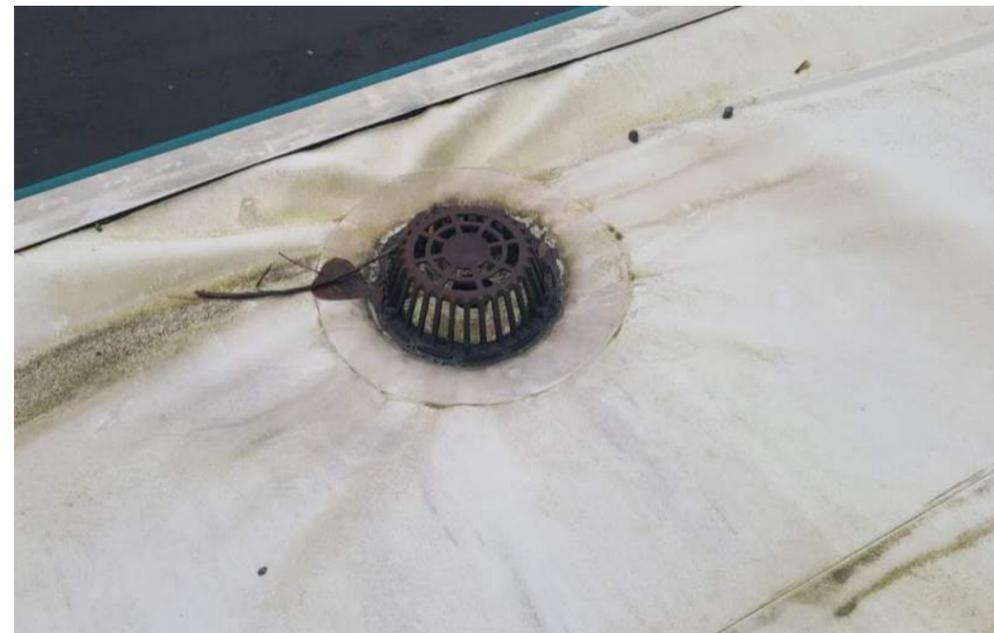
# Granite Falls Middle School Single Ply Roof Sections

- The transition from BUR to singleply is an asphalt 3 course detail which is not conducive for long term performance
- We can see signs of the membrane stretching and contracting, putting extra stress on the system details.
- The perimeter flashings are falling apart and not ponding water is sitting below adhesion strip.
