6 | Easterly Parkway Elementary School

Address:	234 Easterly Parkway State College, PA 16801
Construction Timeline:	Originally constructed in 1955; renovation/addition in 2002.
Building Square Footage:	55,895 sf
Site Acreage:	11.4 acres

Building Summary

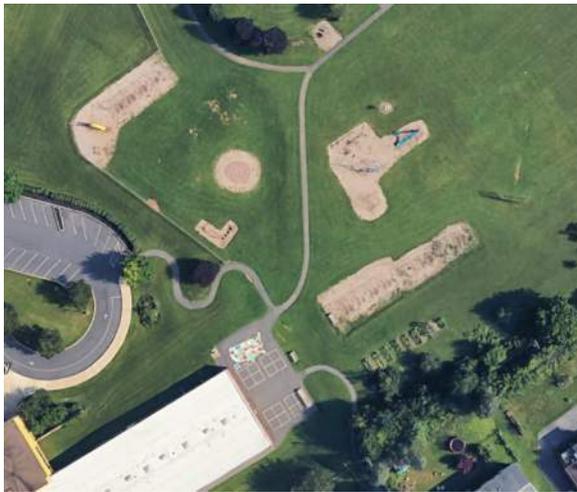
The site has two hard-surface play areas, including one with a basketball court. All are in good condition. The site also has multiple soft-surface play areas with play equipment. These are surfaced in loose wood chips. There are also large expanses of grassy areas. All play areas are well separated from vehicular traffic.

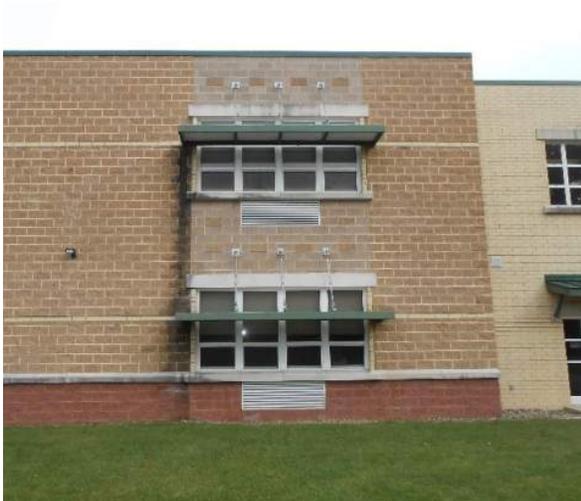
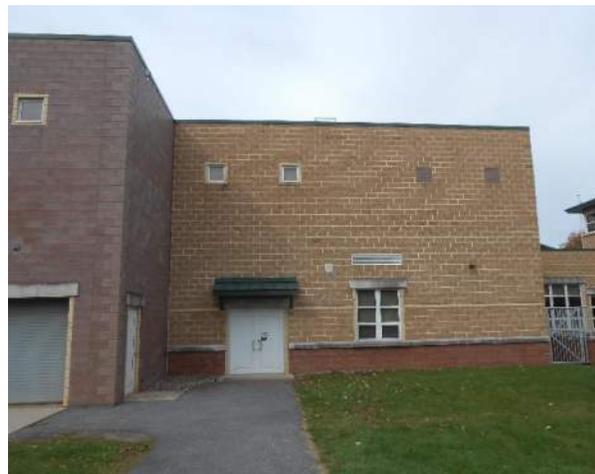
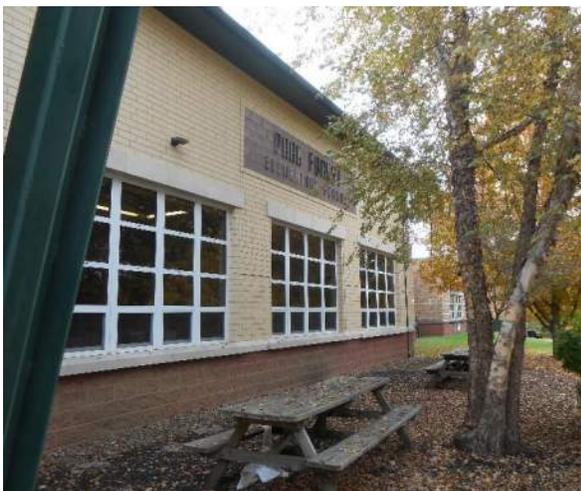
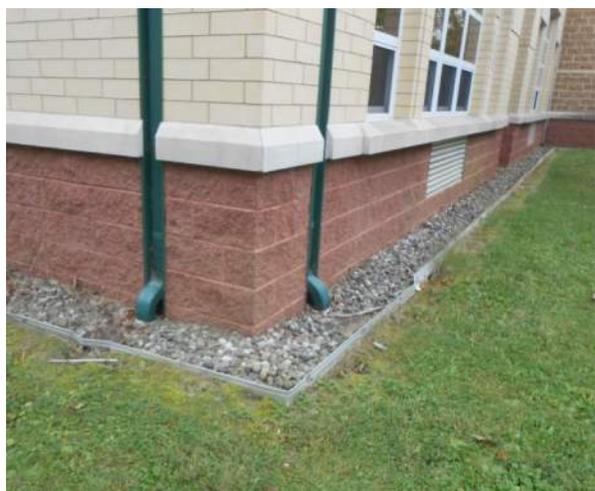
The building exterior consists of insulated masonry cavity walls with brick veneer or split face CMU at select locations and CMU backup. Window stools and headers are cast stone and in good condition. In some areas the stools and headers are darkened and stained. There is significant staining and efflorescence along some of the split face CMU along the 2-story wing, which appears to be caused by the exterior window shade devices.

- Clean exterior brick and masonry veneer to remove efflorescence and staining, most notably at windows and where sun shading devices are located.
- Inspect weep holes at the base of the exterior walls to make sure they are not blocked and trapping moisture within the wall cavity.
- Inspect exterior window shade devices to ensure proper installation and care.

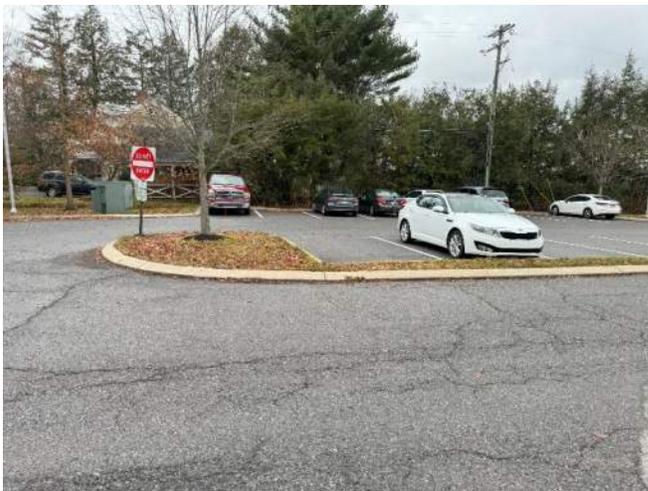
Some of the concrete walks are aging and starting to show signs of wear and tear, in that the aggregate (in the concrete) is beginning to show through to the outside surface. The concrete is also stained in many places. Cracking is occurring on some of the paved surfaces.

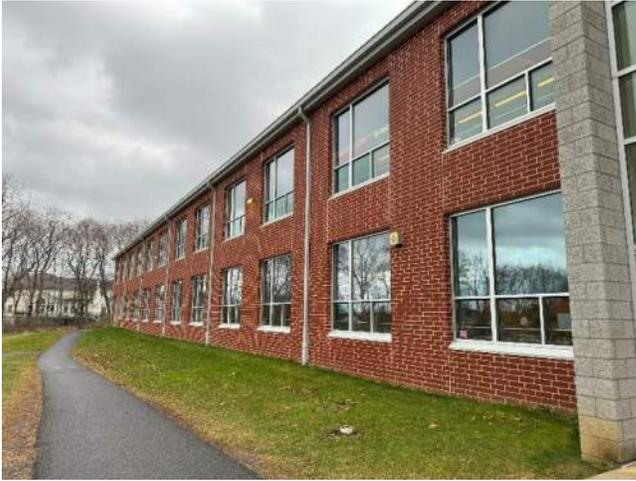
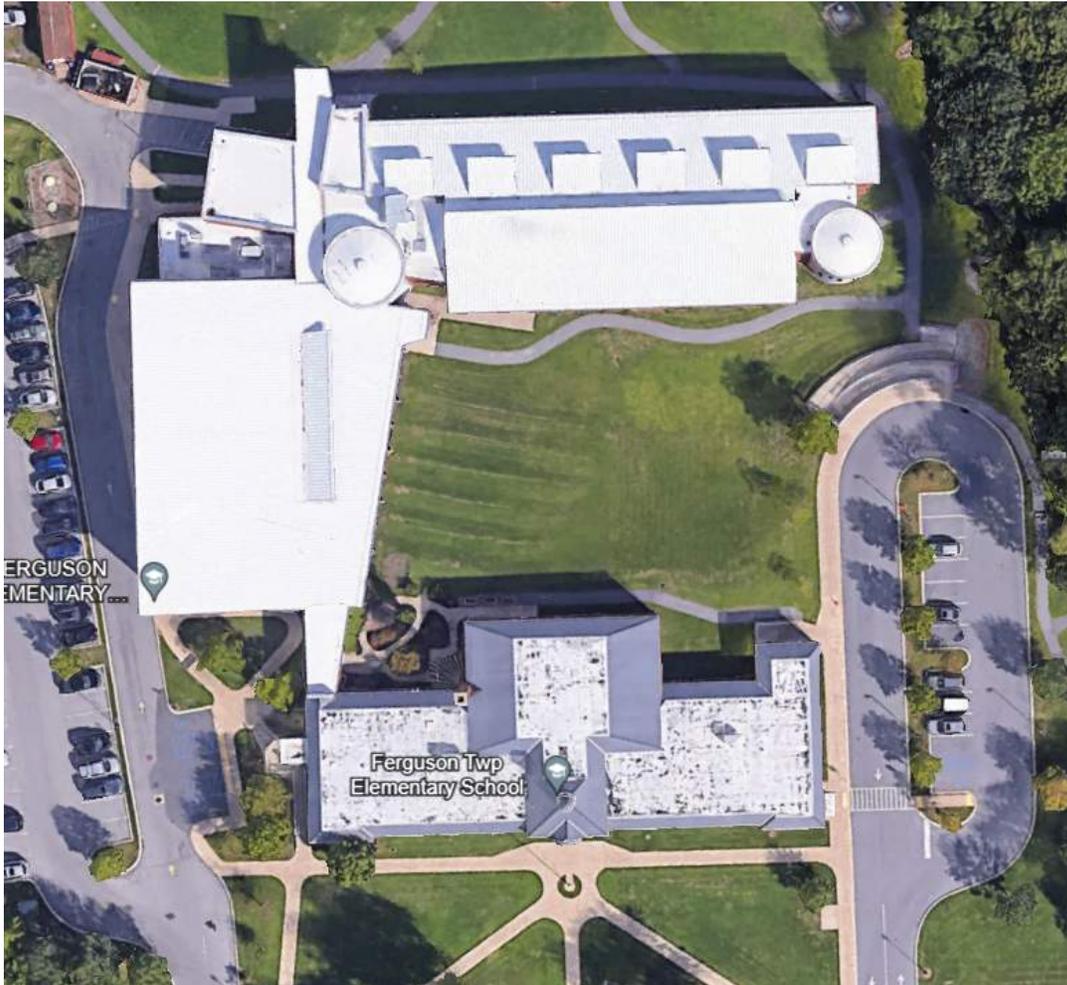
Rainwater for the most part is collected in metal gutters and taken down metal downspouts that tie into an underground storm system. Roofing and rainwater conveyance appear to be in good condition except for the one downspout/underground stormwater piping (shown below) that may be clogged and is staining the face brick.

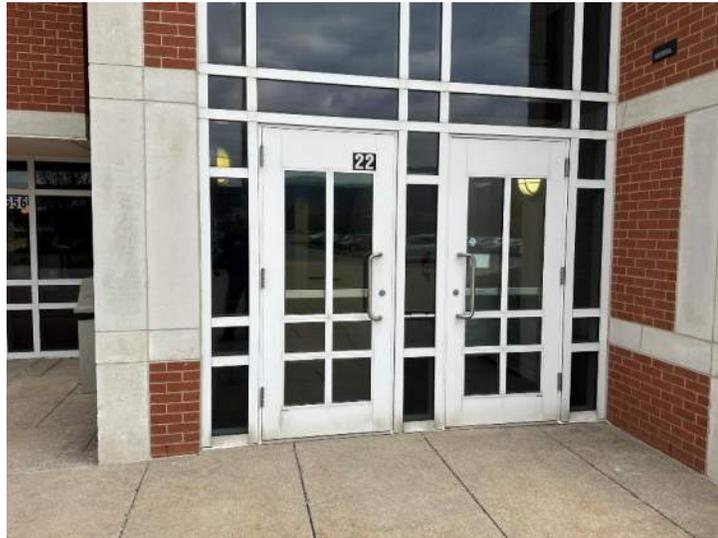
Entrances are clear anodized aluminum storefront with custom wide stile insulated aluminum doors. Aluminum doors and entrances are original to when the building was built and showing some signs of age.

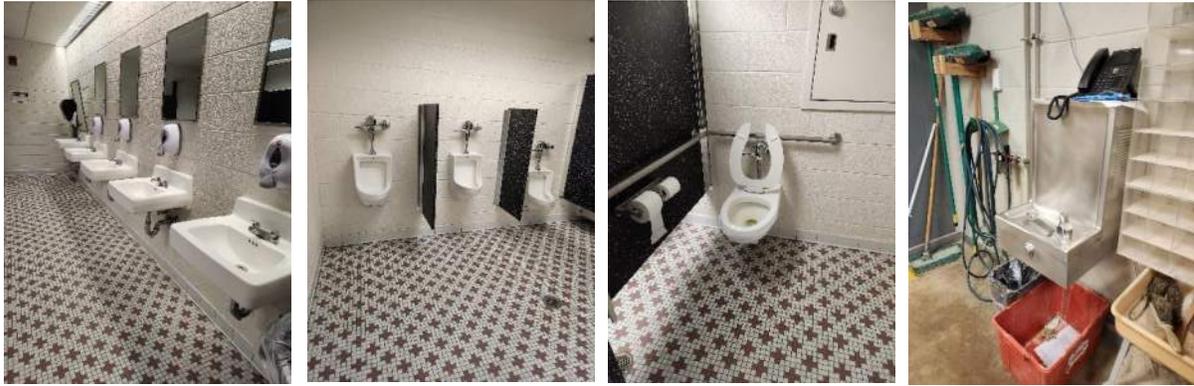
- Plumbing fixtures throughout appear to be aging but in good condition, but they do not appear to comply with current ADA standards.
- Water closets and urinals utilize manual flush valves.
- Wall hung lavatories are utilized with manual faucets.
- Water coolers do not appear to comply with current ADA standards.

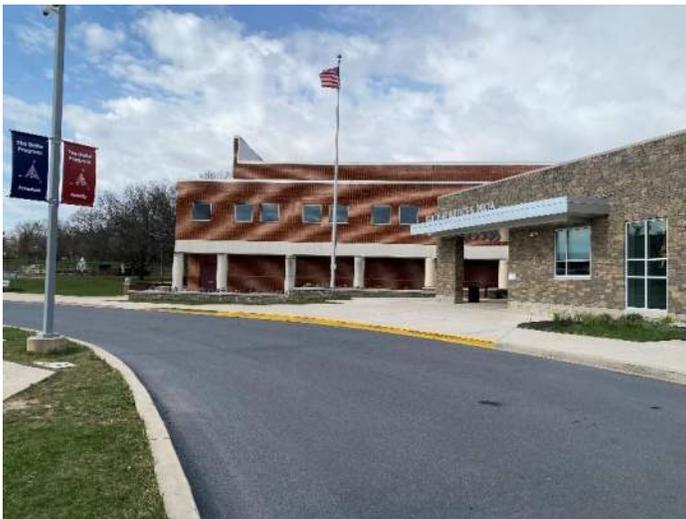
All face masonry associated with the additions is in excellent condition with the face masonry for the original building being in good condition. On the original portion there is some minor efflorescence staining that should be addressed.
