Architects Field Report

Project Name:	MPS Roosevelt HS CTE Improvements				
Location:		Project Number:		22.1007.02	
Contractor:		Construction Results Corp			
Date of Visit:	6/12/25	Weather:	Cloudy and sprinkling		Temp Range: 64 degrees
Time of Visit:	Noon – 12:45 pm	Conformance with Schedule (+/-):		On schedule	
Report By:	Deborah Bauknight, LSE Architects				
Distribution:					
Owner:	Jeffrey Helstrom, MPS	Contractor:	CRC – Carl Hoikka, Melissa Anderson		
Architect:	LSE – Chris Laabs, Jennifer Anderson-Tuttle	Field:	CRC – Gary Swift		
Consultant:	IMEG – Cory Casperson HEI – Angie Thoresen, Jeff Hauswirth, Scott Larson TNCG – Brandon Frazier	Others:

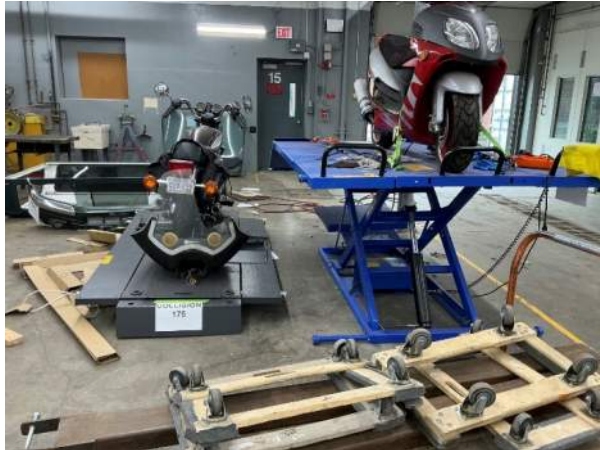
Owner items left behind to be moved – wheeled items can be put in hall per Chad and lifts are intended to go to Edison, coordinating transport

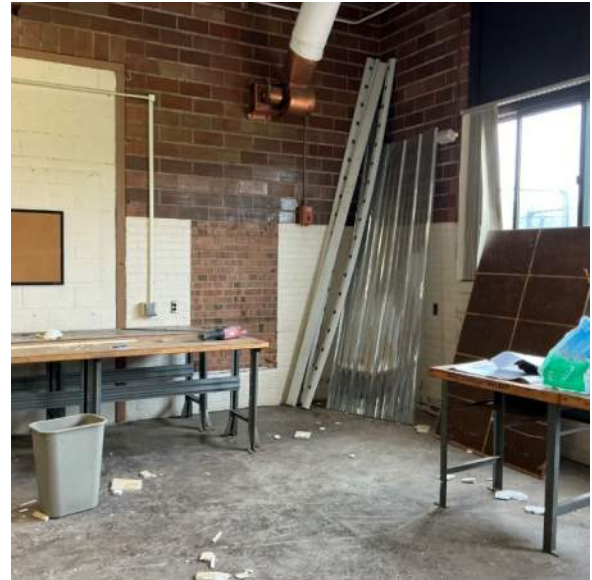
Owner items left behind – confirming status

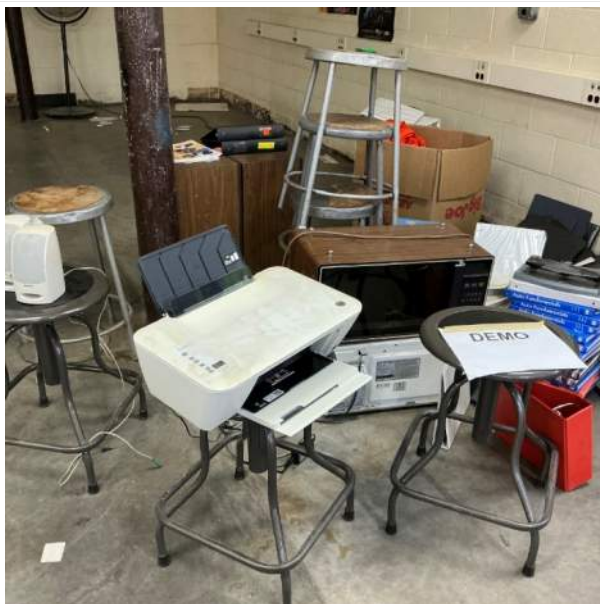
Owner items left behind, marked for demo

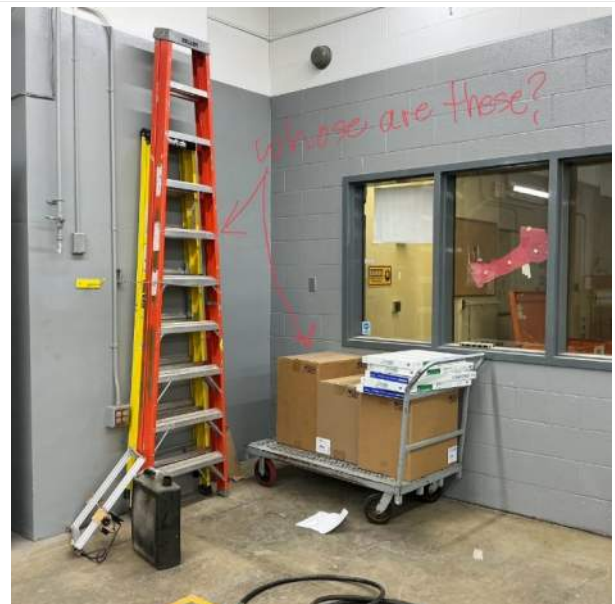
Appear to be Owner items - confirming

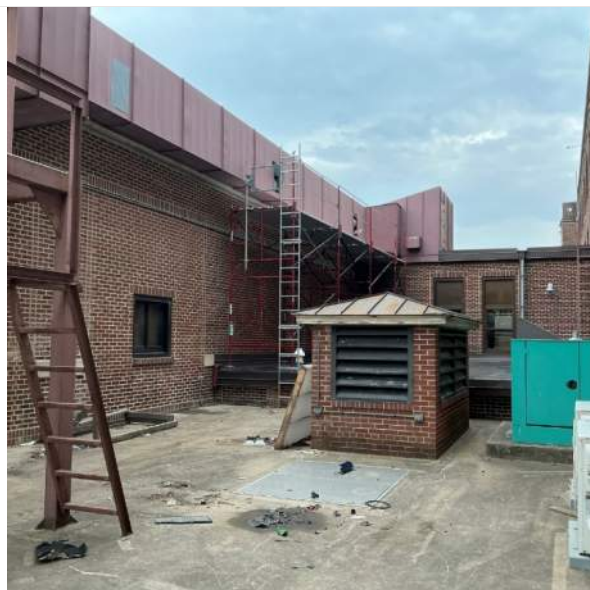
Exterior scaffolding is installed for a portion of the dust collection demolition.

Exterior scaffold for dust collector demolition

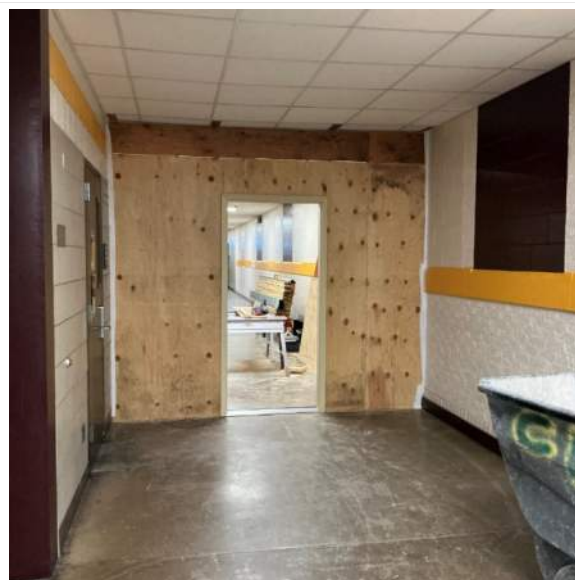
Temp walls are starting to be put up.

Temp wall dividing construction in progress

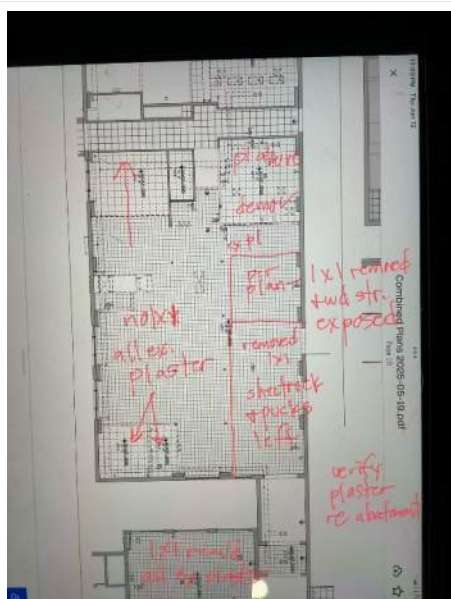
Ceiling scope review after base bid demolition

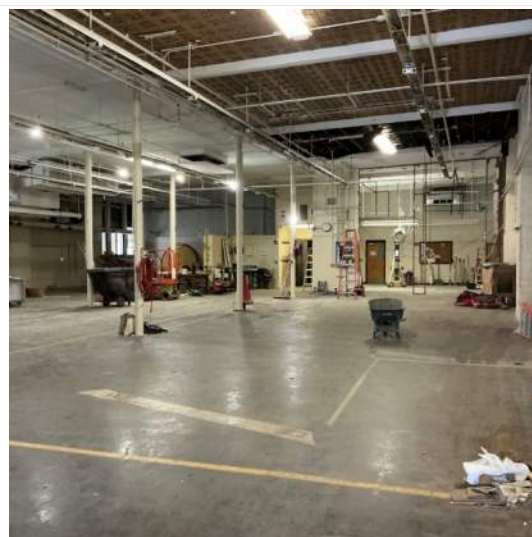
Also reviewed on site the existing conditions at the ceiling in the wood shop. Once the 1x1 acoustic tiles were removed per the demolition plan it was discovered that there were various substrates left exposed and not the anticipated exposed wood structure. There is some exposed wood structure, some gypsum board with adhesive pucks, and some existing plaster ceilings. LSE is reviewing and will need to issue updated ceiling drawings.

Wood shop ceiling demo status – LSE reviewing for adjustments due to different conditions than assumed

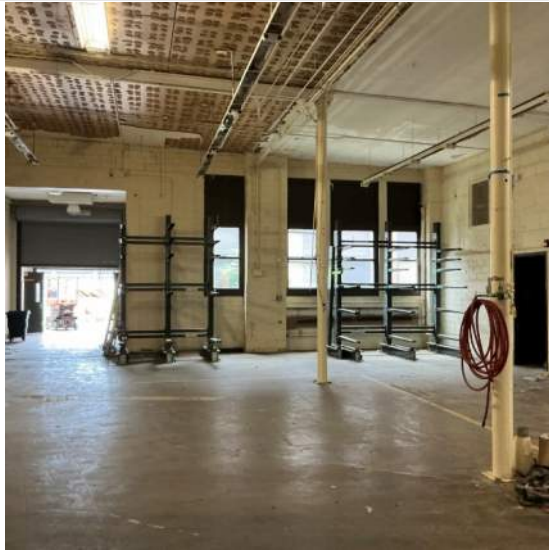
Wood shop demo status with Owner equipment to be moved against wall

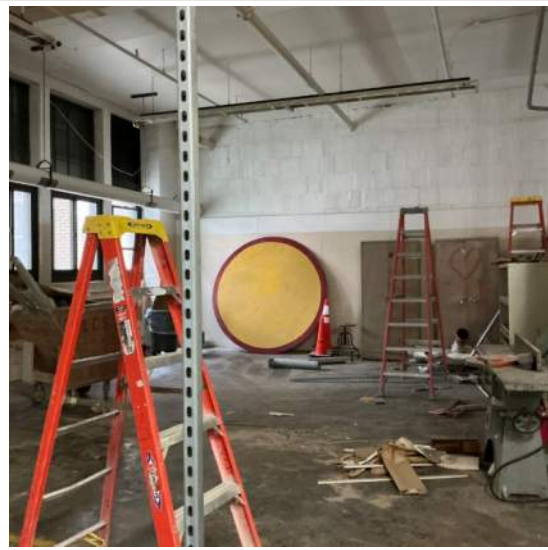
Opposite end of wood shop with some Owner items left behind

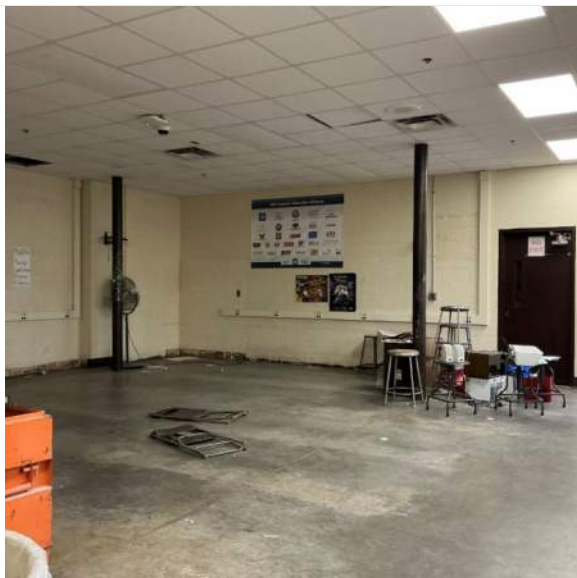
Classroom move out status, stool pile left for demolition with note

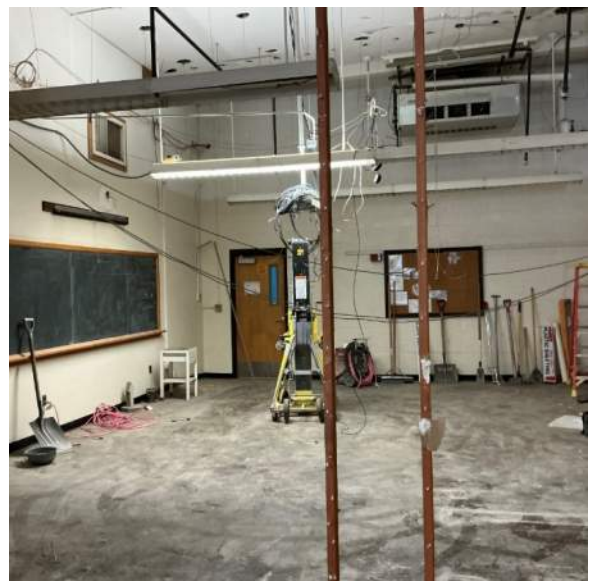
Other classroom demo status, wall gone in front

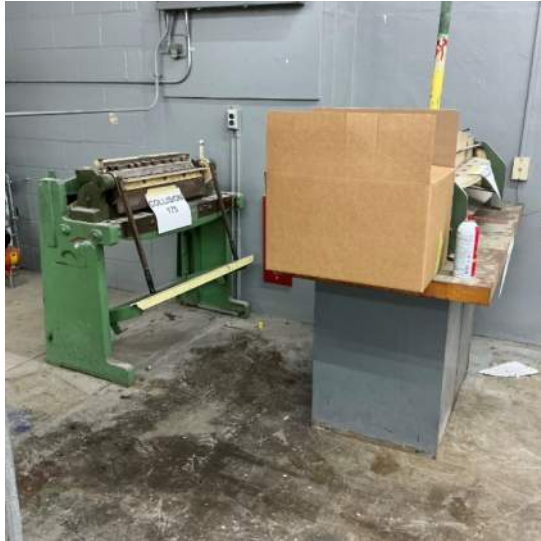
Noted questions on some equipment and an update might be needed for the PR for the equipment coordination based on observations from this site visit. LSE is reviewing.

Verifying extra Owner equipment not identified on plans

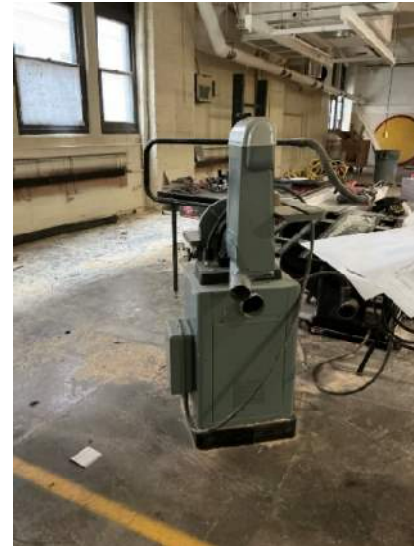
Owner equipment to be confirmed on equipment plan

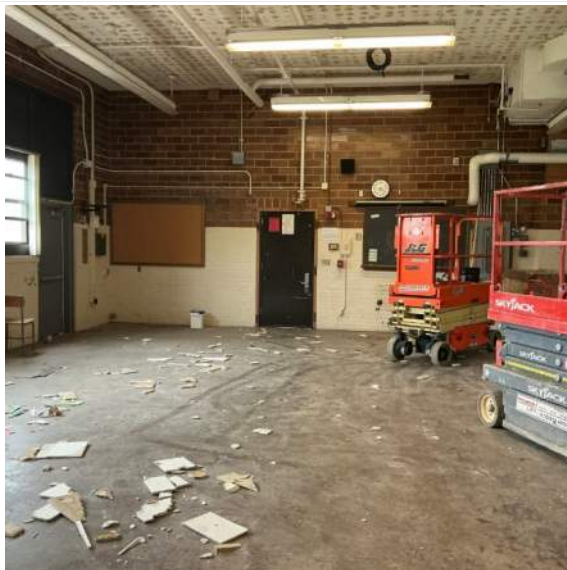
Admin room demolition status with Owner items on walls still

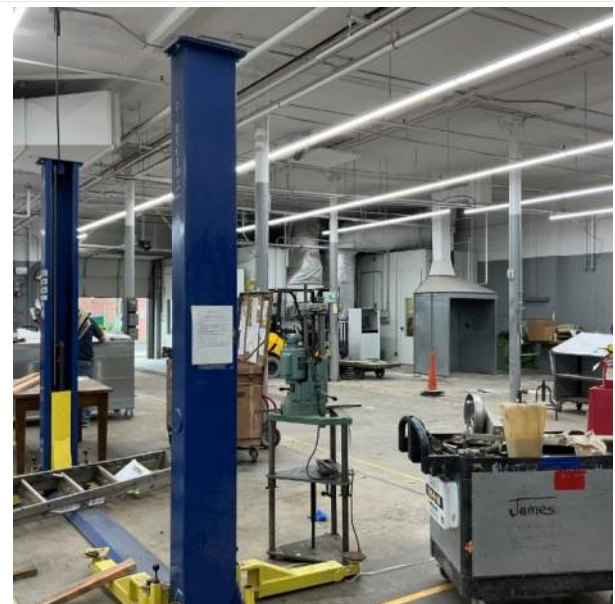
Shop room status
