# Woodside Elementary School Walking & Bicycling Audit

Woodside Elementary School District

## Walking and Bicycling Audit

A walking and bicycling audit was held on Wednesday, June 12, 2013. Audit participants included the Town Engineer, two citizen volunteers with extensive background on school and traffic issues, and two Safe Routes to School professionals.

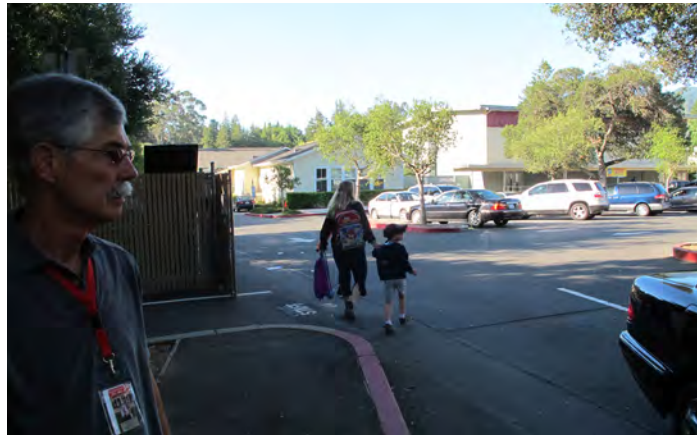
- Separated pathways do not exist between Woodside Road and the school, requiring students and parents to walk through the school's parking lots.
- There is a lack of curb ramps within the school's parking lots, requiring children with rolling backpacks, parents with strollers, and mobility-impaired people to step over curbs.
- Sight lines between motorists and pedestrians are obstructed at crosswalks across the parking lot.
- Motorists double-park within the school's parking lot, and also occasionally obstruct crosswalks.
- The Kindergarten lot crosswalk is controlled with a uniformed crossing guard.
- The Sellman drop-off/pick-up area is controlled with a uniformed crossing guard.

Student and parent walking through eastern parking lot; lack of separated sidewalk connecting Woodside Road and school.

1. Prohibit parking on the south side of Woodside Road in proximity to the school's four driveways and the crosswalks.
2. Construct separated pedestrian walkways between Woodside Road and the school, e.g., on the east side of the most eastern driveway (exit) and on the west side of the most western driveway (entrance).

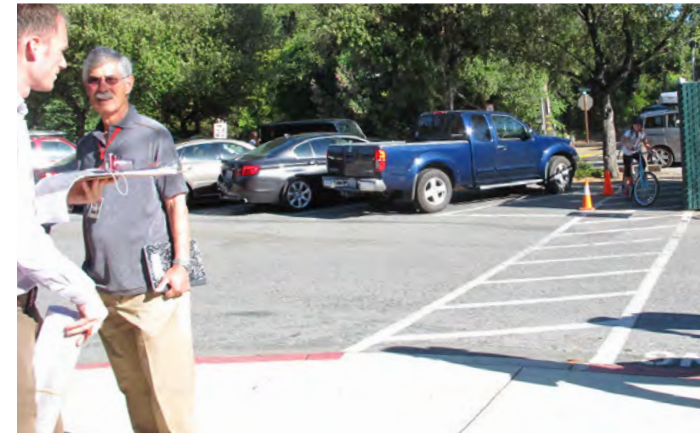
Crosswalk across school parking lot; sight issues and lack of curb ramps.

3. Convert crosswalks through the school parking lot to high-visibility crosswalks or to raised crosswalks.
4. Add curb ramps between crosswalks and school access points.

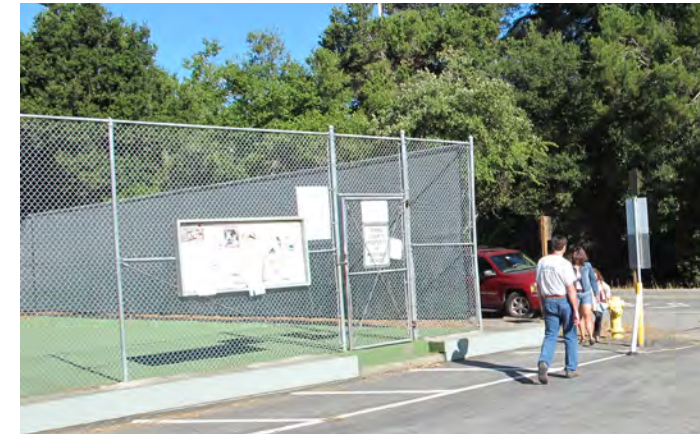
Student and parent walking through western parking lot; lack of separated sidewalk connecting Woodside Road and school.

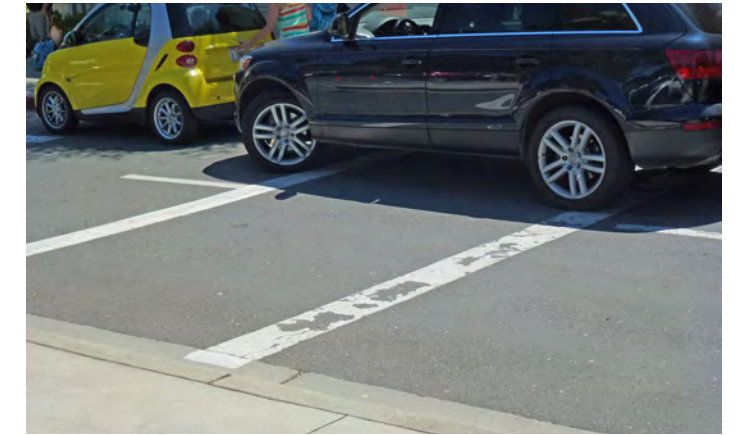
Crosswalk within school parking lot; parking violation and lack of curb ramp.

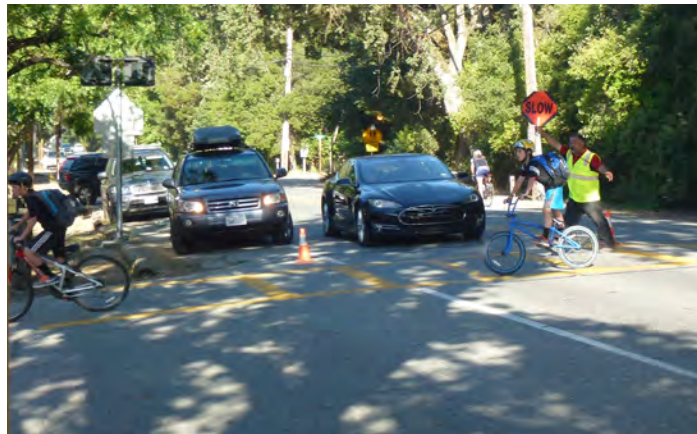
- Two uncontrolled crosswalks (i.e., not controlled with stop signs or a traffic signal) cross Woodside Road near the school. Each crosswalk has faded pavement markings and obsolete school area signage. Flashing beacons exist in advance of each crosswalk.

Western uncontrolled and marked crosswalk on Woodside Road; worn crosswalk, but uniformed and effective crossing guard.

6. Install Rectangular Rapid Flashing Beacons at both uncontrolled crosswalks across Woodside Road.
7. Provide high-visibility school crosswalk pavement markings at both uncontrolled crosswalks across Woodside Road.

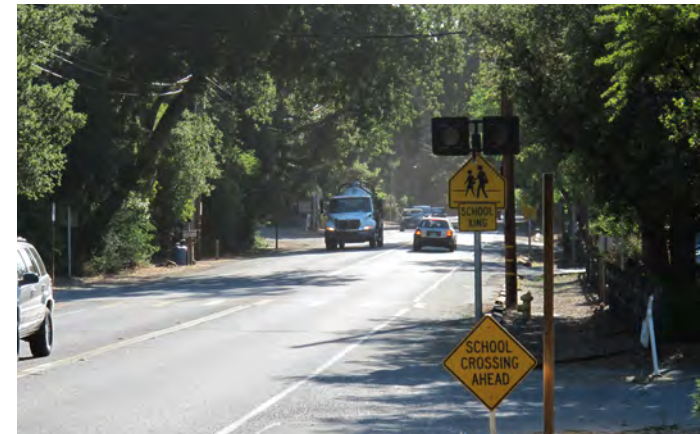
Looking east towards western crosswalk on Woodside Road; obsolete school area signing.

5. Update the school area signing and pavement markings to comply with current State of California standards (see excerpts from the California Manual on Uniform Traffic Control Devices).

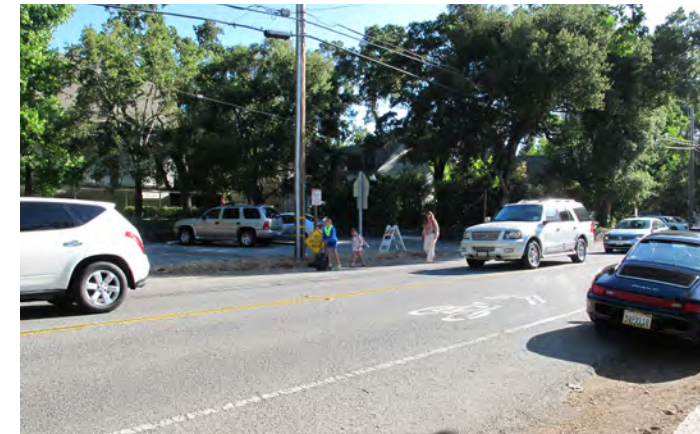
- The north side of Woodside Road consists of a Class II separated bicycle lane, but does not have a pedestrian walkway. Many students and parents were observed walking within the bike lane, adjacent to westbound vehicular traffic.

Students and parent walking westerly along northern side of Woodside Road; lack of separated walkway.

8. Narrow Woodside Road's vehicular travel lanes from 12 feet wide to 11 feet wide, while retaining the southern (eastbound) edge line. This will shift the westbound bicycle lane two feet to the south, enabling a walkway to the north of the bicycle lane.

9. Provide a raised and separated walkway on the north side of Woodside Road.
10. Improve the pathway on the south side of Woodside Road by regrading the surface, widening where feasible, and providing a more compact surface. Remove poles placed sideways on the ground to reduce the potential for tripping. When possible, install underground utility lines and remove above ground poles.

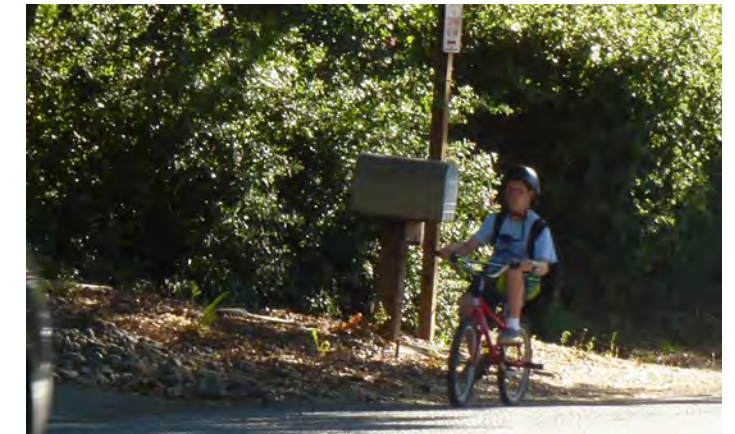
Student cycling westerly along northern side of Woodside Road; bicycle lane is designated in westbound direction.

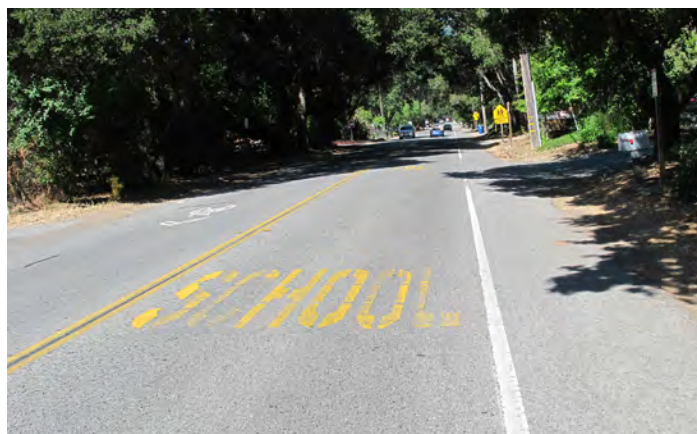
Looking west on Woodside Road towards school; bicycle lane and no separated walkway on north side of roadway.

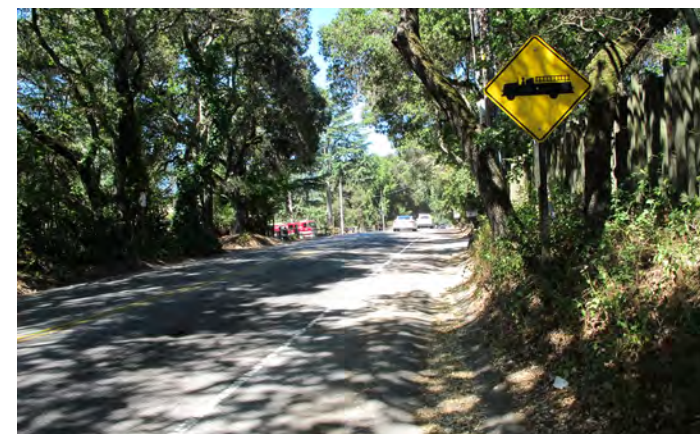
Looking west on Woodside Road, east of school: trees, utility poles and ground slope constrain widening for walkway.

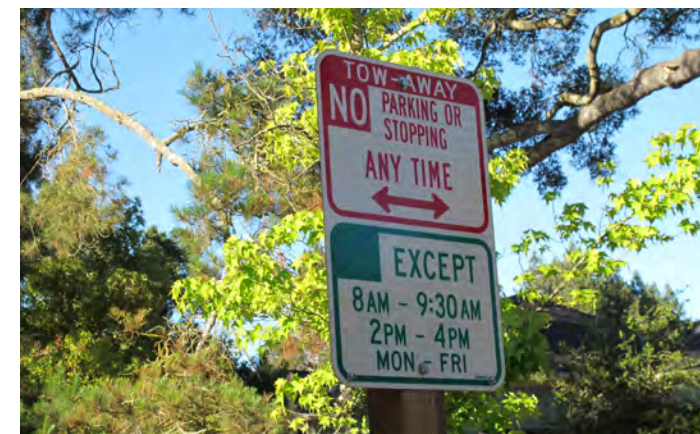
- Parking is allowed on weekdays along the south side of Woodside Road in the vicinity of the school between 8:00 and 9:30 a.m. and between 2:00 and 4:00 p.m. During these times some vehicles block walking and bicycling routes, and cars parked near the school's four driveways can obstruct sight distance for motorists entering or exiting the school, and between pedestrians using the crosswalks and approaching drivers.

Signs on south side of Woodside Road adjacent to school; parking and stopping allowed during school commute hours.

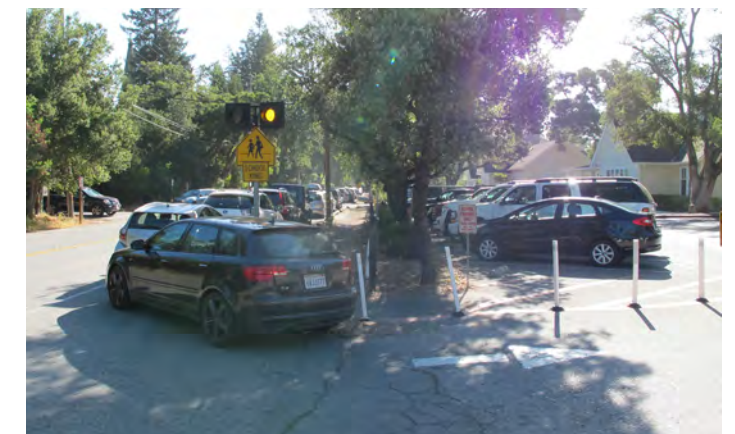
Parking along south side of Woodside Road at western entrance; parked vehicle blocking walkway and limiting sight distance.

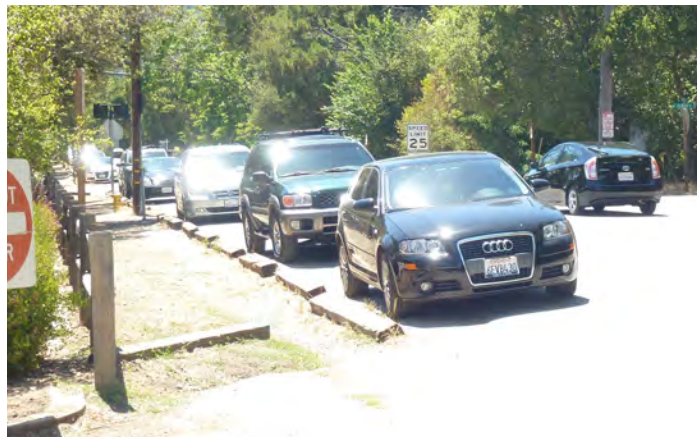
*Parking along south side of Woodside Rd. at western exit; parked vehicle limiting sight distance for motorists exiting driveway.*

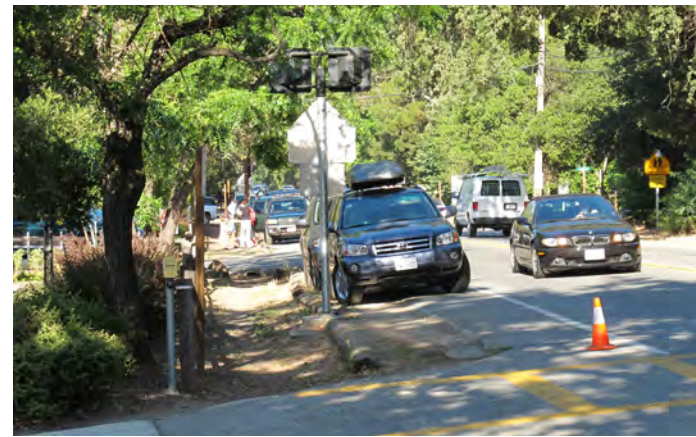
*Parking along south side of Woodside Road near eastern crosswalk; parked vehicle limiting sight distance at crosswalk.*

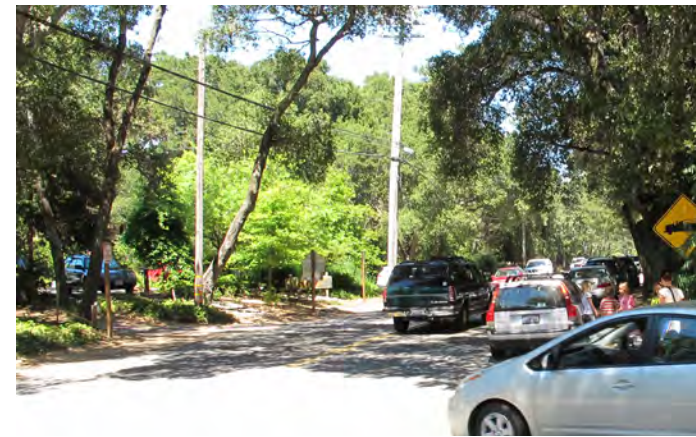
*Vehicle egressing from eastern driveway exit; sight line obstructed by vehicle parked to east.*

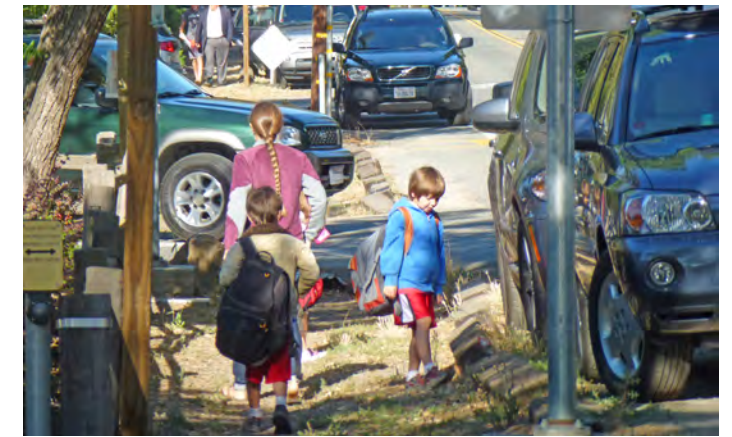
- The south side of Woodside Road consists of a discontinuous equestrian pathway that consists primarily of gravel and dirt. Many students and parents use part of the pathway, primarily to egress from or access parked vehicles.

*South side of Woodside Road adjacent to school; pedestrians use narrow and uneven dirt path.*

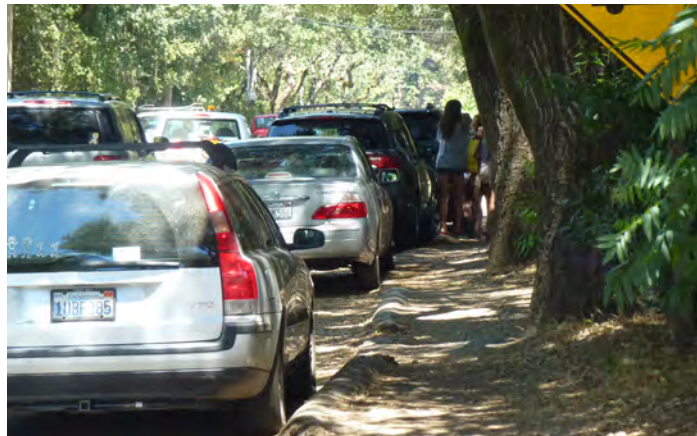
*South side of Woodside Road east of school; narrow path obstructed by trees and car doors.*

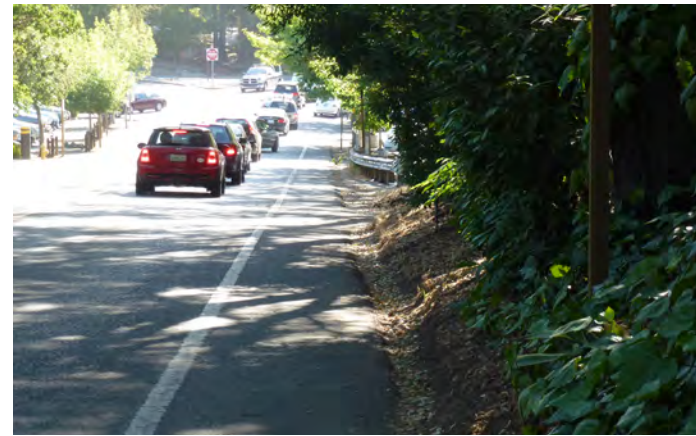
*South side of Woodside Road approaching Town Center: lack of separated walkway.*

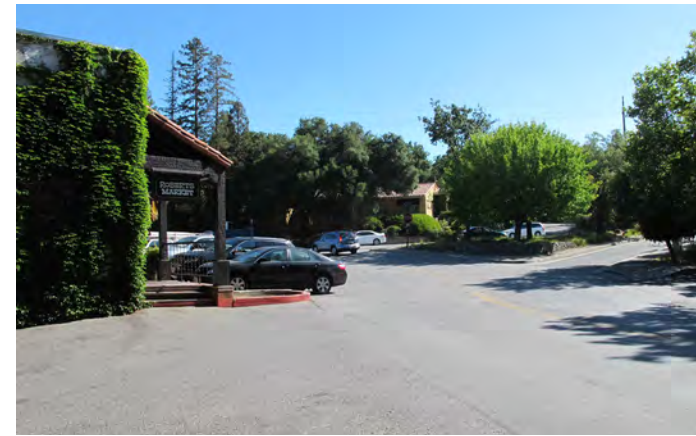
- Students were observed crossing Mountain Home Road south of Roberts' Market; however there are no designated pedestrian crossings and vehicular sight distance can be constrained due to the narrow roadway and its curves.

*Looking north on Mountain Home Road towards Roberts Market and Woodside Road; no designated crossing markings.*

11. Rearrange the existing vehicular parking west of Roberts' Market and install a pedestrian and bicycle pathway within the existing paved area.
12. Add pedestrian warning signs and pavement markings in the vicinity of Mountain Home Road just south of Robert's Market. Develop a longer term plan to traffic calm the intersection, enhance pedestrian and bicycle circulation, and improve sight lines.

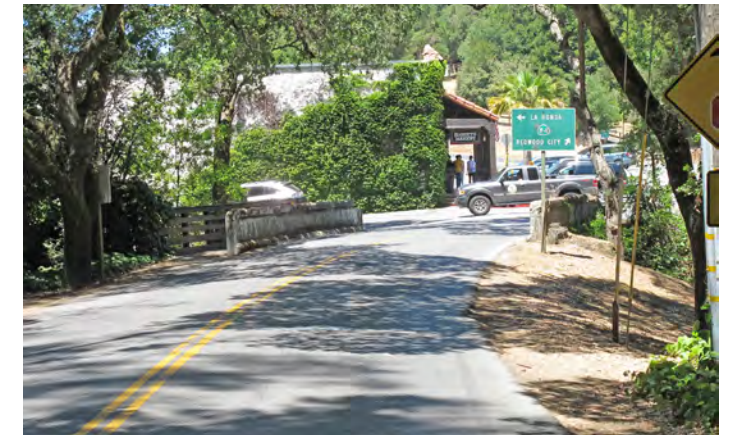
*Looking north on Mountain Home Road towards Cedar Lane; curved narrow roadway and obstructed sight lines.*

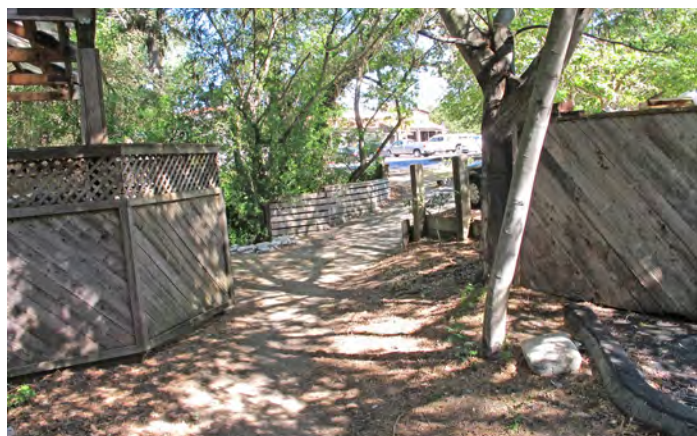
- The existing pathway is narrow, consists of dirt and gravel, and is steep in places. It is popular with students, except those with heavy or rolling backpacks and is difficult to use during wet weather.

*Pathway between Mountain Home Road and Whiskey Hill Road; looking west towards Roberts Market.*

13. Explore the feasibility of providing a pathway between the south side of Woodside Road and Cedar Lane through the fire station.
14. Improve the Dry Creek trail between Mountain Home Road and Whiskey Hill Road by providing a more compact surface, regrading where feasible, and stairs where practical.

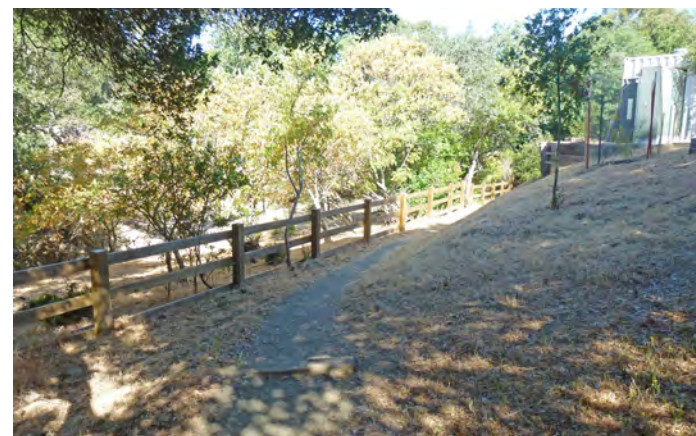
*Pathway between Mountain Home Road and Whiskey Hill Road; looking northwest.*

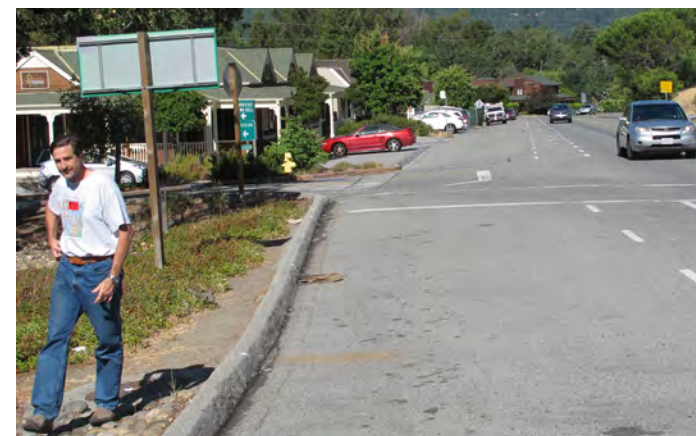
*Looking west on Woodside Road near Whiskey Hill Road; lack of separated pedestrian facilities and marked crosswalks.*

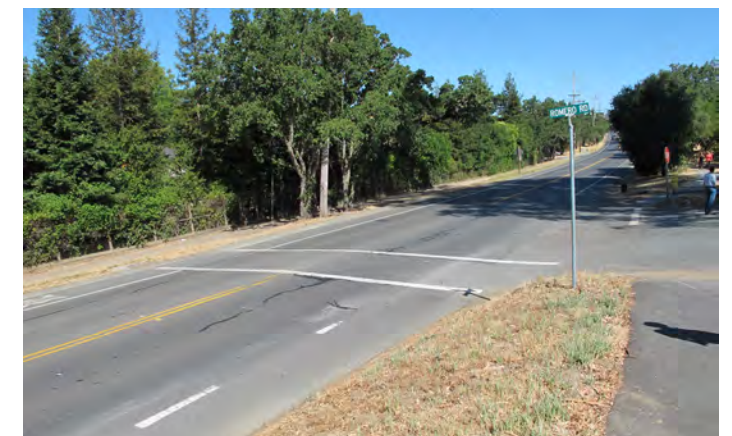
- A paved pathway is located on the east side of Cañada Road. The pathway lacks curb ramps with the Woodside Road/Mountain Home Road intersection, as well as at Romero Road.
- The pathway's crosswalk at Romero Road lacks high-visibility signage and markings, and a paved connection with the pathway to the southwest the ends at "Woody the Fish" (wooden fish structure).
- There is not a marked crosswalk across Cañada Rd at Glenwood Avenue.

*Crosswalk across Cañada Road at Romero Road; standard crosswalk without signing, curb ramps, and connection to pathway on west side of roadway.*

16. Convert Romero Road's crosswalk at Cañada Road to a high-visibility crosswalk with warning signs, curb ramps, and a paved connection to "Woody the Fish."
