# Seismic Assessment Update for the Beaverton School District

Version 0.0.0  
October 6, 2023  
Project 22264.10

## EXECUTIVE SUMMARY

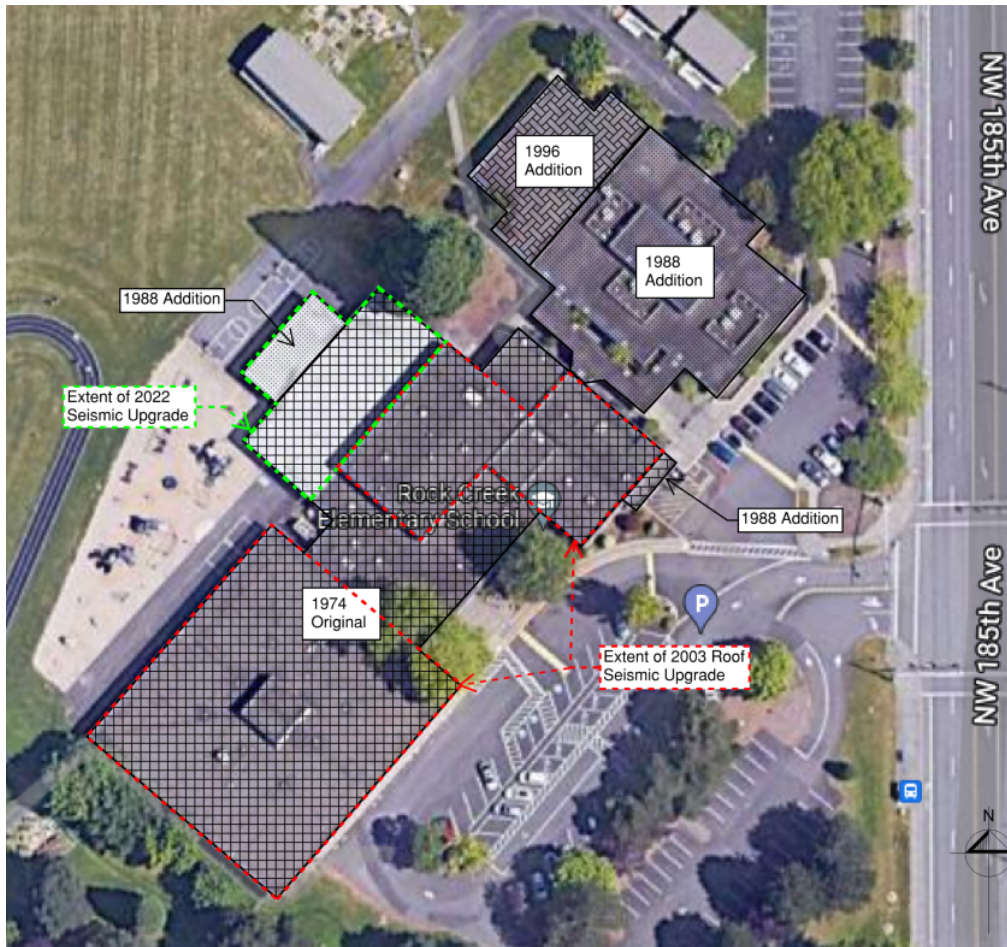
Rock Creek Elementary School - Approximate Outlines of Construction Dates

- Deficient reinforcement within the perimeter masonry bearing/shear walls. This deficiency may be disproven with further analysis.
- The roof diaphragms are not reinforced at re-entrant corners.
- Wood posts lack positive connection to foundations at the 1988 and 1996 additions.
- Discontinuous diaphragm along the long continuous windows on the sides of the 1988 pop-up roof area.
- Cross-grain bending in wood ledgers exists at some roof connections throughout the original building and additions
- Covered play area tongue and groove decking is still likely a deficiency and warrants plywood overlay strengthening.
- Foundation element ties at the covered play area are not present.
- The school is in an area identified as a moderate liquefaction hazard.

The 2023 seismic upgrade was focused on the covered play area. The upgrade was designed using the current building code loads from the American Society of Civil Engineers (ASCE 7-16). The project upgraded the connection of the covered play to the reinforced masonry wall between the covered play area and the original structure as well as the addition of steel ordinary moment frames to provide lateral bracing to the outer edge of the play area.

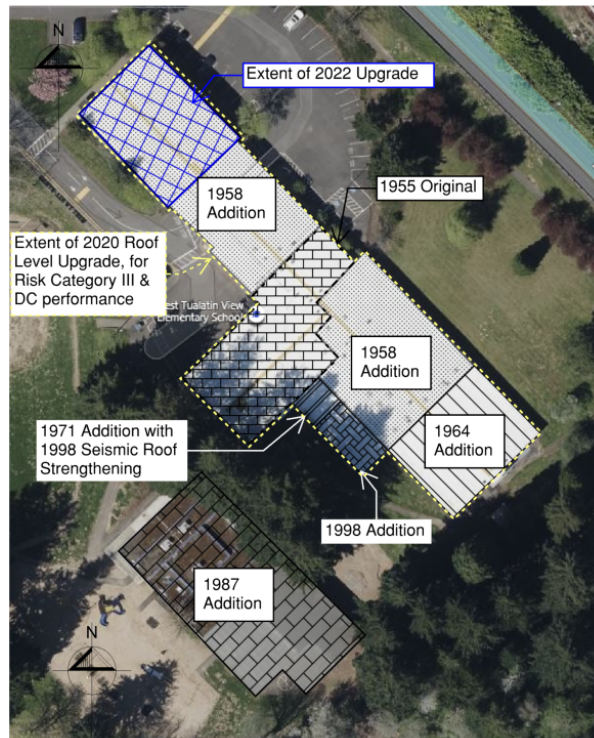
West Tualatin View Elementary School - Approximate Outlines of Construction Dates

These improvements do not bring the expected performance of the entire building up to the district goal. Additional future seismic improvement of the building below the roof level is needed to complete the building upgrade. Further, the 2020 roof level seismic upgrade does not appear to address all the roof level deficiencies identified in the 2019 Tier 1 assessment performed by KPFF. The 2020 project appears to address the in-plane connections of the roof to shear walls identified as deficient in the prior report.

The 2020 roof level seismic retrofit did not fully upgrade the building. Strengthening was completed at the roof level only, with the anticipation of future upgrade work to be done below the roof in the future. Phasing a seismic retrofit in this way ties the roof level work and a reroofing project together to replace the roofing when necessary and avoid needing to disturb the new roofing for a future seismic project. The scope of the roof level retrofit covered the main building (the 1987 Addition was not included) including increasing the sheathing nailing at the gymnasium roof, adding anchorage of the east gymnasium wall to the low roof of the classrooms, and verification of roof sheathing nailing patterns at wall and beam locations.

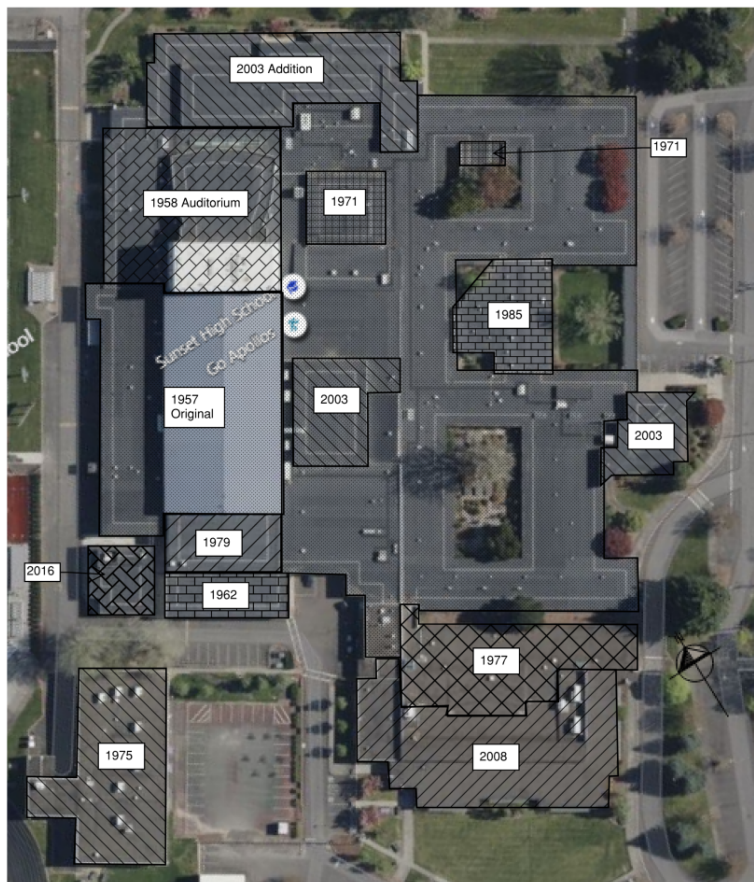
Sunset High School - Approximate Outlines of Construction Dates

- CMU wall anchorage at science room and concrete wall anchorage at gymnasium may be inadequate for out-of-plane lateral loads as they do not provide continuous support between diaphragm chords.
- Seismic separation of the gym and auditorium.
- Weak points of lateral support from windows at exterior elevations.
- Existing shear walls may be inadequate to resist lateral forces.
- Narrow shear wall present at east wall of shop addition.
- Roof chord continuity is lacking at study hall and student center roof pop-ups.
- Likely that wood diaphragm spans are inadequate to resist lateral loads.
- Large span diaphragms likely need increased panel edge blocking.
- Concrete shear walls in the auditorium may be inadequate to resist lateral loads.
- Lateral drifts likely to cause deflection compatibility for pilasters in the auditorium.
- Coupling beam reinforcement at auditorium inadequate.

- South walls at auditorium may be inadequate to resist lateral loads due to large openings.
- Tectum roof at gymnasium. Unknown sheathing and sheathing attachments from 2014 roof project.

- Concrete tilt-up walls at gymnasium may be inadequate to resist lateral loads.
- Concrete tilt-up walls at gymnasium may be too thin and lacks out of plan capacity to span.

- Concrete tilt-up walls at gymnasium unlikely to have positive attachments to footings.
- Girder connections at gymnasium concrete tilt-up walls may inadequate.

- Half-height masonry bearing wall at south side of trash enclosure may be inadequate to support main building.
- The school is in an area identified as a moderate liquefaction hazard.

The seismic improvement was undertaken to address a specific deficiency identified in a previous seismic assessment. As mentioned above, the auditorium at Sunset High School uses a plywood sheathed diaphragm to transfer earthquake and wind loads to the concrete shear walls. The 2022 upgrade added a connection of the concrete shear walls to the slab on grade to ensure the lateral load will be transferred to the foundation. This provides a load path for the lateral forces to improve the overall seismic performance of the auditorium.
