UPPER DARBY SCHOOL DISTRICT

Long Range Facilities Master Plan

Facility Condition Assessment

Finance and Operations Committee Meeting
28 February 2023

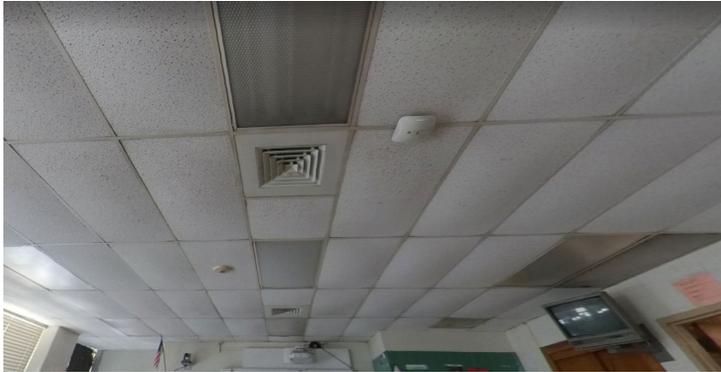
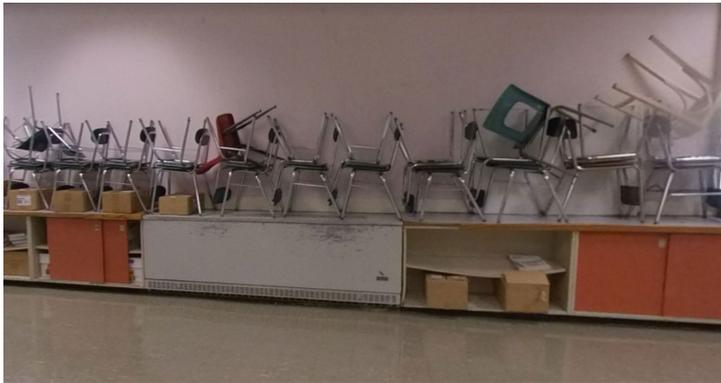
BUILDING ASSESSMENTS: UPPER DARBY HS

- ✓ AHU's above natatorium
- ✓ Metal casework
- ✓ Window treatments
- ✓ Ceiling tiles

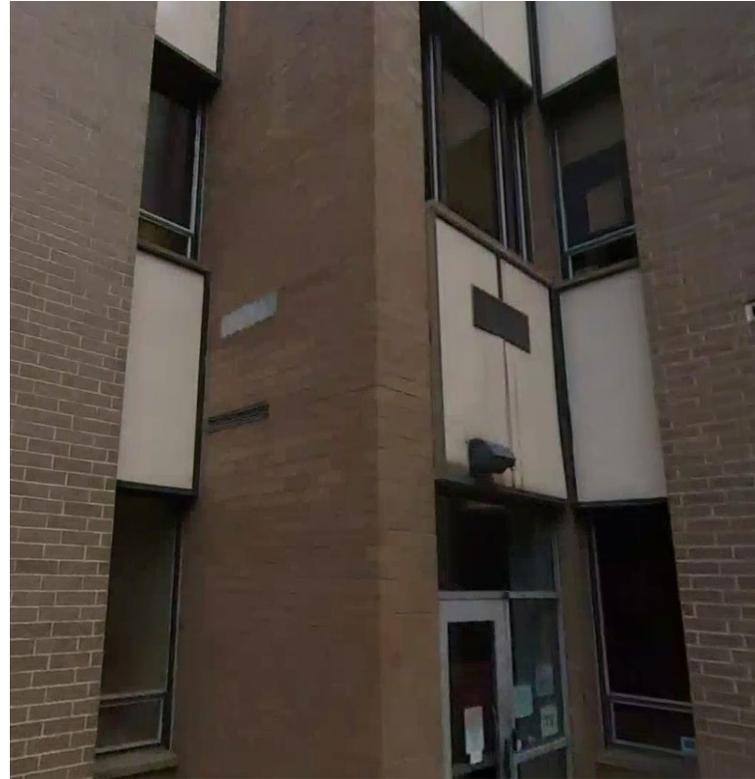
- ✓ Exterior brick masonry restoration and repointing in select areas

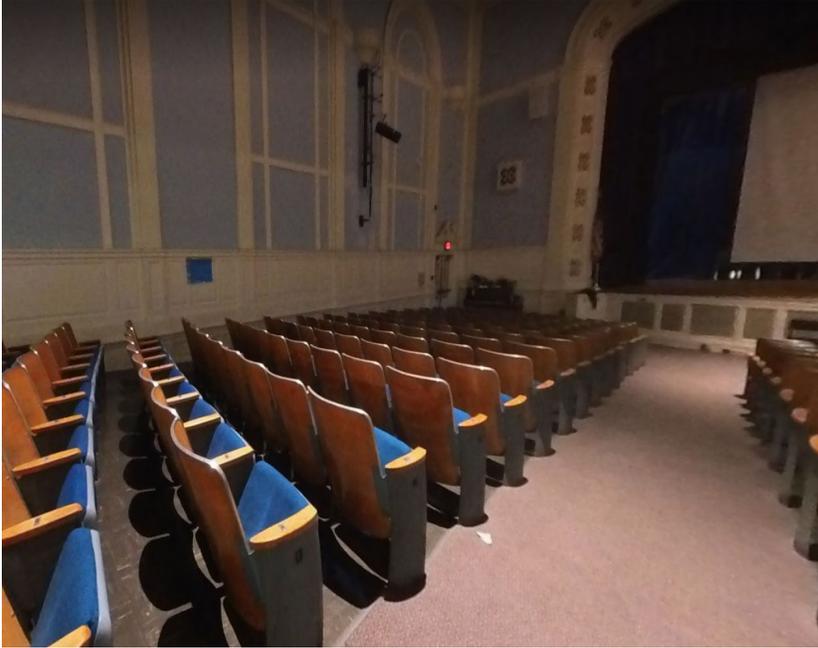
BUILDING ASSESSMENTS: BEVERLY HILLS MS

- ✓ Auditorium and classrooms painting
- ✓ Boiler room handrail

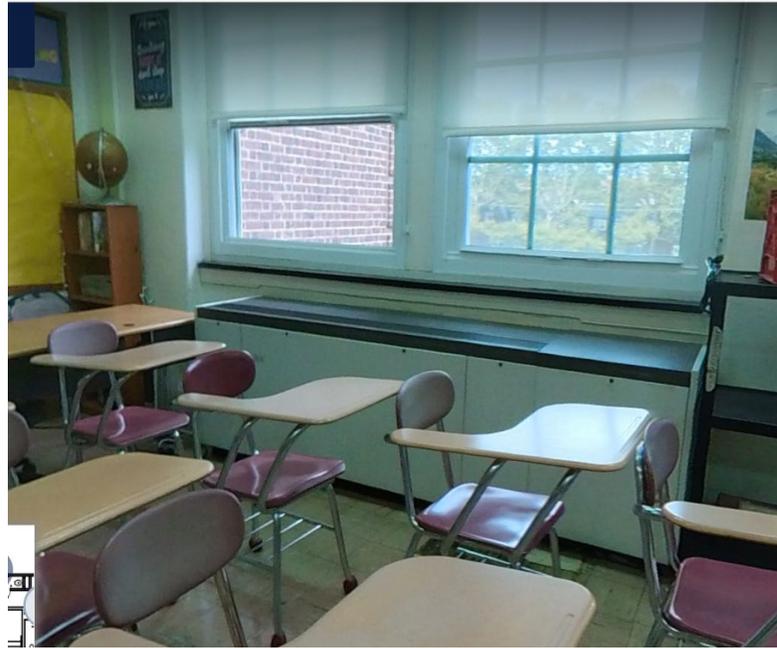
- ✓ Carpeting, window treatments, ceiling tiles

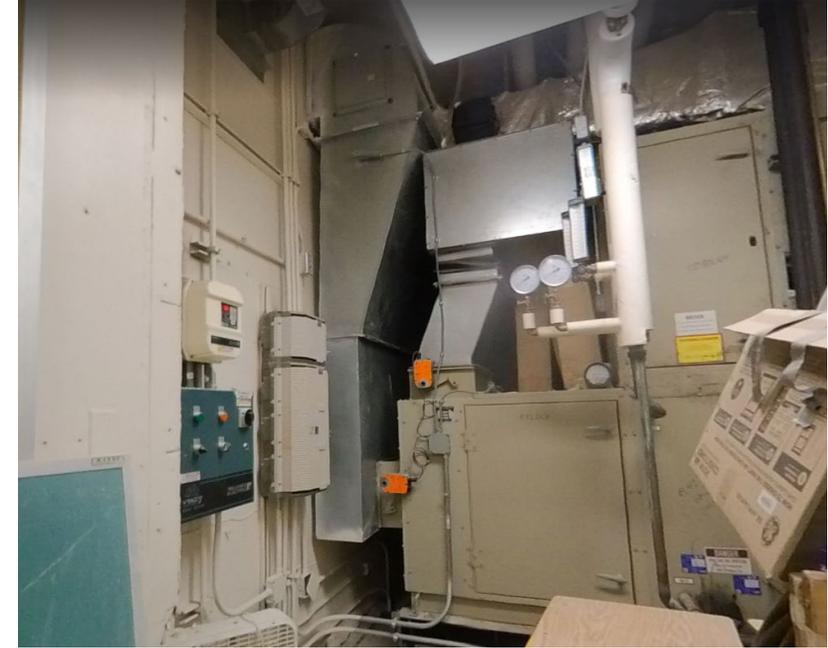
- ✓ HVAC terminal equipment operating in a degraded condition
- ✓ Boiler, AHUs, chillers, pumps equipment

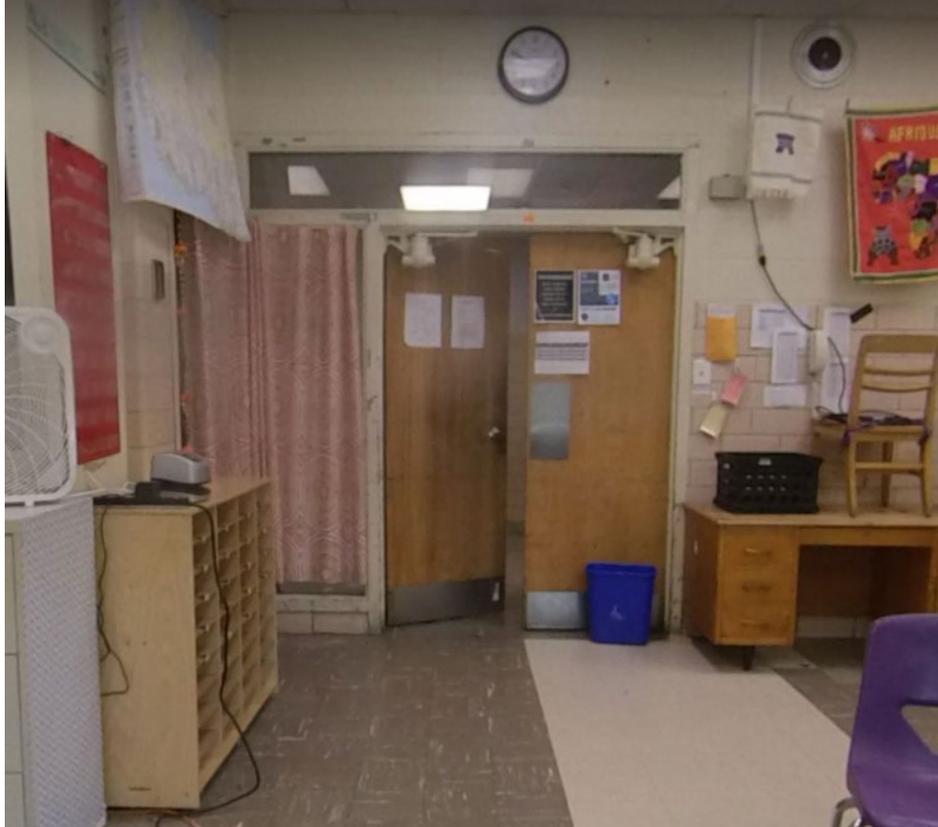
BUILDING ASSESSMENTS: DREXEL HILLS MS

- ✓ Door hardware doesn't meet code
- ✓ Ceiling tiles need to be replaced

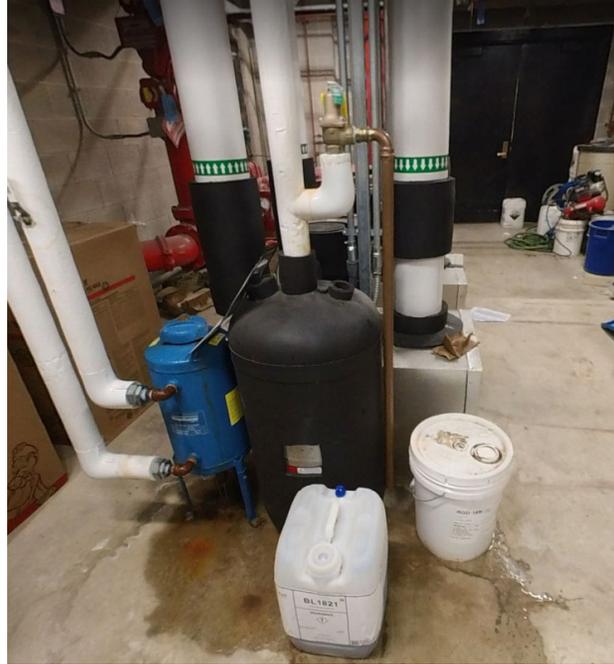
- ✓ Concrete floor in corridor requires finish (paint, stain and seal)

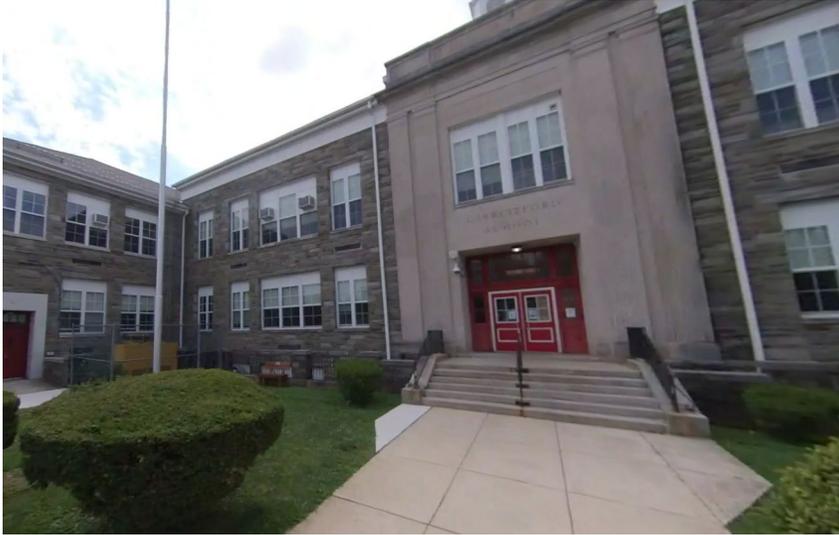
BUILDING ASSESSMENTS: GARRETFORD ES

- ✓ Façade needs repointing and stone masonry repair
- ✓ Caulking maintenance in select areas around windows

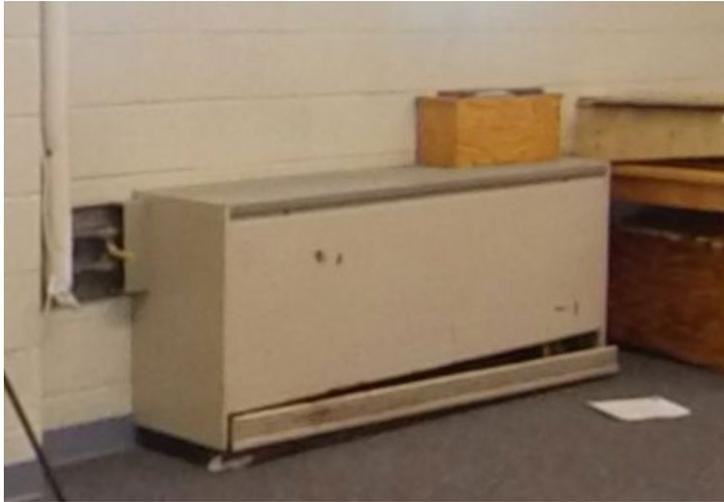
BUILDING ASSESSMENTS: HILLCREST ES

- ✓ Heating only unit ventilators are in need of repairs
- ✓ HVAC terminal equipment operating in a degraded condition

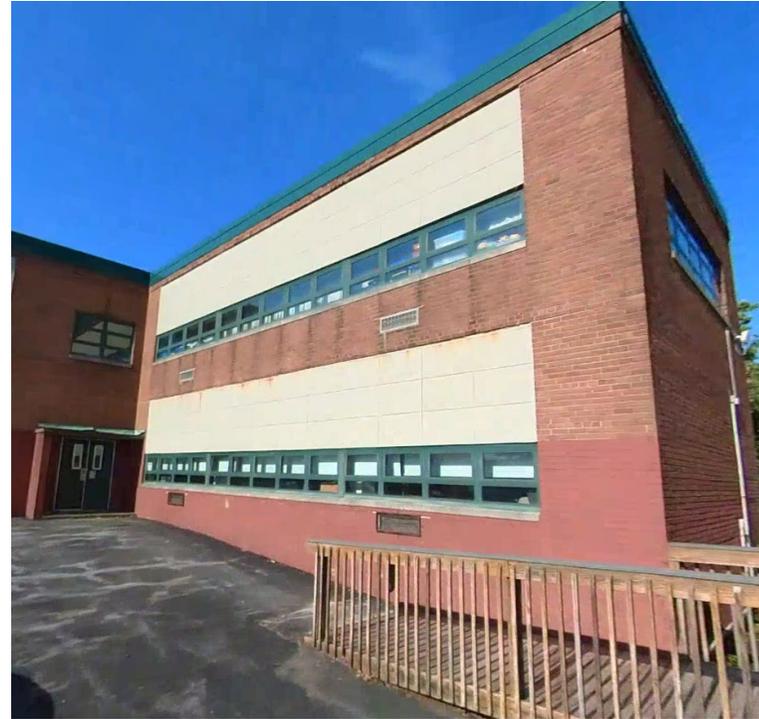
- ✓ Brick masonry veneer in poor condition
- ✓ Exposed steel columns are rusted and delaminated

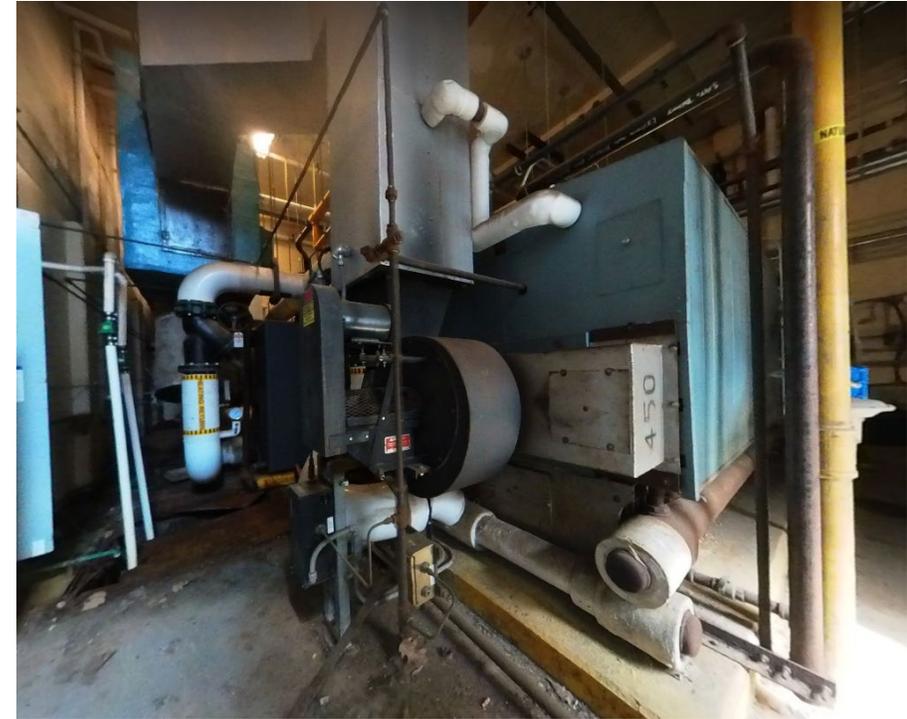
- ✓ Condensing units, AHUs, hot water pumps, hot water boiler equipment in need of repairs or excessively past life

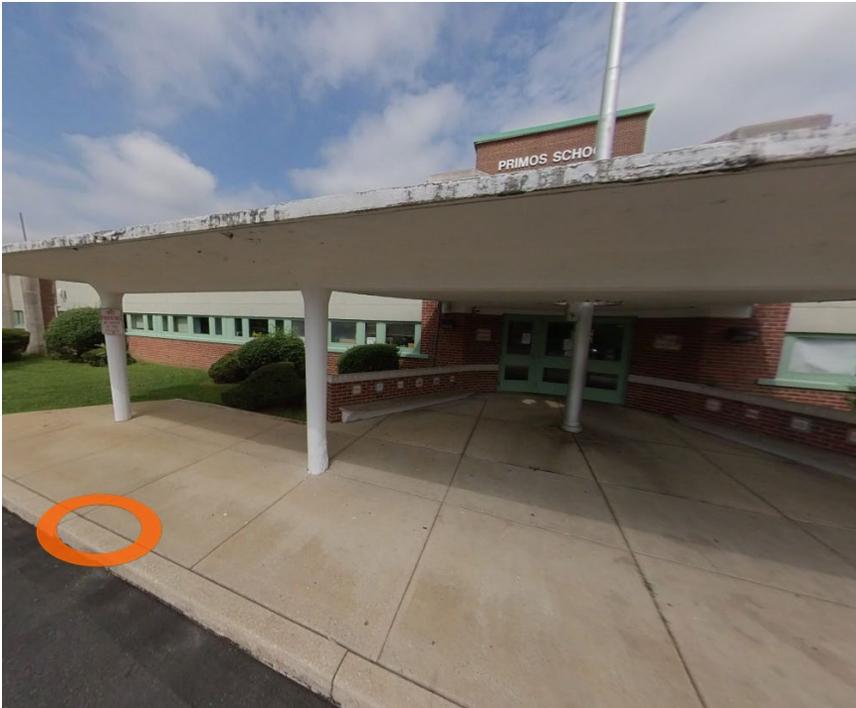
BUILDING ASSESSMENTS: PRIMOS ES

- ✓ Exposed steel columns, entrance canopy, glass curtain wall, doors and frames in need of repair

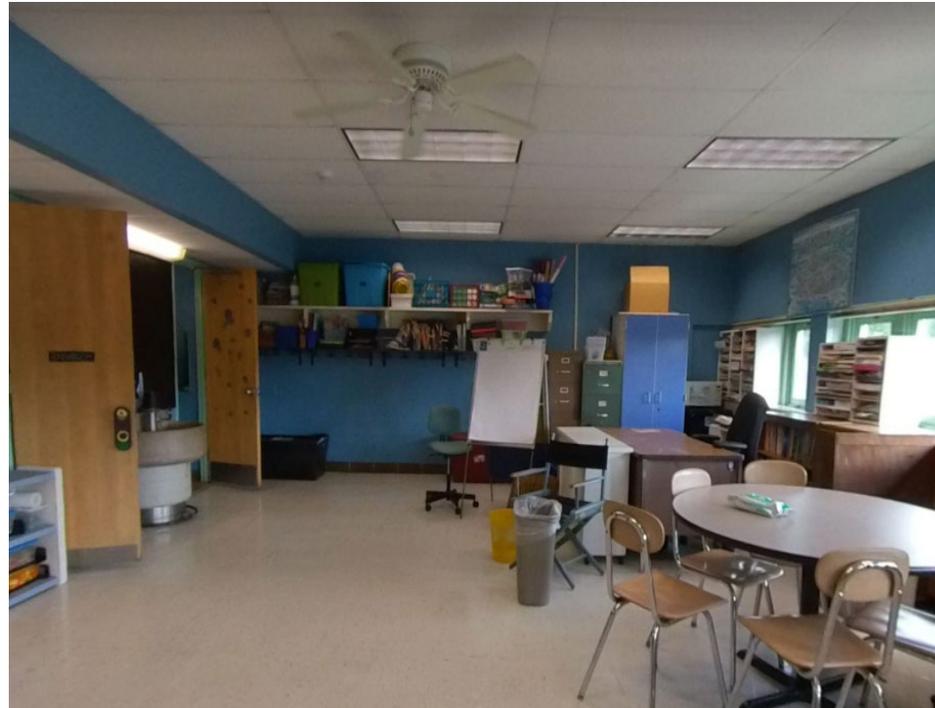
- ✓ Single wood hardwood doors are ADA inaccessible
- ✓ Entry vestibule non-secure
- ✓ Ceilings, flooring, casework needs repairs/replacement

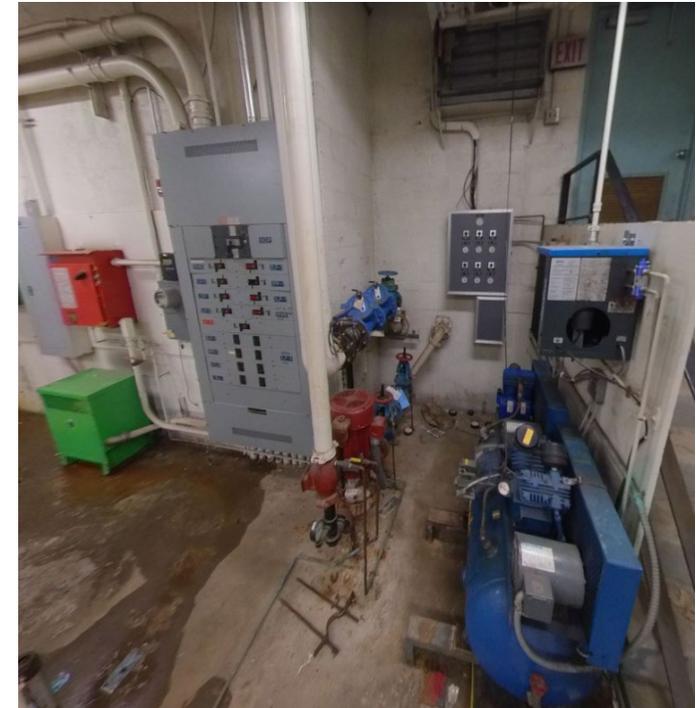
- ✓ Controls, electrical distribution, fire alarm system, lighting fixtures, hot water pumps equipment operating in a degraded condition
