## Architects Field Report

Project Name:	MPS Roosevelt HS CTE Improvements		
Location:		Project Number:	22.1007.02
Contractor:	Construction Results Corp		
Date of Visit:	7/31/25	Weather:	Smoky Haze Sunshine
		Temp Range:	76 degrees
Time of Visit:	11:45 -1:00 pm	Conformance with Schedule (+/-):	On schedule
Report By:	Deborah Bauknight, LSE Architects		
Distribution:			
Owner:	Jeffrey Helstrom, MPS	Contractor:	CRC – Carl Hoikka, Melissa Anderson
Architect:	LSE – Deb Bauknight, Jennifer Anderson-Tuttle	Field:	CRC – Gary Swift
Consultant:	IMEG – Cory Casperson HEI – Angie Thoresen, Jeff Hauswirth, Scott Larson TNCG – Brandon Frazier	Others:

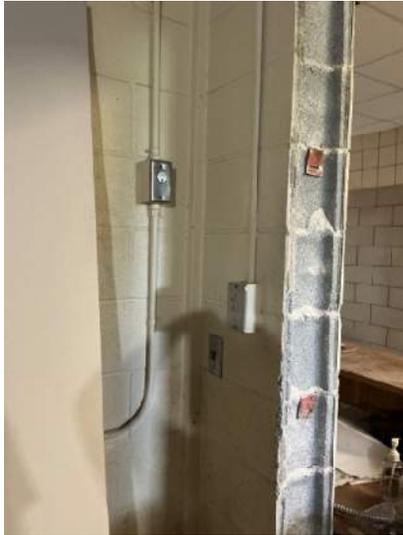
Reviewed existing conditions for Door 13 hardware – key switch in place in Admin room

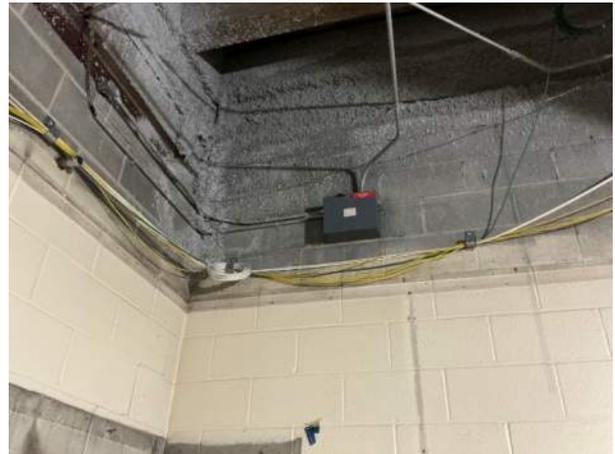
Traced conduit to the controller for Door 13

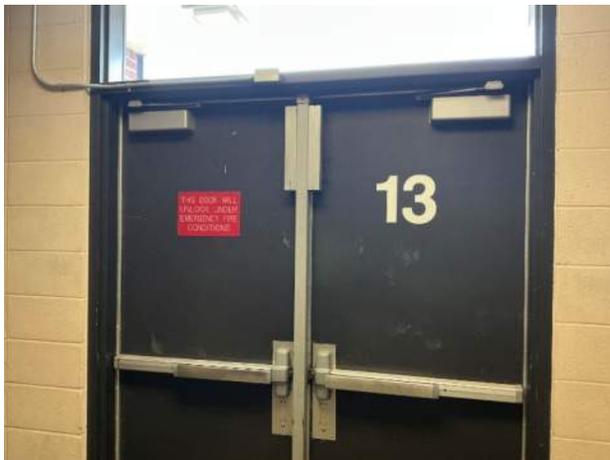
Reviewed an existing condition at Door 13 and confirmed existing items are in place. Because the fire alarm is in test mode cannot confirm the maglocks work but assume they will.

Door 13 mag locks in place – cannot verify operational as building in test mode

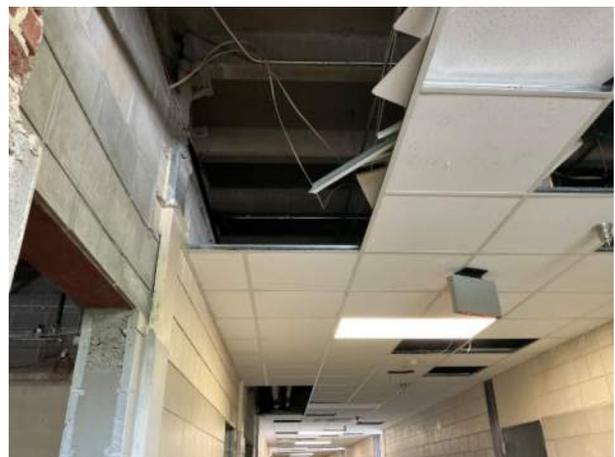
Hall at admin end showing existing structure for wall framing above new storefront

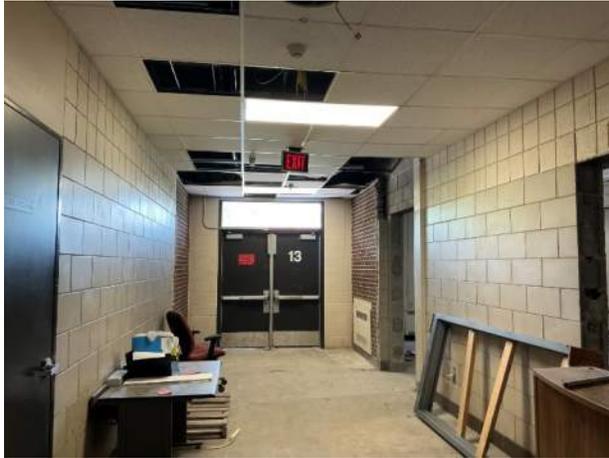
Admin hall status

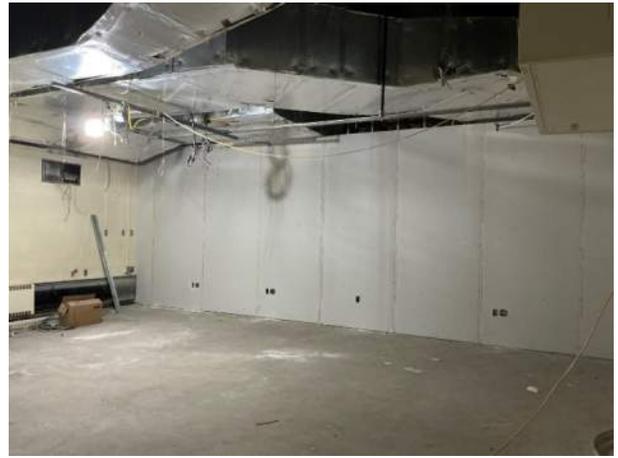
Admin new office temporary wall

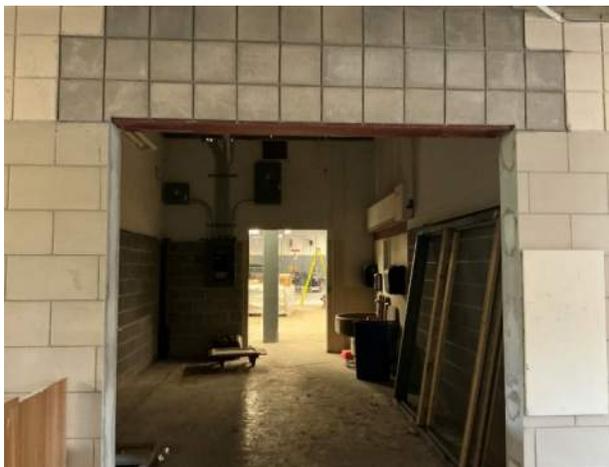
Hall opening for new doors to Auto Repair

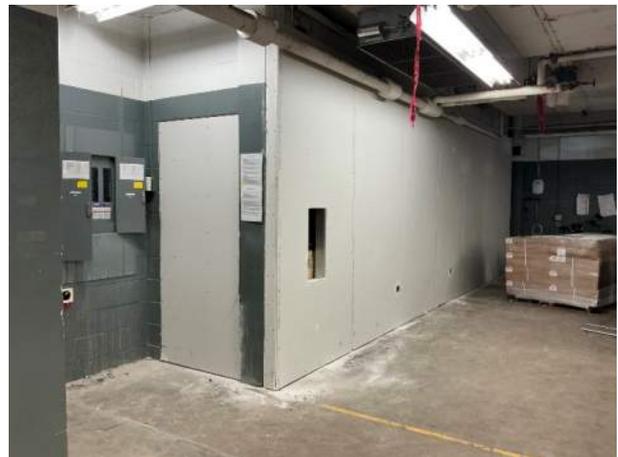
Temporary wall from Auto Repair side with gypsum board installed

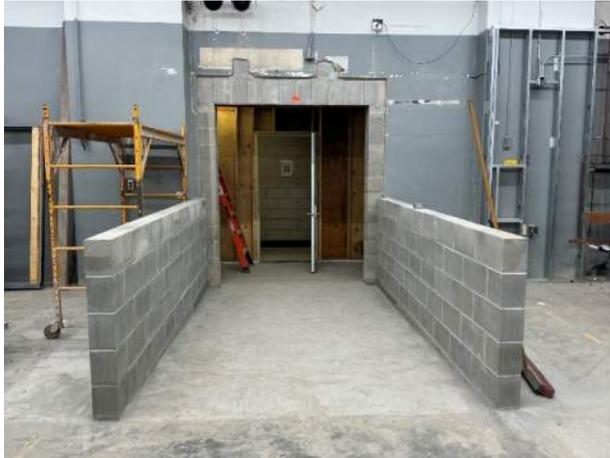
Concrete ramps masonry work installed.

Collision Lab ramp with masonry installed

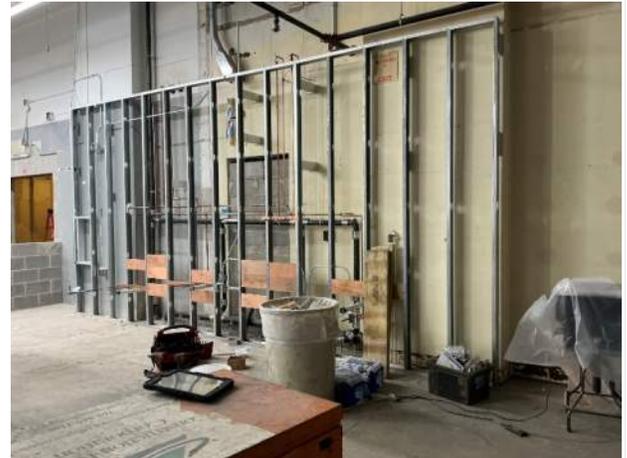
Collision Lab plumbing wall with more MEP and blocking

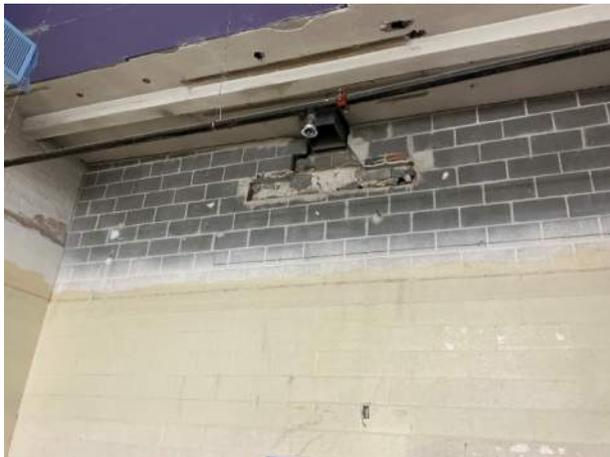
Collision Lab wall patch to be fixed as exposed

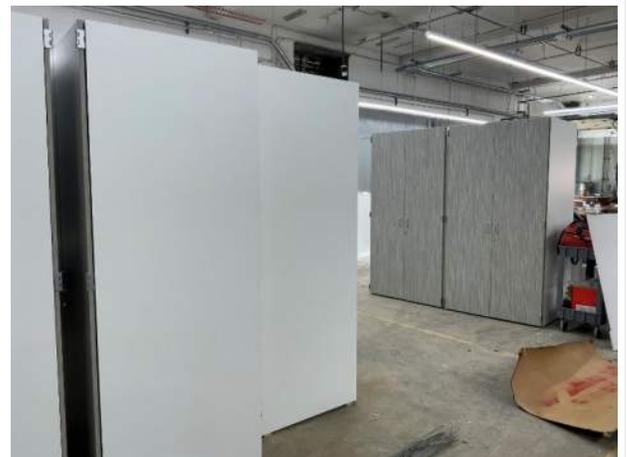
Cabinets are on site.

Cabinets on site

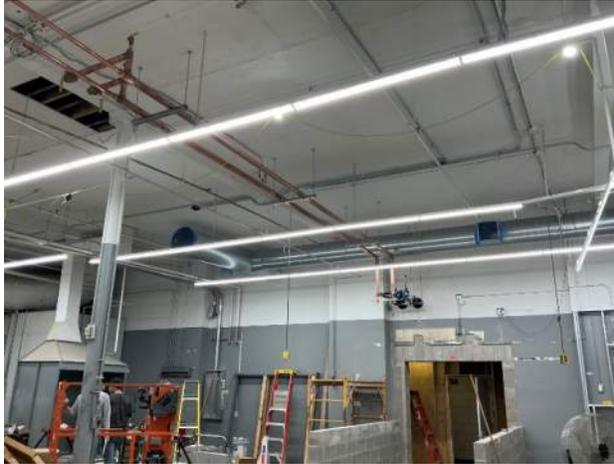
Collision Lab MEP status

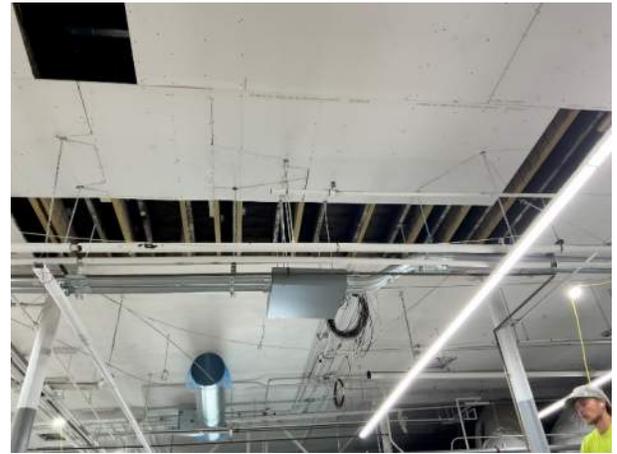
Collision Lab structural LVL installation

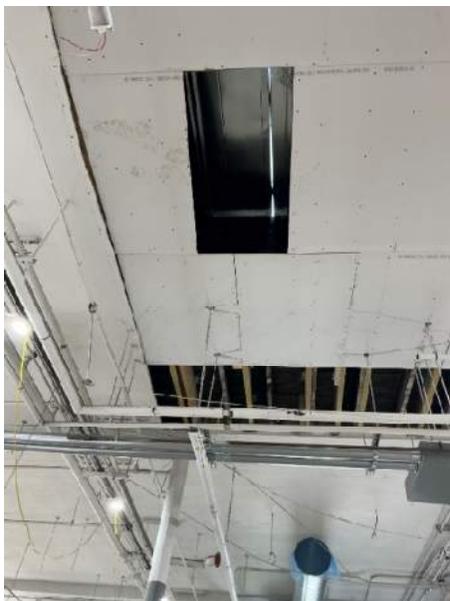
Collision Lab roof curb installed

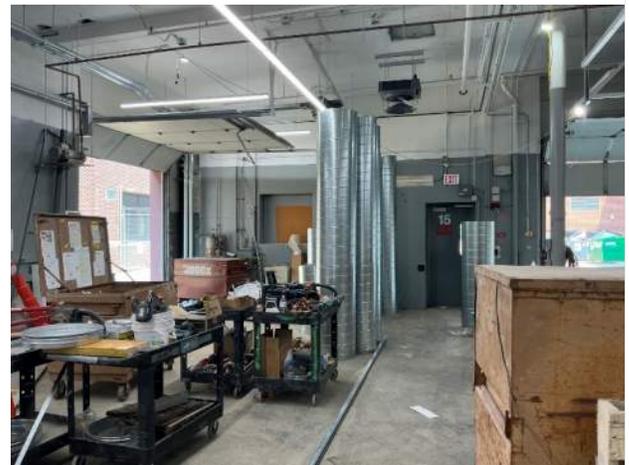
Collision lab MEP and materials

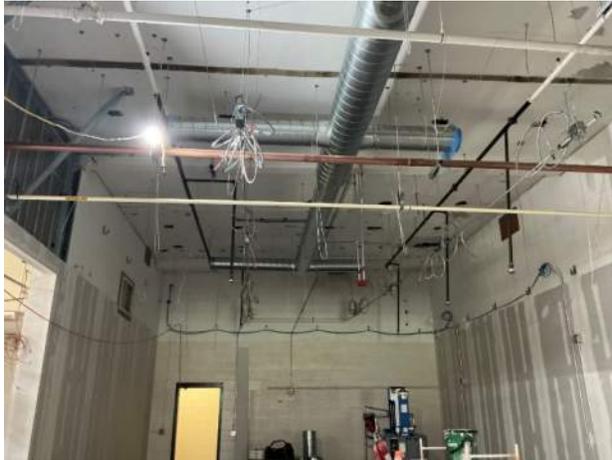
Construction classroom taped at gypsum board and MEP installation

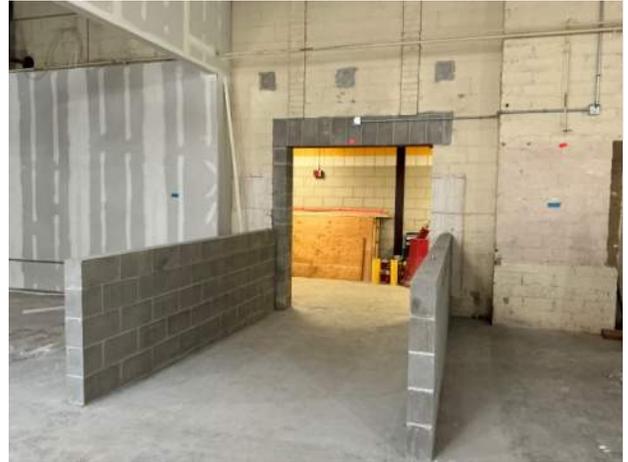
Construction Lab ramp with masonry installed

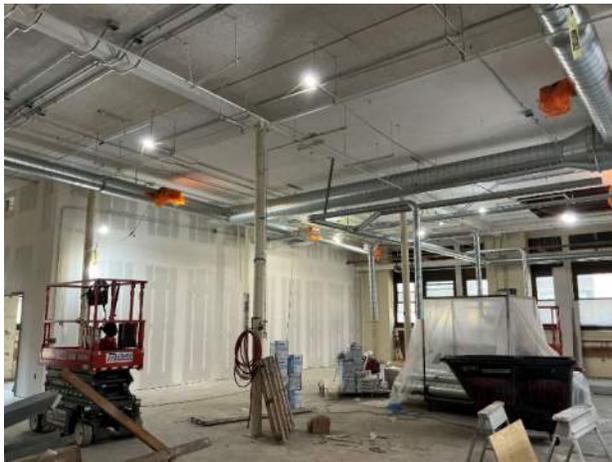
Construction Lab general status

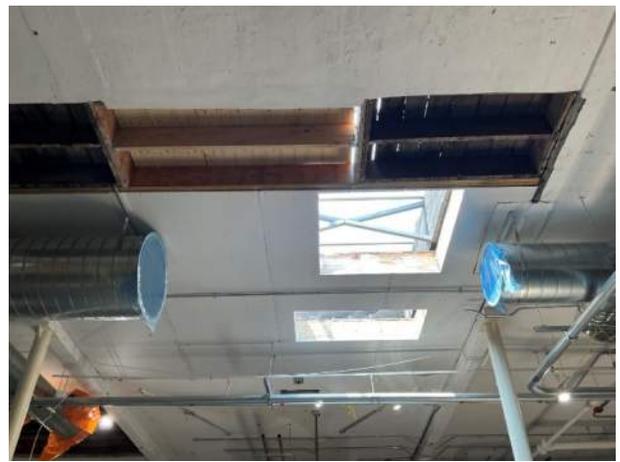
Construction Lab roof openings started

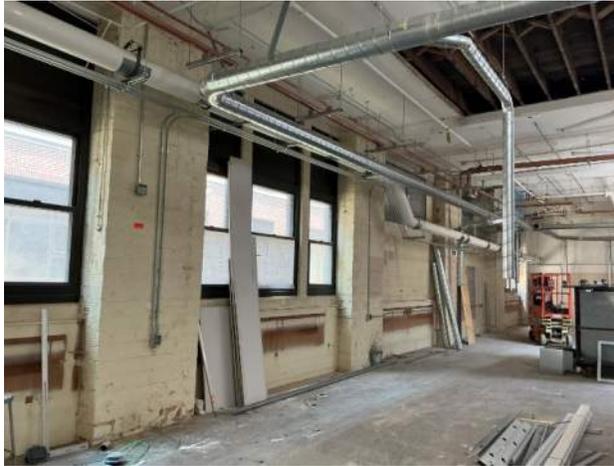
Construction Lab general progress

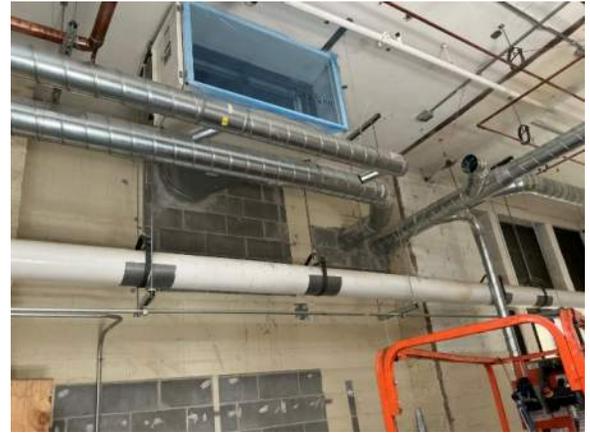
Dust collector penetration through exterior wall has been infilled with masonry.

Construction lab dust collector masonry infill

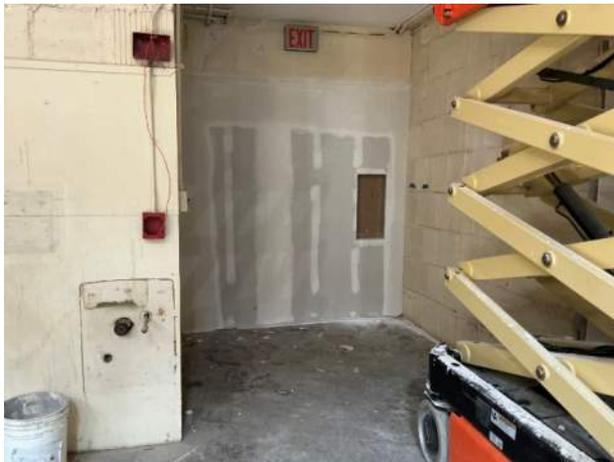
Construction Lab hall infill taped

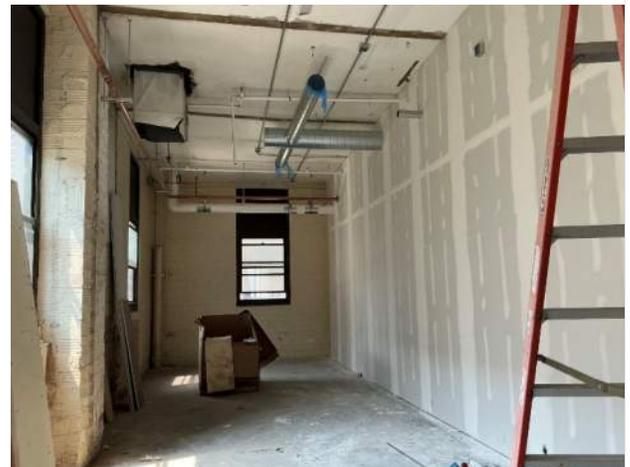
Construction storage taped

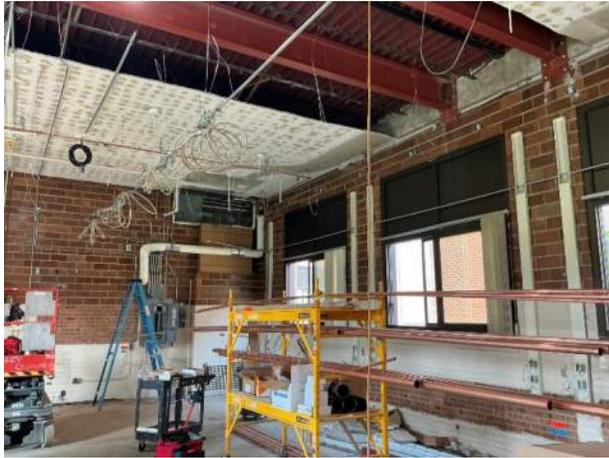
Admin space status

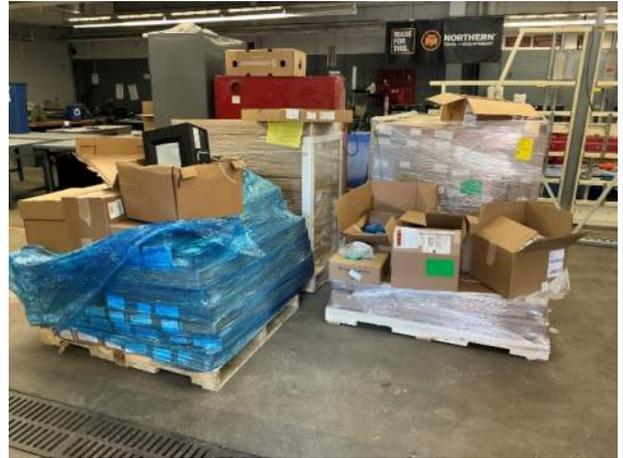
Electrical materials on site

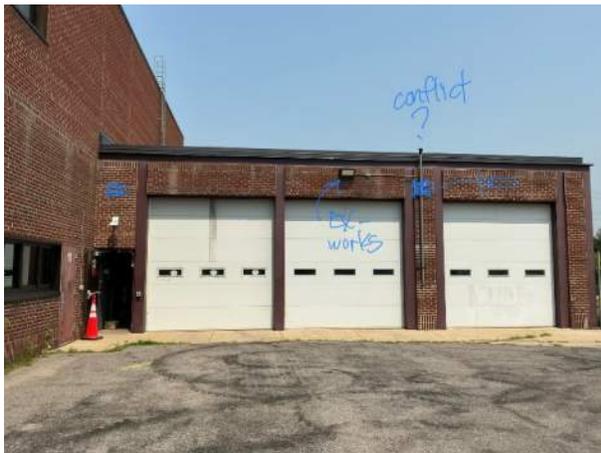
Existing condition at Auto Repair exterior light fixture scope – PR to be issued to delete work and provide materials for use in Phase 2

Reviewed exterior electrical light fixture question since there are existing light fixtures in the general area although not shown on the existing drawings. Since this area will be revised in Phase 2 it doesn't make sense to complete this work only to take it down. Turn over light fixtures for use in Phase 2, PR to be issued.

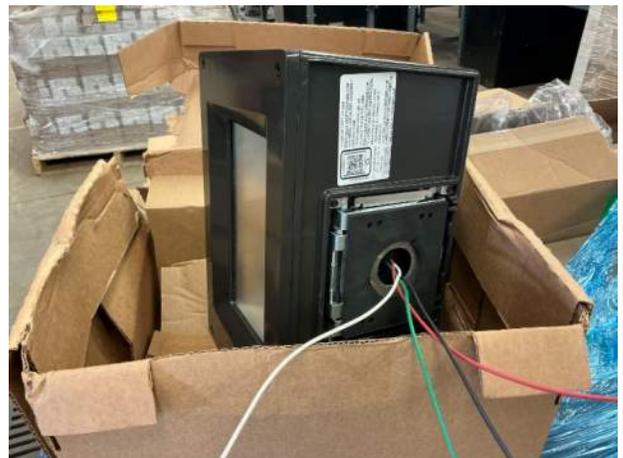
Exterior light fixture to be turned over
