Architects Field Report

Project Name:	MPS Edison HS CTE Improvements				
Location:	700 22 nd Avenue NE, Minneapolis, MN		Project Number:		22.1007.02
Contractor:		Jorgenson Construction			
Date of Visit:	7/22/25	Weather:	Sunny		Temp Range: 84 degrees
Time of Visit:	11:00 am - 12:00 pm	Conformance with Schedule (+/-):		Making up time	
Report By:	Deborah Bauknight, LSE Architects				
Distribution:					
Owner:	Jeffrey Helstrom, MPS	Contractor:	JCI – Alex Rustad, Tara McMahon		
Architect:	LSE – Chris Laabs, Jennifer Anderson - Tuttle	Field:	JCI – Ben Gabatino		
Consultant:	Larson – Eric Meyer IMEG – Cory Casperson HEI – Angie Thoreson, Jeff Hauswirth, Scott Larson, TNCG – Brandon Frazier	Others:

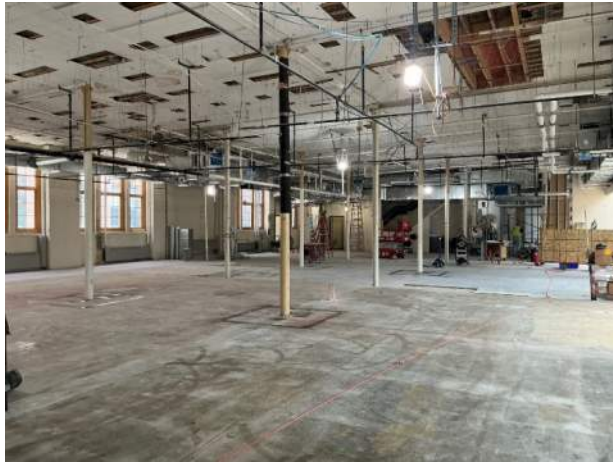
3 classroom lab area status

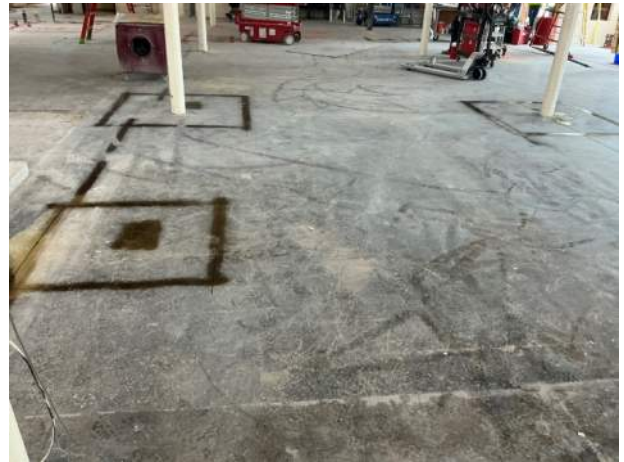
Column demo prep in 3 lab area

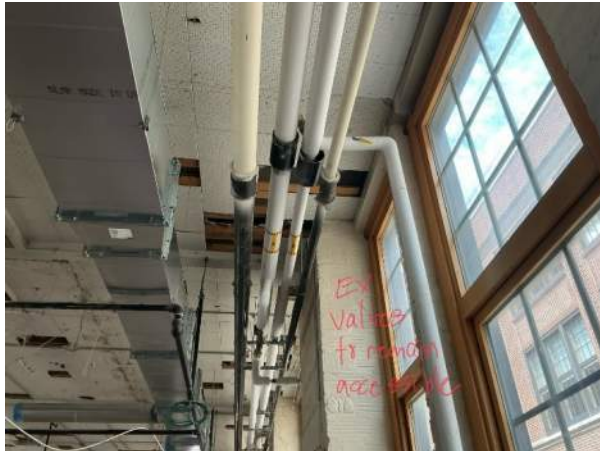
Reviewed existing valves to remain in Commons area for RFI

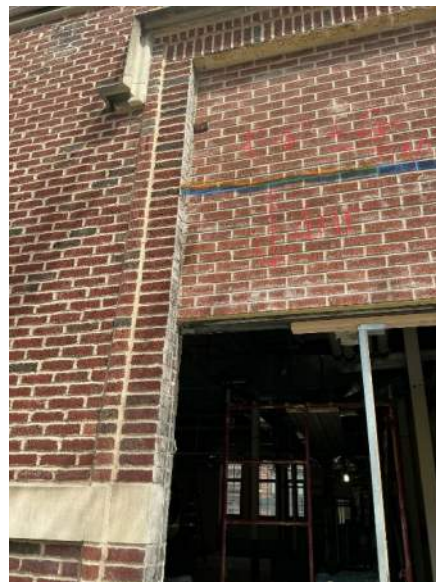
Exterior entry demolition status

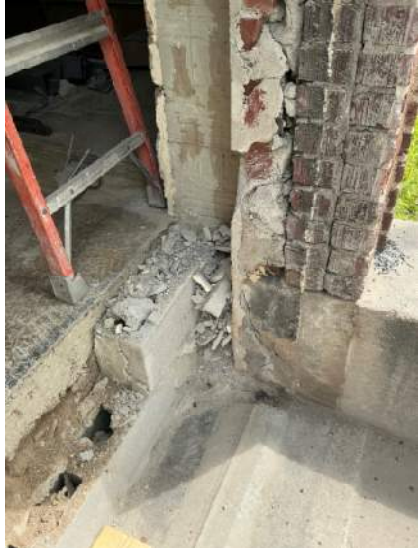
Exterior entry wall section – 2 layers brick and 2 layers backup - unexpected

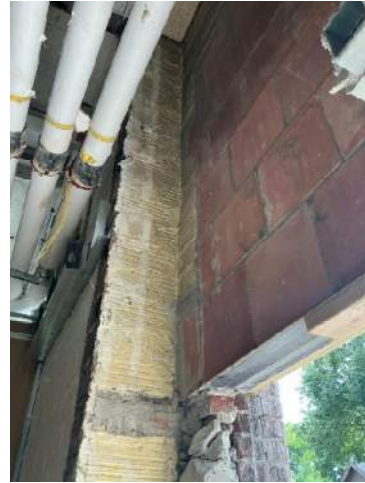
Exterior entry wall above door level- lintel at door not resting on backup wall structure fully – take all down

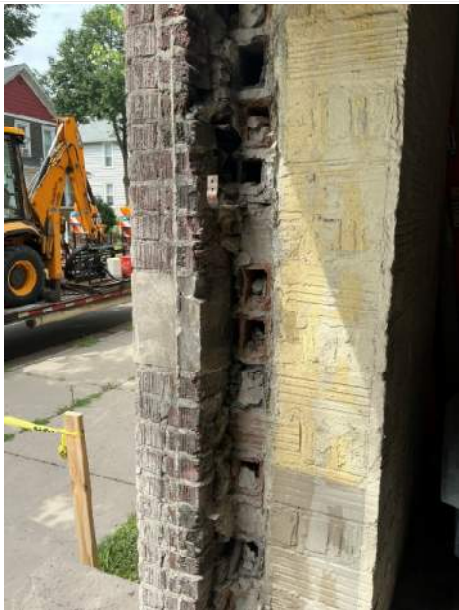
Exterior entry wall construction with all layers

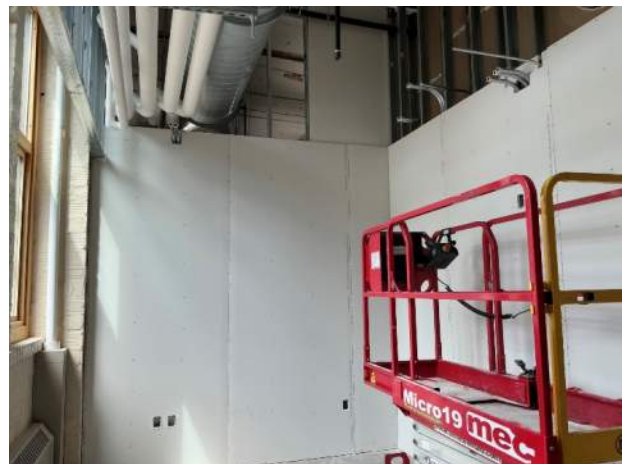
Conference room gypsum board installation

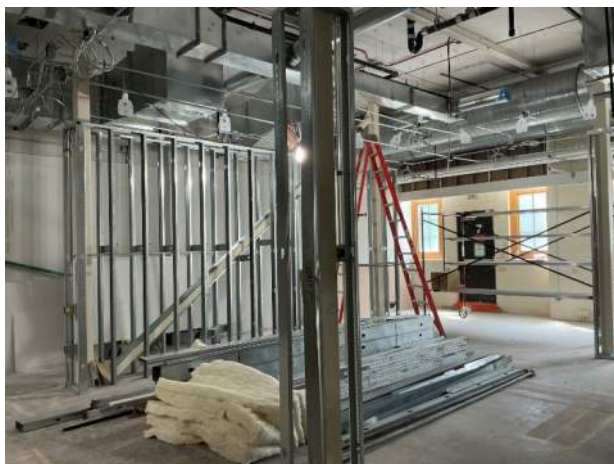
Staff lounge framing

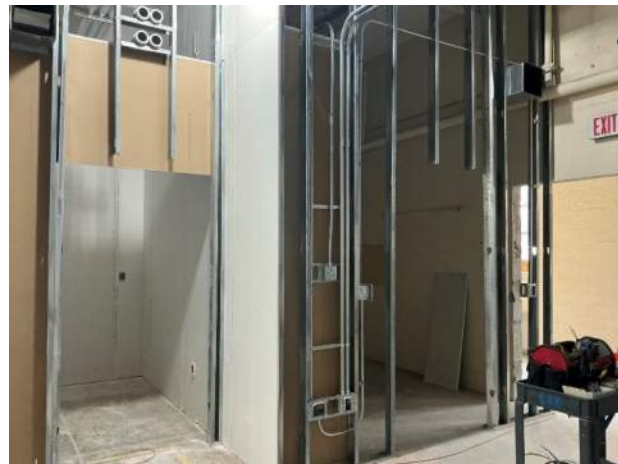
Office and data room framing and gypsum board

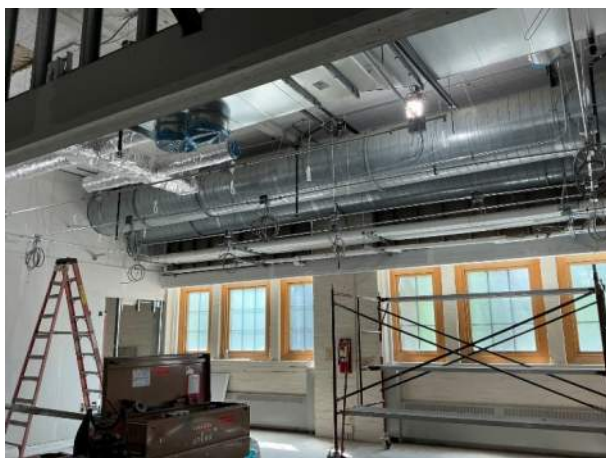
Lab 124 MEP overhead installation progress

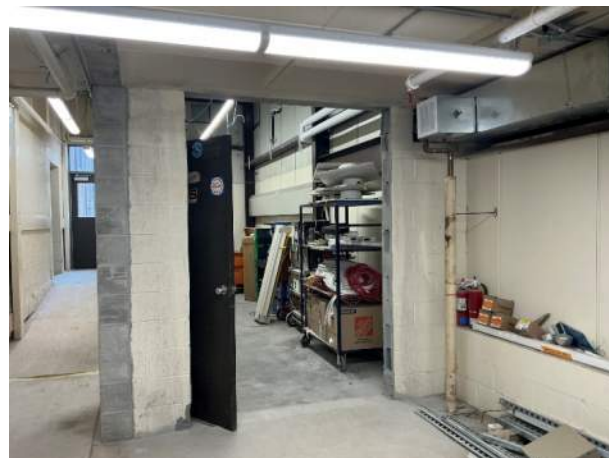
AG Lab storage door cut for PR

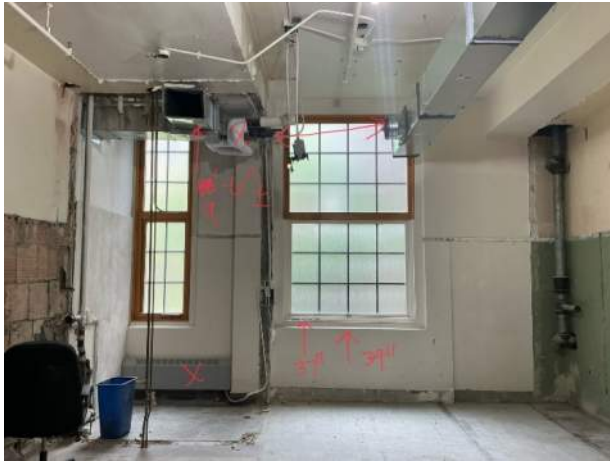
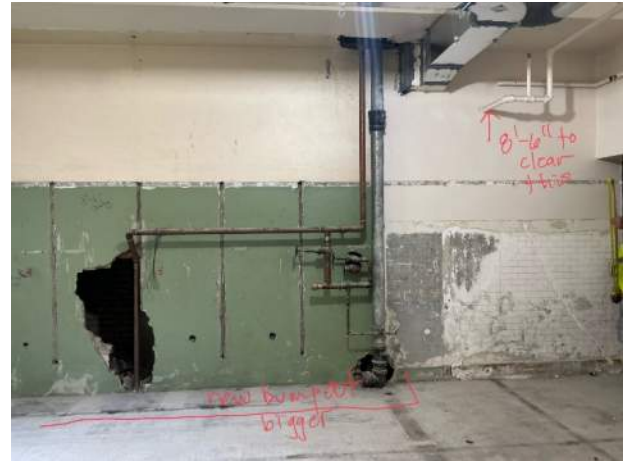
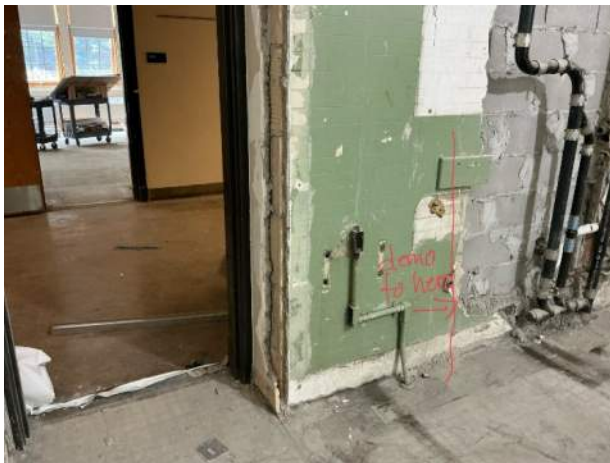
DCD bath room review existing conditions for PR 21

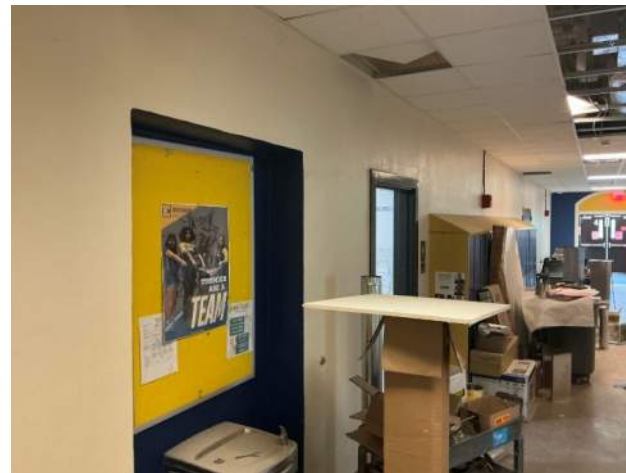
DCD bath room review existing conditions for PR – demolition of the wall as indicated in CD's would require more rebuild including ACT ceiling than anticipated and than schedule allows

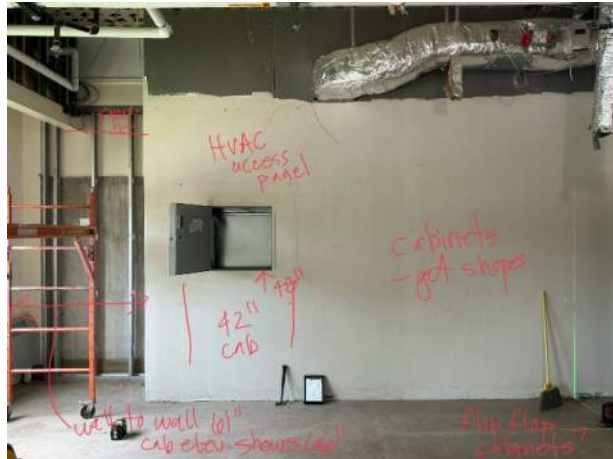
Different existing conditions than CD's for Rm 111
– see PR 20

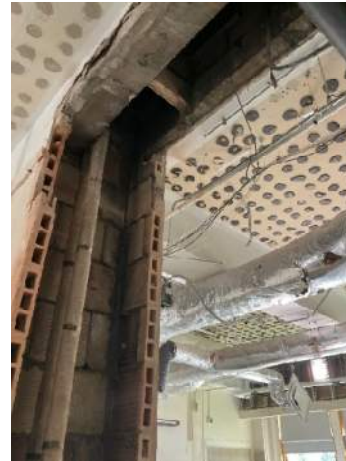
Room 111 opening at chase wall head condition –
reviewed this week that existing pipes go multiple
floors so needed shaft construction detail – see
PR 20

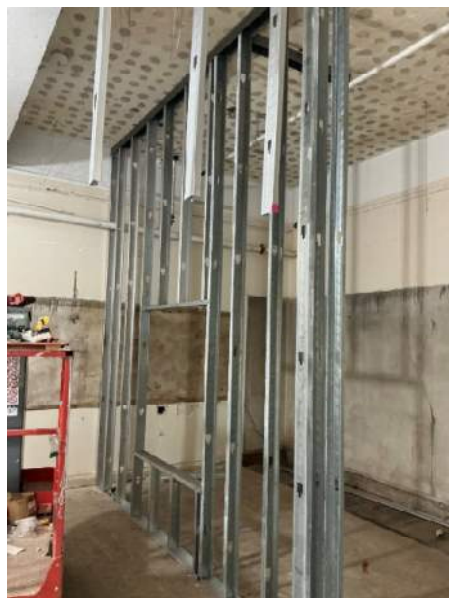
Sensory room framing

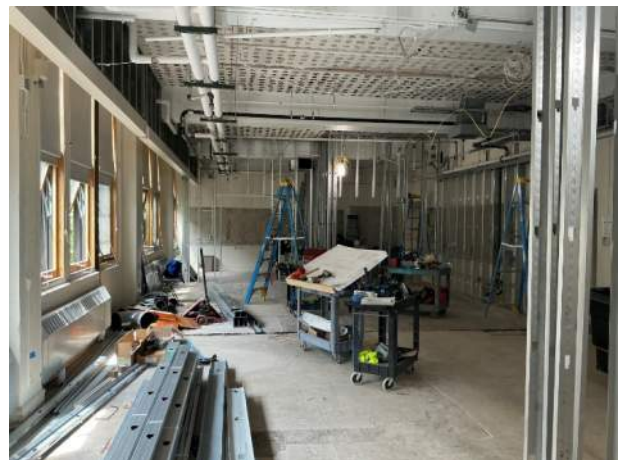
DCD classroom framing status

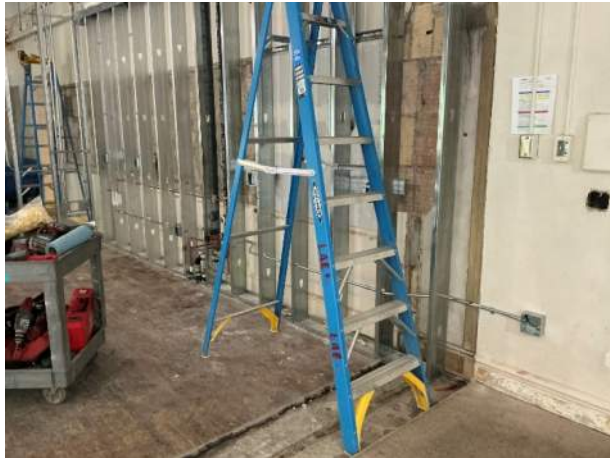
DCD plumbing rough-ins

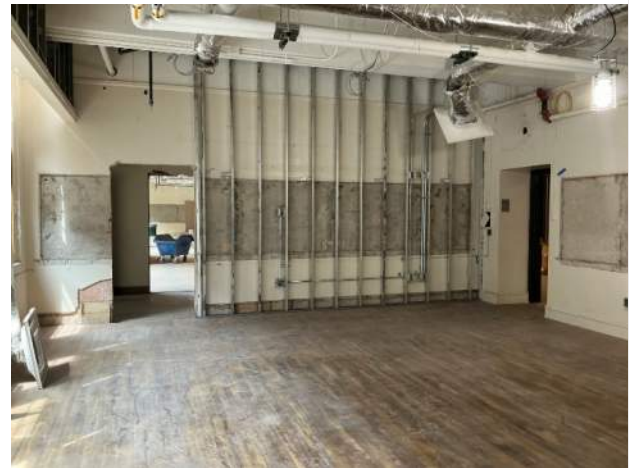
Framing at Room 115 and patch to left- reviewed on site to continue framing to corner

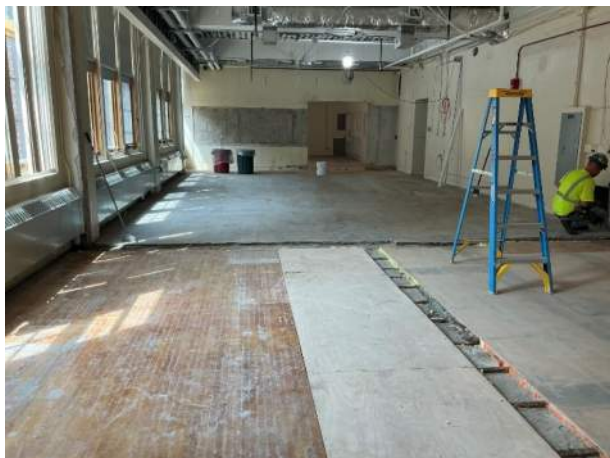
Scene shop floor existing conditions

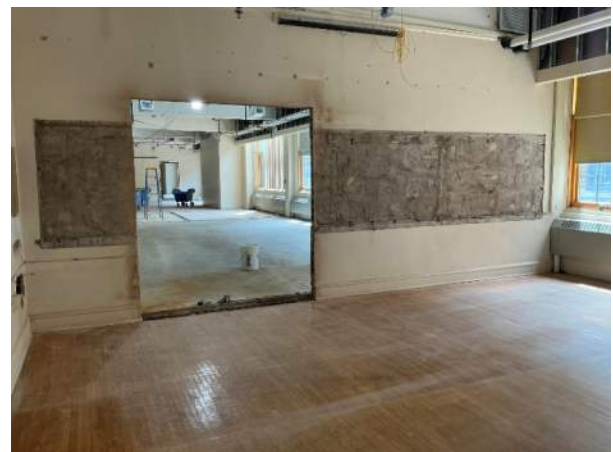
Storage room at scene shop floor difference – see PR 20

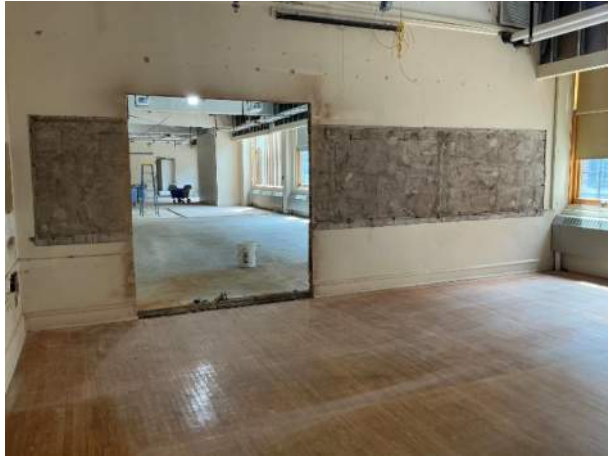
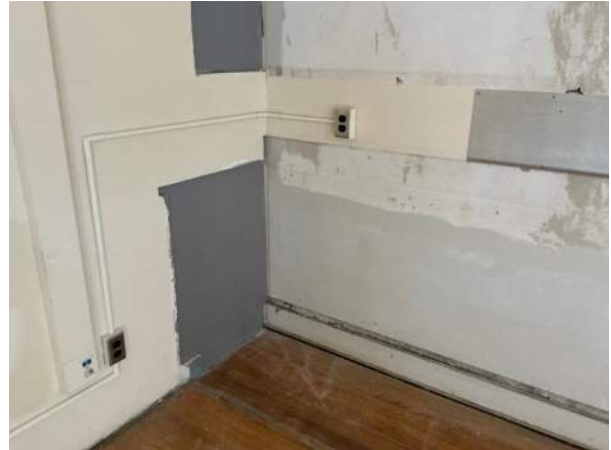
More patch areas for PR 17 – Storage 105E was closed off for abatement at the time and now visible.

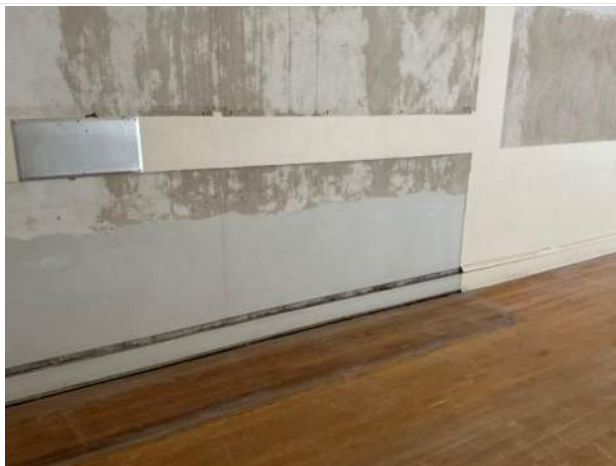
More patch areas for PR 17 – Storage 105E was closed off for abatement at the time and now visible – this is also for the wood base – missing shoe and cap.

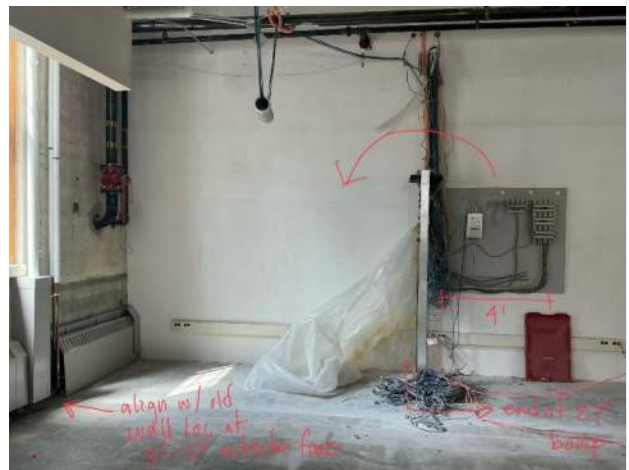
Gas closet area to be enlarged to enclose the remaining data as shown and in PR 19.
