Architects Field Report

Project Name:	MPS Roosevelt HS CTE Improvements					
Location:				Project Number:	22.1007.02	
Contractor:		Construction Results Corp				
Date of Visit:	7/24/25	Weather:	Partly Sunny		Temp Range:	80 degrees
Time of Visit:	12:00 -12:45 pm	Conformance with Schedule (+/-):		On schedule		
Report By:	Deborah Bauknight, LSE Architects					
Distribution:						
Owner:	Jeffrey Helstrom, MPS	Contractor:	CRC – Carl Hoikka, Melissa Anderson			
Architect:	LSE – Deb Bauknight, Jennifer Anderson-Tuttle	Field:	CRC – Gary Swift			
Consultant:	IMEG – Cory Casperson HEI – Angie Thoresen, Jeff Hauswirth, Scott Larson TNCG – Brandon Frazier	Others:

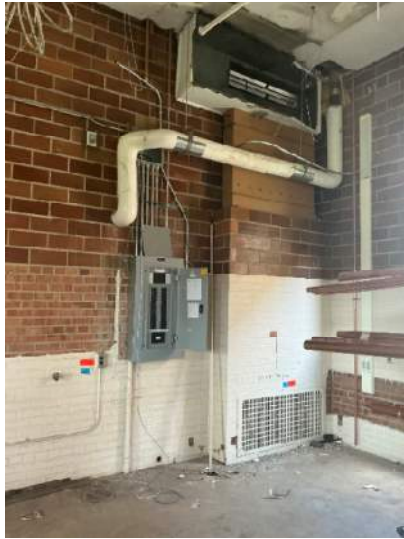
Reviewed an existing conditions different from drawings for the ceiling height and existing wall condition in the Admin room off Construction Lab.

Reviewed existing conditions for wall showing below ceiling height – LSE to address this issue

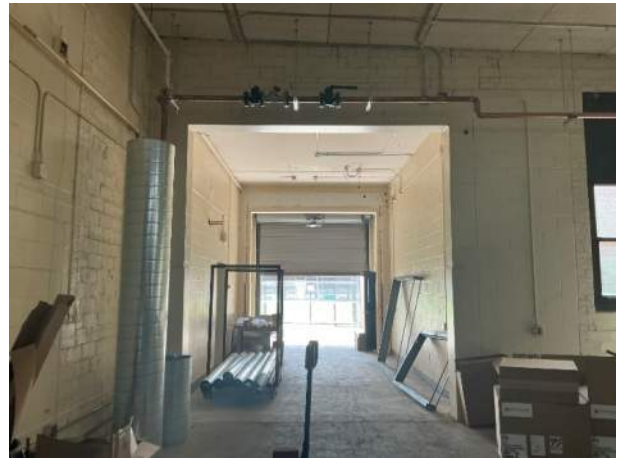
Construction lab materials and status

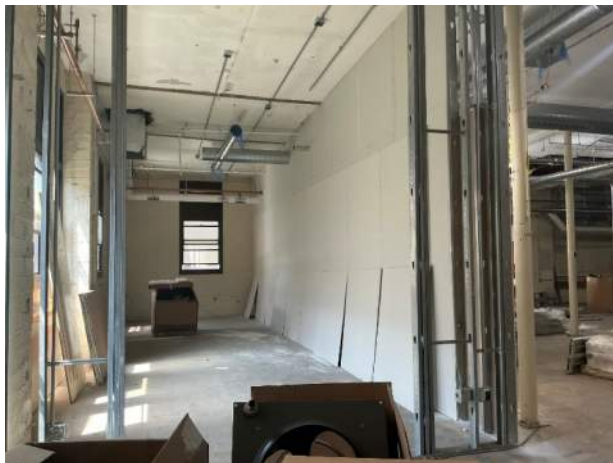
Construction storage room gypsum board installed

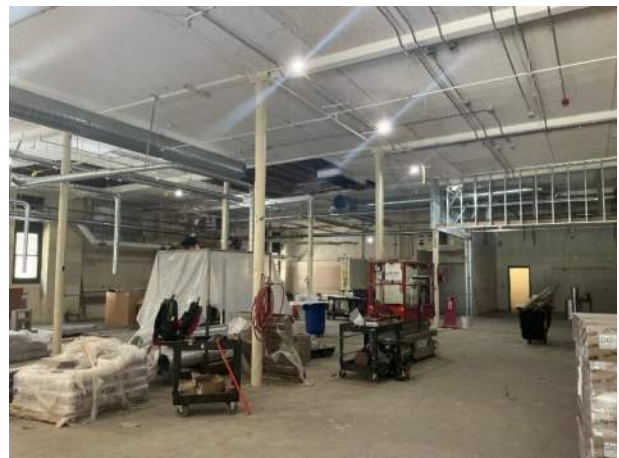
Construction lab general status

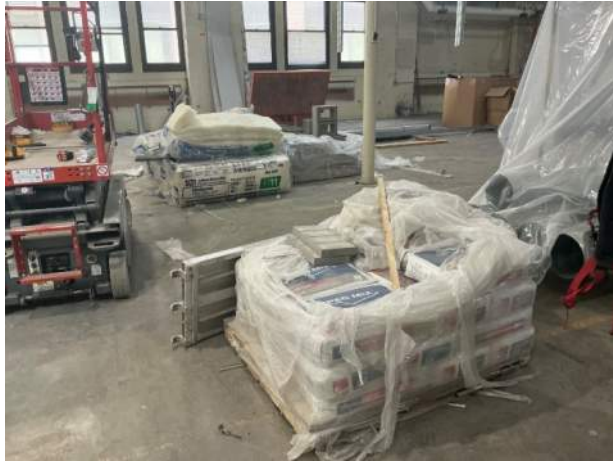
Materials on site

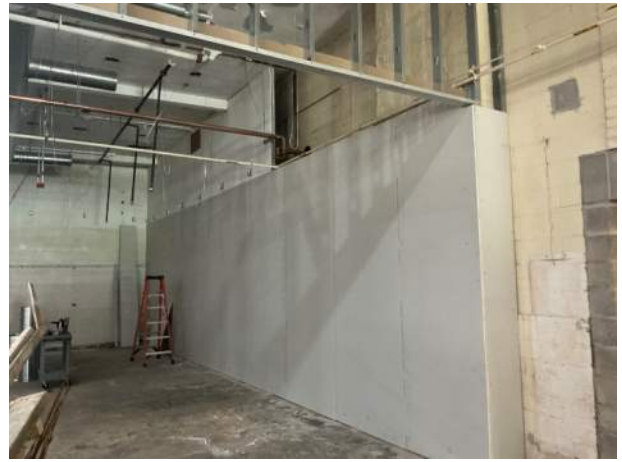
Construction classroom wall with gypsum board

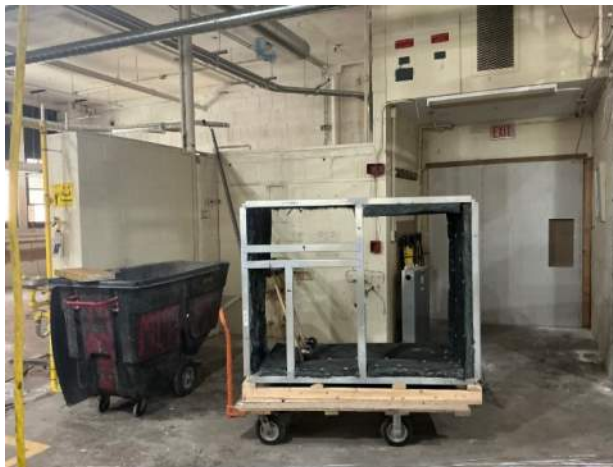
Hall wall infill to close off Construction Lab per PR
– new location

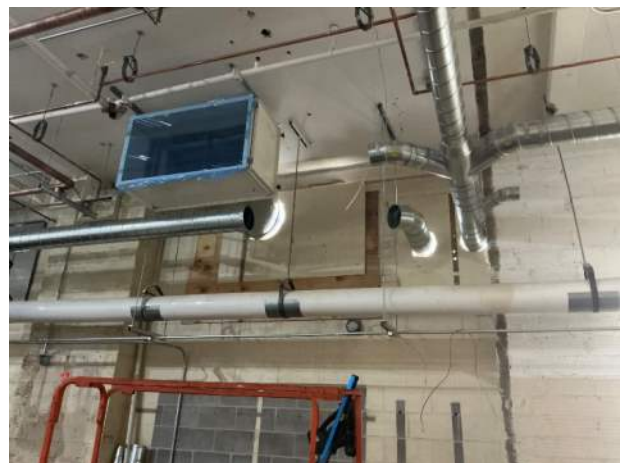
Dust collector ductwork entry from exterior status

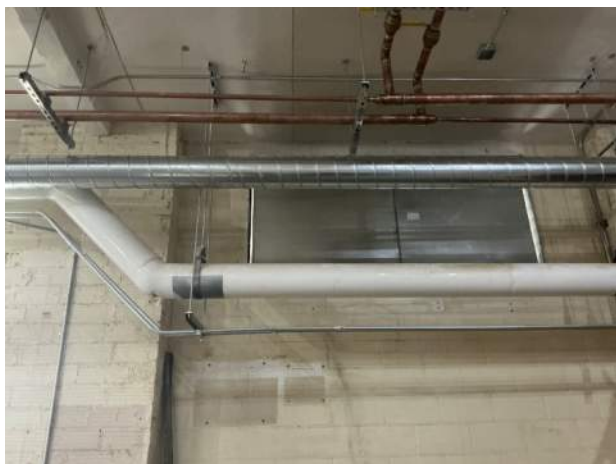
Construction Lab infill at removed mechanical

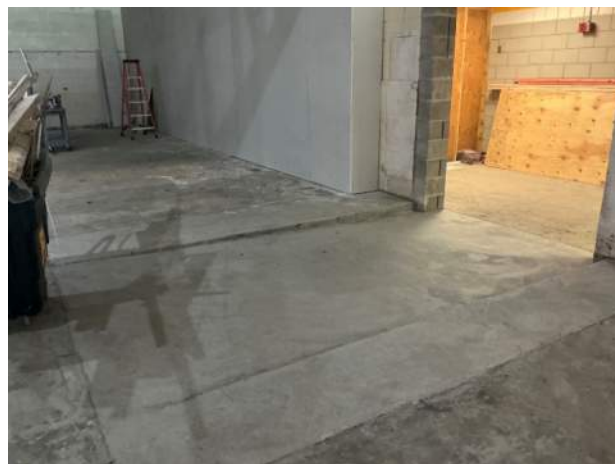
Construction Lab ramp poured

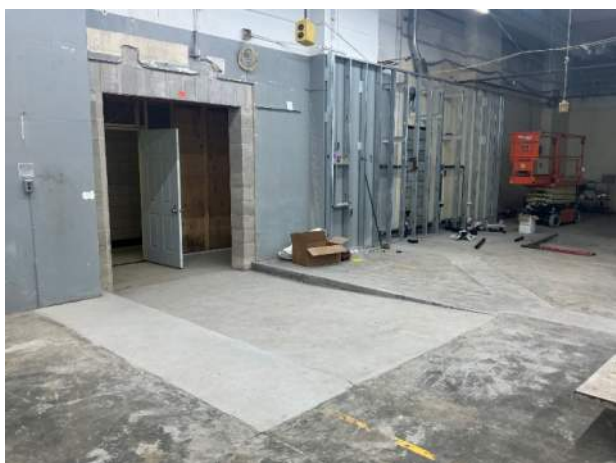
Collision Lab ramp poured

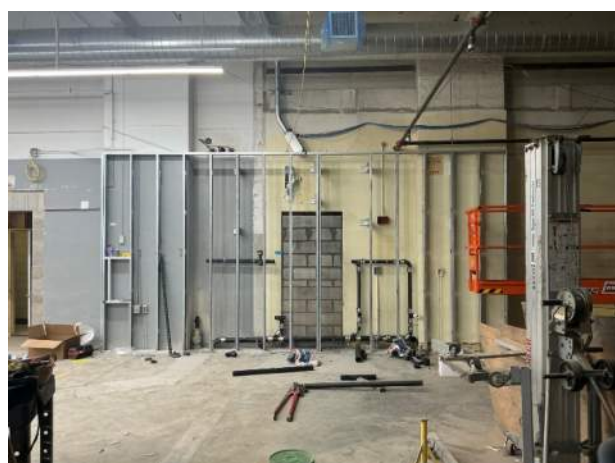
Collision Lab plumbing wall

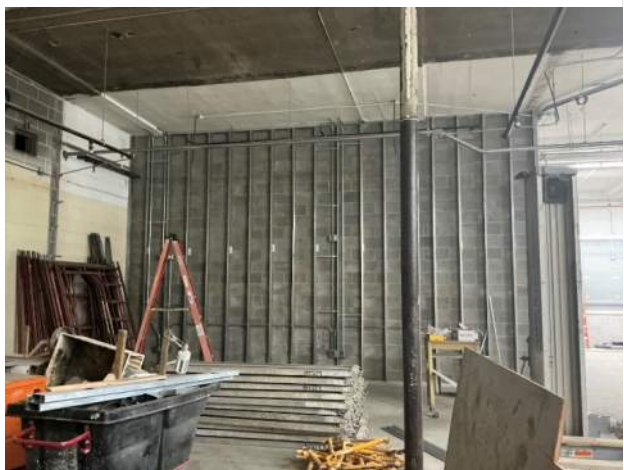
Collision Lab framing outside storage for teaching wall

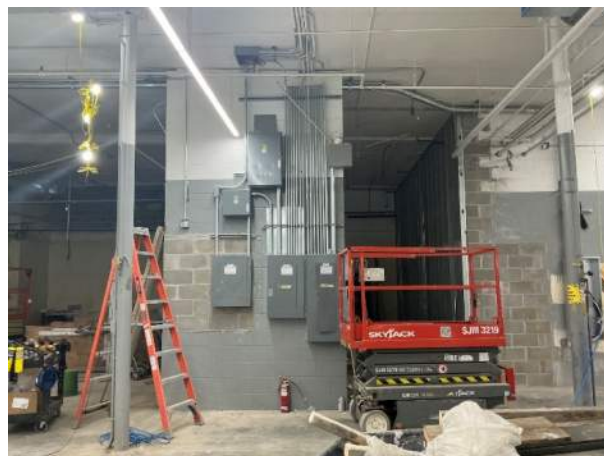
Collision electrical and masonry work

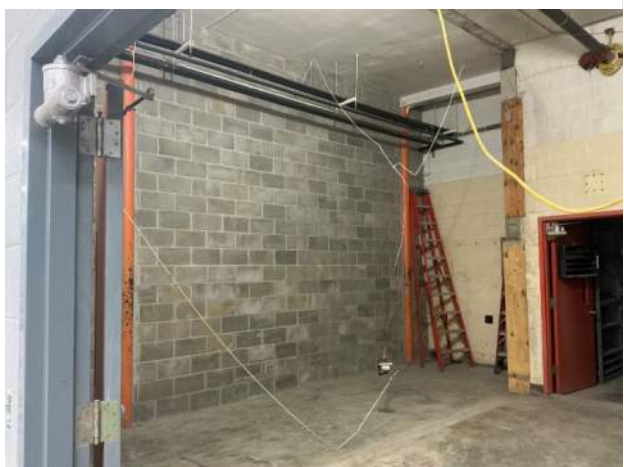
Collision masonry storage wall

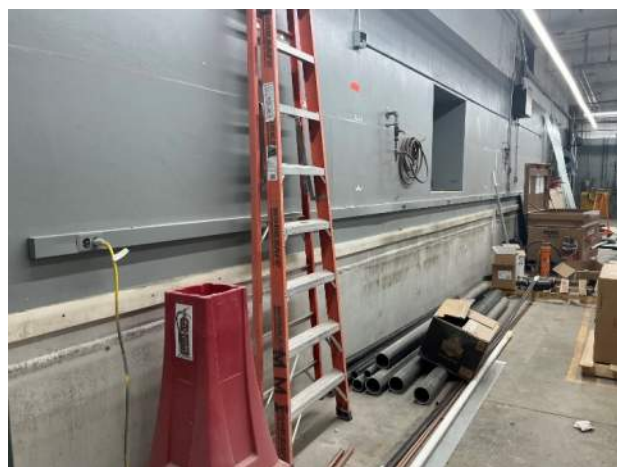
Collision lab mechanical demo along wall

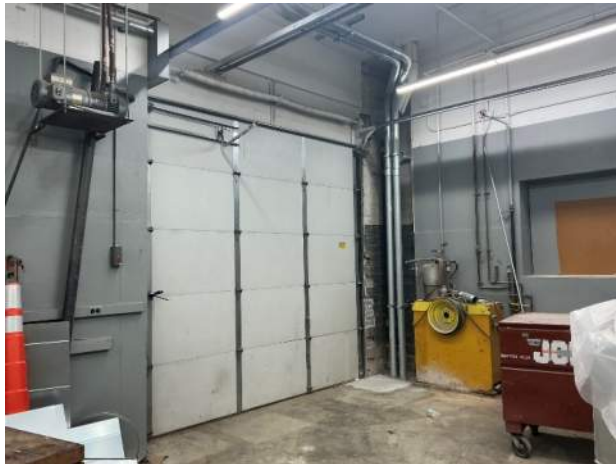
Collision door 1024B with electrical and floor poured

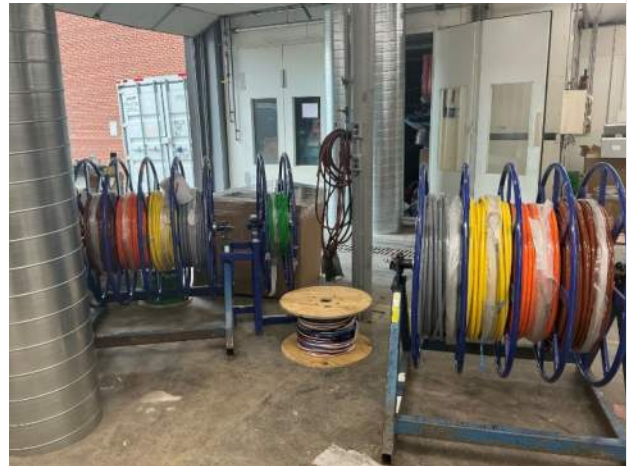
Collision Lab – materials on site

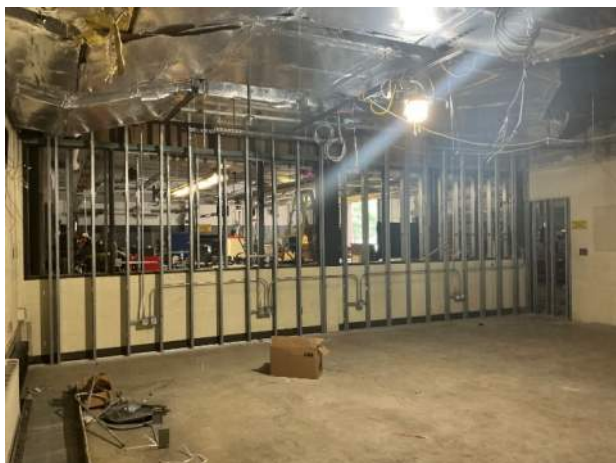
Framing at new room in Auto Repair for Admin

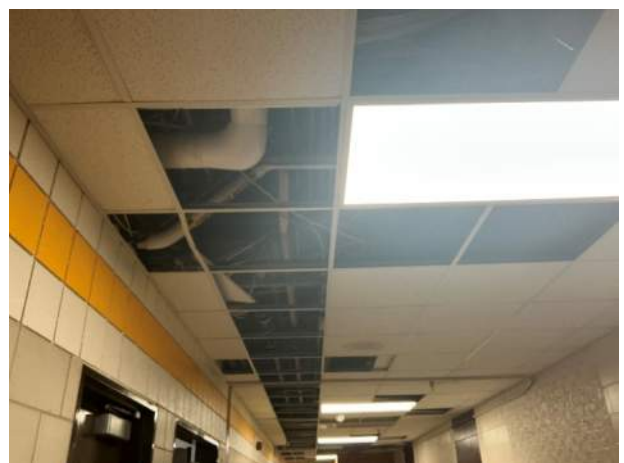
Hall MEP work in progress
