## Architects Field Report

Project Name:	MPS Edison HS CTE Improvements				
Location:	700 22 <sup>nd</sup> Avenue NE, Minneapolis, MN		Project Number:		22.1007.02
Contractor:		Jorgenson Construction			
Date of Visit:	7/15/25	Weather:	Sunny		Temp Range: 85 degrees
Time of Visit:	10:45 -12:15 pm	Conformance with Schedule (+/-):		Making up time	
Report By:	Deborah Bauknight, LSE Architects				
Distribution:					
Owner:	Jeffrey Helstrom, MPS	Contractor:	JCI – Alex Rustad, Tara McMahon		
Architect:	LSE – Chris Laabs, Jennifer Anderson - Tuttle	Field:	JCI – Ben Gabatino		
Consultant:	Larson – Eric Meyer IMEG – Cory Casperson HEI – Angie Thoreson, Jeff Hauswirth, Scott Larson, TNCG – Brandon Frazier	Others:

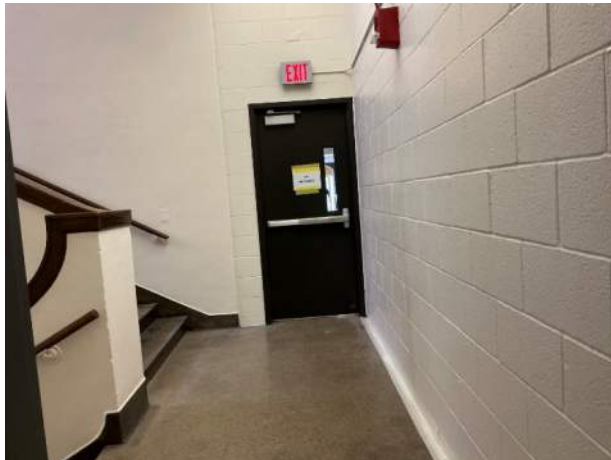
NO ENTRANCE sign on stair doors to construction area

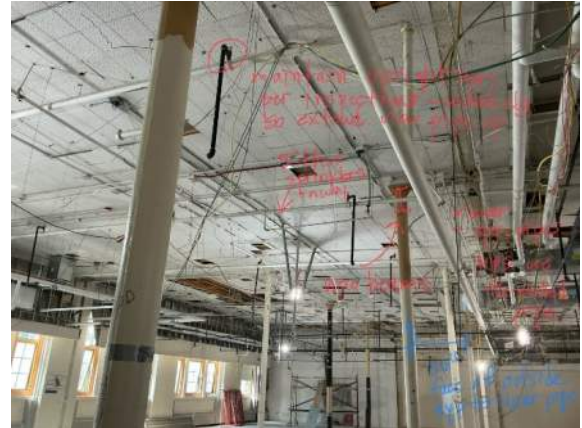
Reviewed sprinkler piping that was above drop ceiling that conflicts with new steel beams, will need to be revised

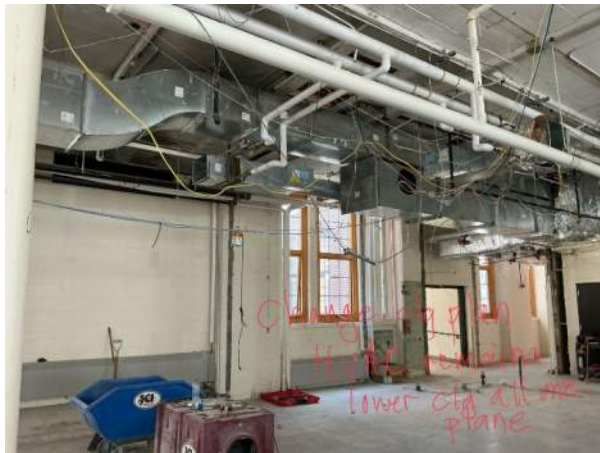
Reviewed HVAC mentioned in meeting and will need to lower commons ceiling

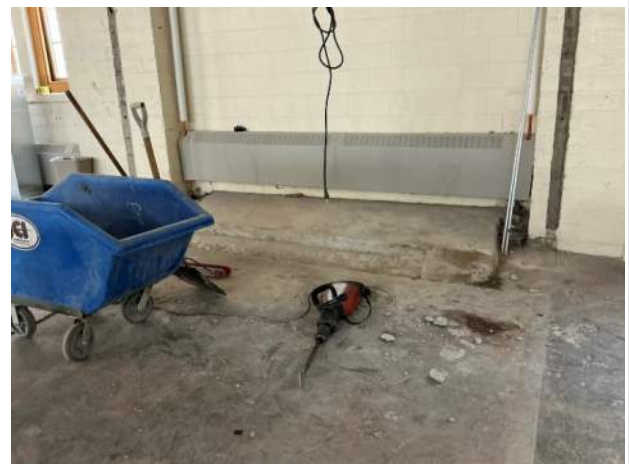
Hidden ramp chipped out for stud track

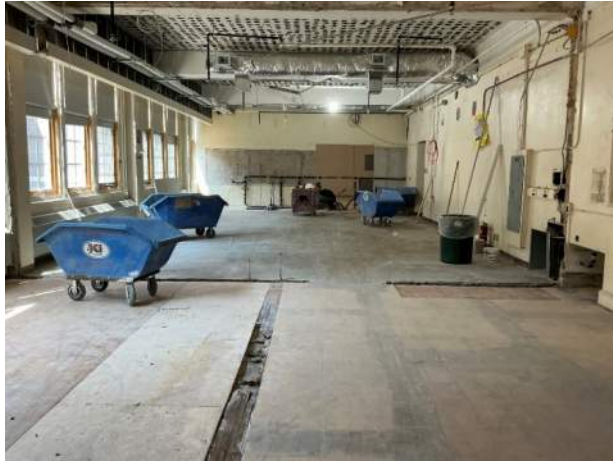
Scene shop demo of walls and conditions left after

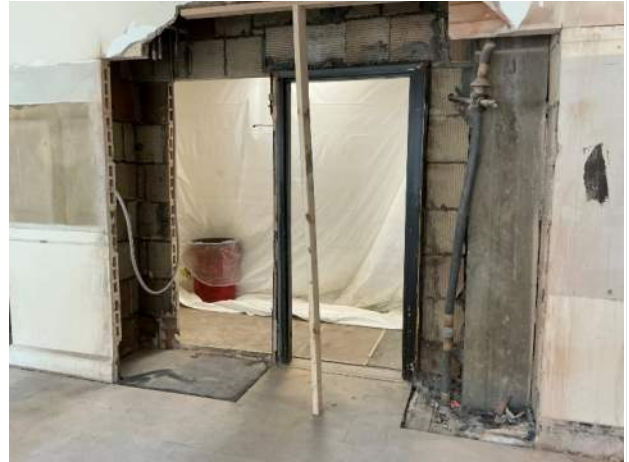
Scene shop new door opening and existing conditions to address within the chase space

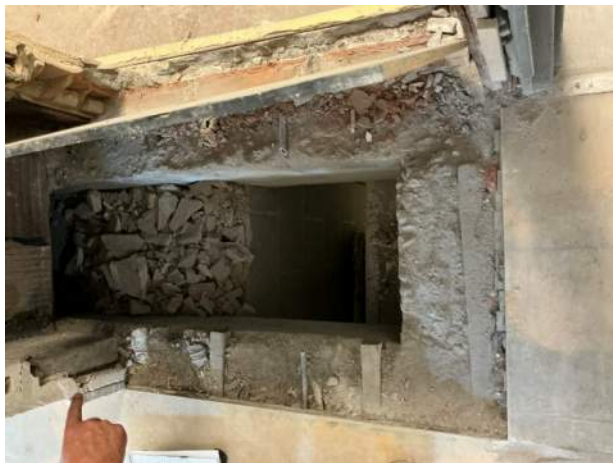
Hole in floor to below at scene shop new door opening per previous photo

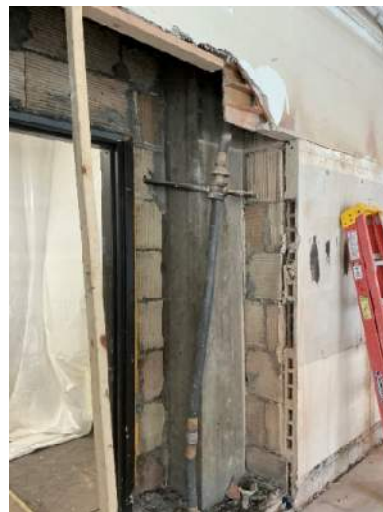
Existing condition chase wall at door demo

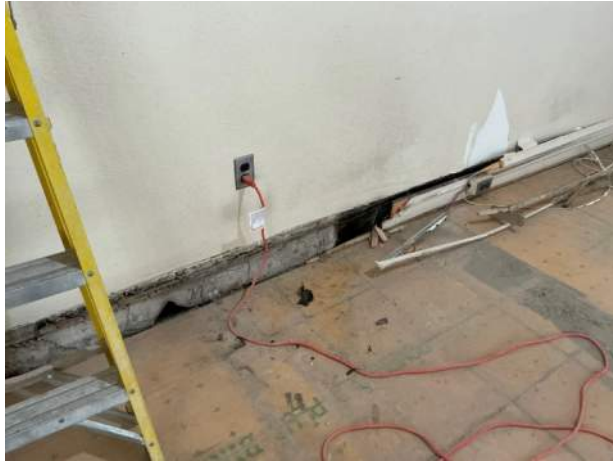
Some rooms wood base will need repair/replace

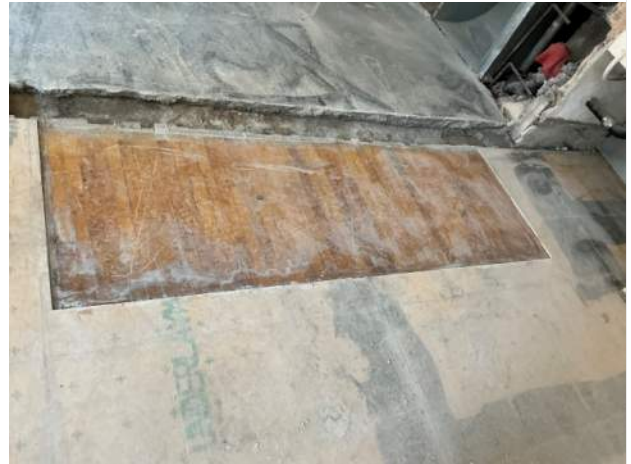
Scene shop floor height difference at removed wall – existing condition to deal with

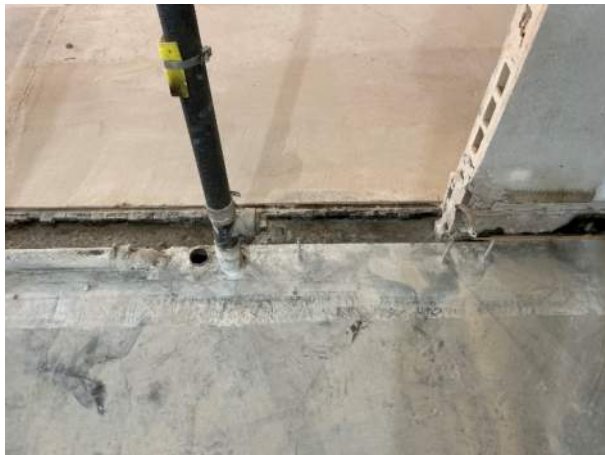
New door opening to storage – floor poured either side to wall so will need to address door threshold area

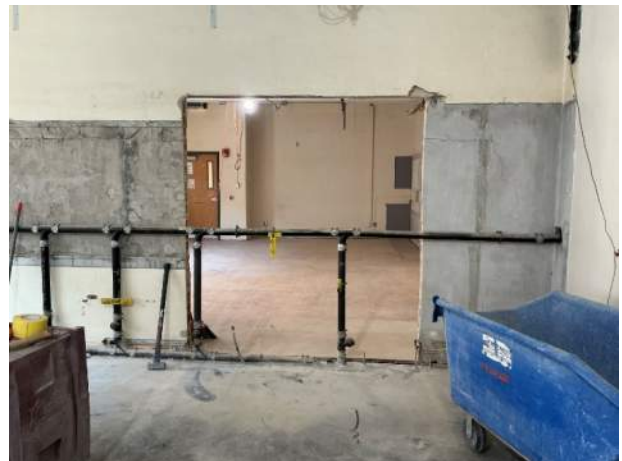
Larger view of new door opening to storage – also to left uneven wall from chalkboard abatement

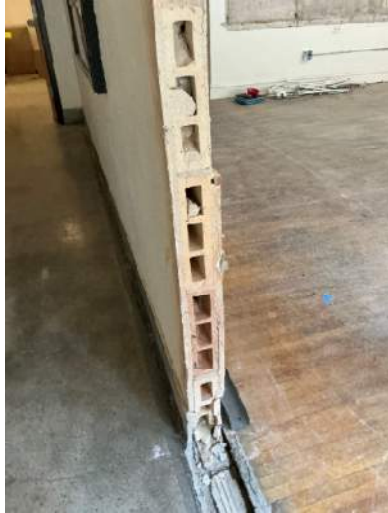
Clay tile wall at new door to Classroom 115 – will need trim to close off standard door frame depth, similar to other doors on hall with wood trim

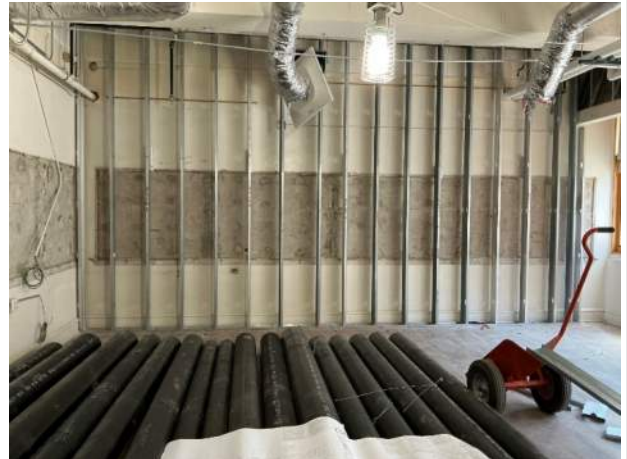
Framing for cabinet wall in new staff lounge and RWL piping

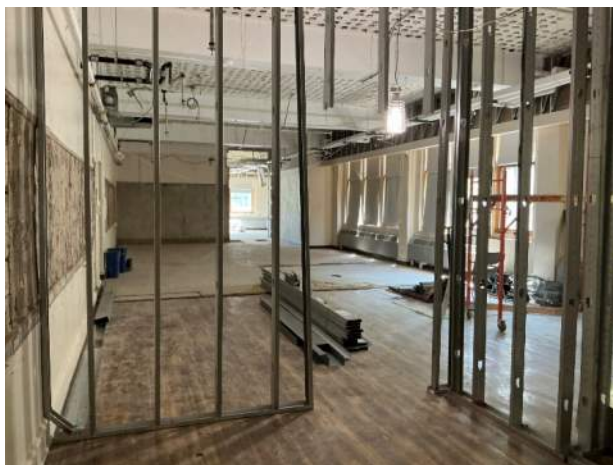
DDC area framing for new layout

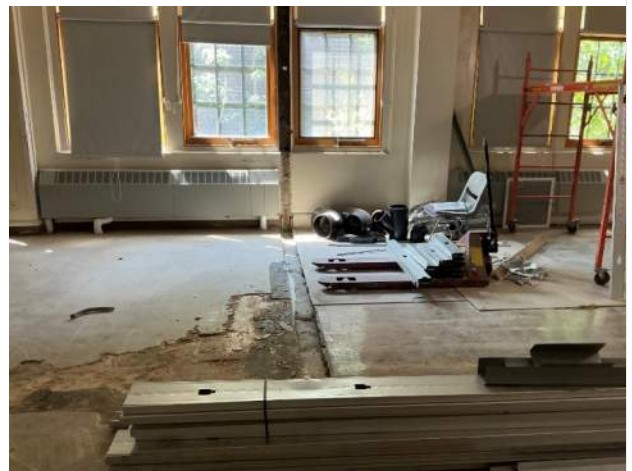
DDC area floor - existing conditions to be modified so flooring can go down – and up exterior wall at removed interior wall will need patching

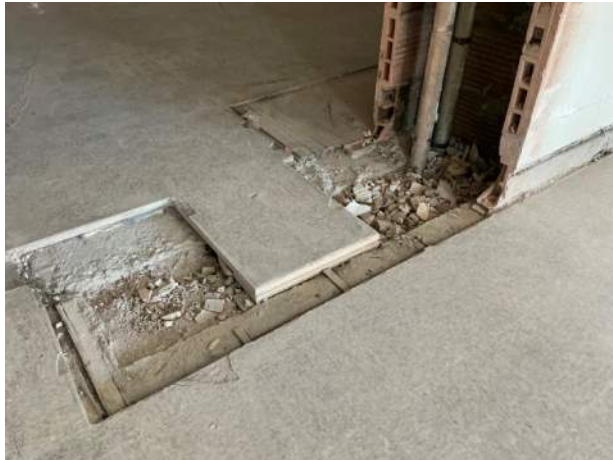
Another floor condition post demolition at the chase wall in DDC area – needing subfloor repair – between rooms 111 and 112

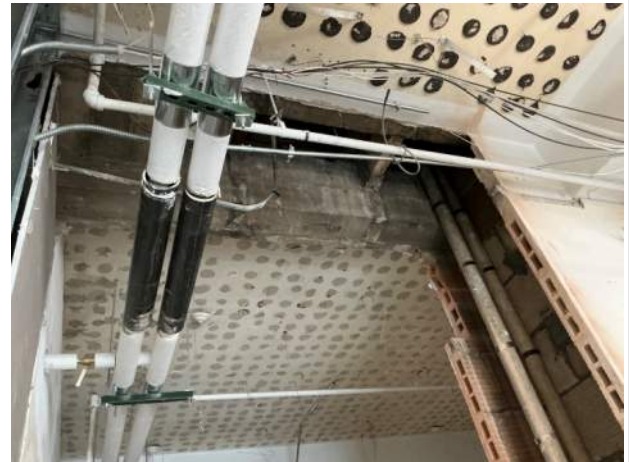
Room 111 opening at chase wall head condition

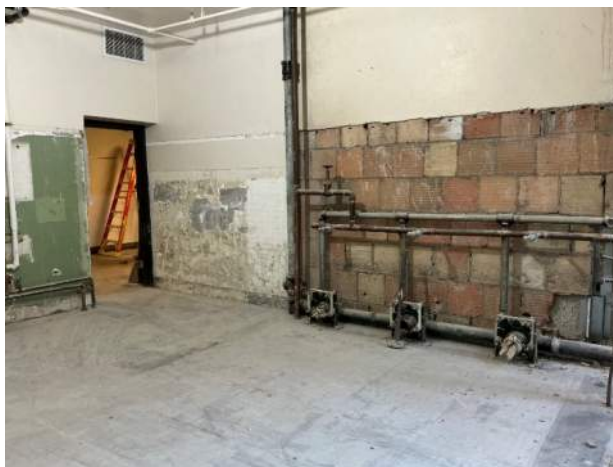
Existing bath demolition status

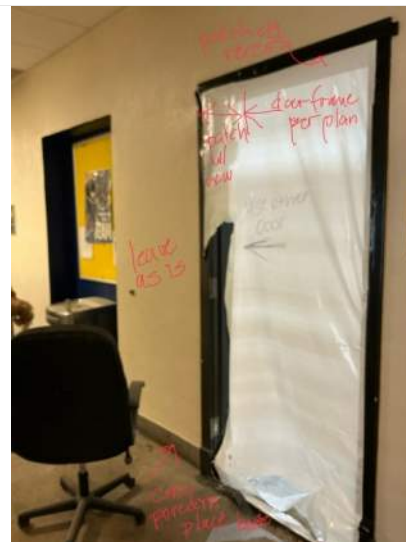
Reviewed complications of existing construction at the new DDC bath opening – determining path forward

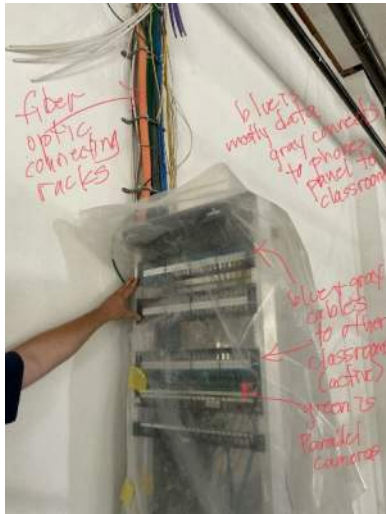
Reviewed existing data near gas closet that still serves active areas, need to resolve way forward

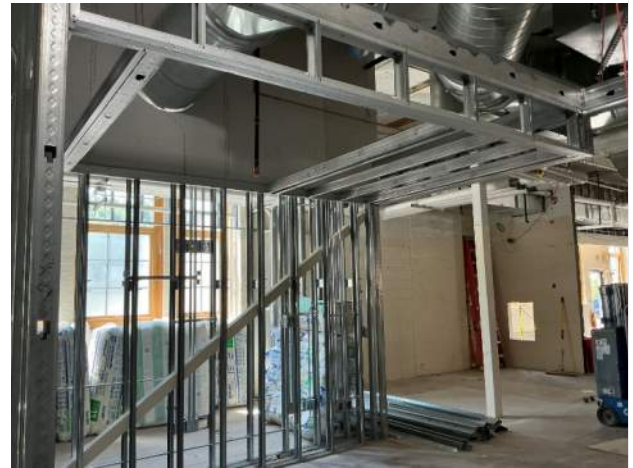
Framing including ceiling soffit at new CTE entry

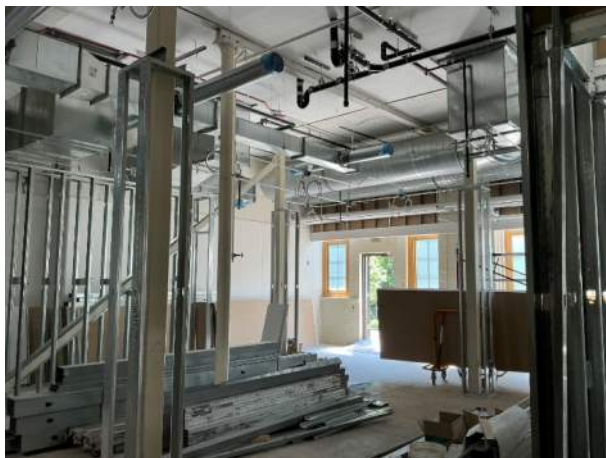
Framing at staff lounge

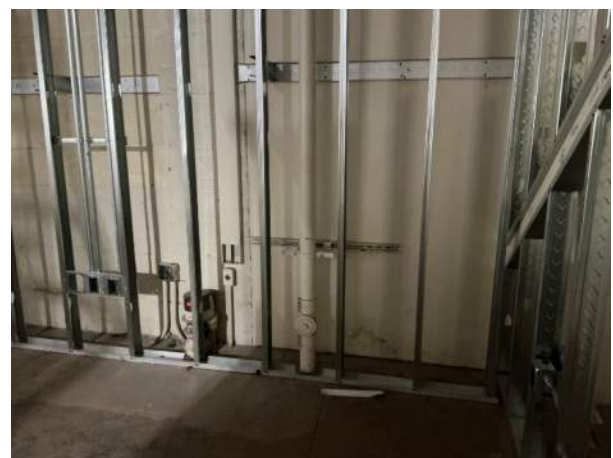
Framing and MEP at conference room end wall

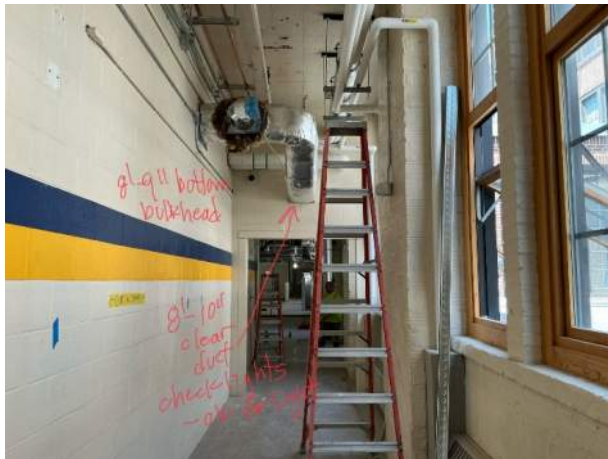
Existing ceiling item conflicts with new ceiling hts

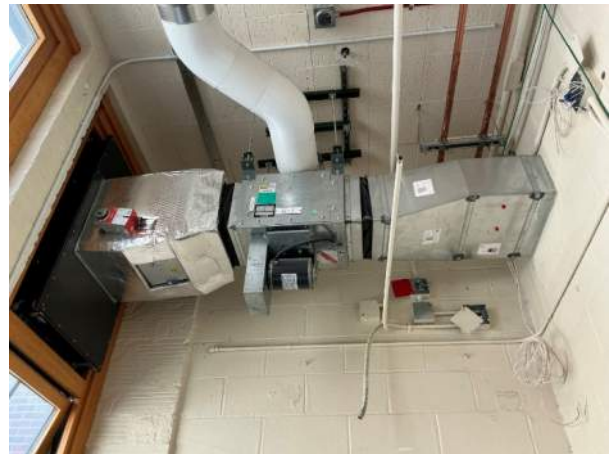
Existing VAV at other end of the hall

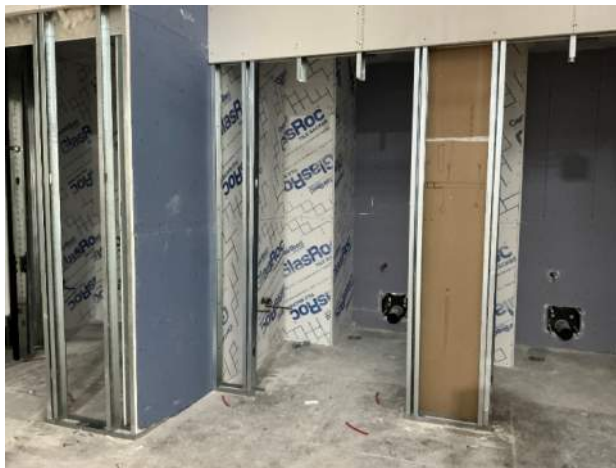
CTE bath status – waiting on door frames

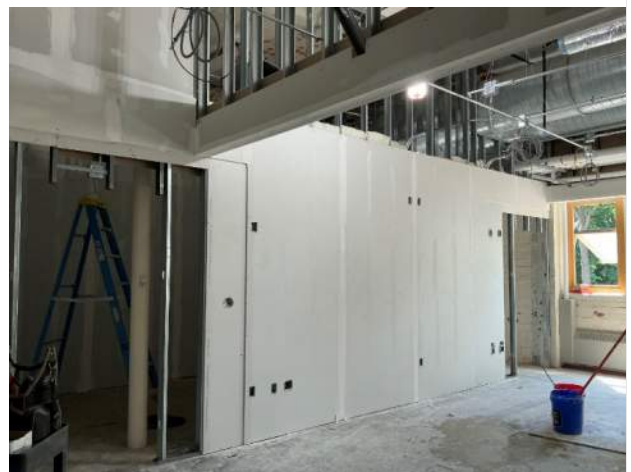
Gypsum board installation

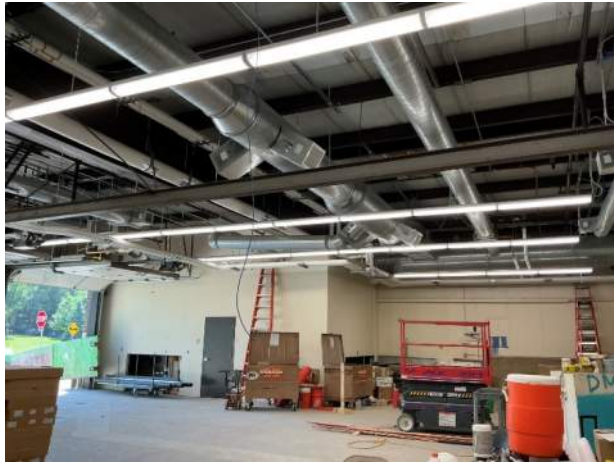
AG lab light fixtures installed
