FRANKLIN-MCKINLEY  
SCHOOL DISTRICT  
District Service Center

645 Wool Creek Drive, San Jose, CA 95112

## Franklin-McKinley School District Service Center - Master Planning Evaluation

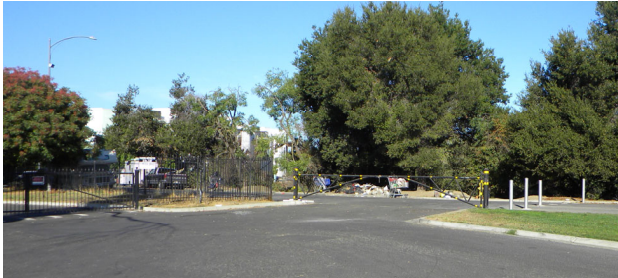
from another. The District has since closed off this route with a fence at the end of one side of the parking lot. As a consequence, the AC pavement is extremely damaged. This parking lot received a slurry several years ago to provide a temporary means of longevity. The smaller parking lot is in need of a complete repair and replace. The access to the secondary exits are not ADA compliant.

It is recommended that the smaller parking lot

next to the Business Center be replaced and restriped. The walkways need to be reconfigured to allow for ADA access to the secondary exits. Signage will need to be added to comply with current code requirements.

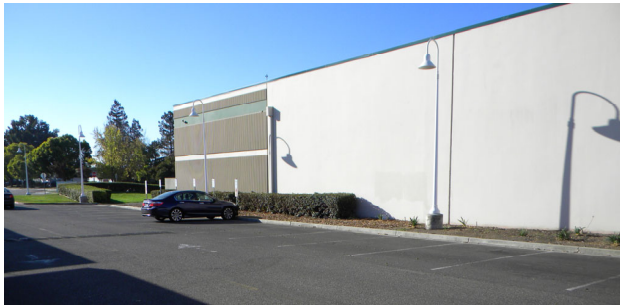
The only known issue is the smaller parking lot on the Business Center side is slow to drain. A study is needed with the likely result than additional storm drains are needed at this parking lot.

It is recommended that additional storm drains be installed at the smaller parking lot.

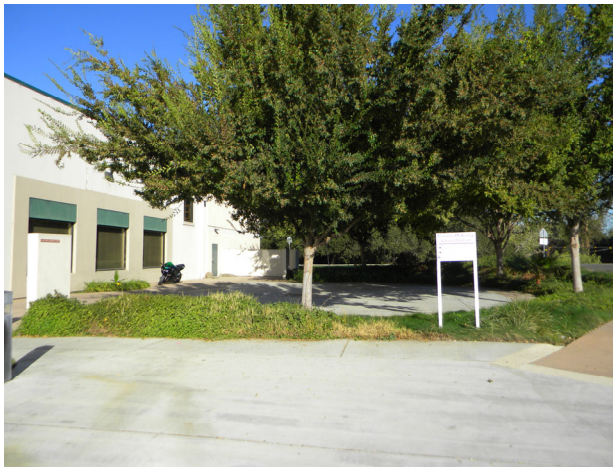
There are several locations of the exterior cement plaster decaying above the existing windows.

It is recommended that the cement plaster be removed and patched to match the existing cement plaster above all of the windows at this site.

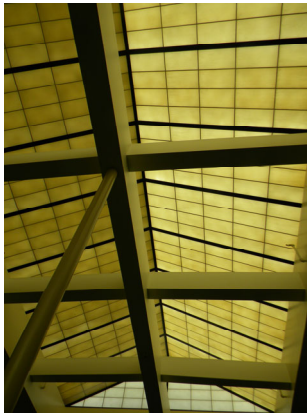
This complex has been re-roofed and is under warrantee. The two tory section of the Service Center has a skylight system which has surpassed its life expectancy. This system, known as a KalWall proprietary system is in need of replacement. The roofing inspection service suggested ongoing preventative maintenance to ensure longevity.

It is recommended that the KalWall system be replaced and money be set aside for minor yearly upgrades and maintenance especially at flashing areas, curbs and roof penetrations.

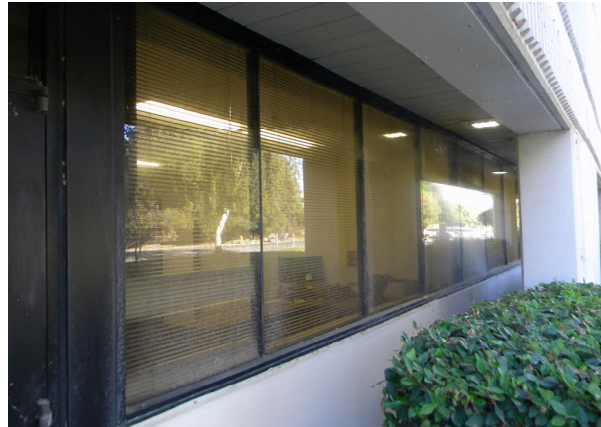
The exterior paint at the complex has surpassed its life expectancy and needs to be repainted. There is no clear address defining this complex as a separate educational facility as this complex blends in with the surrounding warehouses.

It is recommended that a large clearly defined

address and logo be painted at the front of the building defining the entry and what type of facility this is. It is recommended that the paint scheme be more creative.

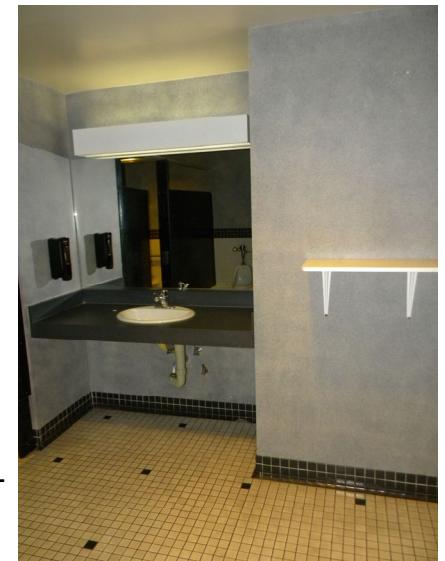
The existing toilet rooms have not been updated or modernized since the Service Center was constructed in 1990. The counter-

tops in all bathrooms have surpassed their intended life span. Wall surfaces, faucets, toilet paper dispensers have all surpassed their intended lifespan. The bathrooms have not been updated with the current services of bathroom facilities. The second floor bathroom floors need to be replaced.

It is recommended that the second floor bathrooms surfaces should be removed and replaced. All walls in all bathrooms should be painted. It is recommended that all faucets and toilet paper holders be replaced. Changing stations should be added to all of the ground floor

bathrooms. Shelves and coat hooks should be added to all bathrooms.

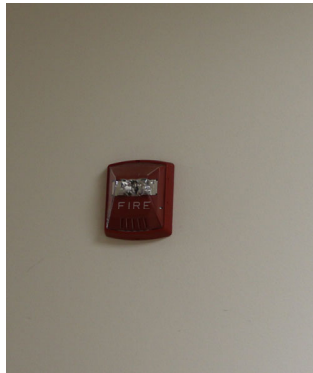
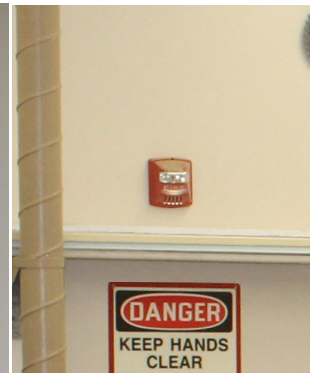
The existing fire alarm system meets the needs of current code and local fire authorities, however it does not meet the District Standards for maintenance. The system is proprietary and should be replaced with a non-proprietary system.

It is recommended that the entire campus be retrofitted with a new fire alarm system. The chemical in the MDF fire suppression system needs to be replaced with a new fire suppression system that can be properly maintained.
