# FMSD M.O.T. Yard

420 Tully Road, San Jose, CA

## FMSD Maintenance Operations and Transportation (M.O.T) - Master Planning Evaluation

### **Evaluation Summary**

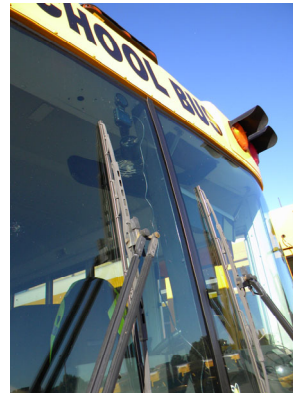
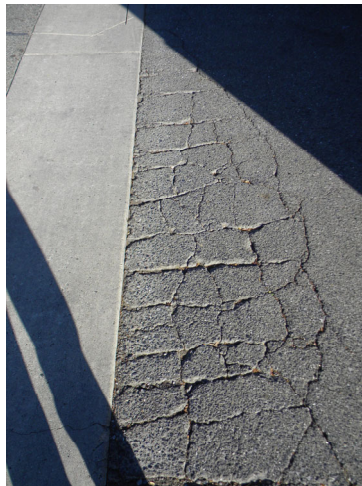
The existing parking area is mainly used for parking the District Bus fleet. The existing pavement is in fair condition. There is some moisture damage to some areas of the pavement. The layout of the bus parking area is in need of better traffic flow. The parking area requires the bus drivers to back up

which can cause unsafe issues in the future.

It is recommended that the parking area for the buses be redesigned and reconfigured to allow buses to flow in and out safely and to allow parking without

backing up. There are several areas of the pavement that is recommended to be removed and replaced.

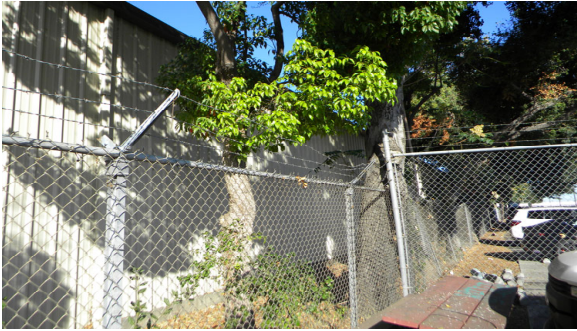
Fencing and security is important to maintain at this location. The existing fencing is older and in need of repair at some locations. There are locations where an intruder might creatively be

able to climb the fence.

It is recommended that portions of the perimeter fence be removed and replaced with a taller no-climb fencing material.

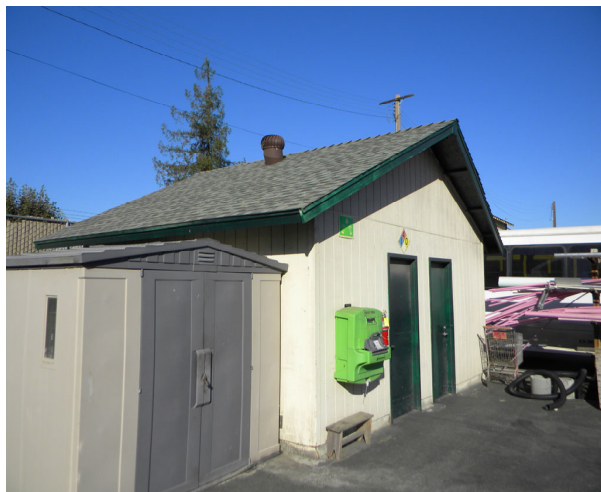
The existing roofing on the portable buildings will need to be repaired at the seams and as needed on the standing seam metal roofing. The storage buildings will need roof repairs as well. The larger storage warehouses will also need repairs and coating in the future for normal maintenance.

It is recommended that all roofs at the MOT be repaired, recoated, and reroofed as needed.

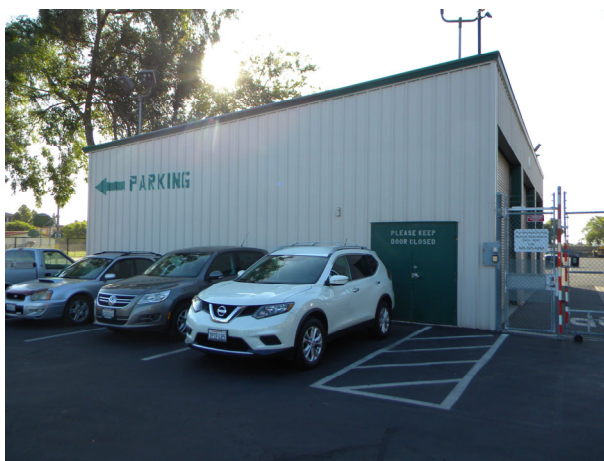
The existing exterior painting at the MOT is in fair condition.

It is recommended that all portable buildings and warehouses be painted in the next five years.
