**LIMITED ASBESTOS
SURVEY REPORT**

**KYRENE DE LA SIERRA ELEMENTARY SCHOOL
MAIN BUILDING
ROOF RENOVATION PROJECT
1122 EAST LIBERTY LANE
PHOENIX, ARIZONA 85048**

Dominion Project Number: AZ1418.65

Inspection Date: August 8, 2025

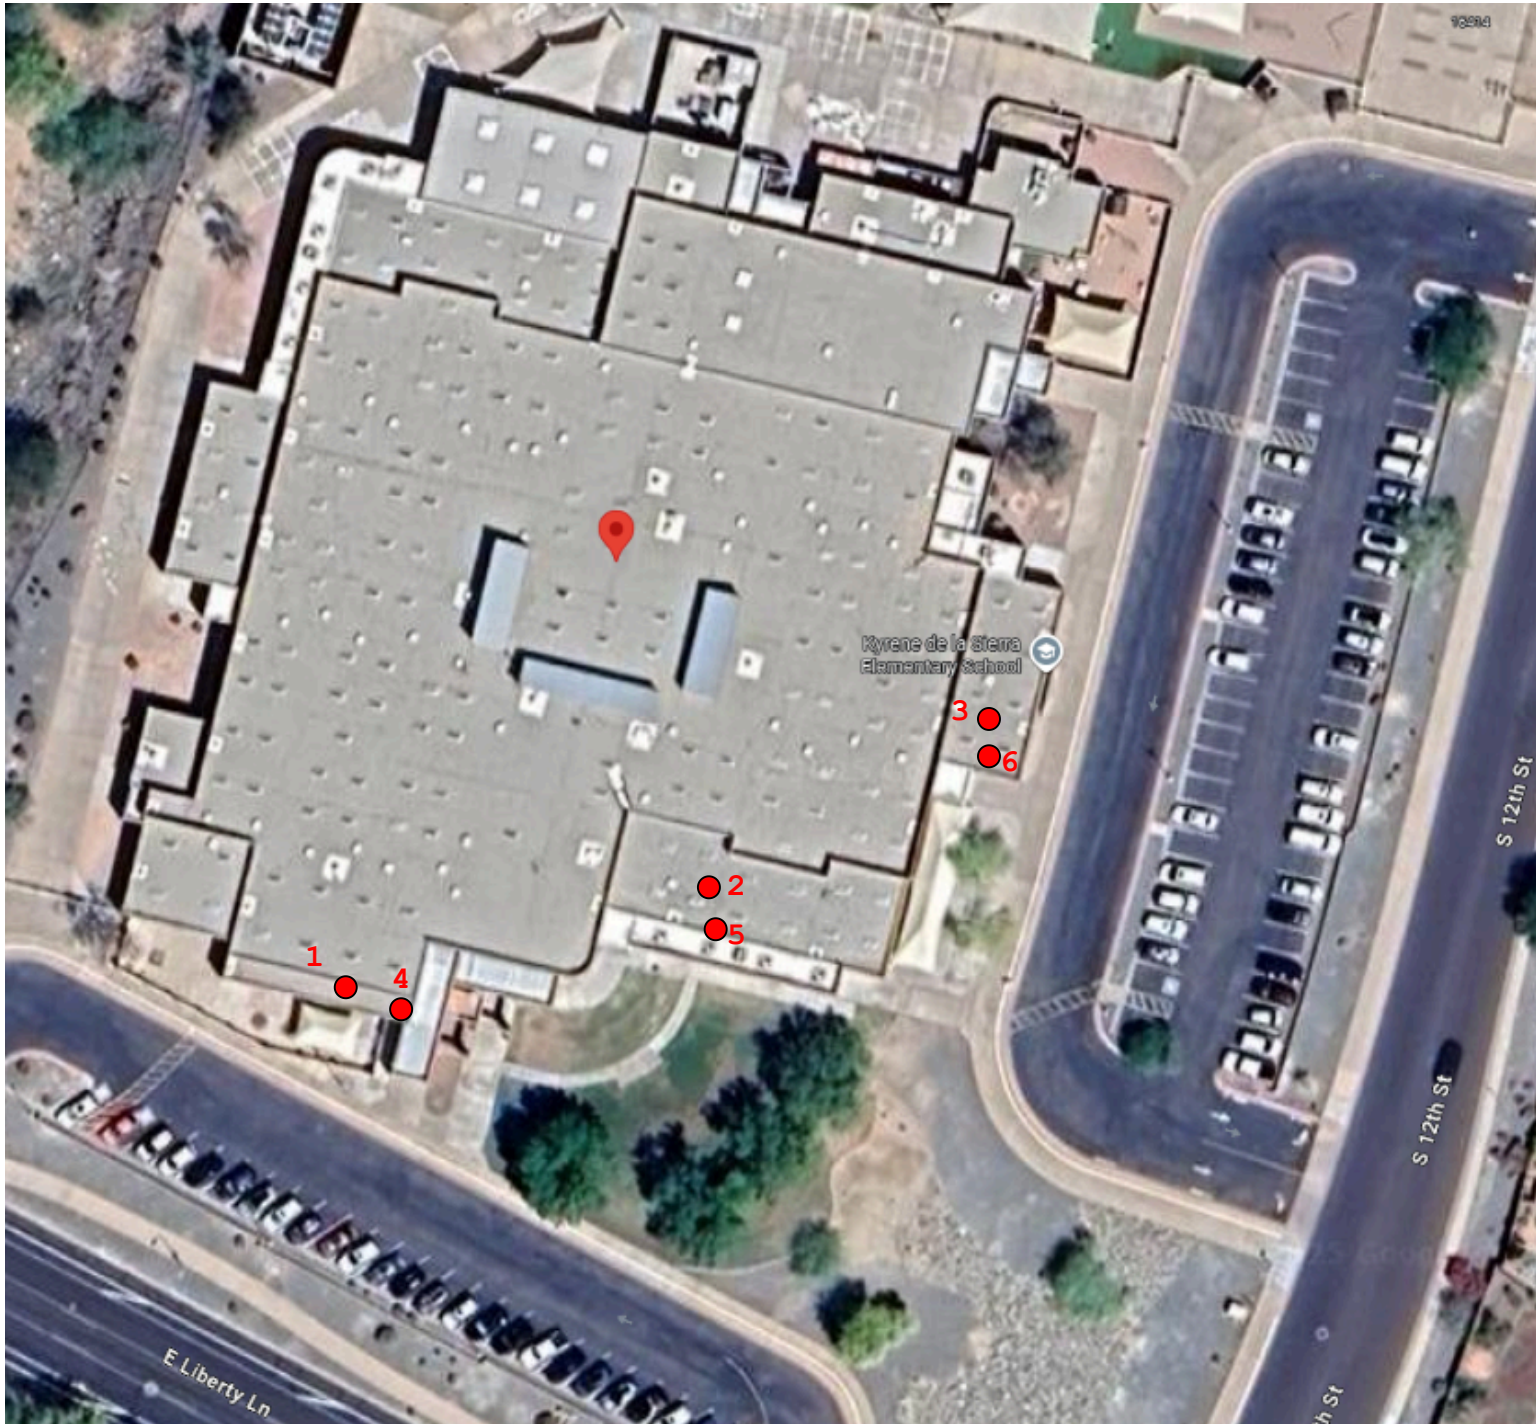
PLM Bulk Sample Location Map
Kyrene De La Sierra Elementary School
1122 East Liberty Lane, Phoenix, AZ 85048

Dominion Project Number: AZ1418.65		Client: Kyrene Elementary School District		
Sample Date: August 8, 2025		Site: Kyrene de la Sierra Elementary School - Exterior Roof		
Sample Number	Material Description	Sample Location	Friable	Asbestos Content
AZ1418.65-PLM-1	Black Asphalt Roll-on Roofing Tar & Felt Layers	Exterior Roof - Southwest	No	None Detected
	Black Tar with Gray Pebbles for Roll-on Roofing		No	None Detected
	Black Roofing Mastic for Roll-on Roofing		No	None Detected
	Brown Fibrous Material with Black Surface for Roll-on Roofing		No	None Detected
AZ1418.65-PLM-2	Black Asphalt Roll-on Roofing Tar & Felt Layers	Exterior Roof - Southeast	No	None Detected
	Black Tar with Gray Pebbles for Roll-on Roofing		No	None Detected
	Black Roofing Mastic for Roll-on Roofing		No	None Detected
	Brown Fibrous Material with Black Surface for Roll-on Roofing		No	None Detected
AZ1418.65-PLM-3	Black Asphalt Roll-on Roofing Tar & Felt Layers	Exterior Roof - East	No	None Detected

Black Tar with Gray Pebbles for Roll-on Roofing		No	None Detected
	Black Roofing Mastic for Roll-on Roofing		No	None Detected
	Brown Fibrous Material with Black Surface for Roll-on Roofing		No	None Detected
AZ1418.65-PLM-4	Black/White Roofing Material (Membrane)	Exterior Roof - Southwest	No	None Detected
	Silver Paint for Black/White Roofing Material		No	None Detected
	Black Caulk for Black/White Roofing Material		No	None Detected
	Silver Paint 2 for Black/White Roofing Material		No	None Detected
	Black Sealant for Black/White Roofing Material		No	None Detected
	Black Roofing Felt for Black/White Roofing Material		No	None Detected
AZ1418.65-PLM-5	Brown/Green Roofing Material (Membrane)	Exterior Roof - Southeast	No	None Detected
	Silver Paint for Black/White Roofing Material		No	None Detected
	Black Caulk for Black/White Roofing Material		No	None Detected
	Silver Paint 2 for Black/White Roofing Material		No	None Detected

Dominion Project Number: AZ1418.65		Client: Kyrene Elementary School District		
Sample Date: August 8, 2025		Site: Kyrene de la Sierra Elementary School - Exterior Roof		
Sample Number	Material Description	Sample Location	Friable	Asbestos Content
AZ1418.65-PLM-6	Black/White Roofing Material (Membrane)	Exterior Roof - East	No	None Detected
	Silver Paint for Black/White Roofing Material		No	None Detected
	Black Caulk for Black/White Roofing Material		No	None Detected
	Silver Paint 2 for Black/White Roofing Material		No	None Detected
	Black Sealant for Black/White Roofing Material		No	None Detected
	Black Roofing Felt for Black/White Roofing Material		No	None Detected
