**AHERA ASBESTOS  
INSPECTION REPORT**

**KYRENE ALTADENA MIDDLE SCHOOL  
14620 S DESERT FOOTHILLS PKWY,  
PHOENIX, ARIZONA 85048**

Dominion Project Number: AZ1418.54

AHERA Inspection Date: October 29, 2021, March 11, 2024, and July 3, 2025

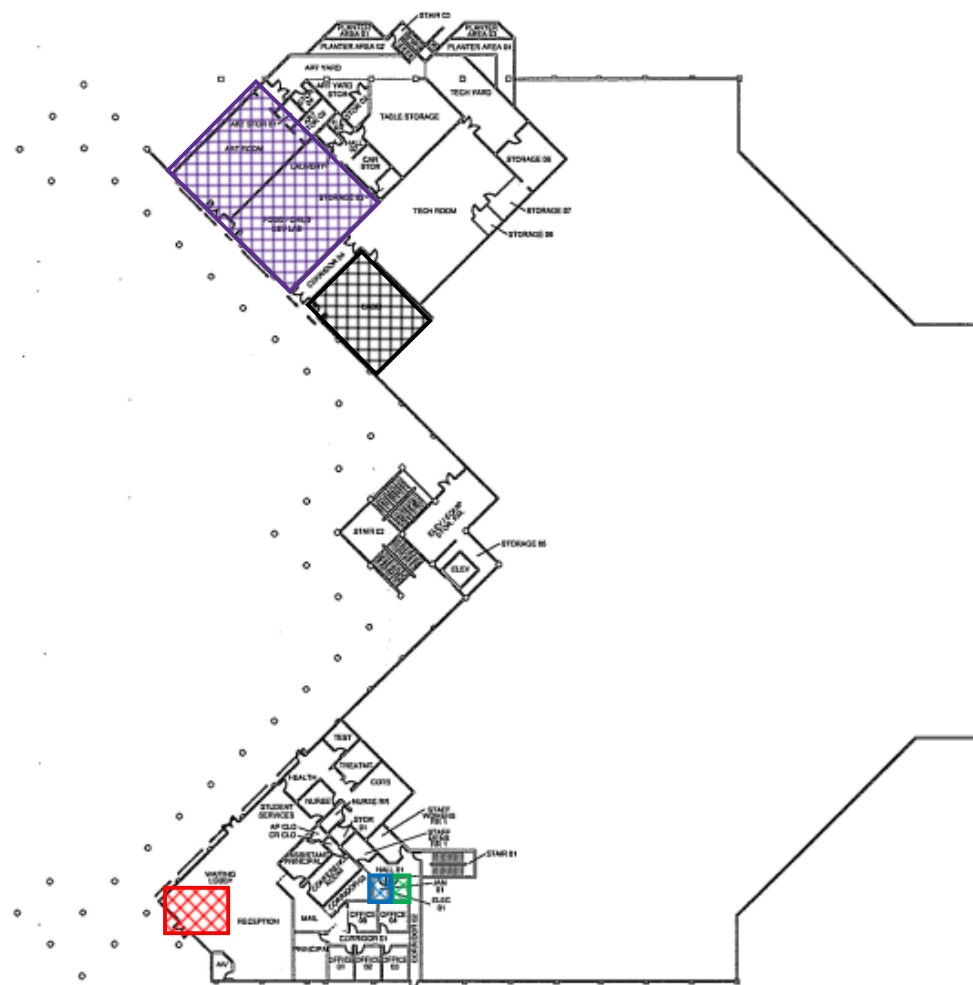
Building 2 (1st)

**Assumed Asbestos-Containing**  
**9"x9" Clear Block Grout**  
**Black 2"x2" Carpet Square & Mastic**  
**Door/Window Sealant**

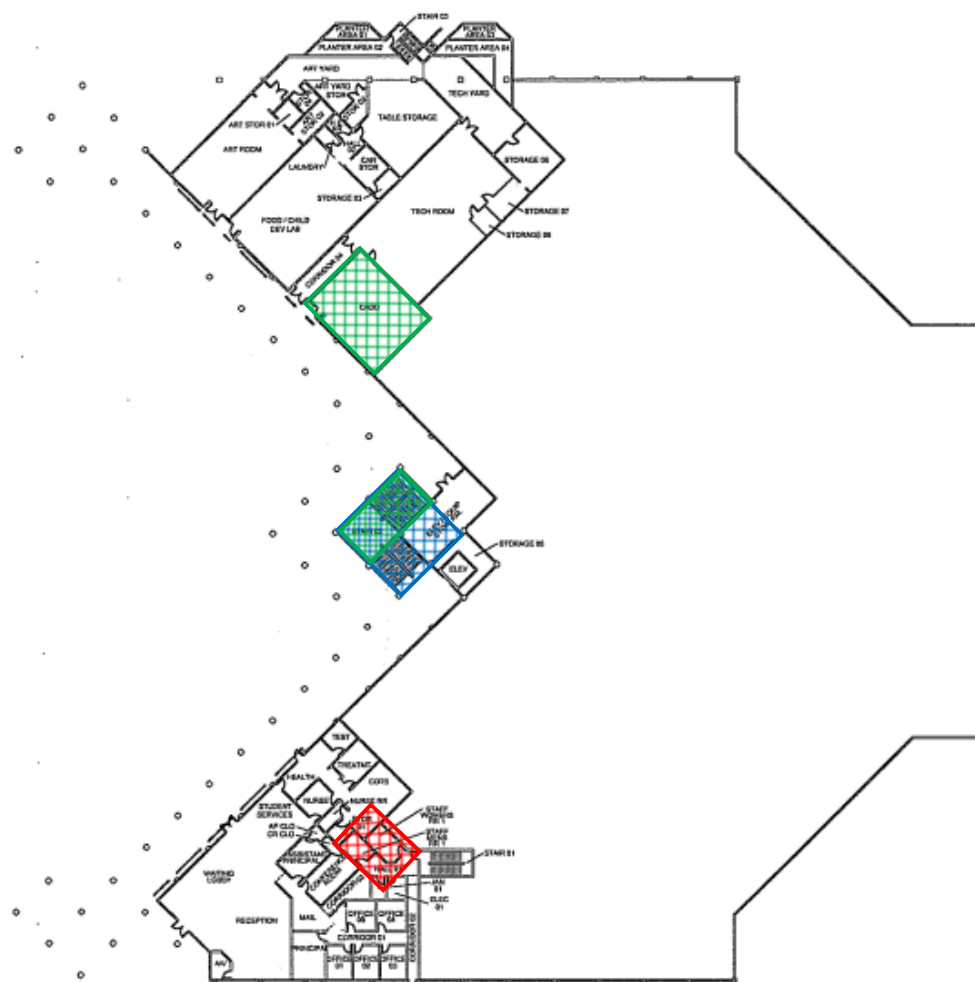
Building 2 (1st)

**Assumed Asbestos-Containing**  
 Pink 4"x4" Ceramic Wall Tile  
 Beige 4"x4" Ceramic Wall Tile  
 Beige FRP  
 Fixture Caulking  
 Tan 4"x4" Ceramic Wall tile  
 Gray 4"x4" Ceramic Wall tile  
 Black 4"x4" Ceramic Wall tile  
 (Grout & Mastic)

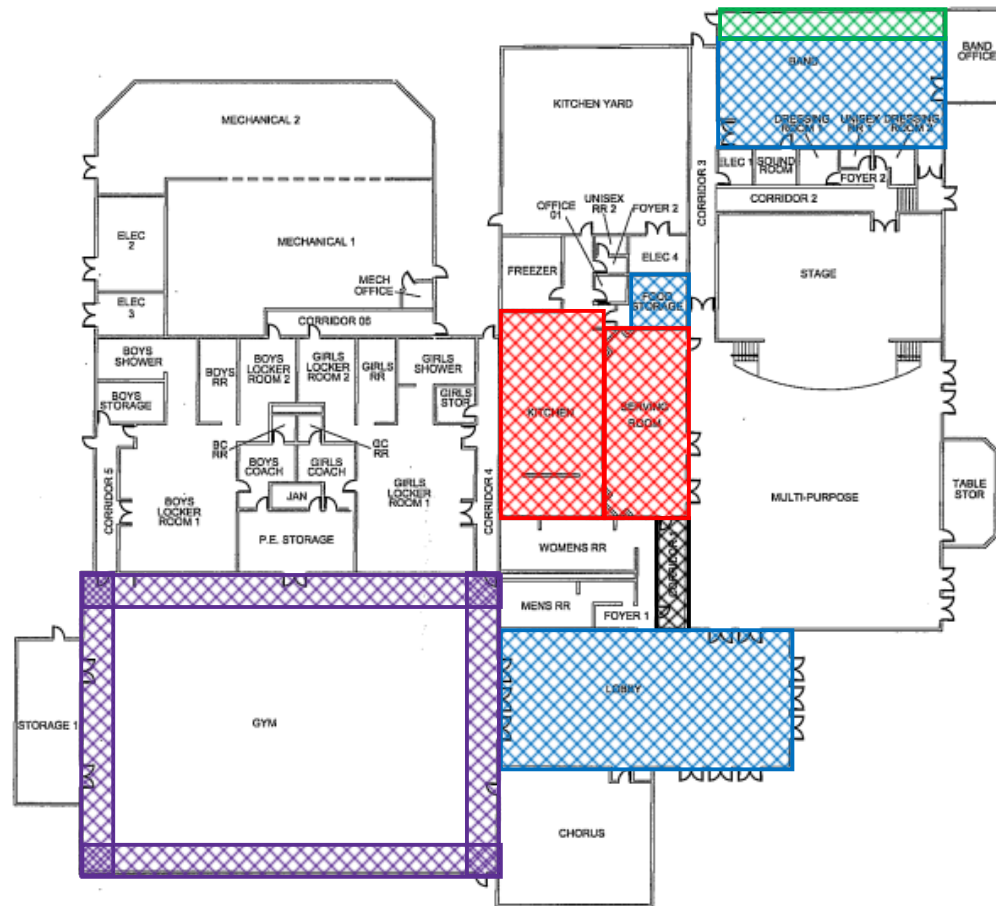
| <p><b>Assumed Asbestos-Containing</b><br/> <b>Floor Expansion Joint</b><br/> Tan 4"x4" Ceramic Floor Tile<br/> Gray 4"x4" Ceramic Floor Tile<br/> Black 4"x4" Ceramic Floor Tile<br/> Gray 12"x12" Ceramic Floor Tile<br/> Gray 6"x4" Cove Base Tile<br/> (Grout, Mastic, &amp; Thinset)<br/> Counter Caulking (Silver)</p> | <p><b>Assumed Asbestos-Containing</b><br/> Blue 12"x12" VCT<br/> White 12"x12" VCT<br/> (Mastic)</p> |

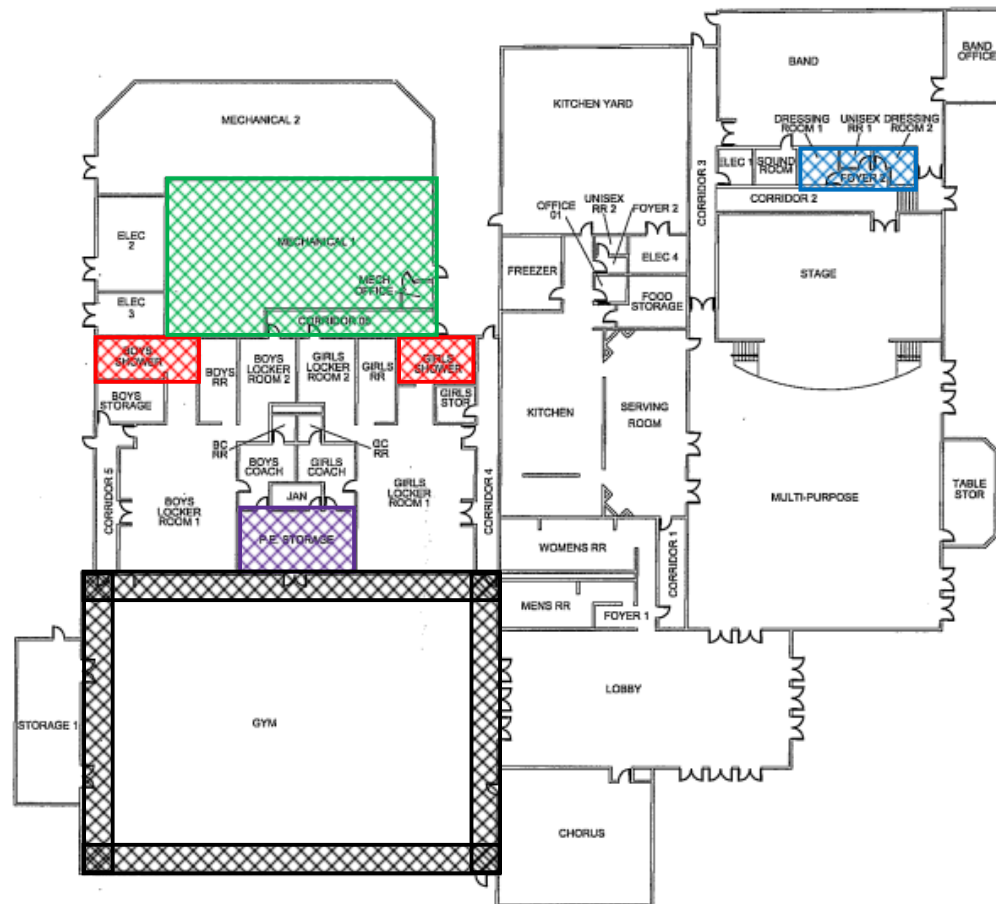
Assumed Asbestos-Containing  
Gray with Specs 2"x2" Floor Tile  
Gray 2"x2" Ceramic Floor Tile  
Tan 1"x1" Ceramic Floor Tile  
(Grout & Thinset)

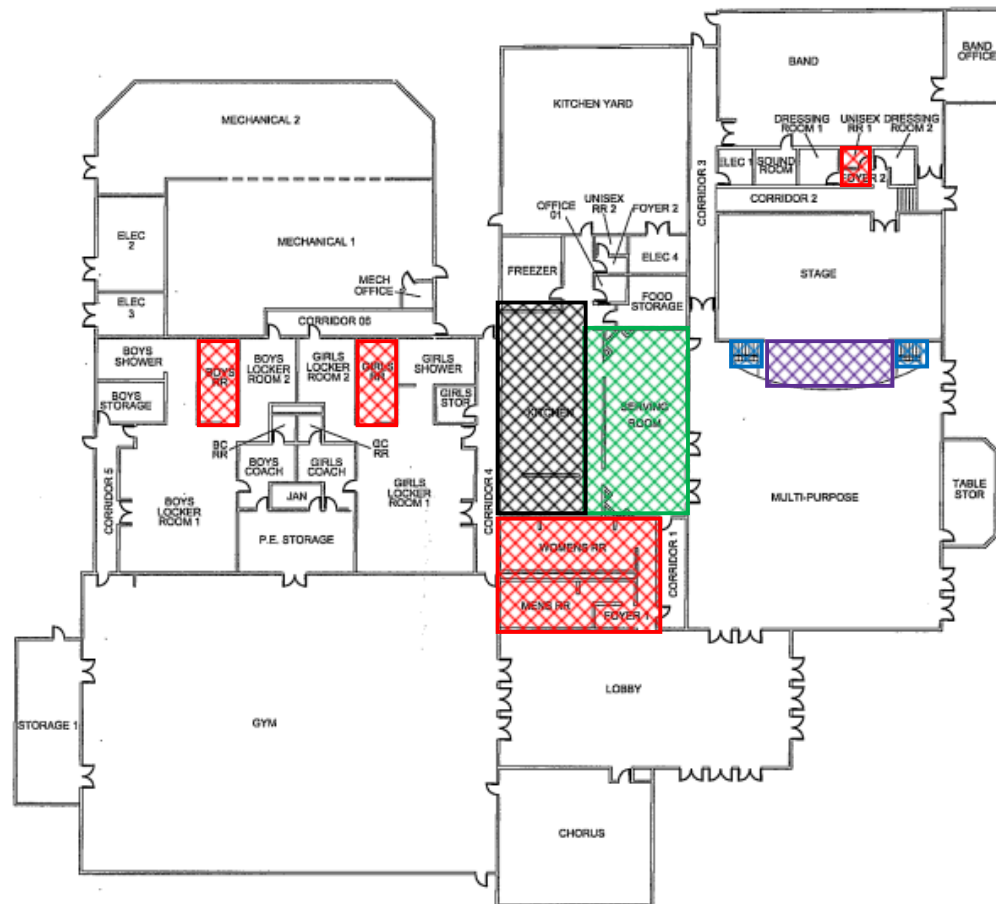
Assumed Asbestos-Containing  
Gray Epoxy Flooring  
Fixture Caulking  
Blue 4"x4" Ceramic Floor Tile  
(Grout & Thinset)

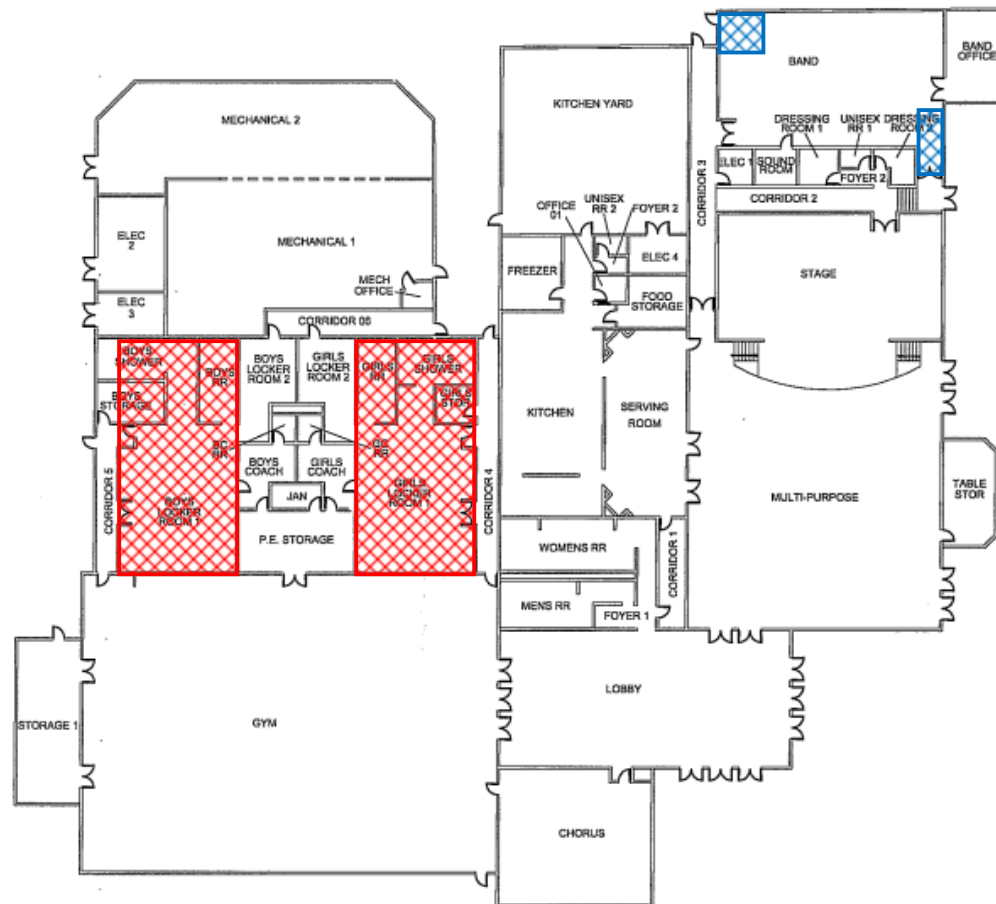
**Assumed Asbestos-Containing**  
Pink 4"x4" Ceramic Wall Tile  
Yellow 4"x4" Ceramic Wall Tile  
White 4"x4" Ceramic Wall Tile  
Blue 4"x4" Ceramic Wall Tile  
Gray Textured 12"x4" Cove Base Tile  
(Grout & Mastic)

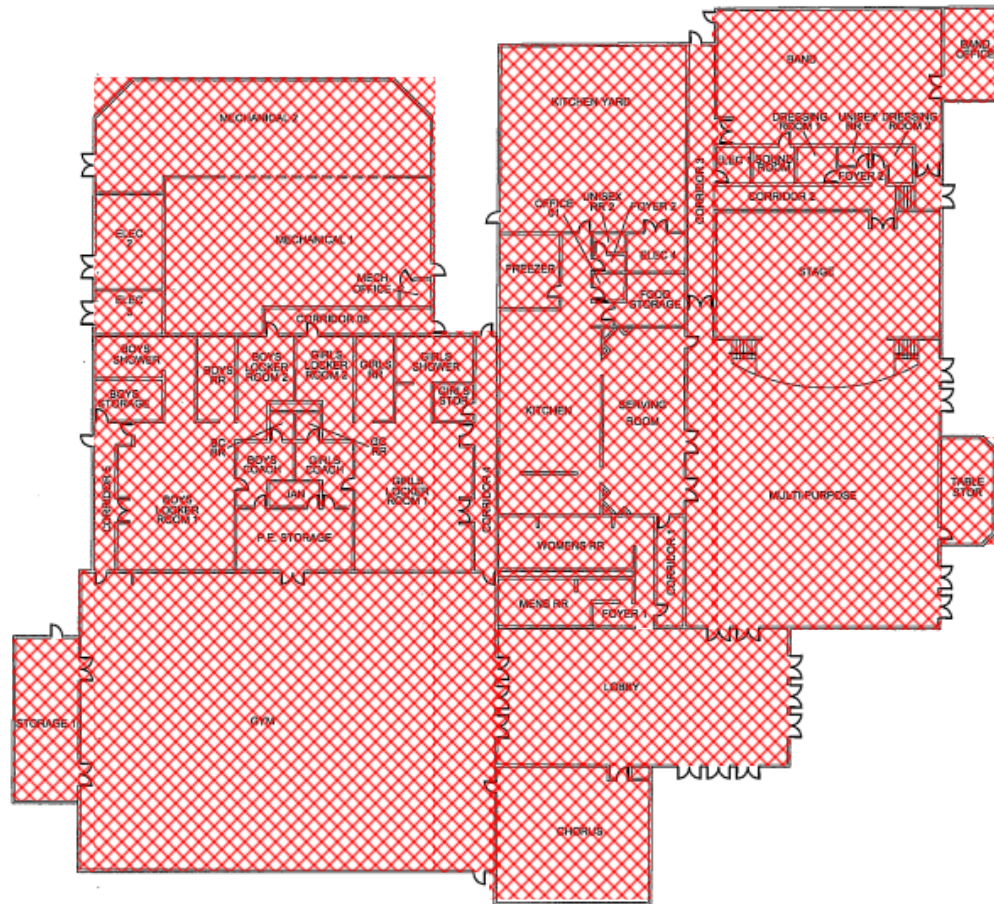
**Assumed Asbestos-Containing**  
**White Seam Tape**  
**Mastic for Seam Tape**  
**Untextured Drywall System**  
**Black Flex Duct & Insulation**  
**Silver Duct Wrap & Insulation**  
**Red Fire Stop Caulking**  
**Ceiling Wrap & Insulation**  
**White Duct Mastic**  
**Concrete Foundation**  
**Frame Caulking**

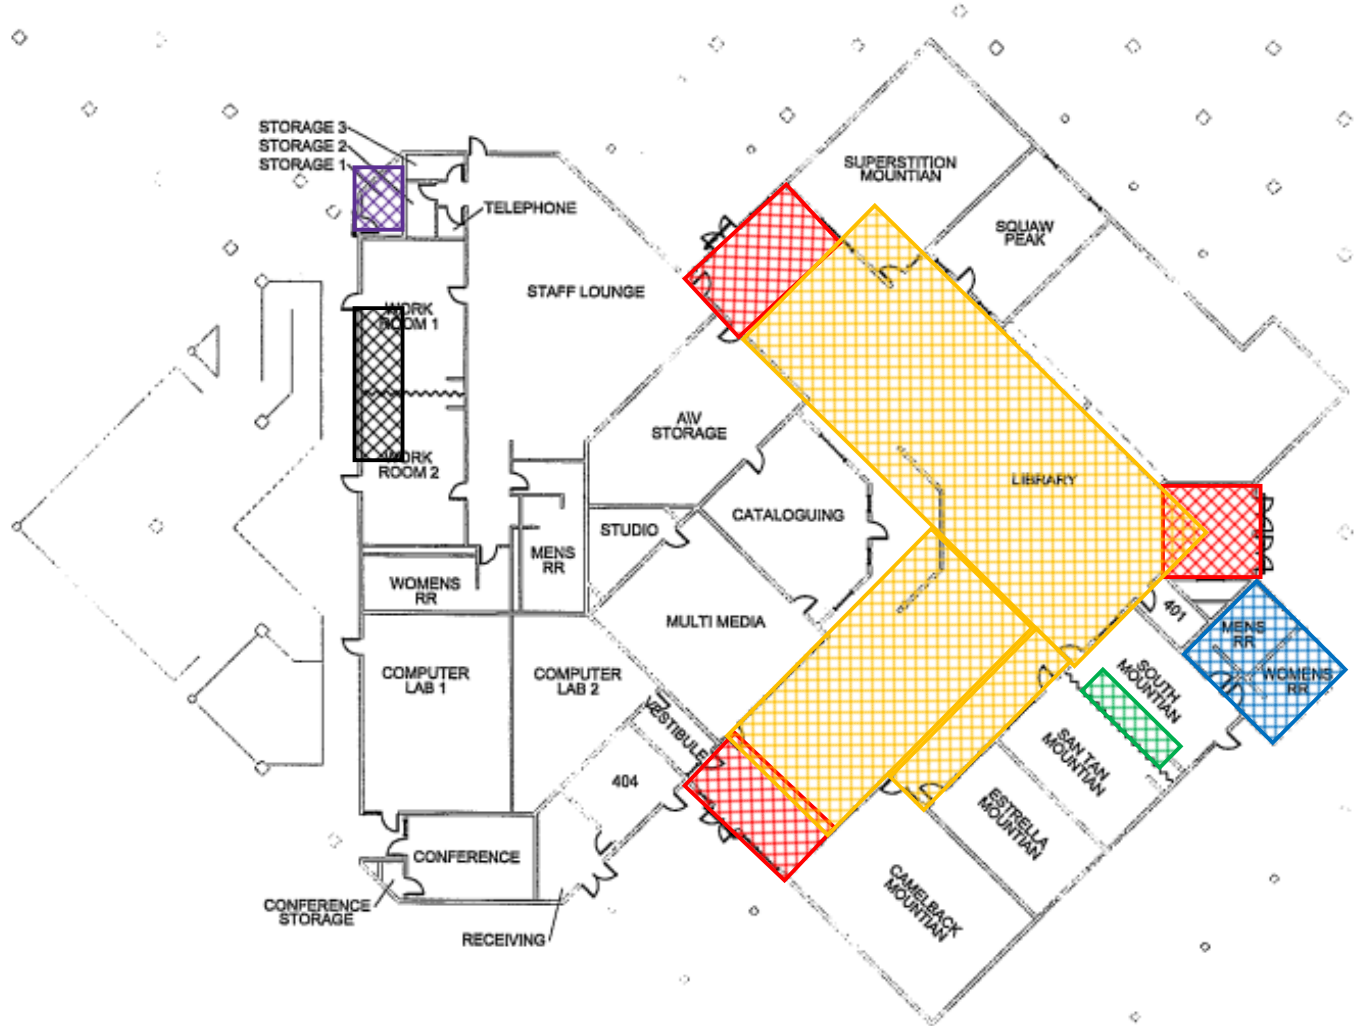
| | Assumed Asbestos-Containing<br>Glass 9"x9" block Mortar<br>Black 2"x2" Carpet & Mastic | | Assumed Asbestos-Containing<br>White 12"x12" VCT & Mastic<br>Fixture Caulking<br>White FRP & Mastic |

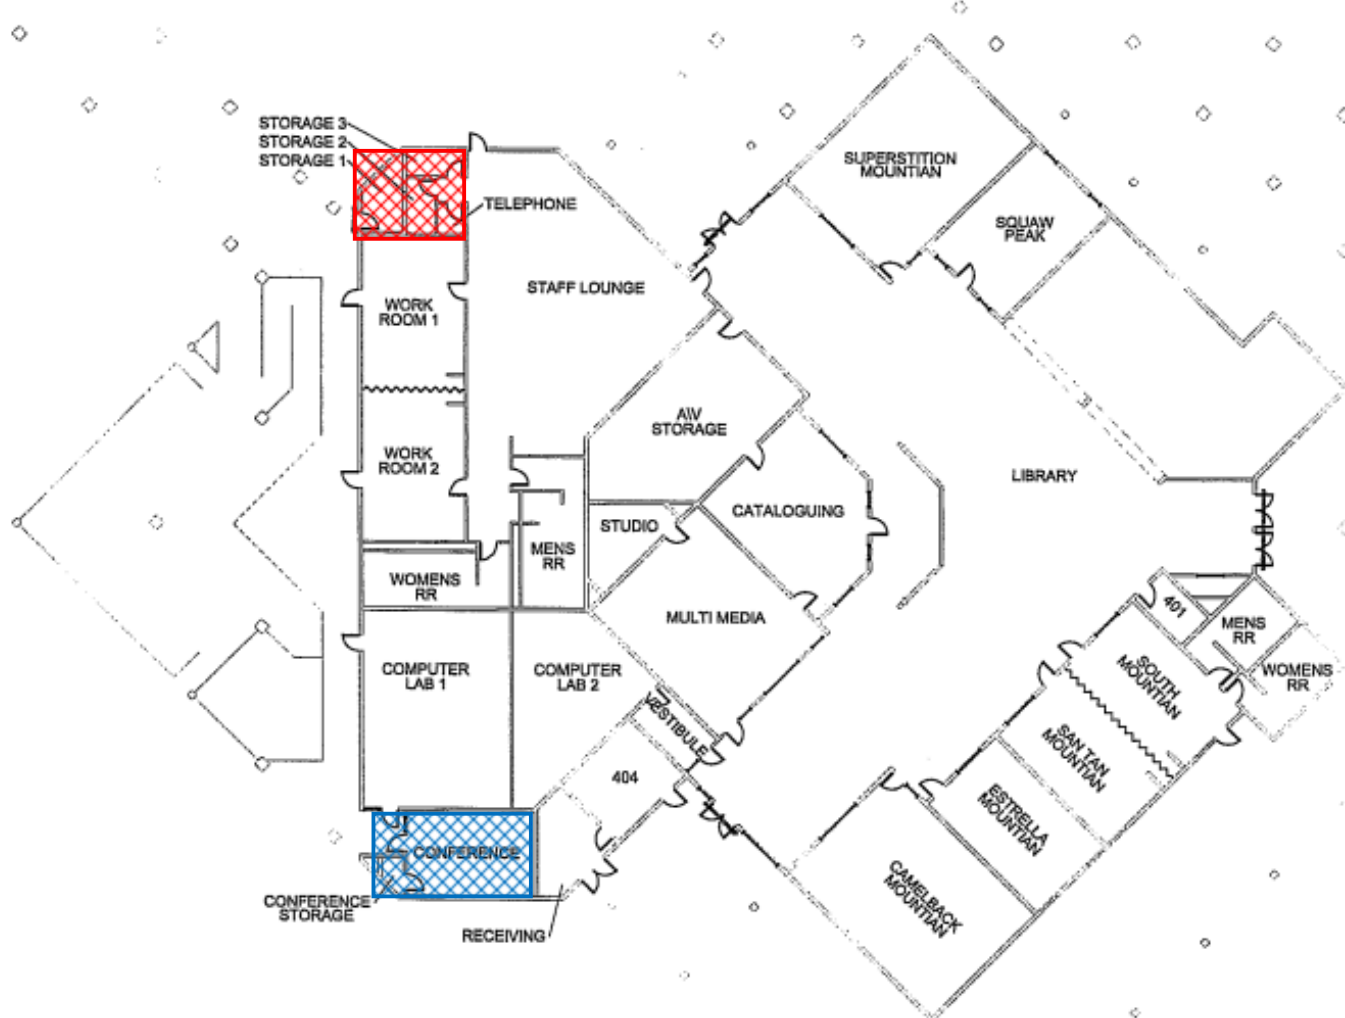
**Assumed Asbestos-Containing**  
**Gray 16"x8" CMU**  
**Brown CMU**  
**Mortar**  
**Brown Decorative CMU**  
**Concrete Pad**  
**Beige Door Frame Sealant**

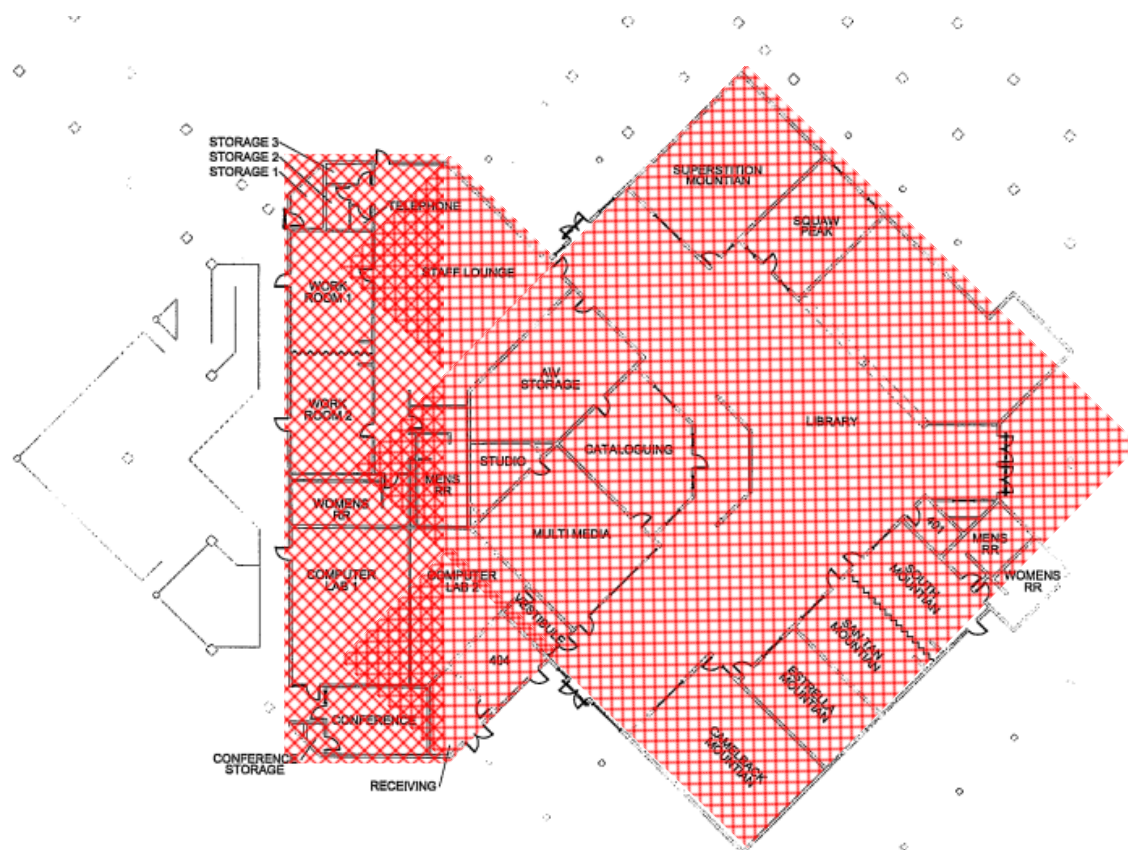
Assumed Asbestos-Containing  
 Pinhole 2'x2' Ceiling Tile  
 Tac Board Wrap & Mastic  
 Frame Caulking  
 Black Window Sealant  
 Beige with Tan 12"x12" VCT & Mastic  
 Counter/Cabinet Caulking  
 Concrete Foundation  
 Unfinished Drywall System  
 Black Flex Duct Wrap & Insulation  
 Silver Duct Wrap & Insulation  
 White Seam Tape & Mastic  
 White Duct Mastic  
 Ceiling Wrap & Insulation  
 White Pipe Wrap & Insulation
