**AHERA ASBESTOS  
INSPECTION REPORT**

**KYRENE APRENDE MIDDLE SCHOOL  
777 NORTH DESERT BREEZE BLVD.,  
CHANDLER, ARIZONA 85226**

Dominion Project Number: AZ1418.55

AHERA Re-Inspection Date: July 2, 2025

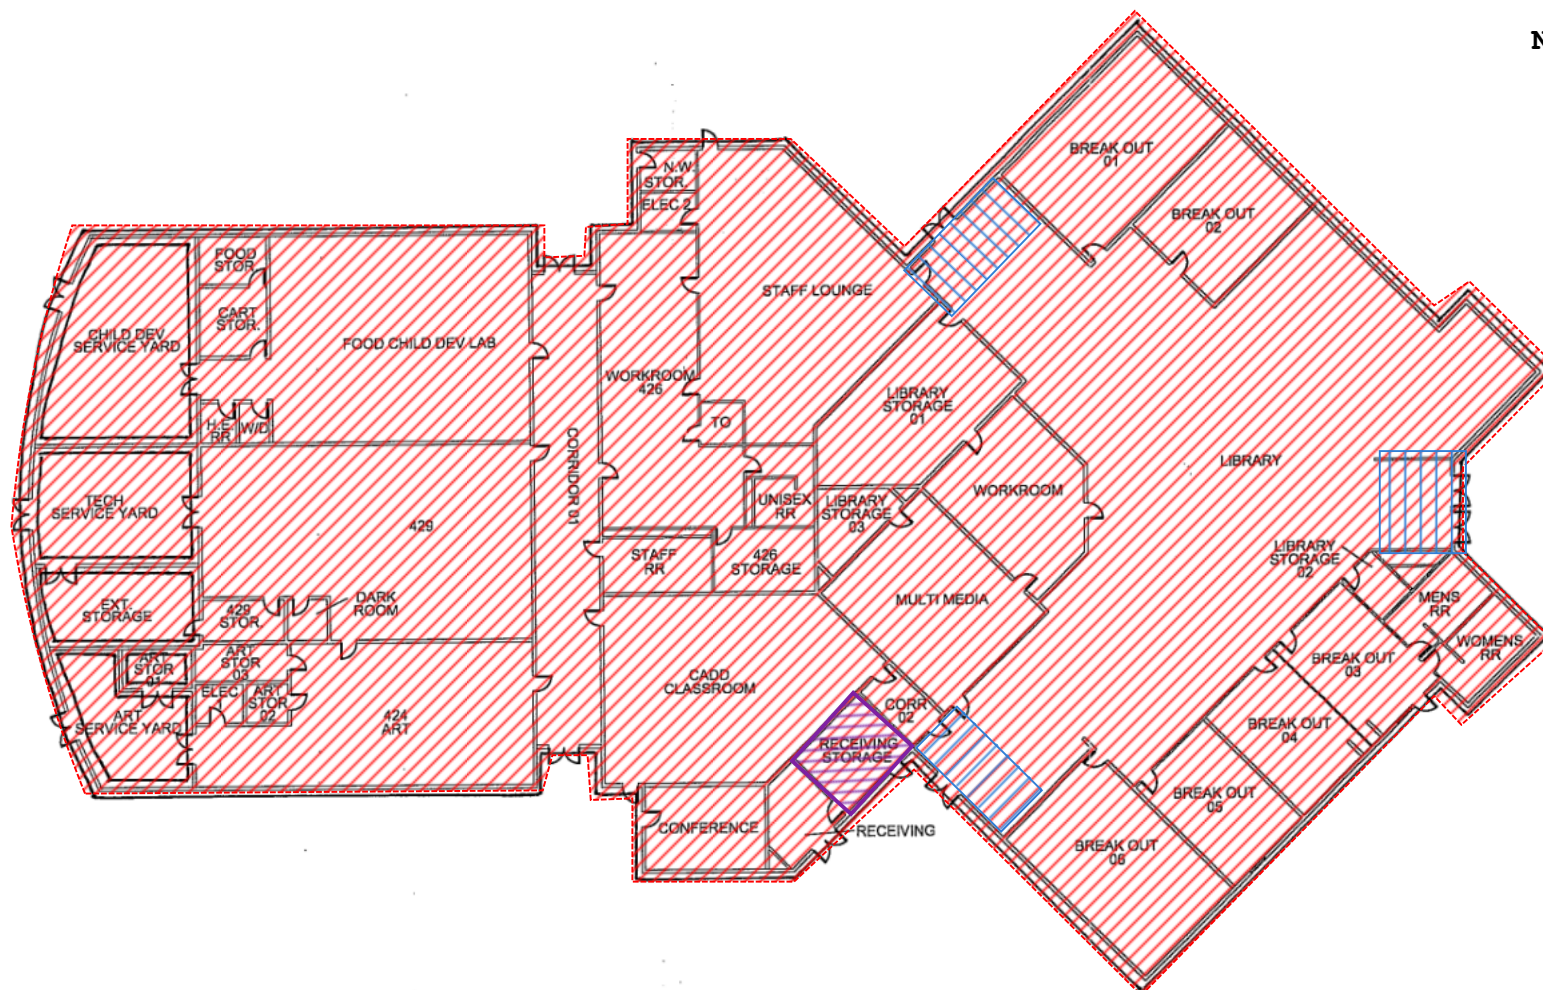
Assumed Asbestos-Containing

Concrete Foundation, Counter/Cabinet  
Caulking, & Blue/Gray 2" x 2" Carpet  
& Mastic

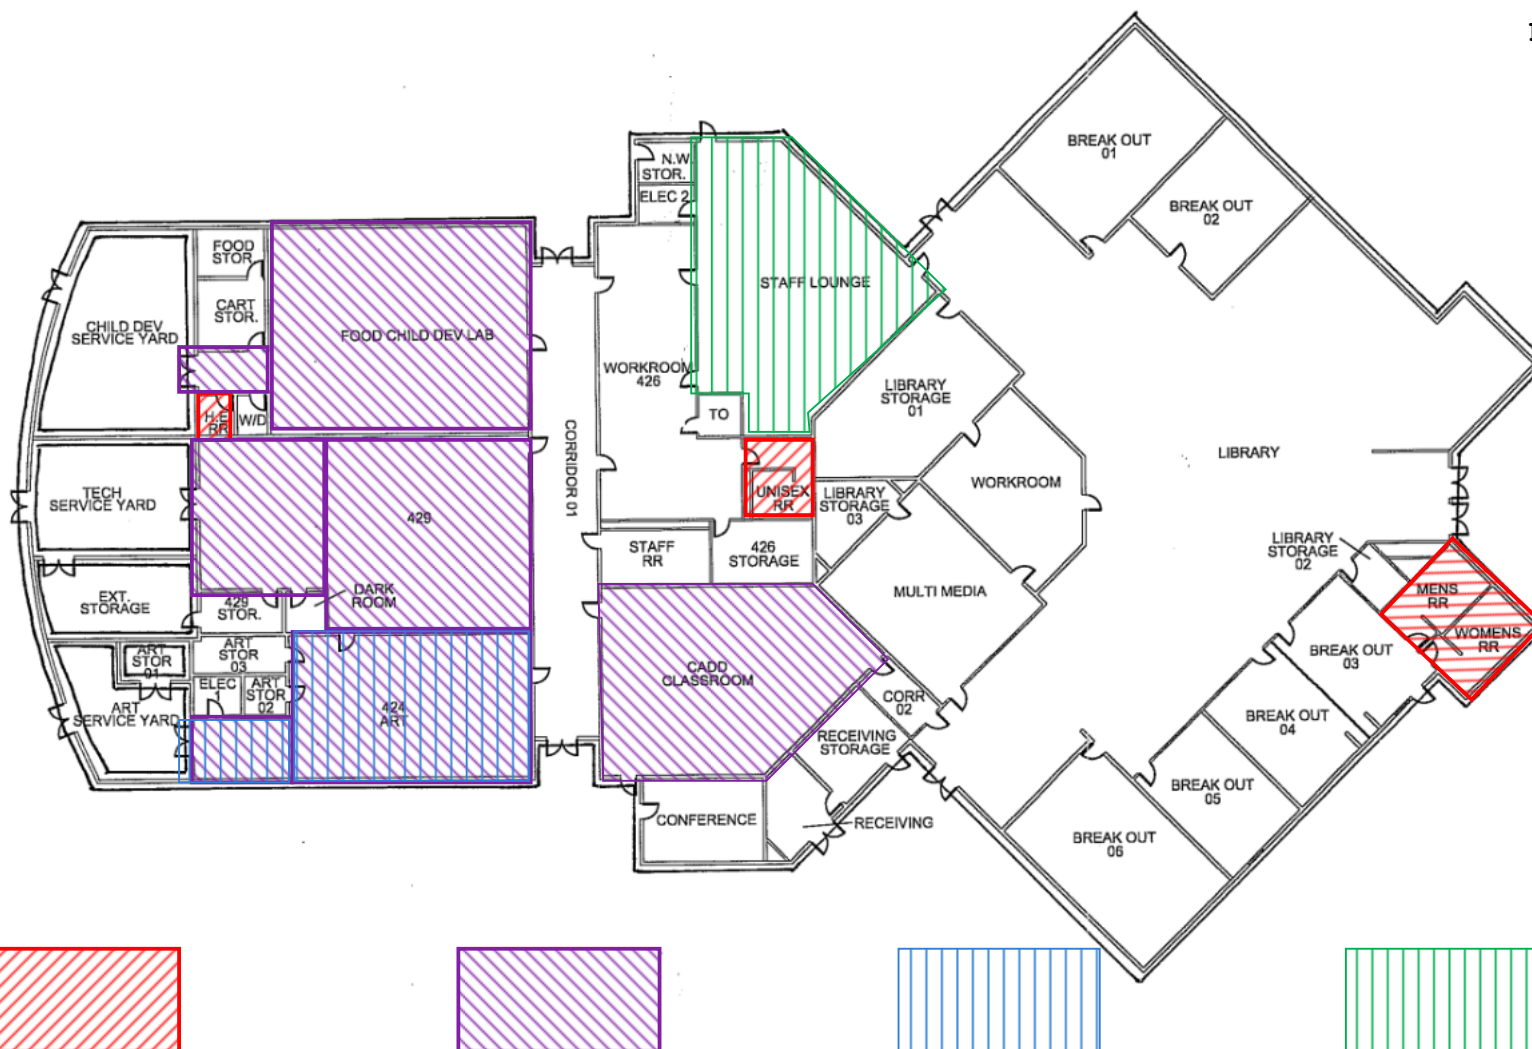
**Assumed Asbestos-Containing**

Gray 2" x 2" Ceramic Floor Tile,  
Grout, & Thinset, White 4" x 4"  
Ceramic Wall Tile, Grout, & Mastic,  
Gray 4" x 4" Ceramic Wall Tile,  
Grout, & Mastic, Black 4" x 4"  
Ceramic Wall Tile, Grout, & Mastic,  
Blue 4" x 4" Ceramic Cove Base Tile,  
Grout, & Mastic, & Fixture Caulking

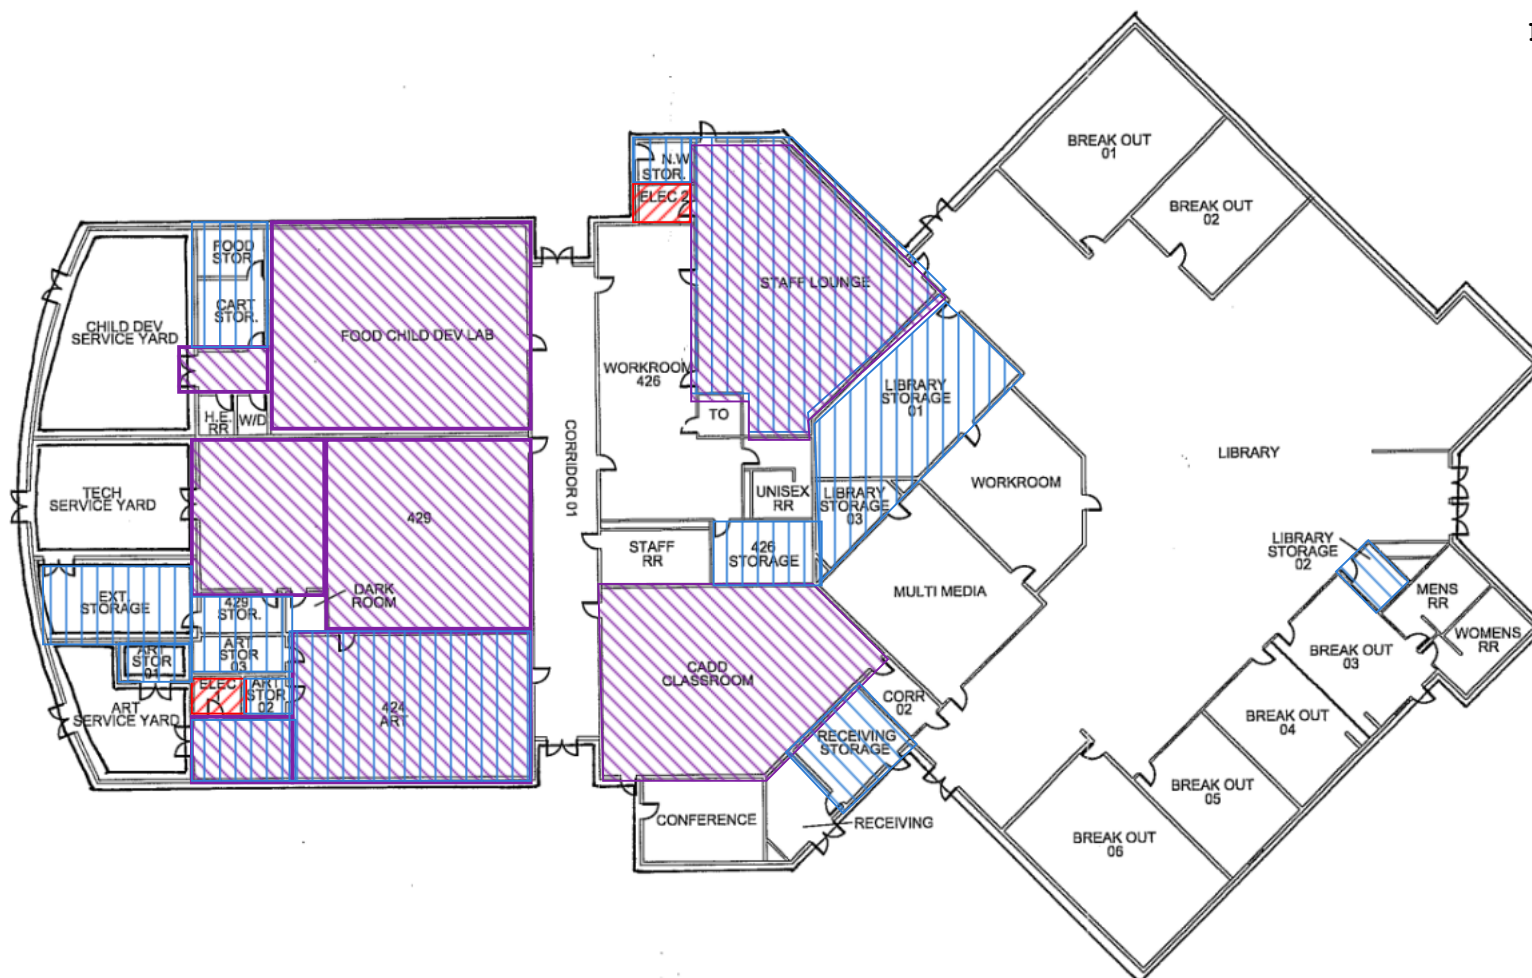
**Assumed Asbestos-Containing**  
**Concrete Pad & Smooth Texture**  
**Drywall System**

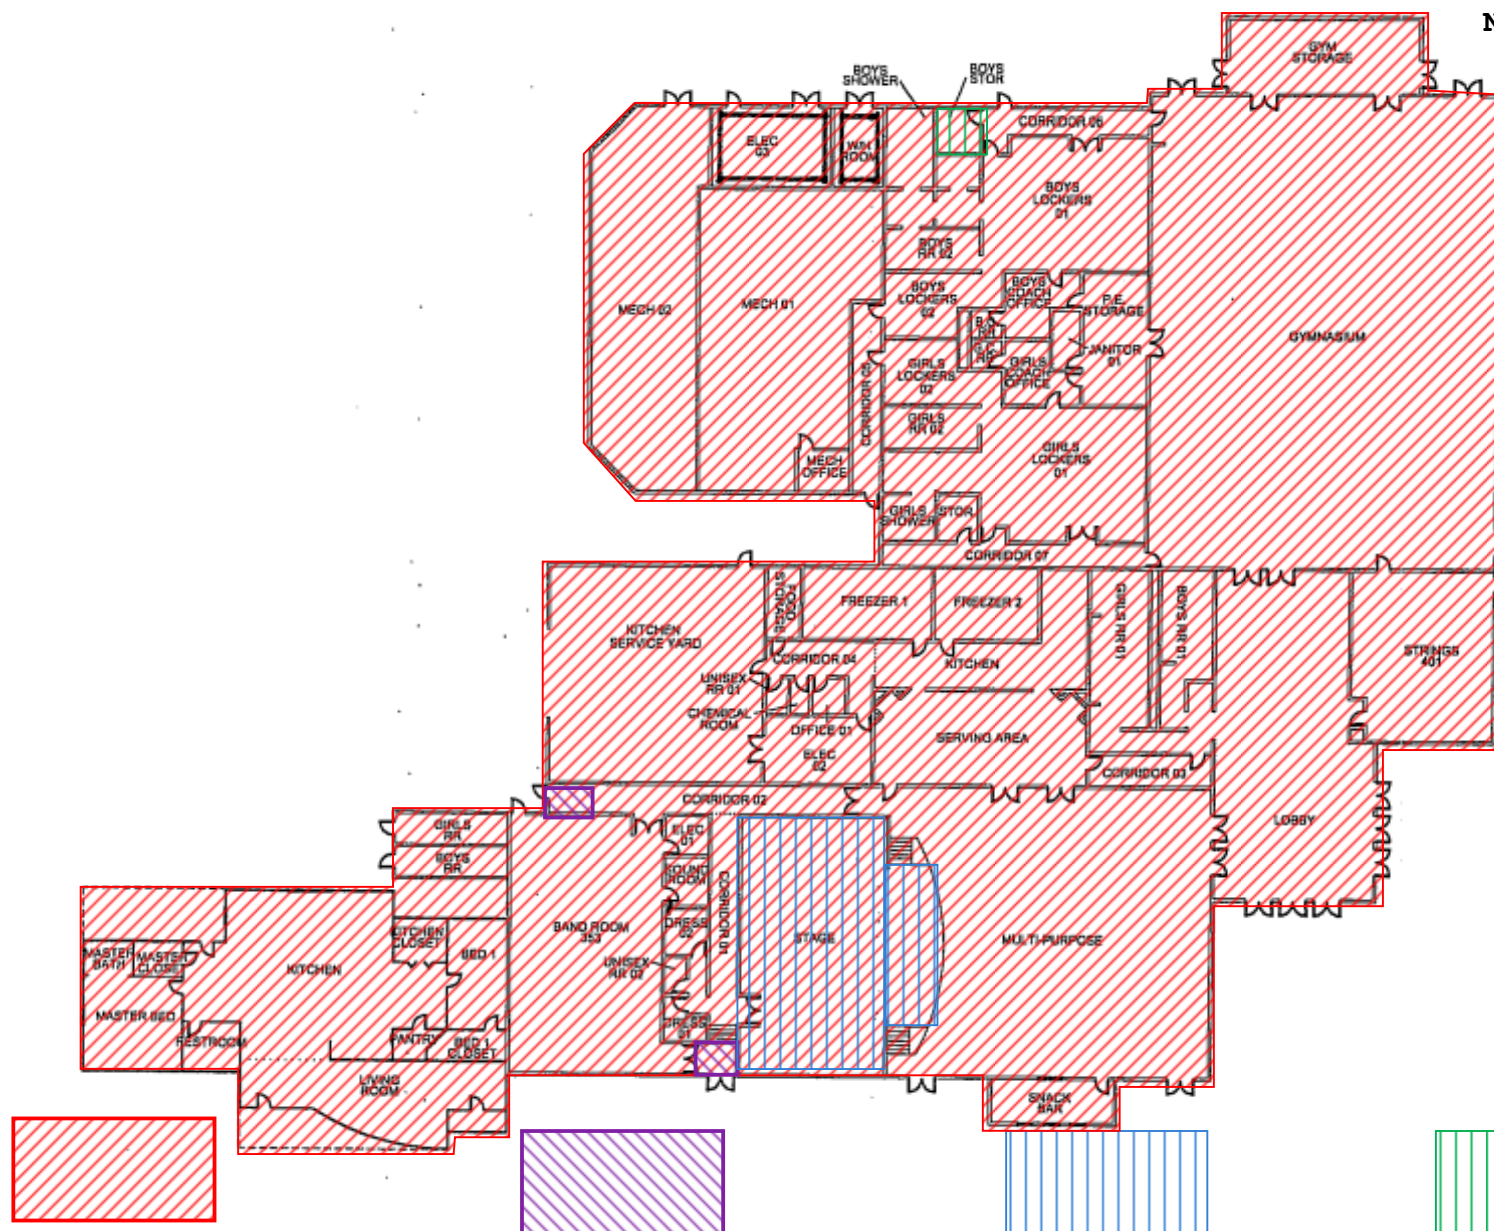
Assumed Asbestos-Containing

Interior Frame Caulking,  
White Frame Caulking, 9" x 9"  
Block Grout, Concrete Foundation,  
Brown 16" x 3" CMU & Mortar,  
& Gray Sink Caulking

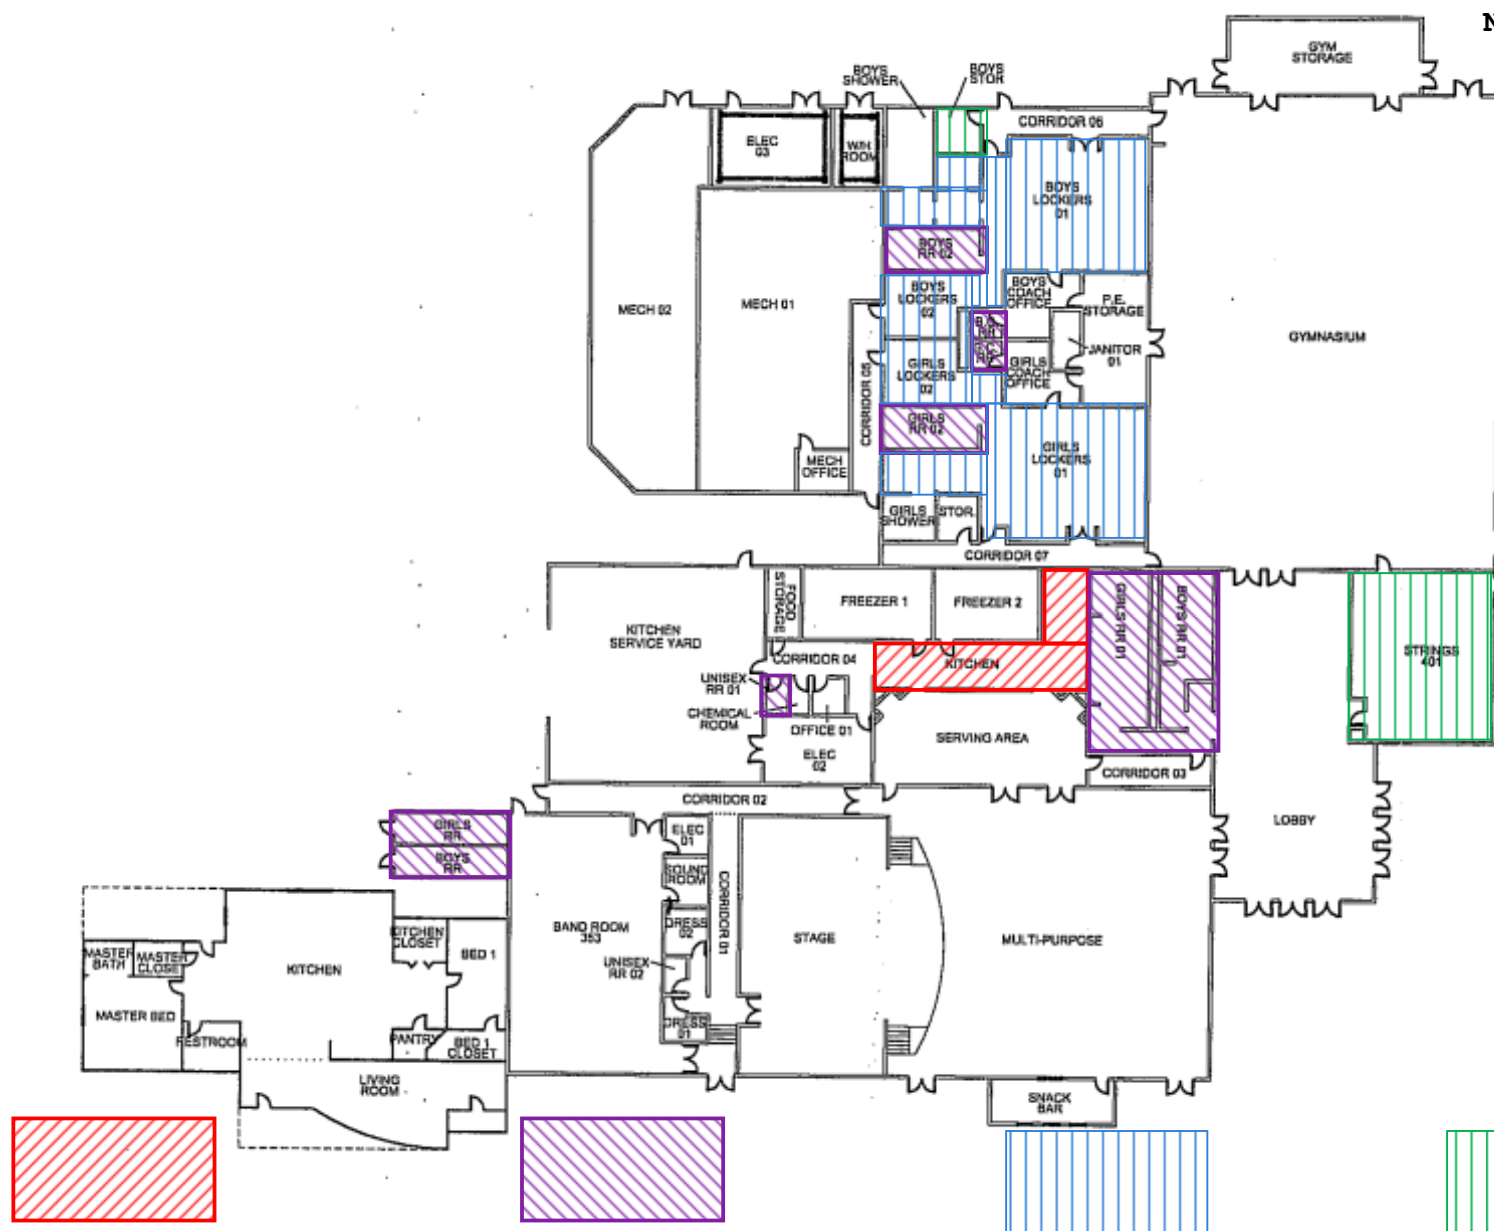
Assumed Asbestos-Containing

4" Brown Cove Base & Mastic,  
6" Gray Cove Base & Mastic,  
6" x 6" Ceramic Cove Base & Mastic,  
& Gray 12" x 12" Ceramic Floor Tile,  
Grout, & Mastic

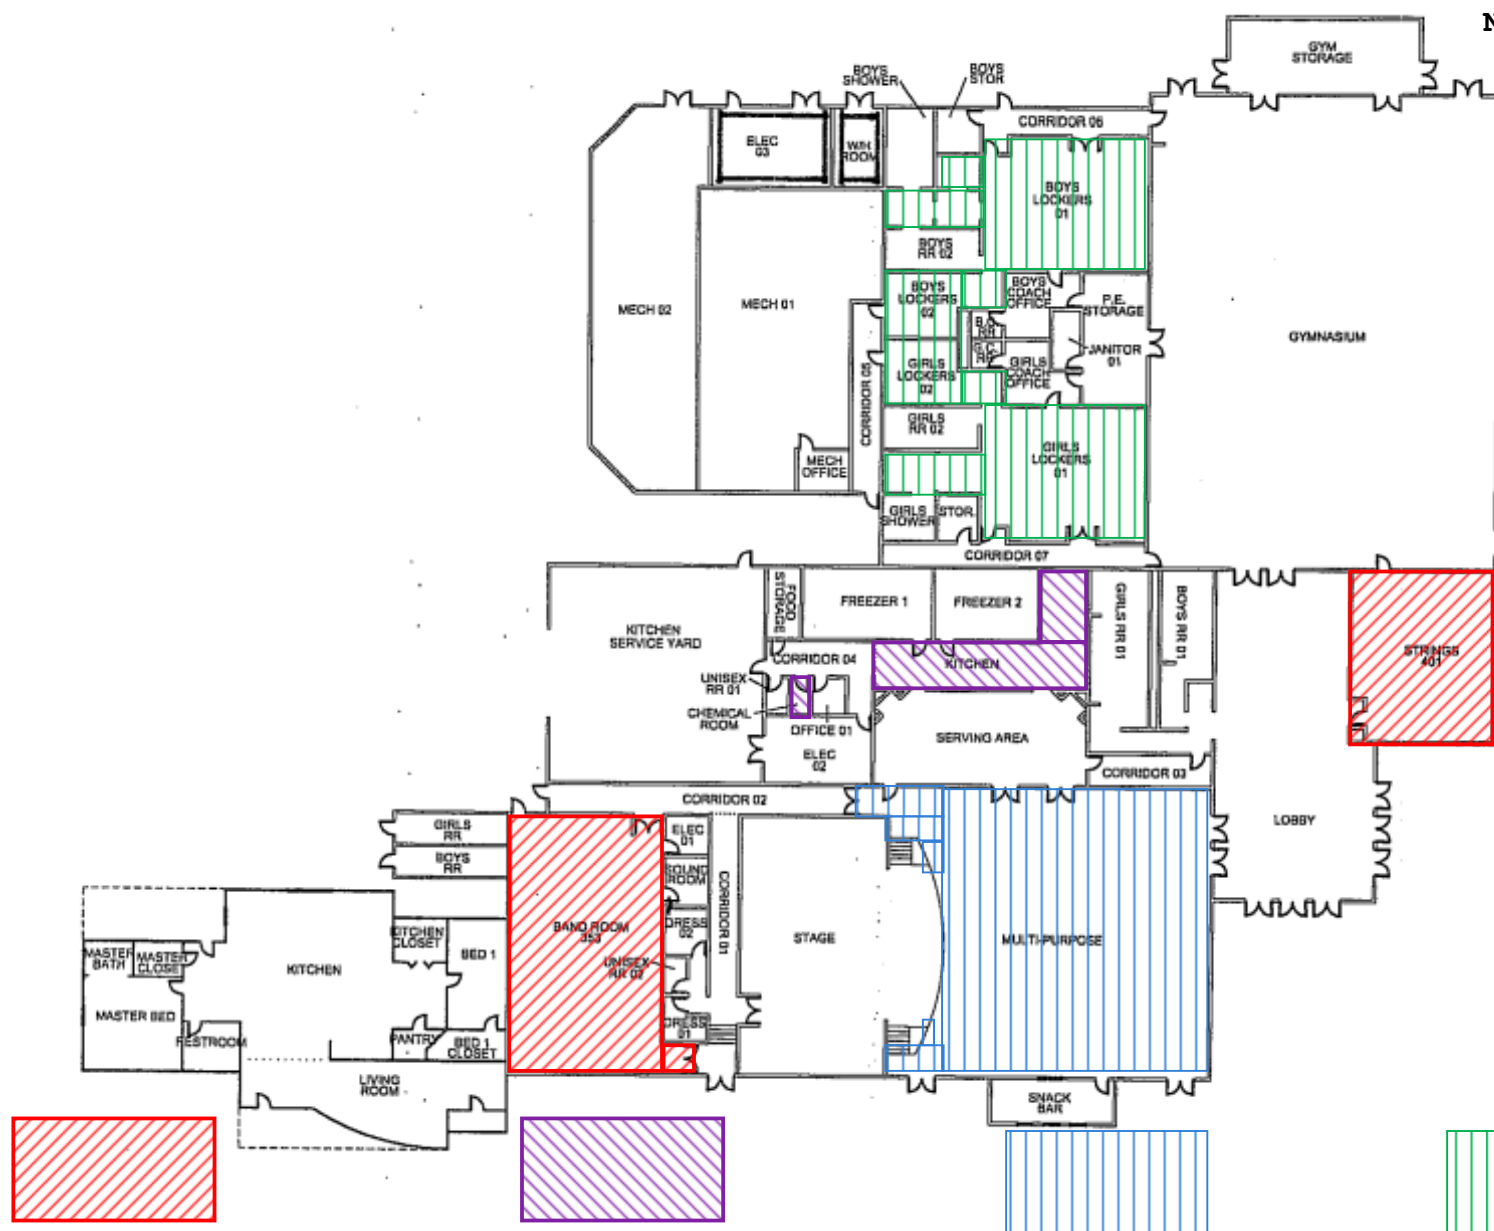
Assumed Asbestos-Containing

Tacboard & Mastic
