**AHERA ASBESTOS  
INSPECTION REPORT**

**KYRENE DE LA MARIPOSA SCIENCE ACADEMY  
50 EAST KNOX ROAD  
TEMPE, ARIZONA 85384**

Dominion Project Number: AZ1418.45

AHERA Re-Inspection Date: June 30, 2025

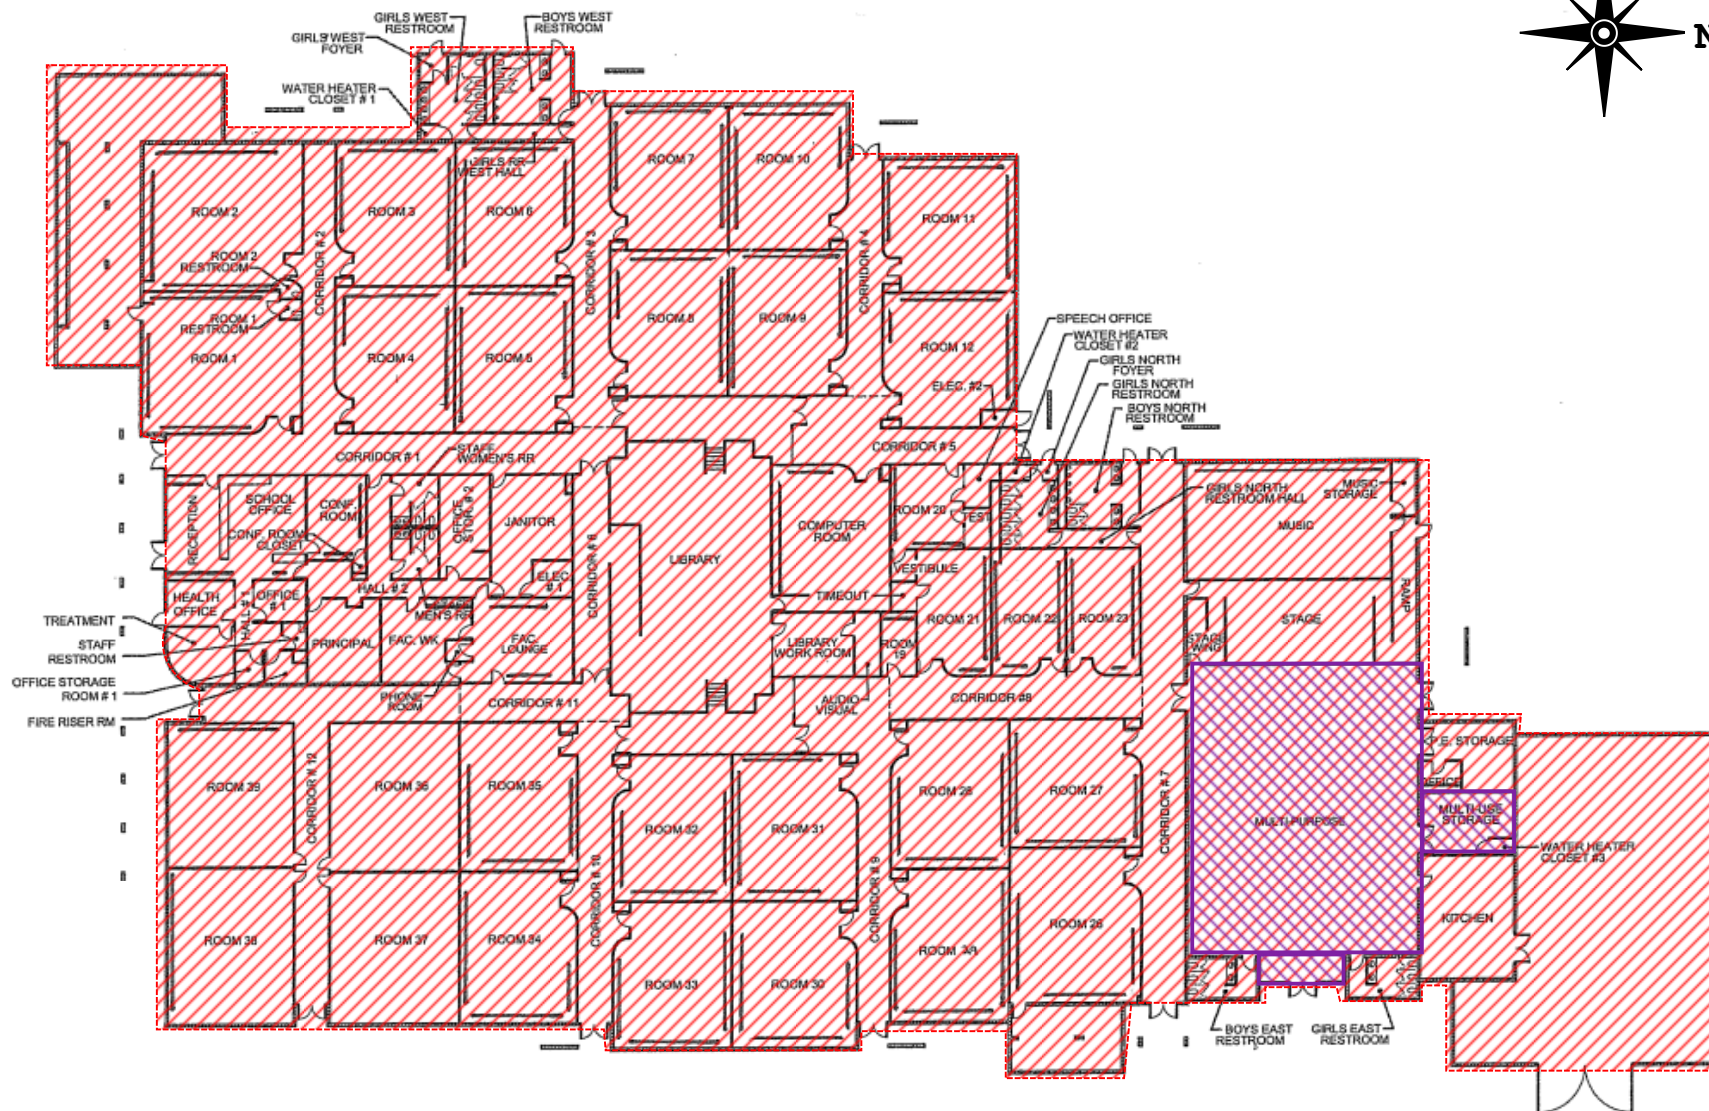
Main Building

**Assumed Asbestos-Containing**

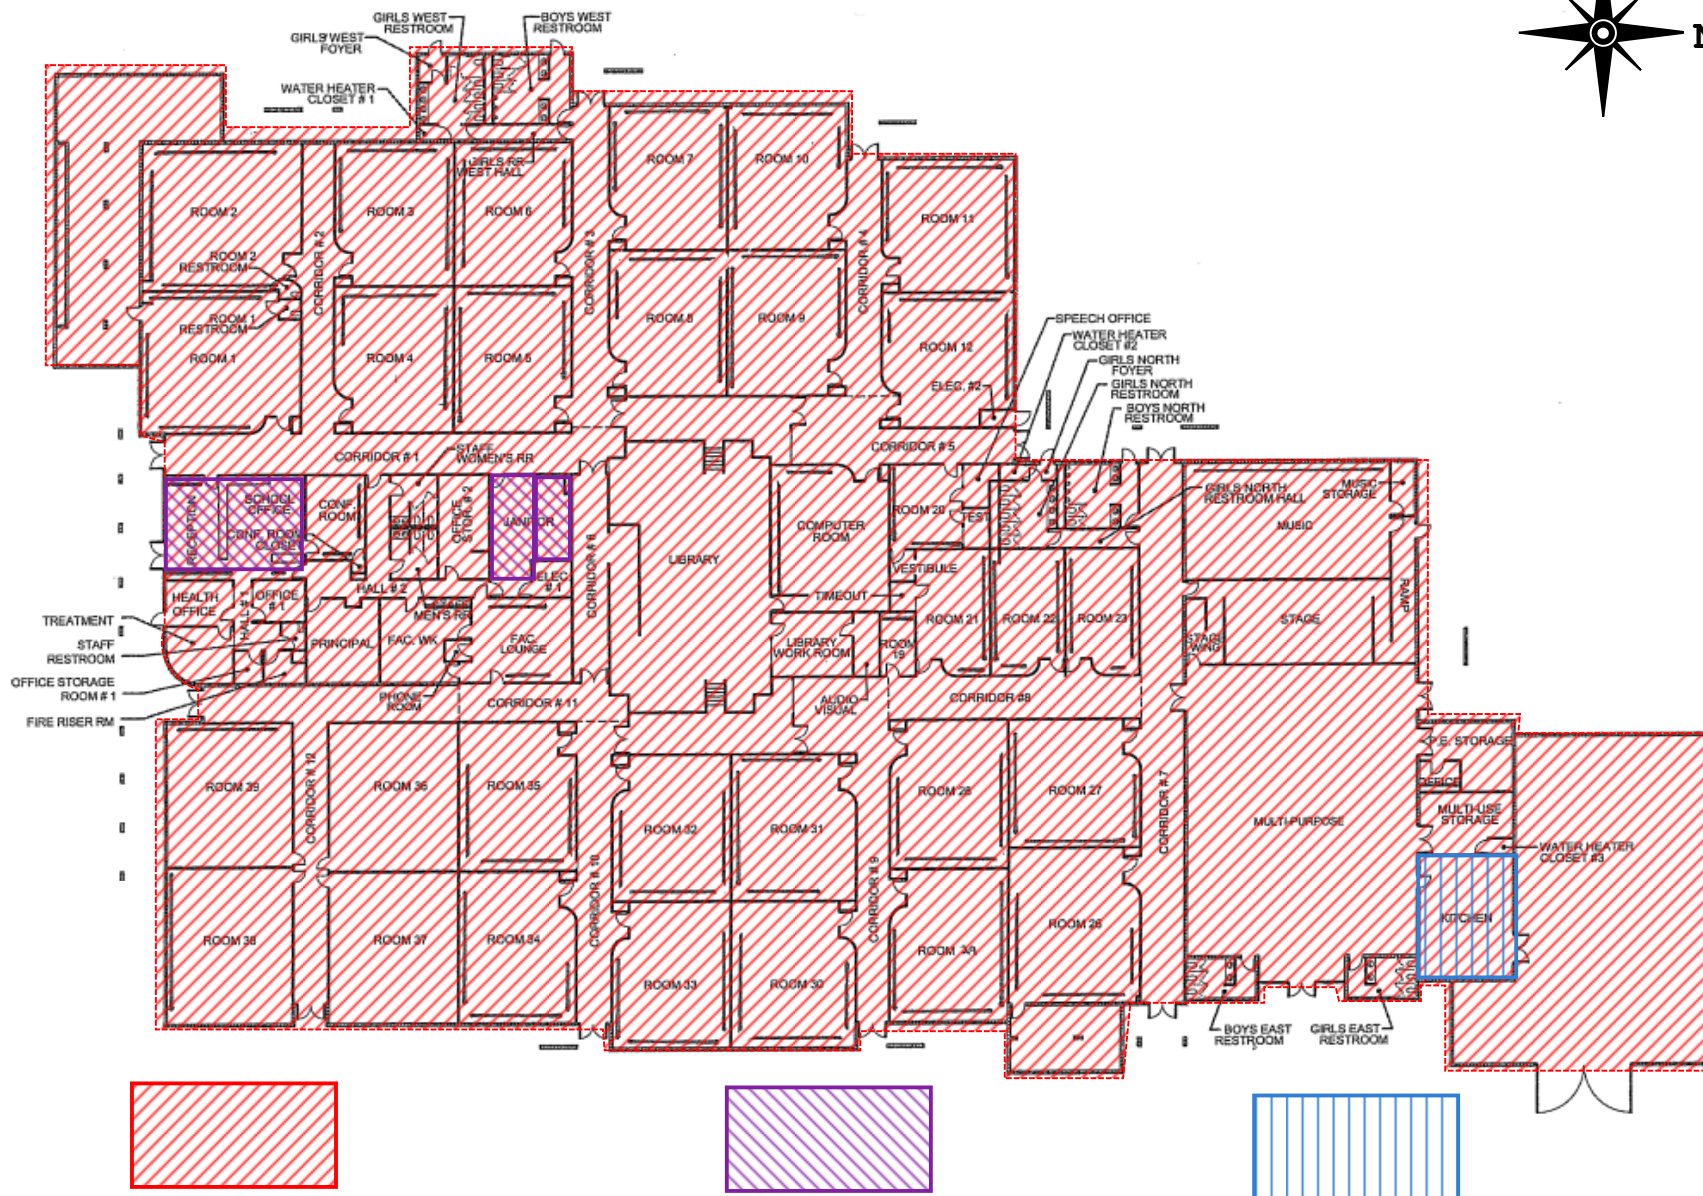
Main Building

**Assumed Asbestos-Containing**

**Black Chiller Tank Foam,  
Gray Chiller Mastic, &  
White Chiller Mastic**

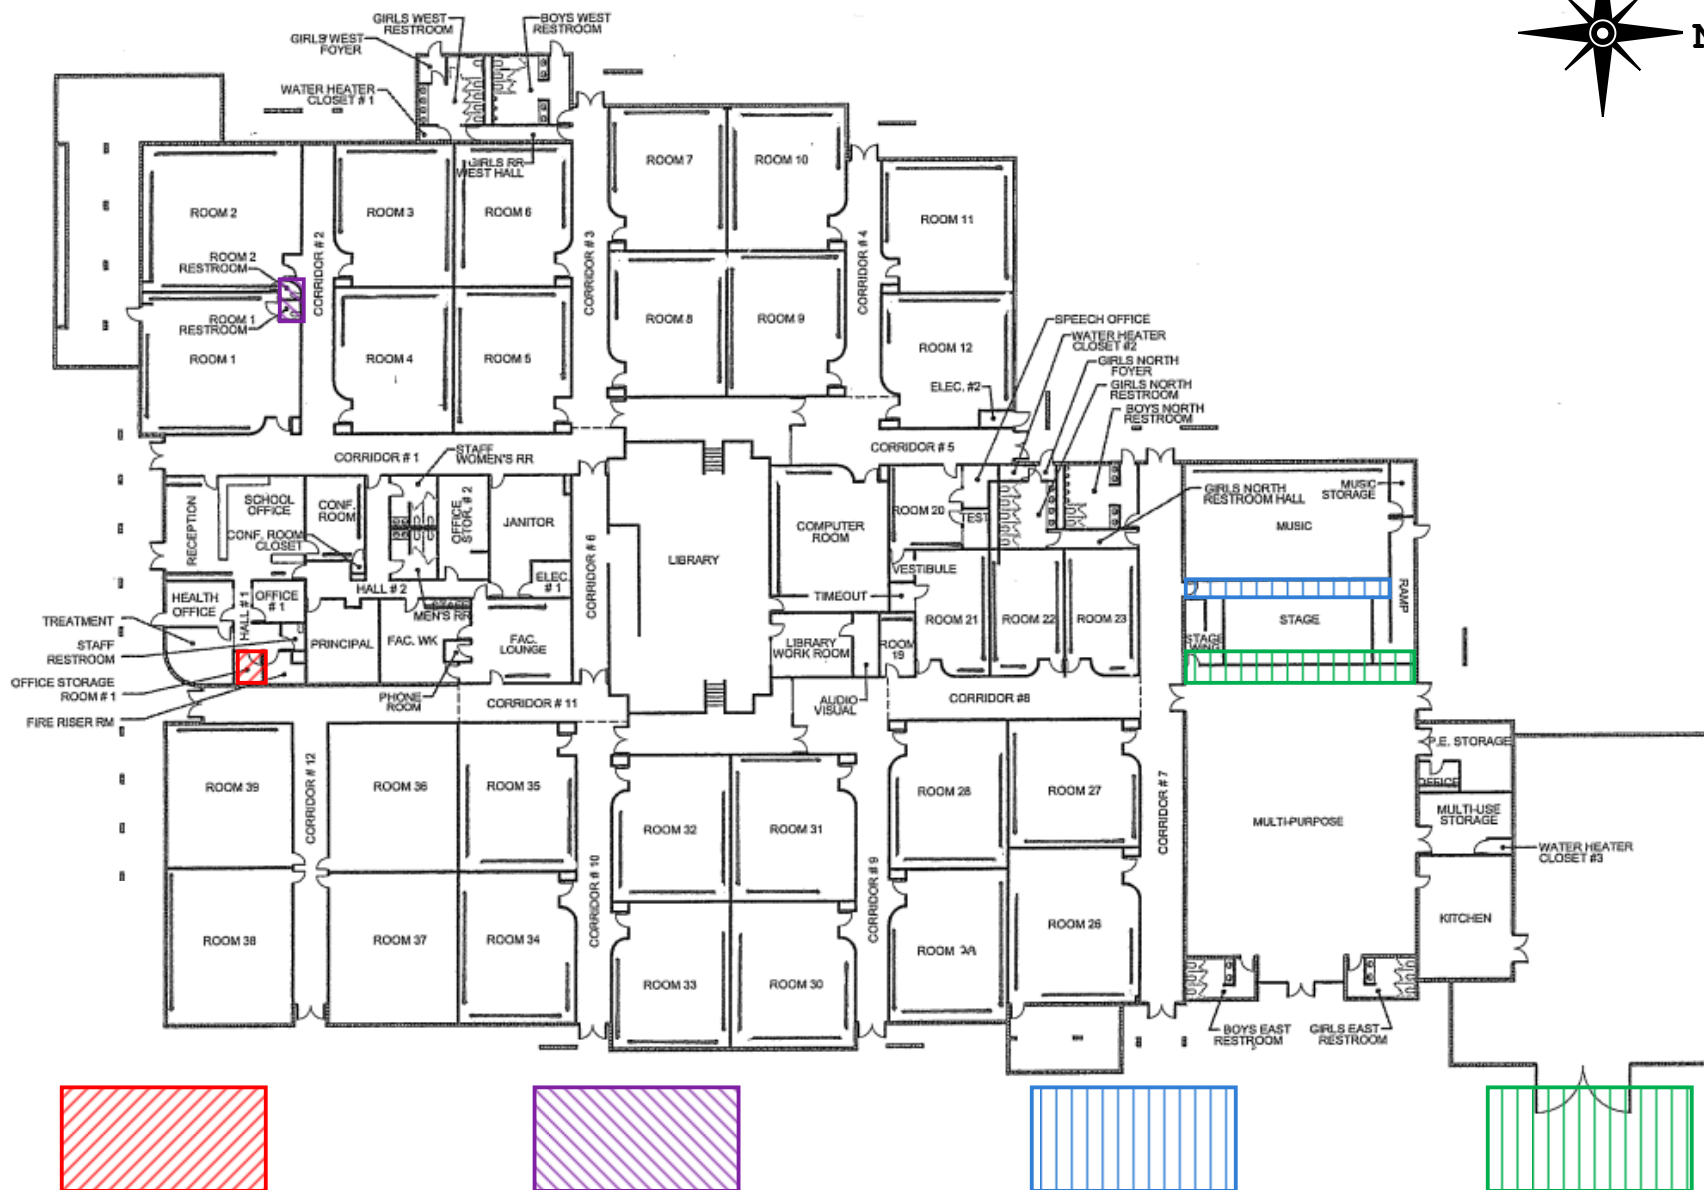
Main Building

**Assumed Asbestos-Containing**

Gray Carpet & Mastic &  
Teal Cove Base & Mastic

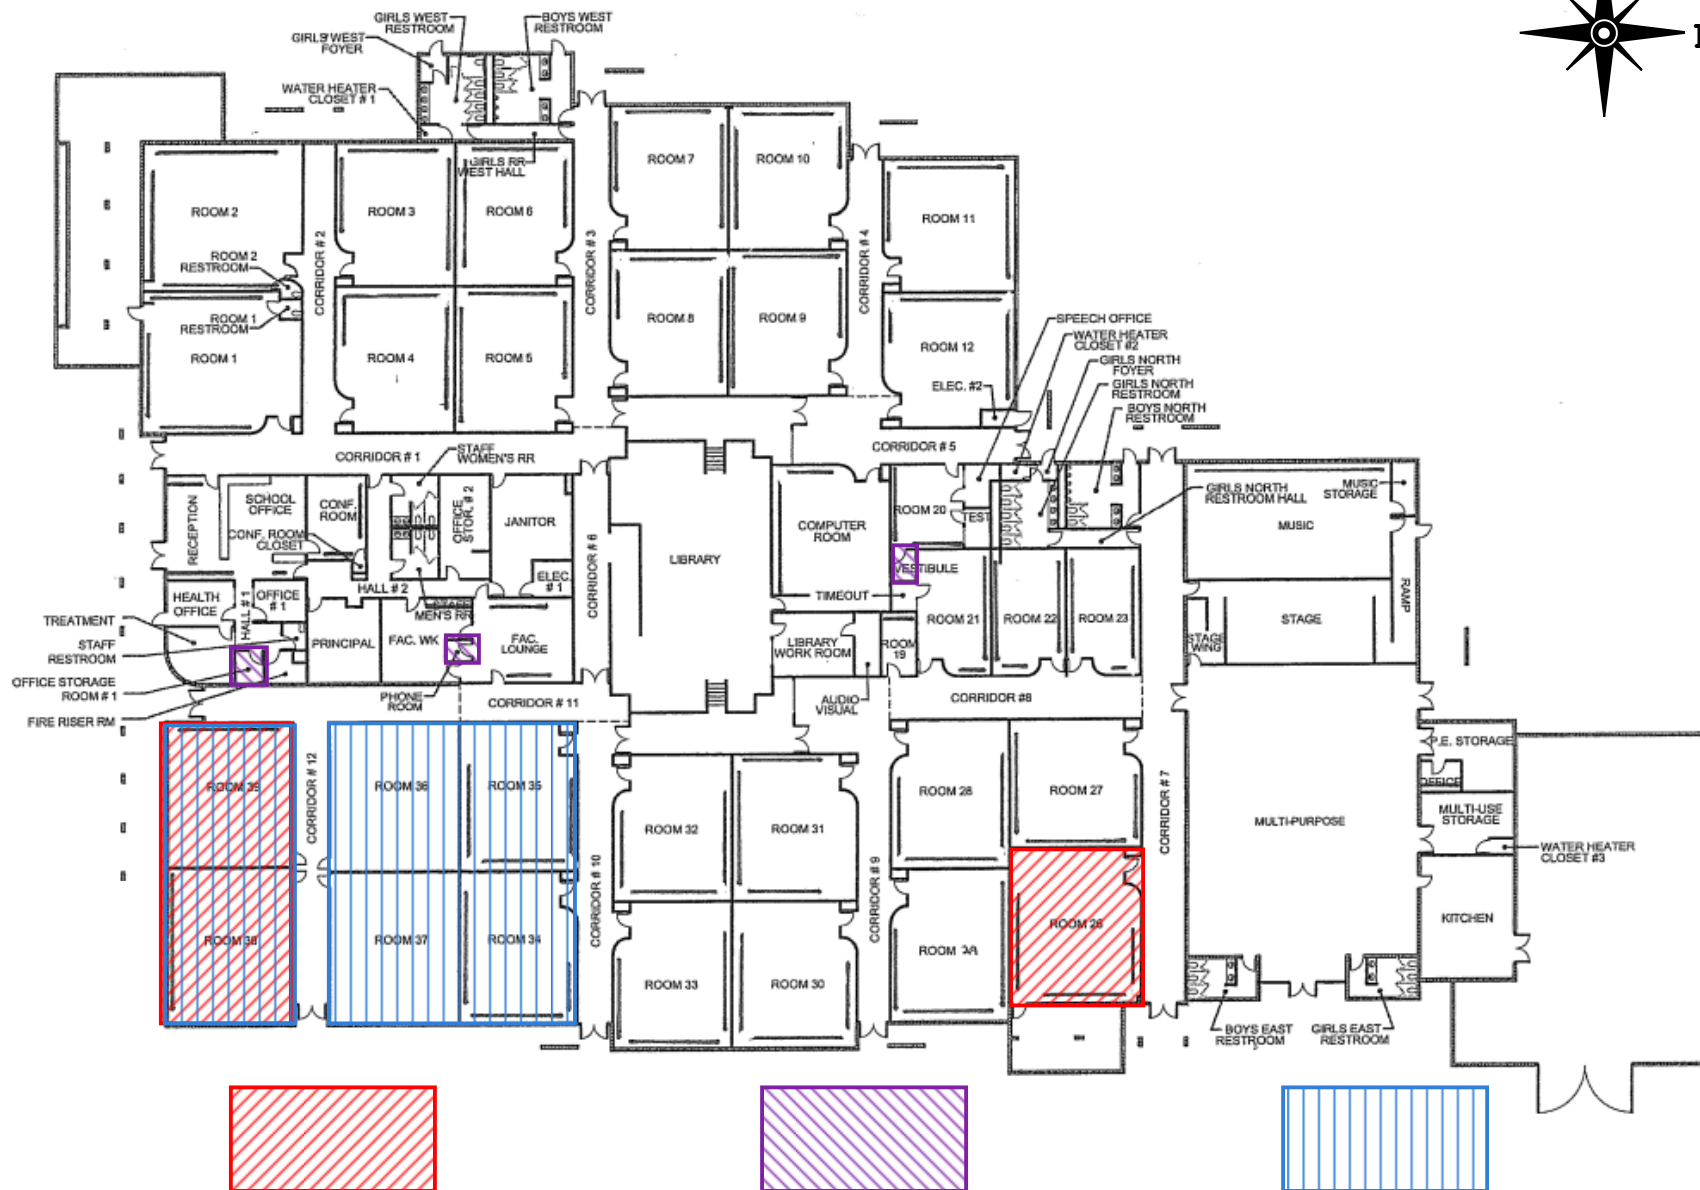
Main Building

**Assumed Asbestos-Containing**

White w/ Black 12" x 12"  
Vinyl Floor Tile & Mastic
