**AHERA ASBESTOS  
INSPECTION REPORT**

**KYRENE DE LA MIRADA LEADERSHIP ACADEMY  
5500 WEST GALVESTON STREET  
CHANDLER, ARIZONA 85226**

Dominion Project Number: AZ1418.47

AHERA Inspection Dates: July 15, 2025

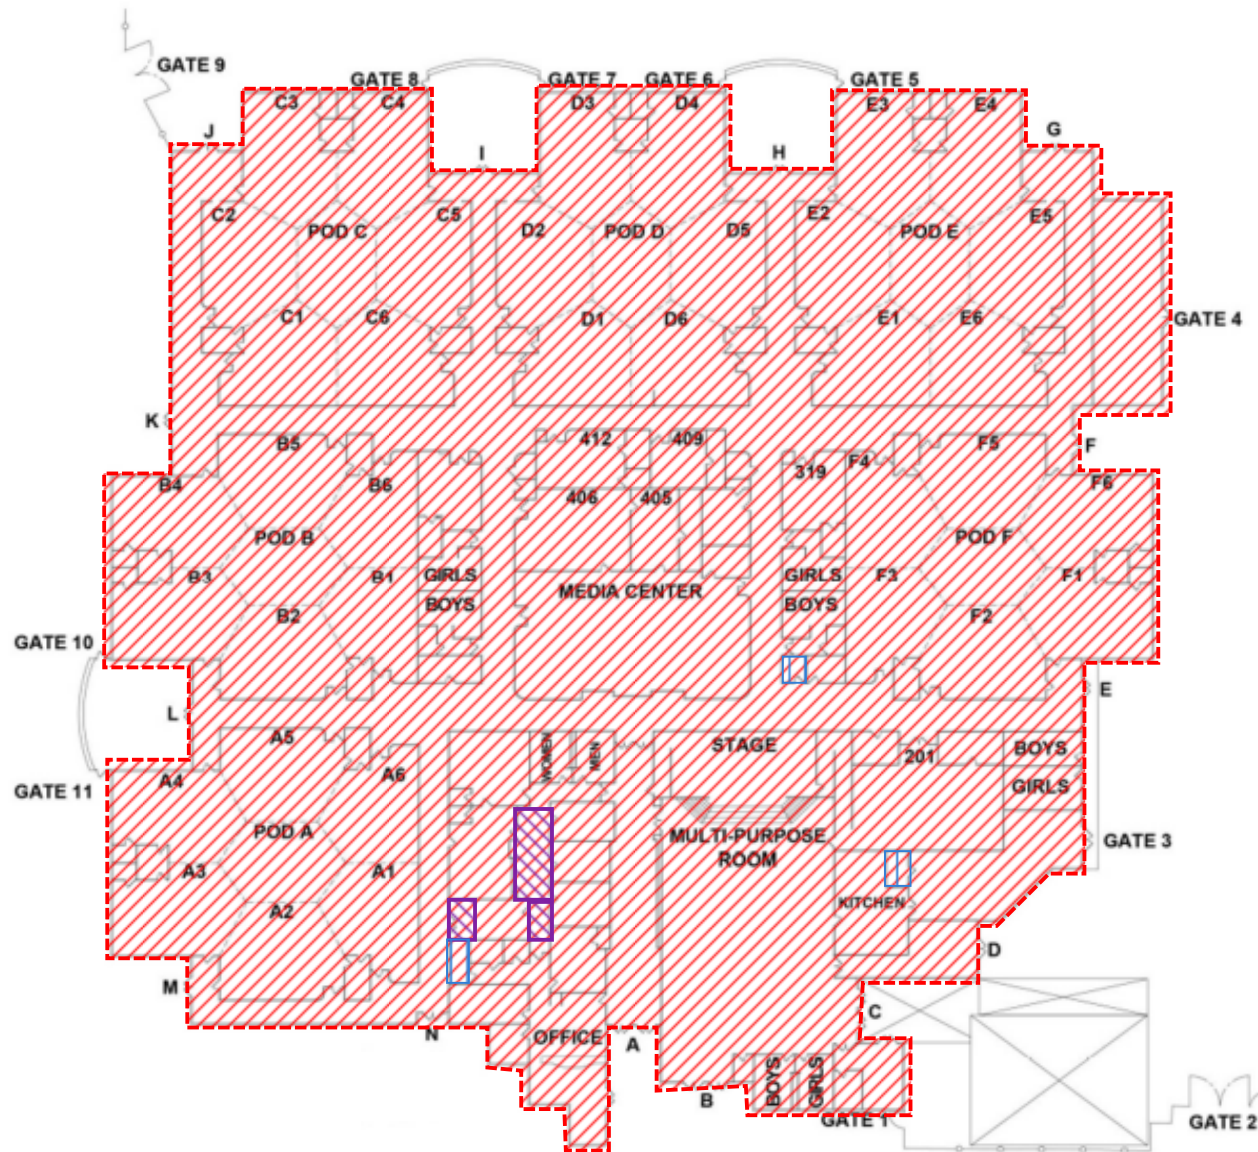
Assumed Asbestos-Containing

Interior Caulking, Blue Cove Base & Mastic,  
Orange Peel Drywall System, Gray Sink Coating,  
Beige 12" x 12" Vinyl Floor Tile & Mastic, Tacboard,  
Divider Walls, & 2' x 4' Drywall Ceiling Tile

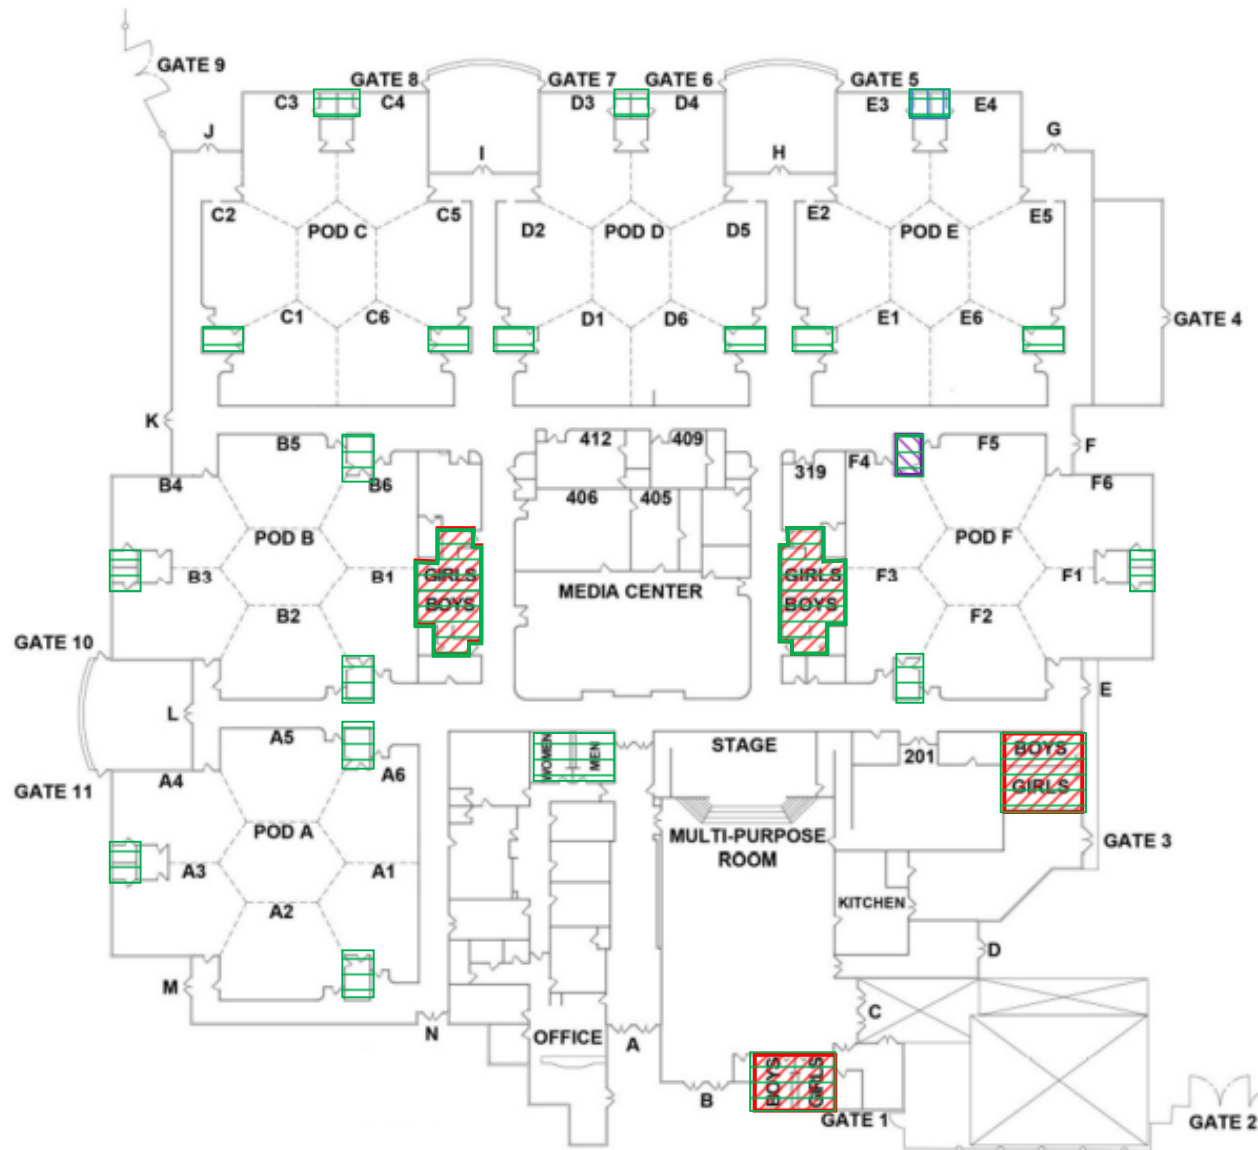
Assumed Asbestos-Containing

Beige 2" x 2" Ceramic Floor Tile,  
White 2" x 2" Ceramic Floor Tile,  
& Grout & Thinset for 2" x 2"  
Ceramic Floor Tiles

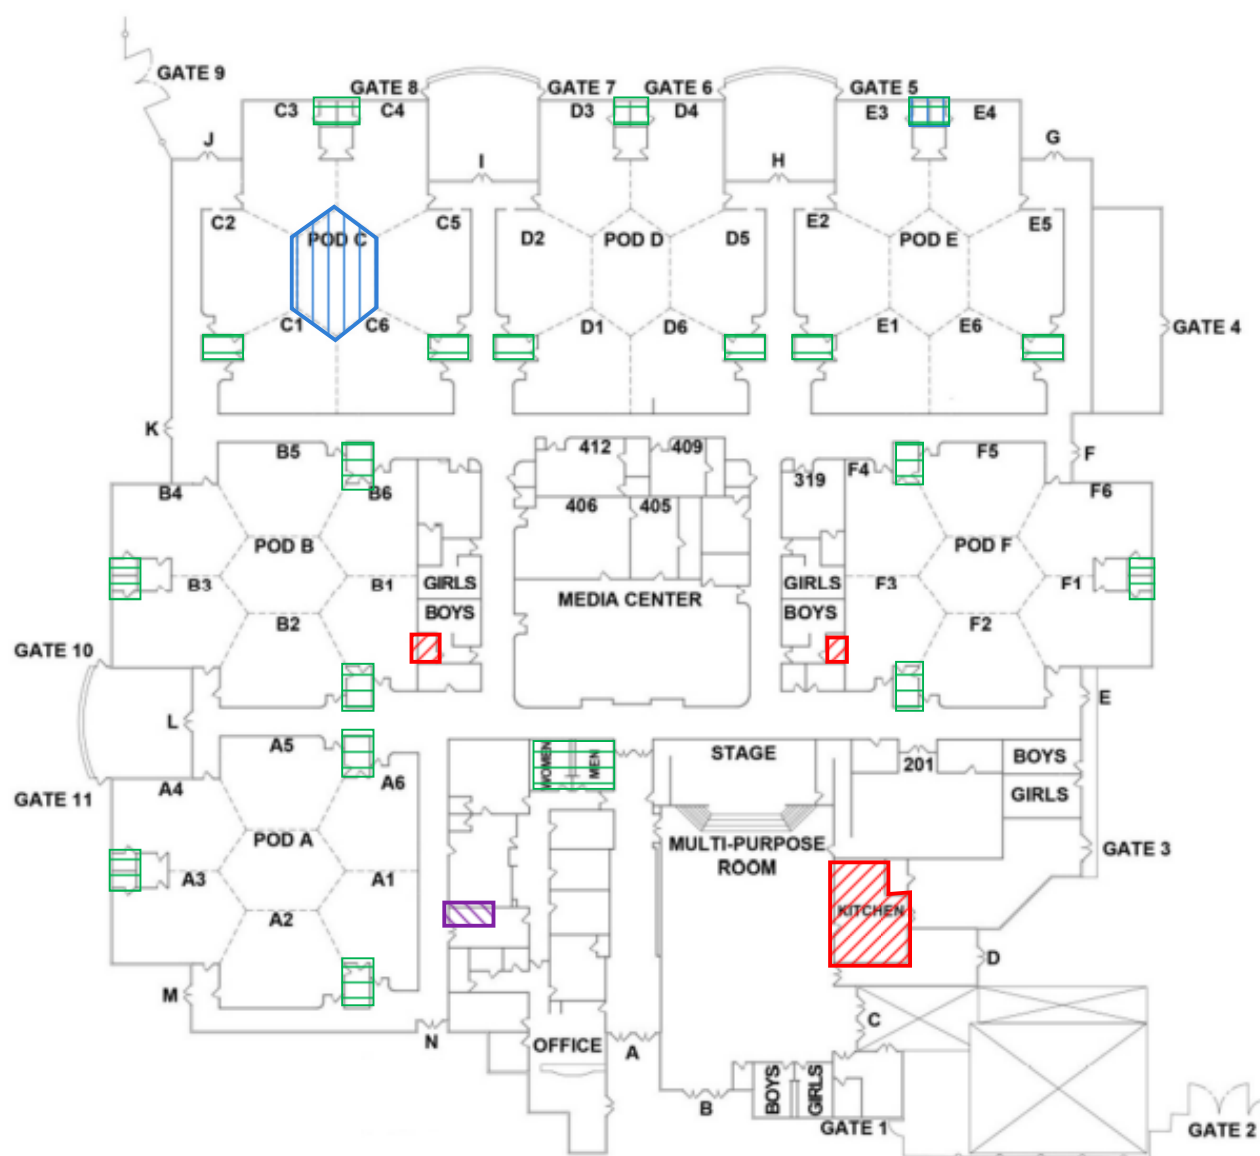
Assumed Asbestos-Containing  
Fiberglass Reinforced Plastic & Mastic

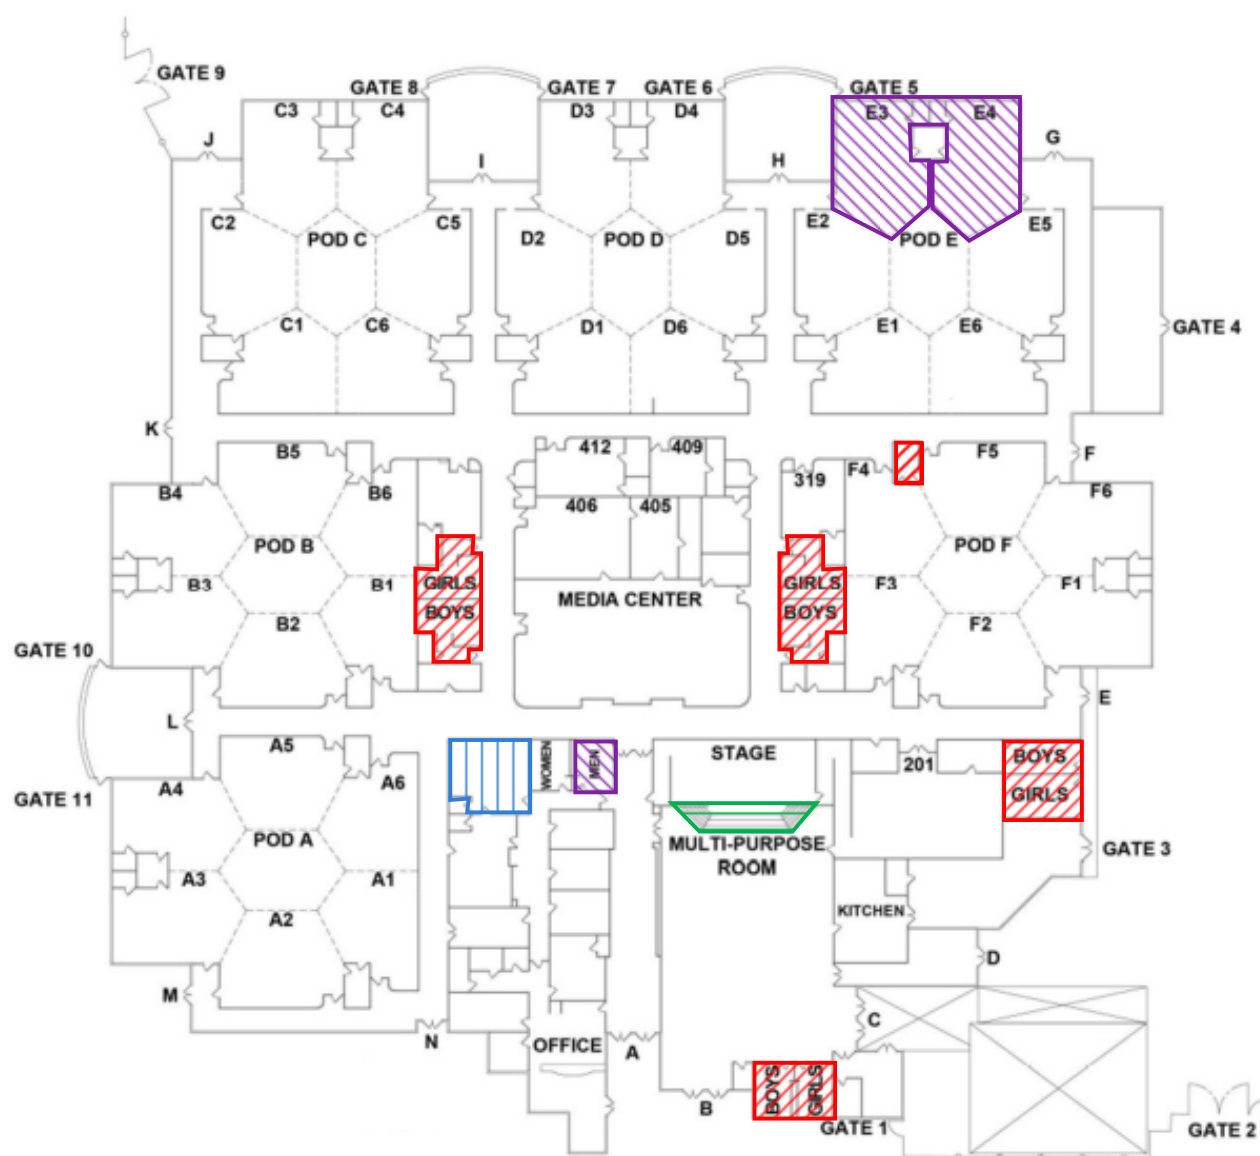
Assumed Asbestos-Containing  
White 4" x 4" Ceramic Wall Tile,  
Grout, & Mastic

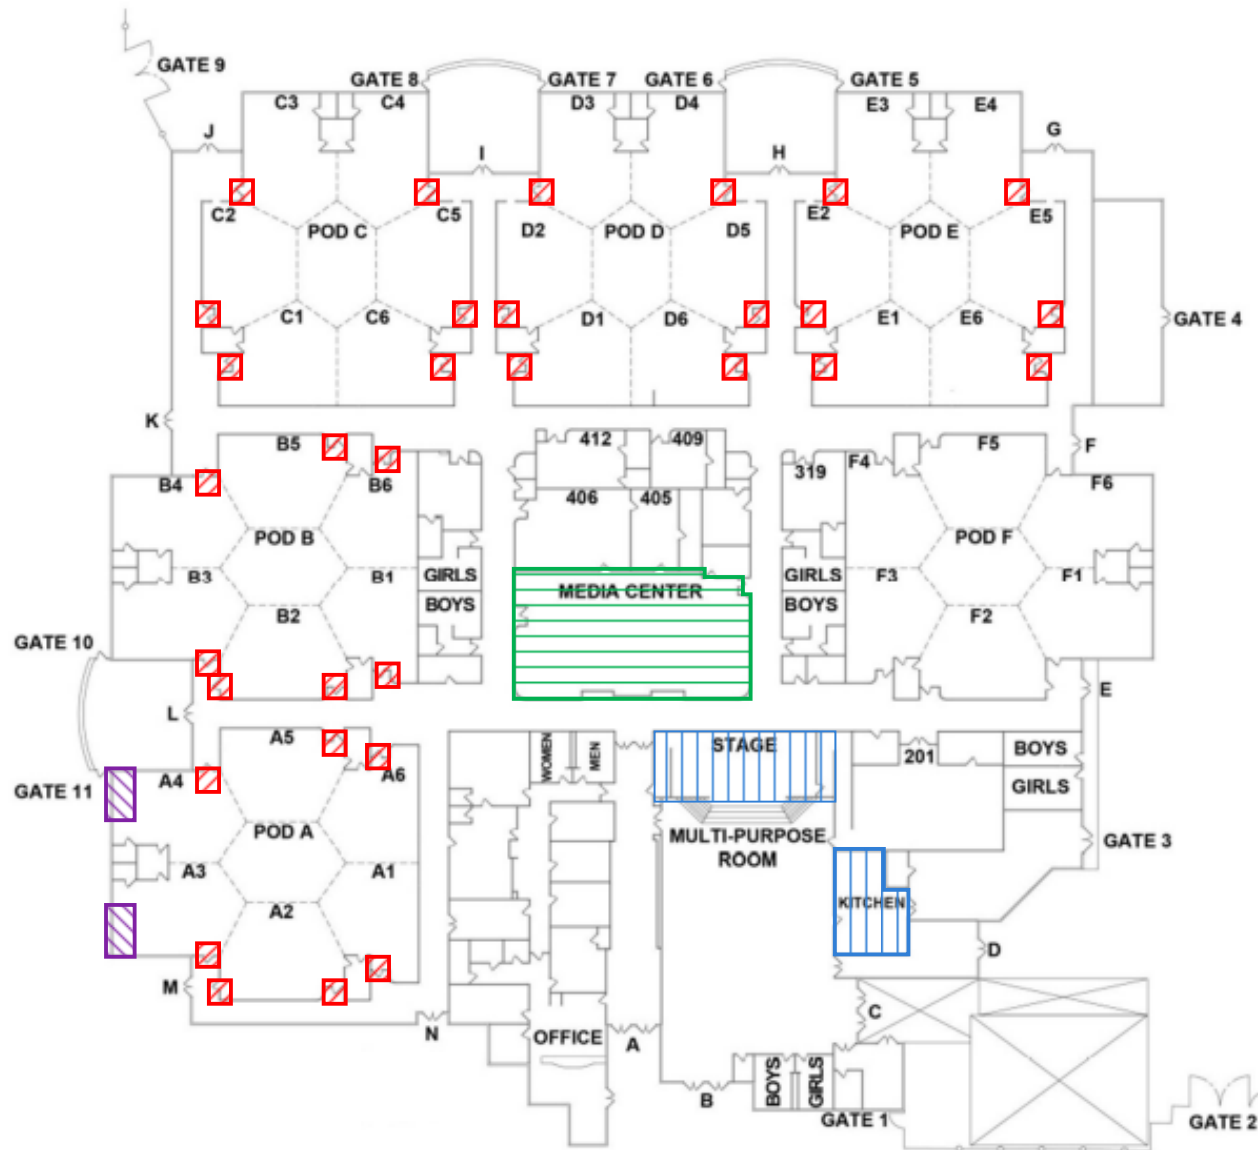
Assumed Asbestos-Containing  
Gray Sheet Flooring & Mastic

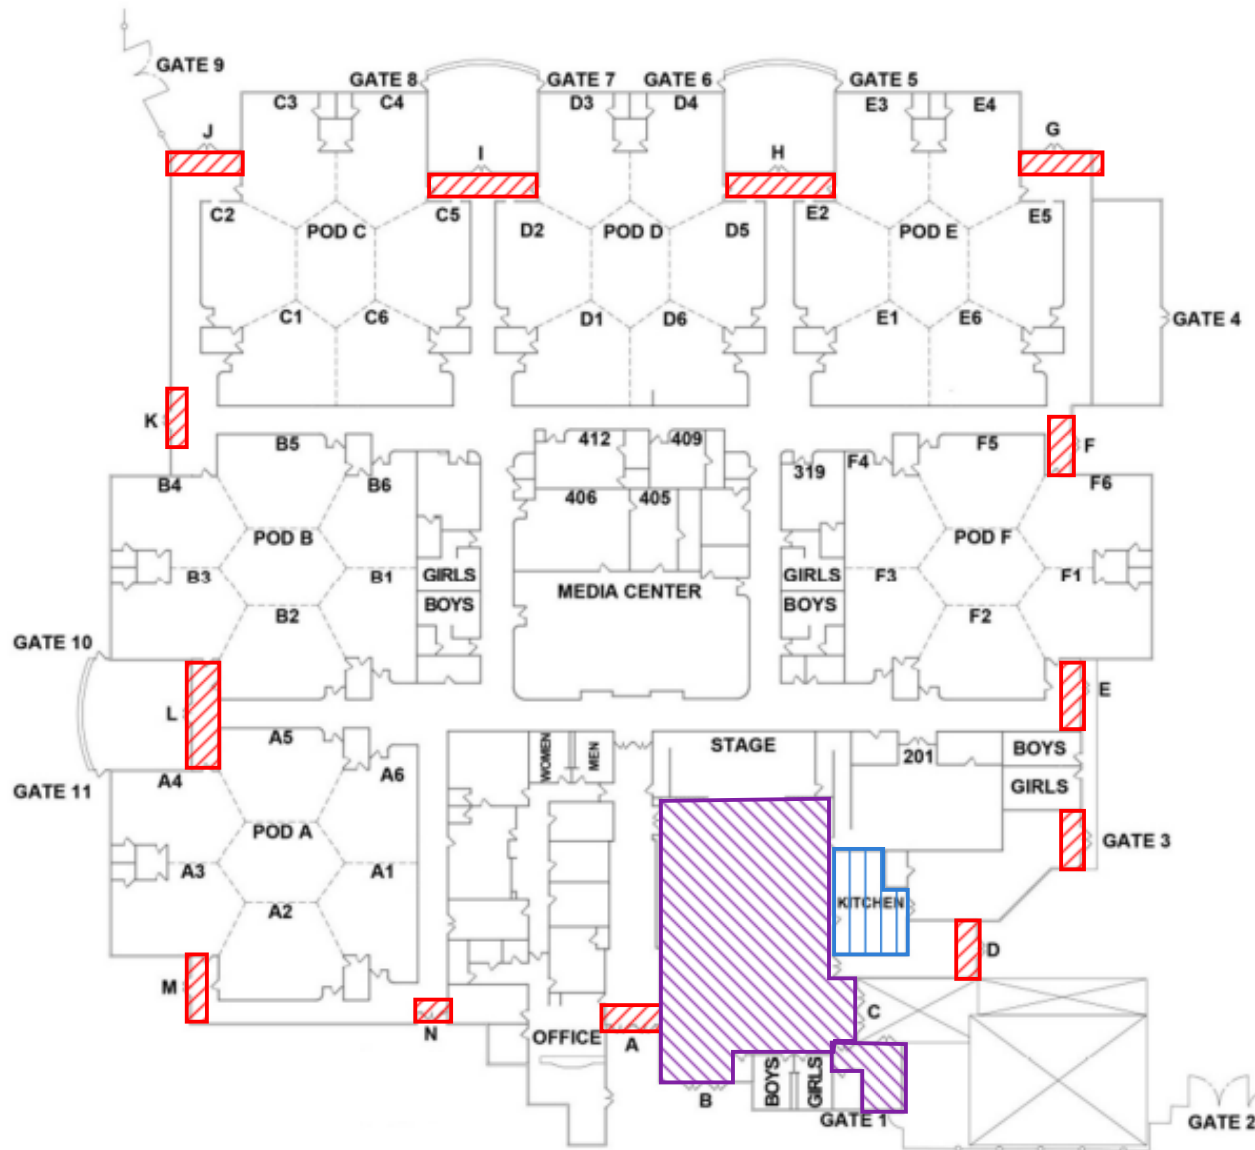
Assumed Asbestos-Containing  
Glass Block Mortar
