**AHERA ASBESTOS  
INSPECTION REPORT**

**KYRENE DE LA PALOMA ARTS ACADEMY  
5000 W. WHITTEN ST.  
CHANDLER, ARIZONA 85226**

Dominion Project Number: AZ1418.51

AHERA Inspection Date: June 26, 2025

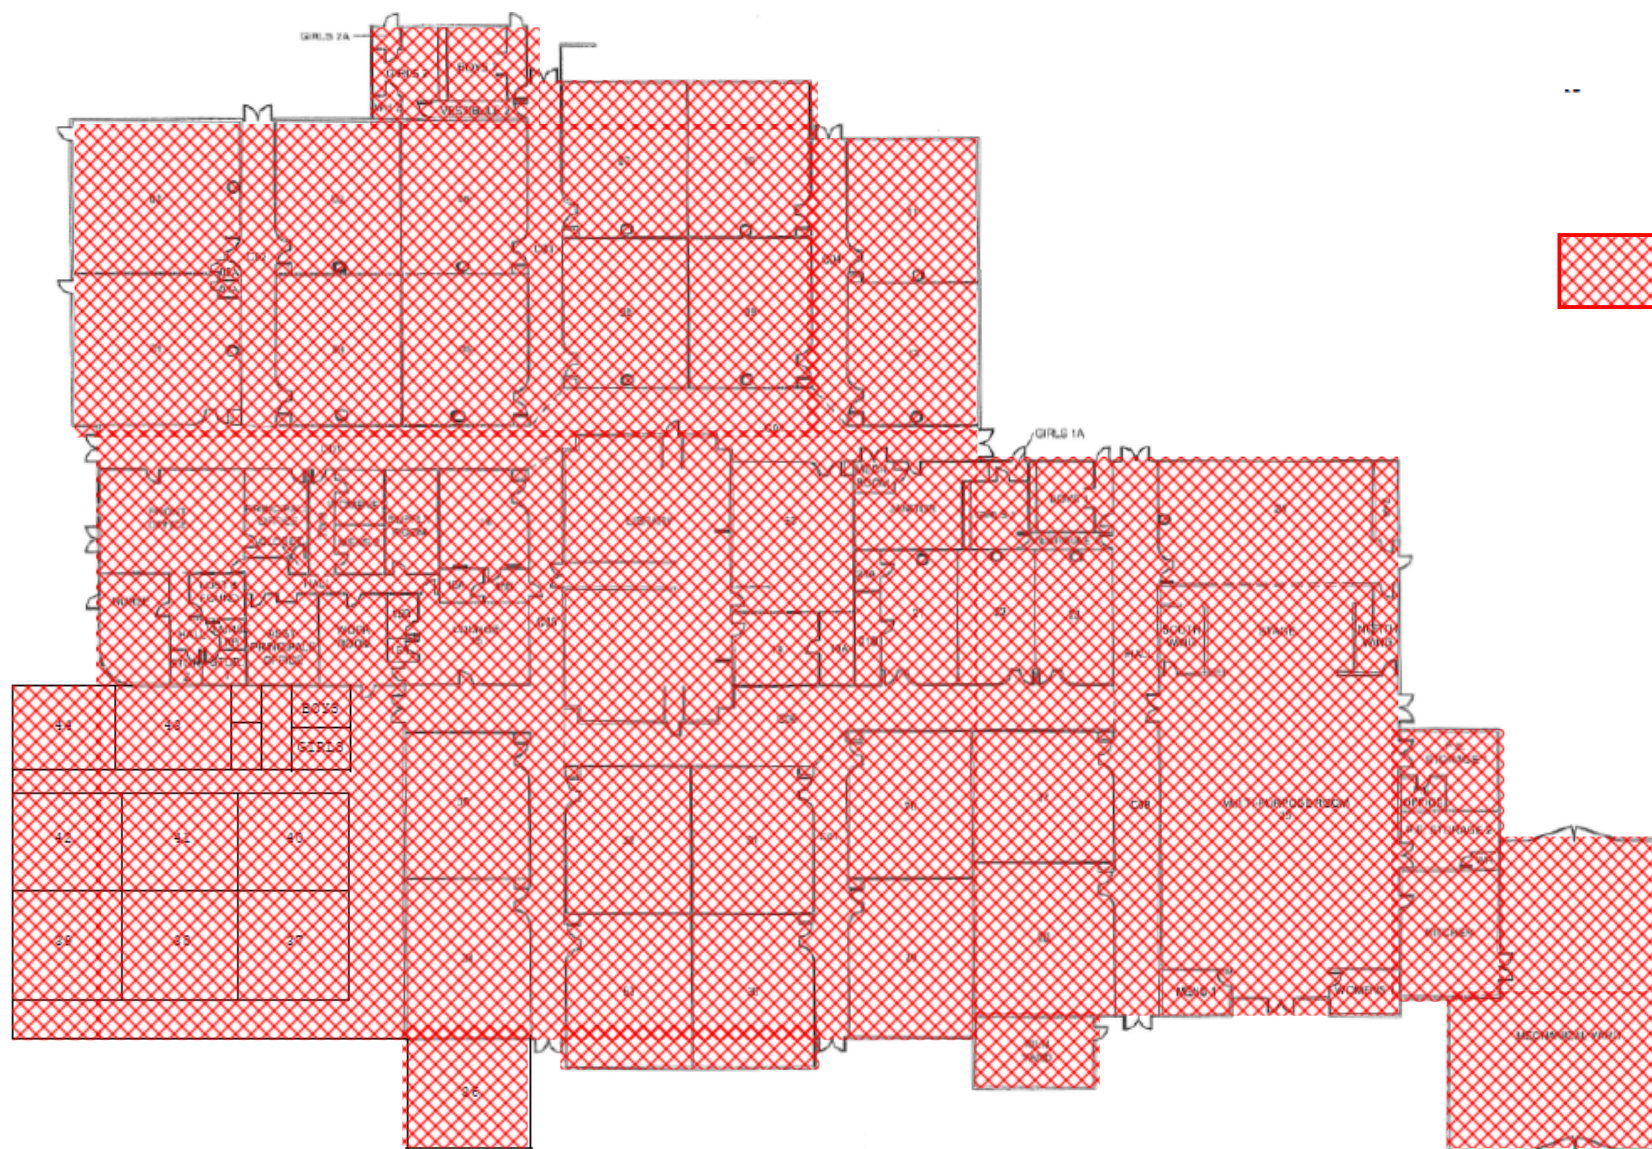
Main Bldg.

Assumed Asbestos-Containing  
Tan 12"x12" VCT & Mastic  
Interior/Exterior Caulking  
White Sink Coating  
Glass Block Mortar  
Divider Wall  
Brick & Mortar  
Tacboard & Mastic

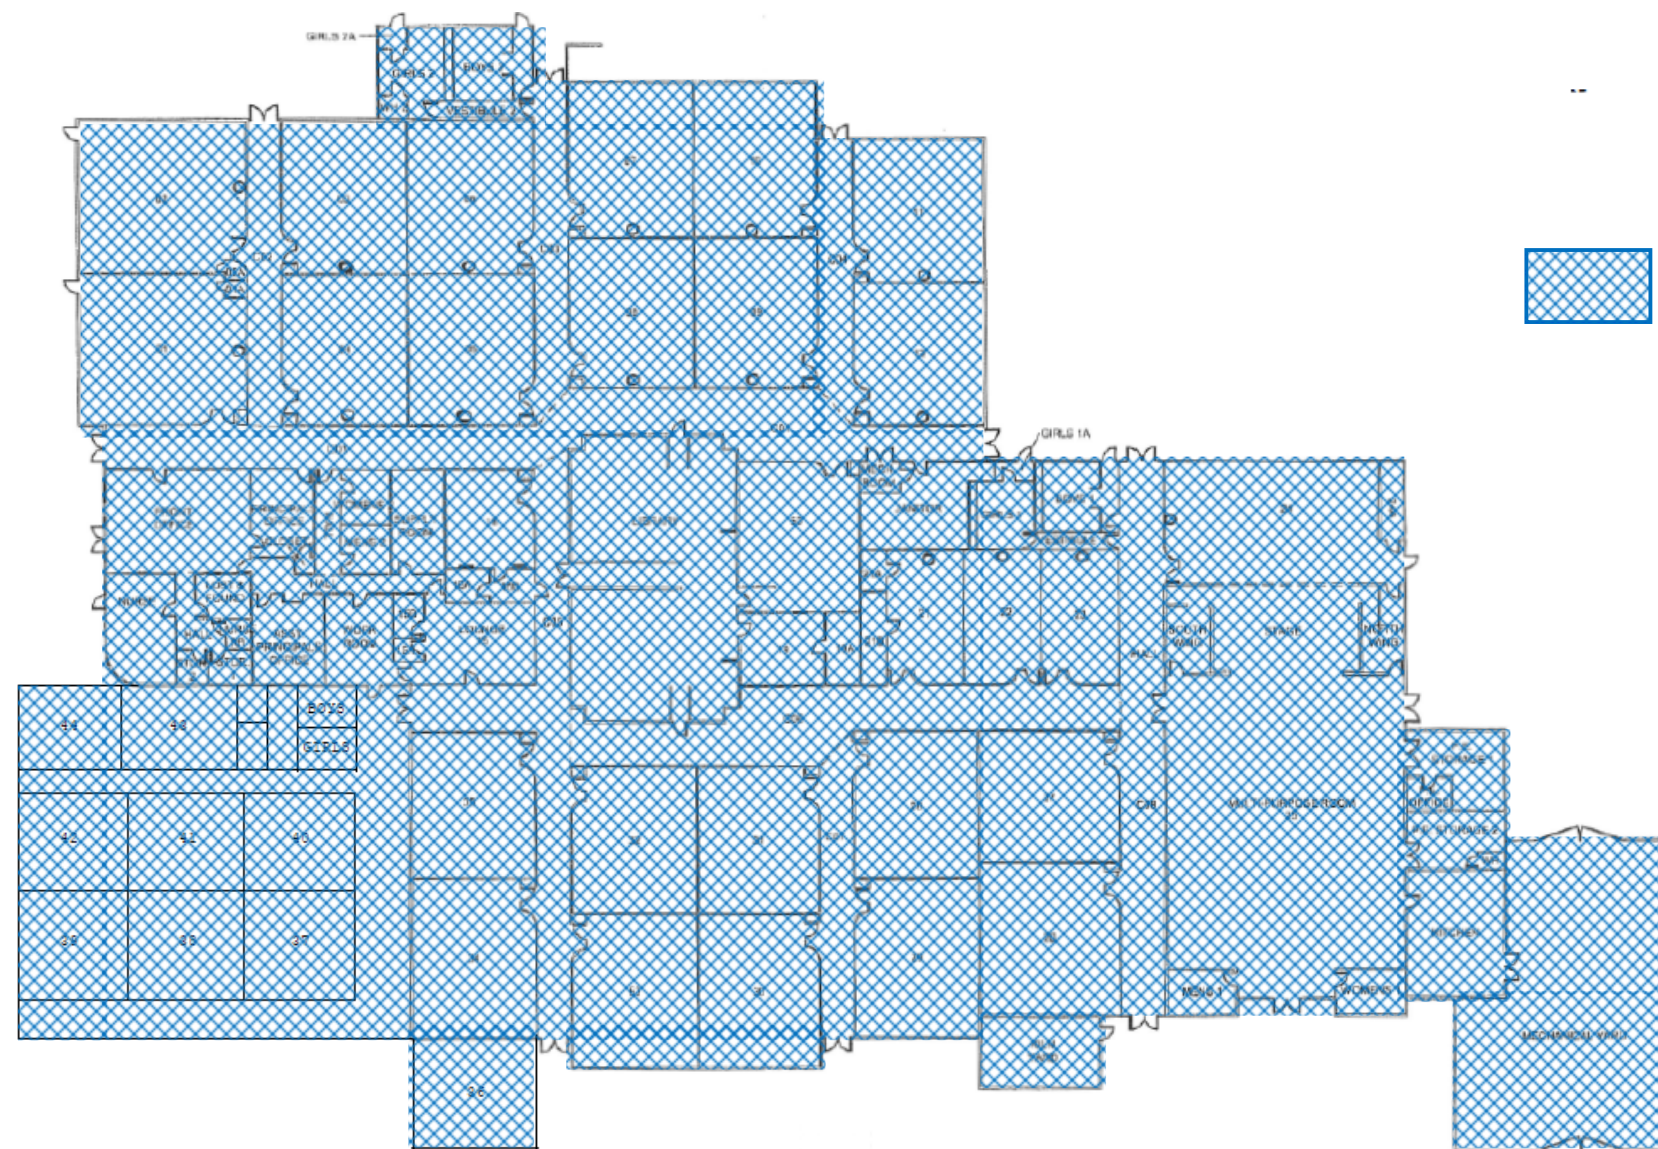
Main Bldg.

**Assumed Asbestos-Containing**  
**Gray Flex Duct Wrap**  
**Silver Duct Wrap**  
**Skylight Insulation Panel**  
**Unfinished Drywall System**  
**Silver Duct Tape**  
**Ceiling Insulation Backing**  
**White Duct Seam Tape & Mastic**  
**Black Foam Pipe Insulation**
