**AHERA ASBESTOS  
INSPECTION REPORT**

**KYRENE DE LAS LOMAS ELEMENTARY SCHOOL  
11820 SOUTH WARNER ELLIOT LOOP  
PHOENIX, ARIZONA 85044**

Dominion Project Number: AZ1418.43

AHERA Inspection Dates: July 17, 2025

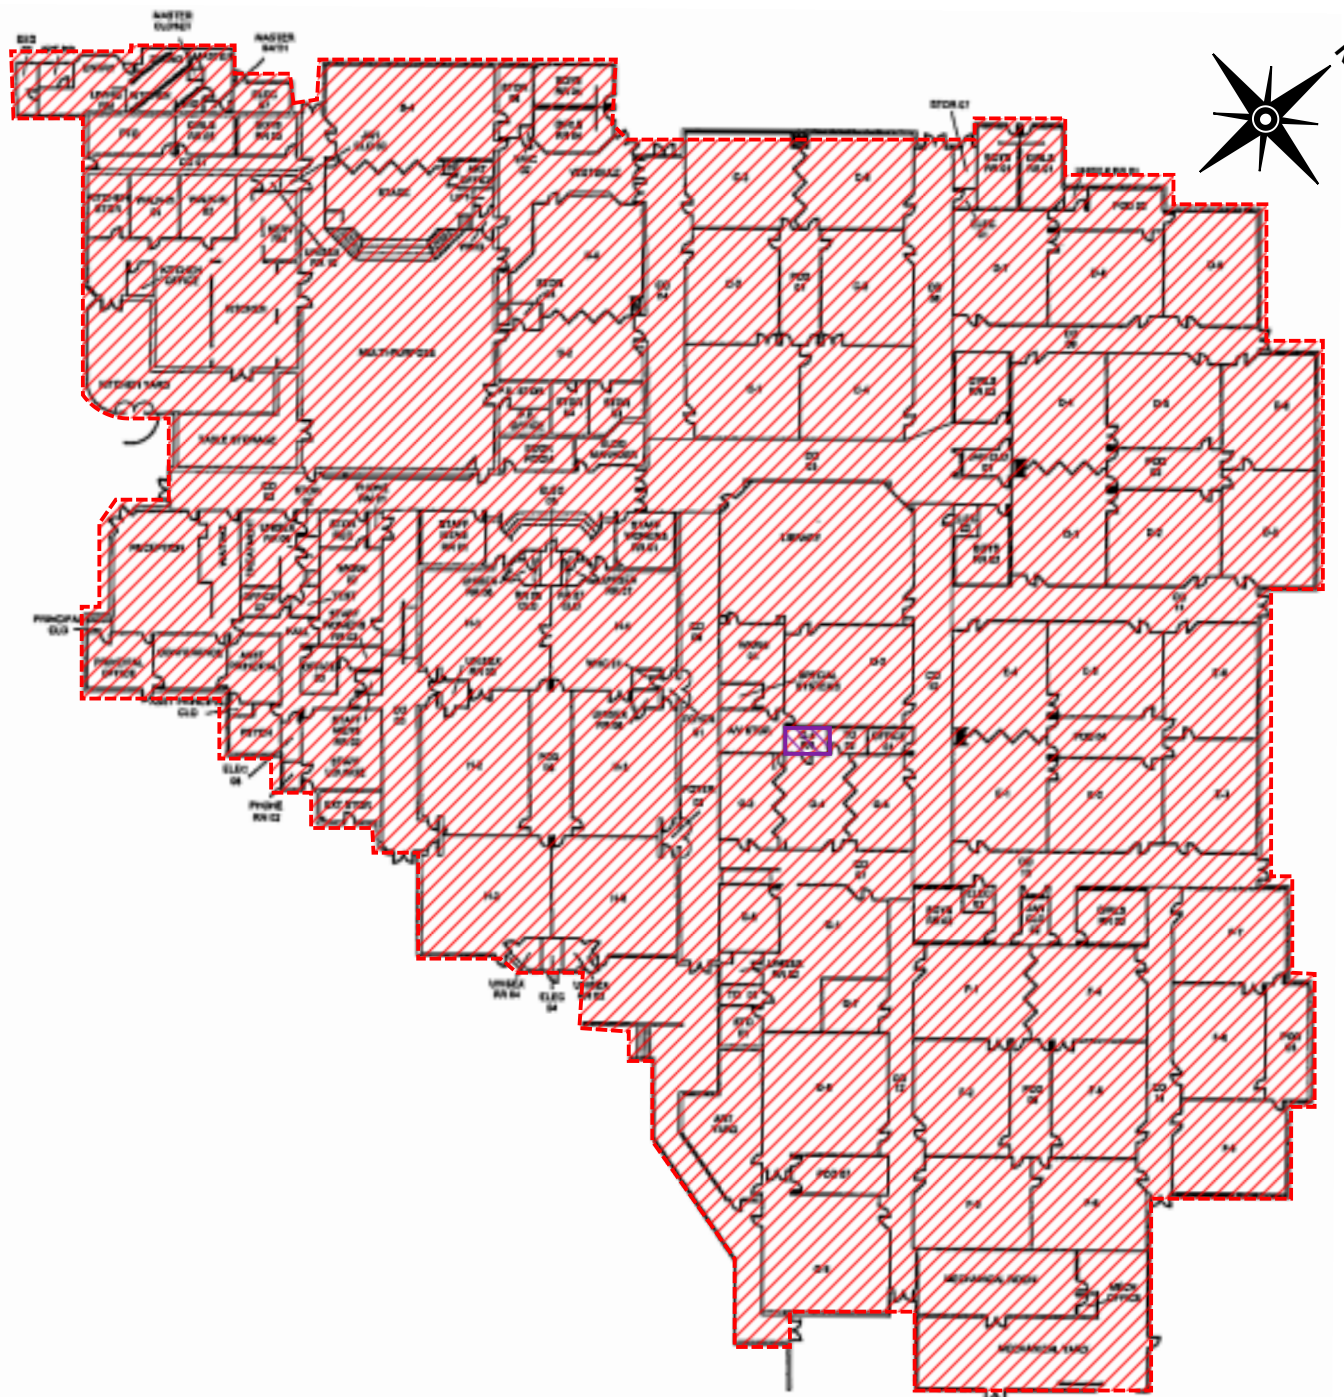
Assumed Asbestos-Containing Material Location Map (1)  
 Kyrene de las Lomas Elementary School  
 11820 South Warner Elliot Loop, Phoenix, Arizona 85044

Assumed Asbestos-Containing

Blue Carpet & Mastic

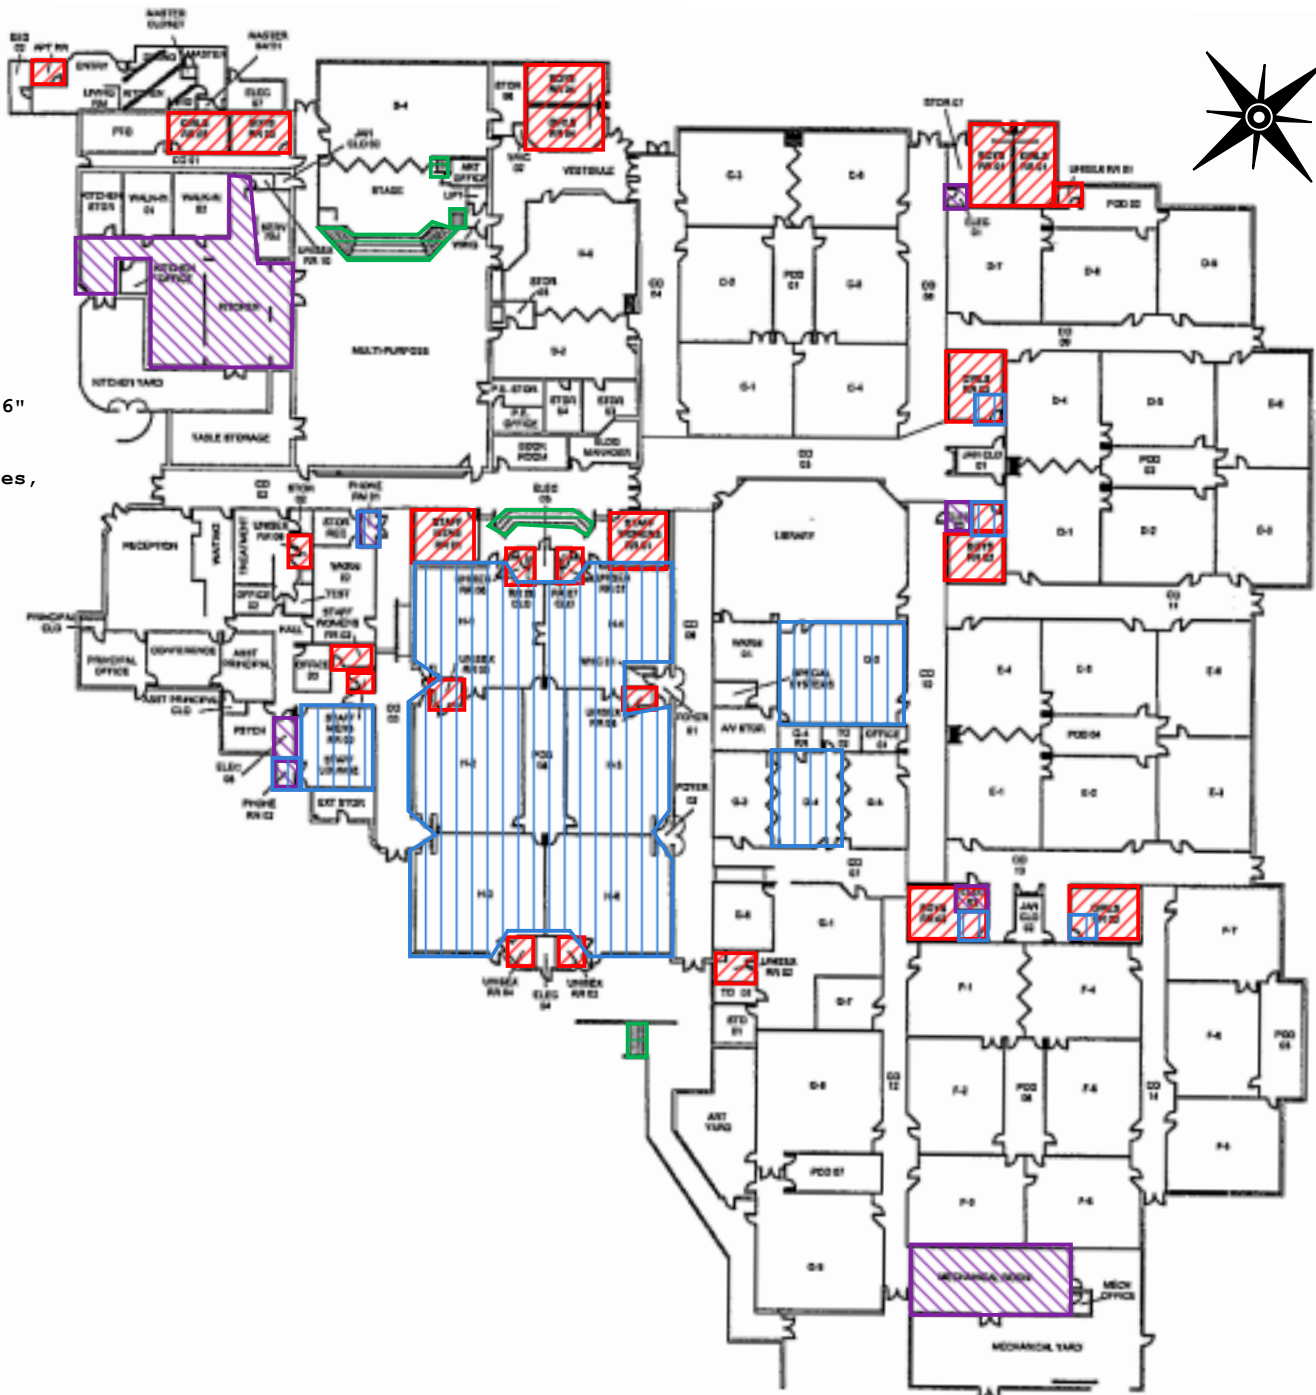
Assumed Asbestos-Containing Material Location Map (2)  
Kyrene de las Lomas Elementary School  
11820 South Warner Elliot Loop, Phoenix, Arizona 85044

Assumed Asbestos-Containing  
Black Stair Tread & Mastic

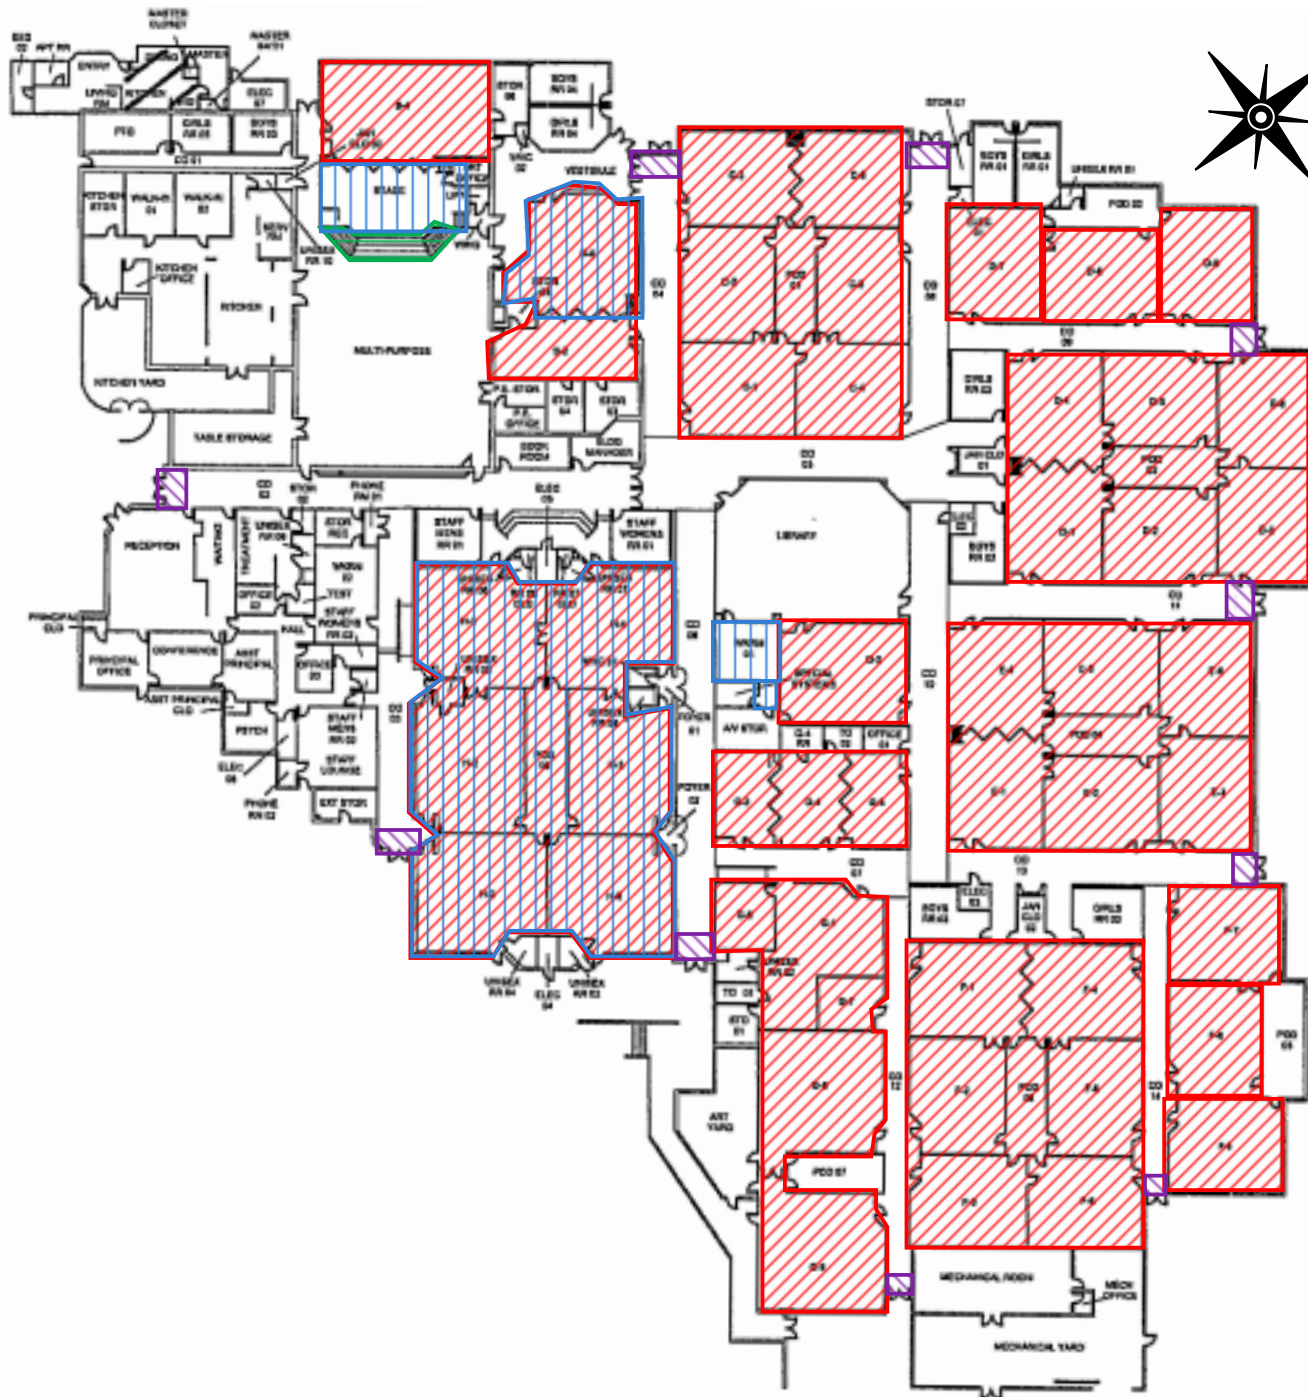
Assumed Asbestos-Containing Material Location Map (3)  
Kyrene de las Lomas Elementary School  
11820 South Warner Elliot Loop, Phoenix, Arizona 85044

Assumed Asbestos-Containing

Fiberglass Reinforced Plastic (FRP)  
& Mastic

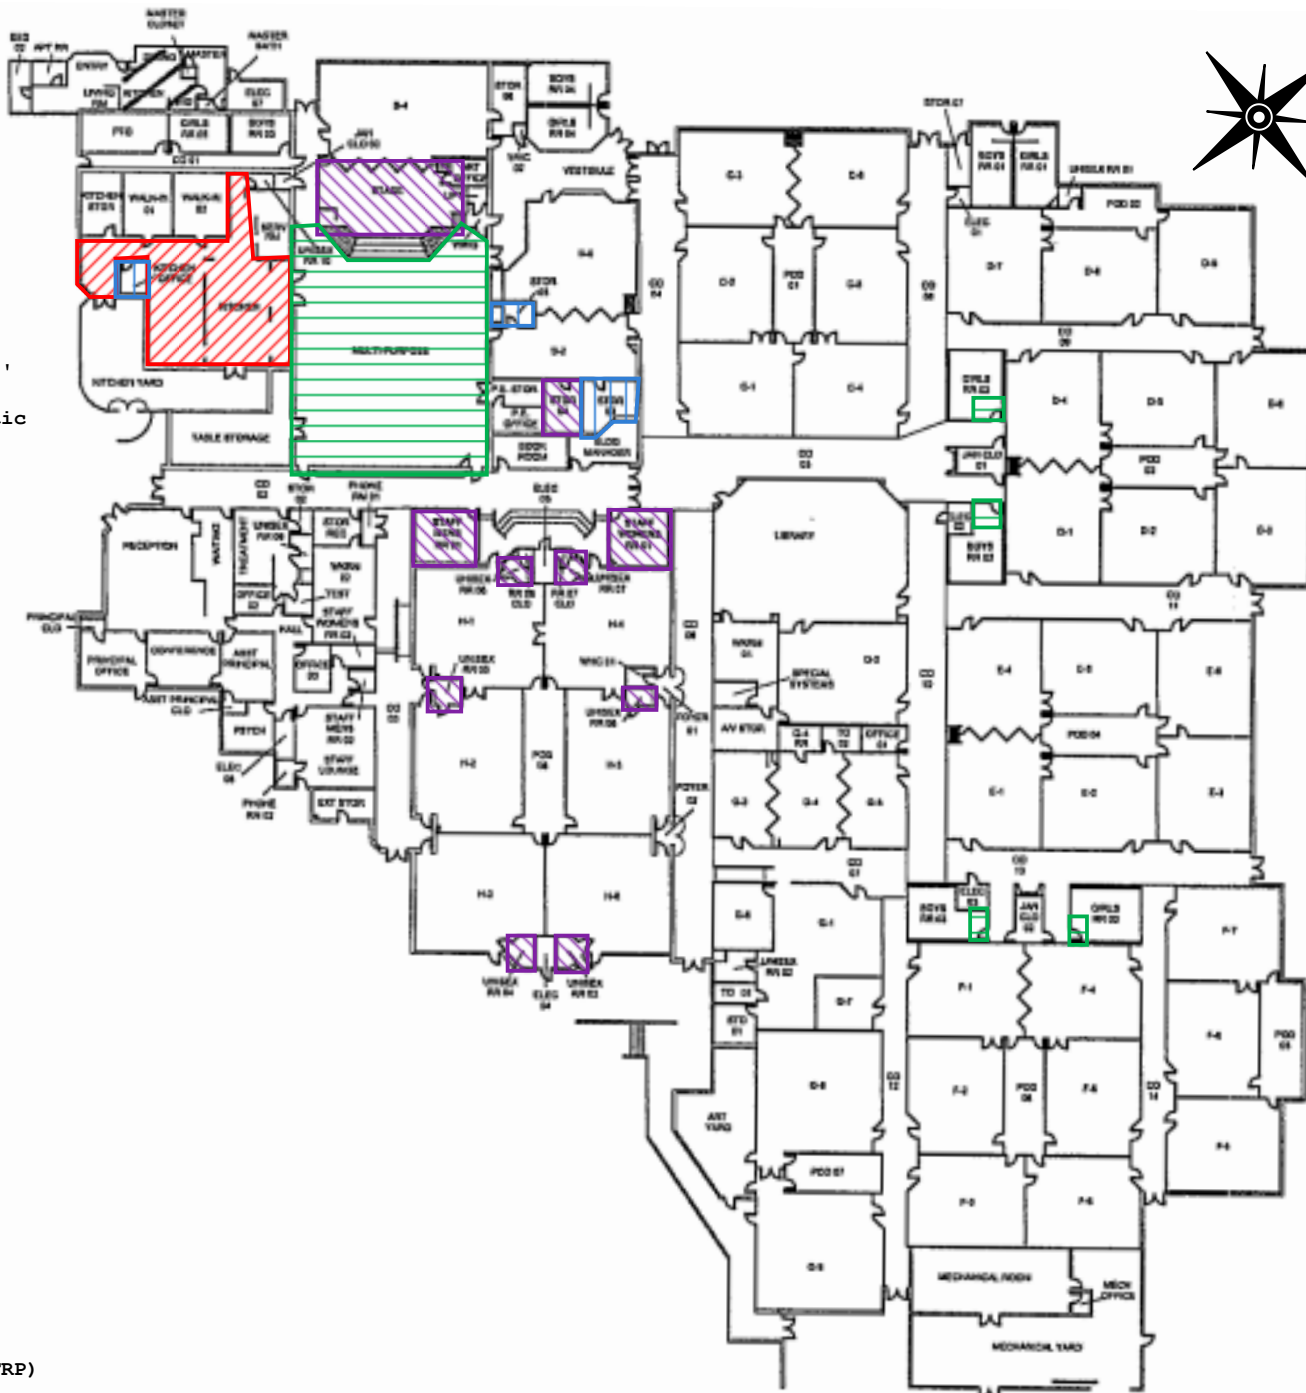
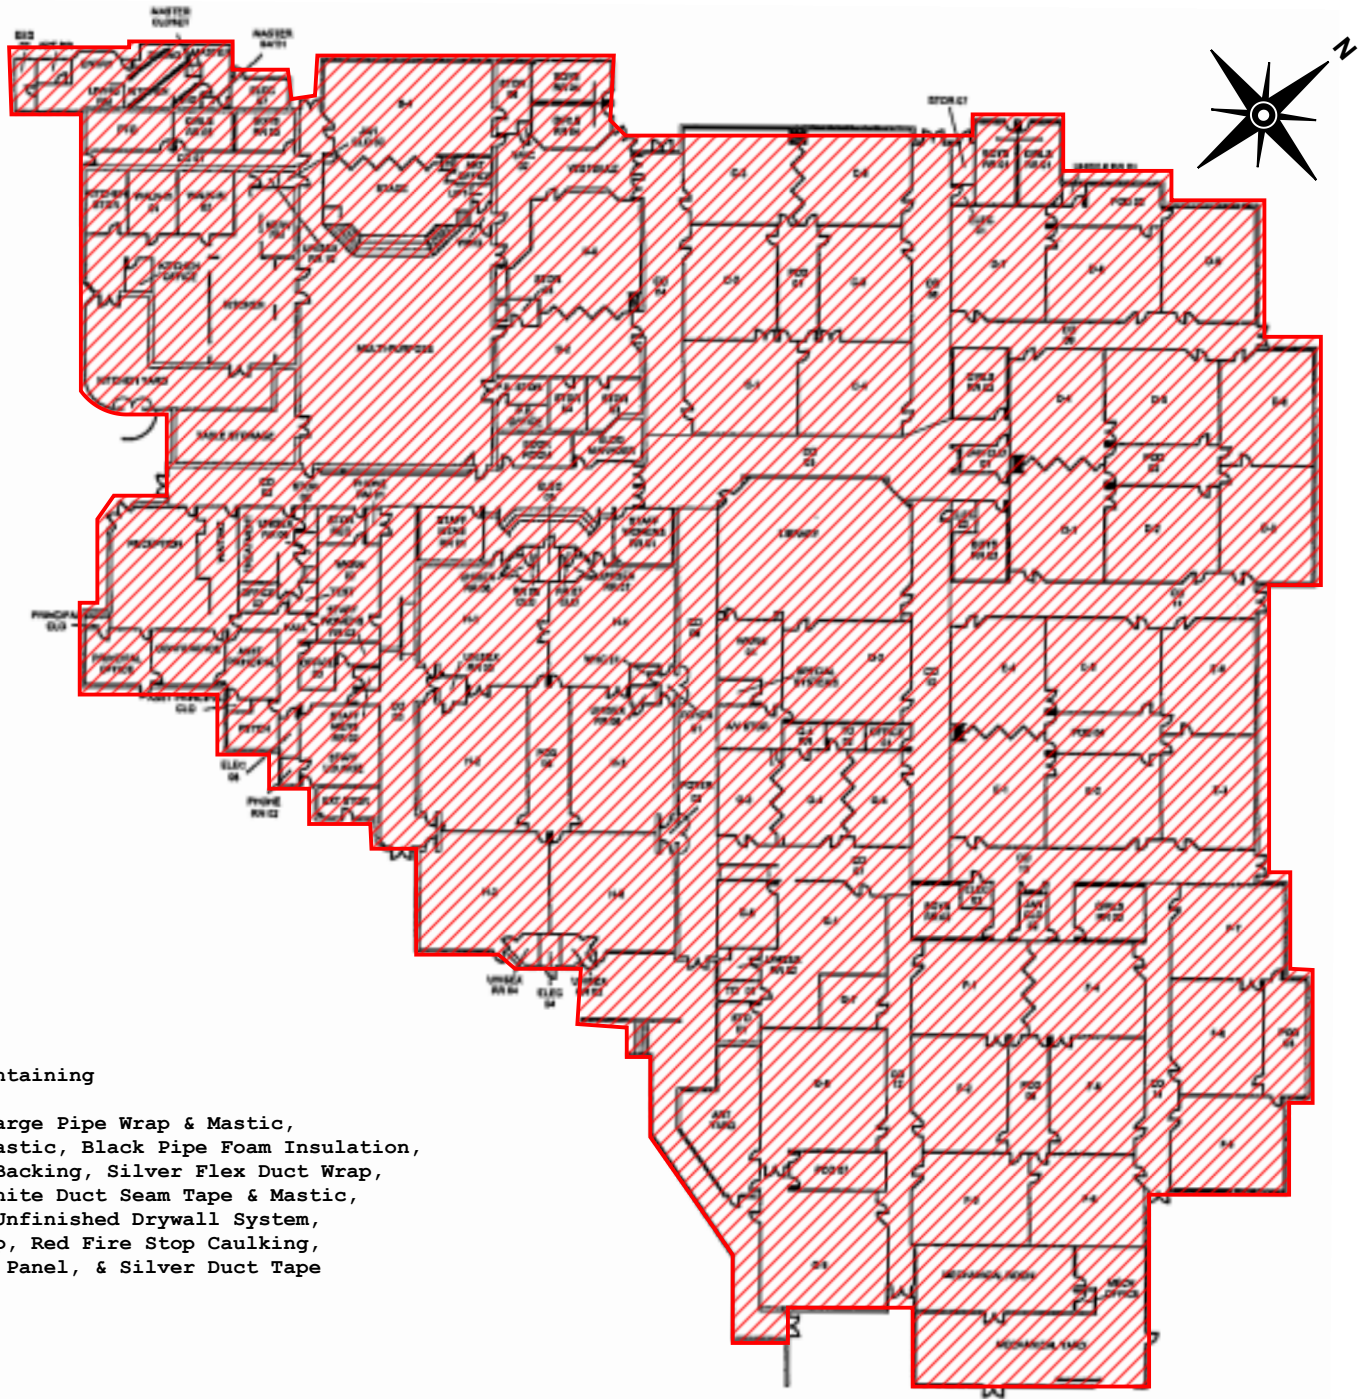
Assumed Asbestos-Containing Material Location Map (4)  
Kyrene de las Lomas Elementary School  
11820 South Warner Elliot Loop, Phoenix, Arizona 85044

#### Assumed Asbestos-Containing

Gray Duct Mastic, Large Pipe Wrap & Mastic,  
Small Pipe Wrap & Mastic, Black Pipe Foam Insulation,  
Ceiling Insulation Backing, Silver Flex Duct Wrap,  
Silver Duct Wrap, White Duct Seam Tape & Mastic,  
White Duct Mastic, Unfinished Drywall System,  
Silver Box Duct Wrap, Red Fire Stop Caulking,  
Skylight Insulation Panel, & Silver Duct Tape
