**AHERA ASBESTOS
INSPECTION REPORT**

**KYRENE DE LAS MANITAS ELEMENTARY SCHOOL
1201 W COURTNEY LANE
TEMPE, ARIZONA 85284**

Dominion Project Number: AZ1418.44

AHERA Inspection Date: May 22, 2025

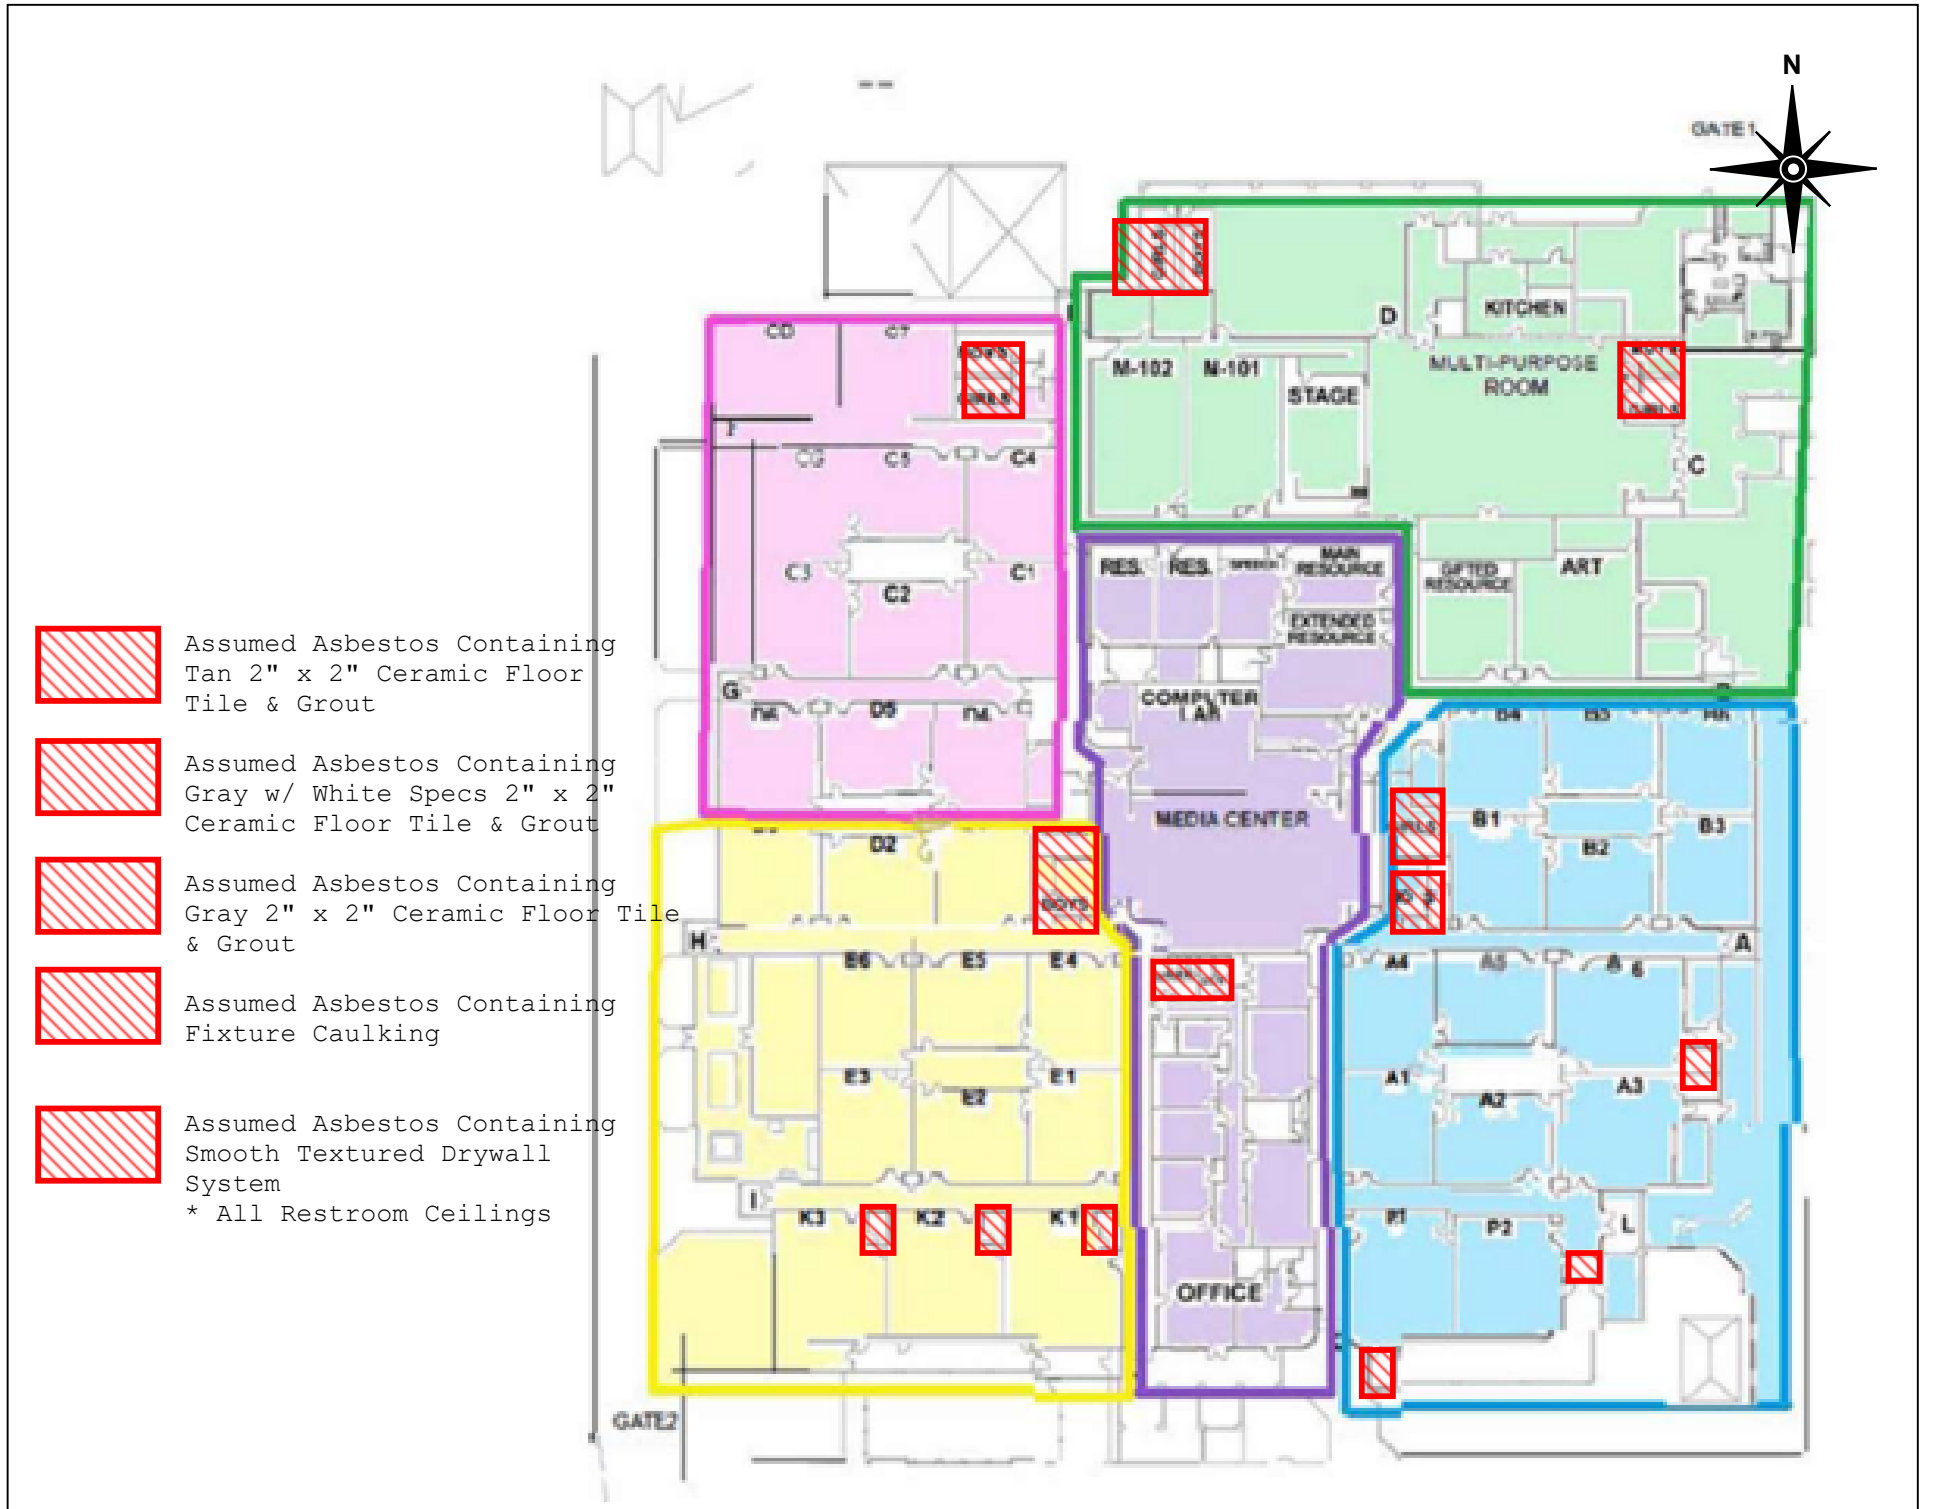
Assumed Asbestos Containing
Tan 2" x 2" Ceramic Floor
Tile & Grout

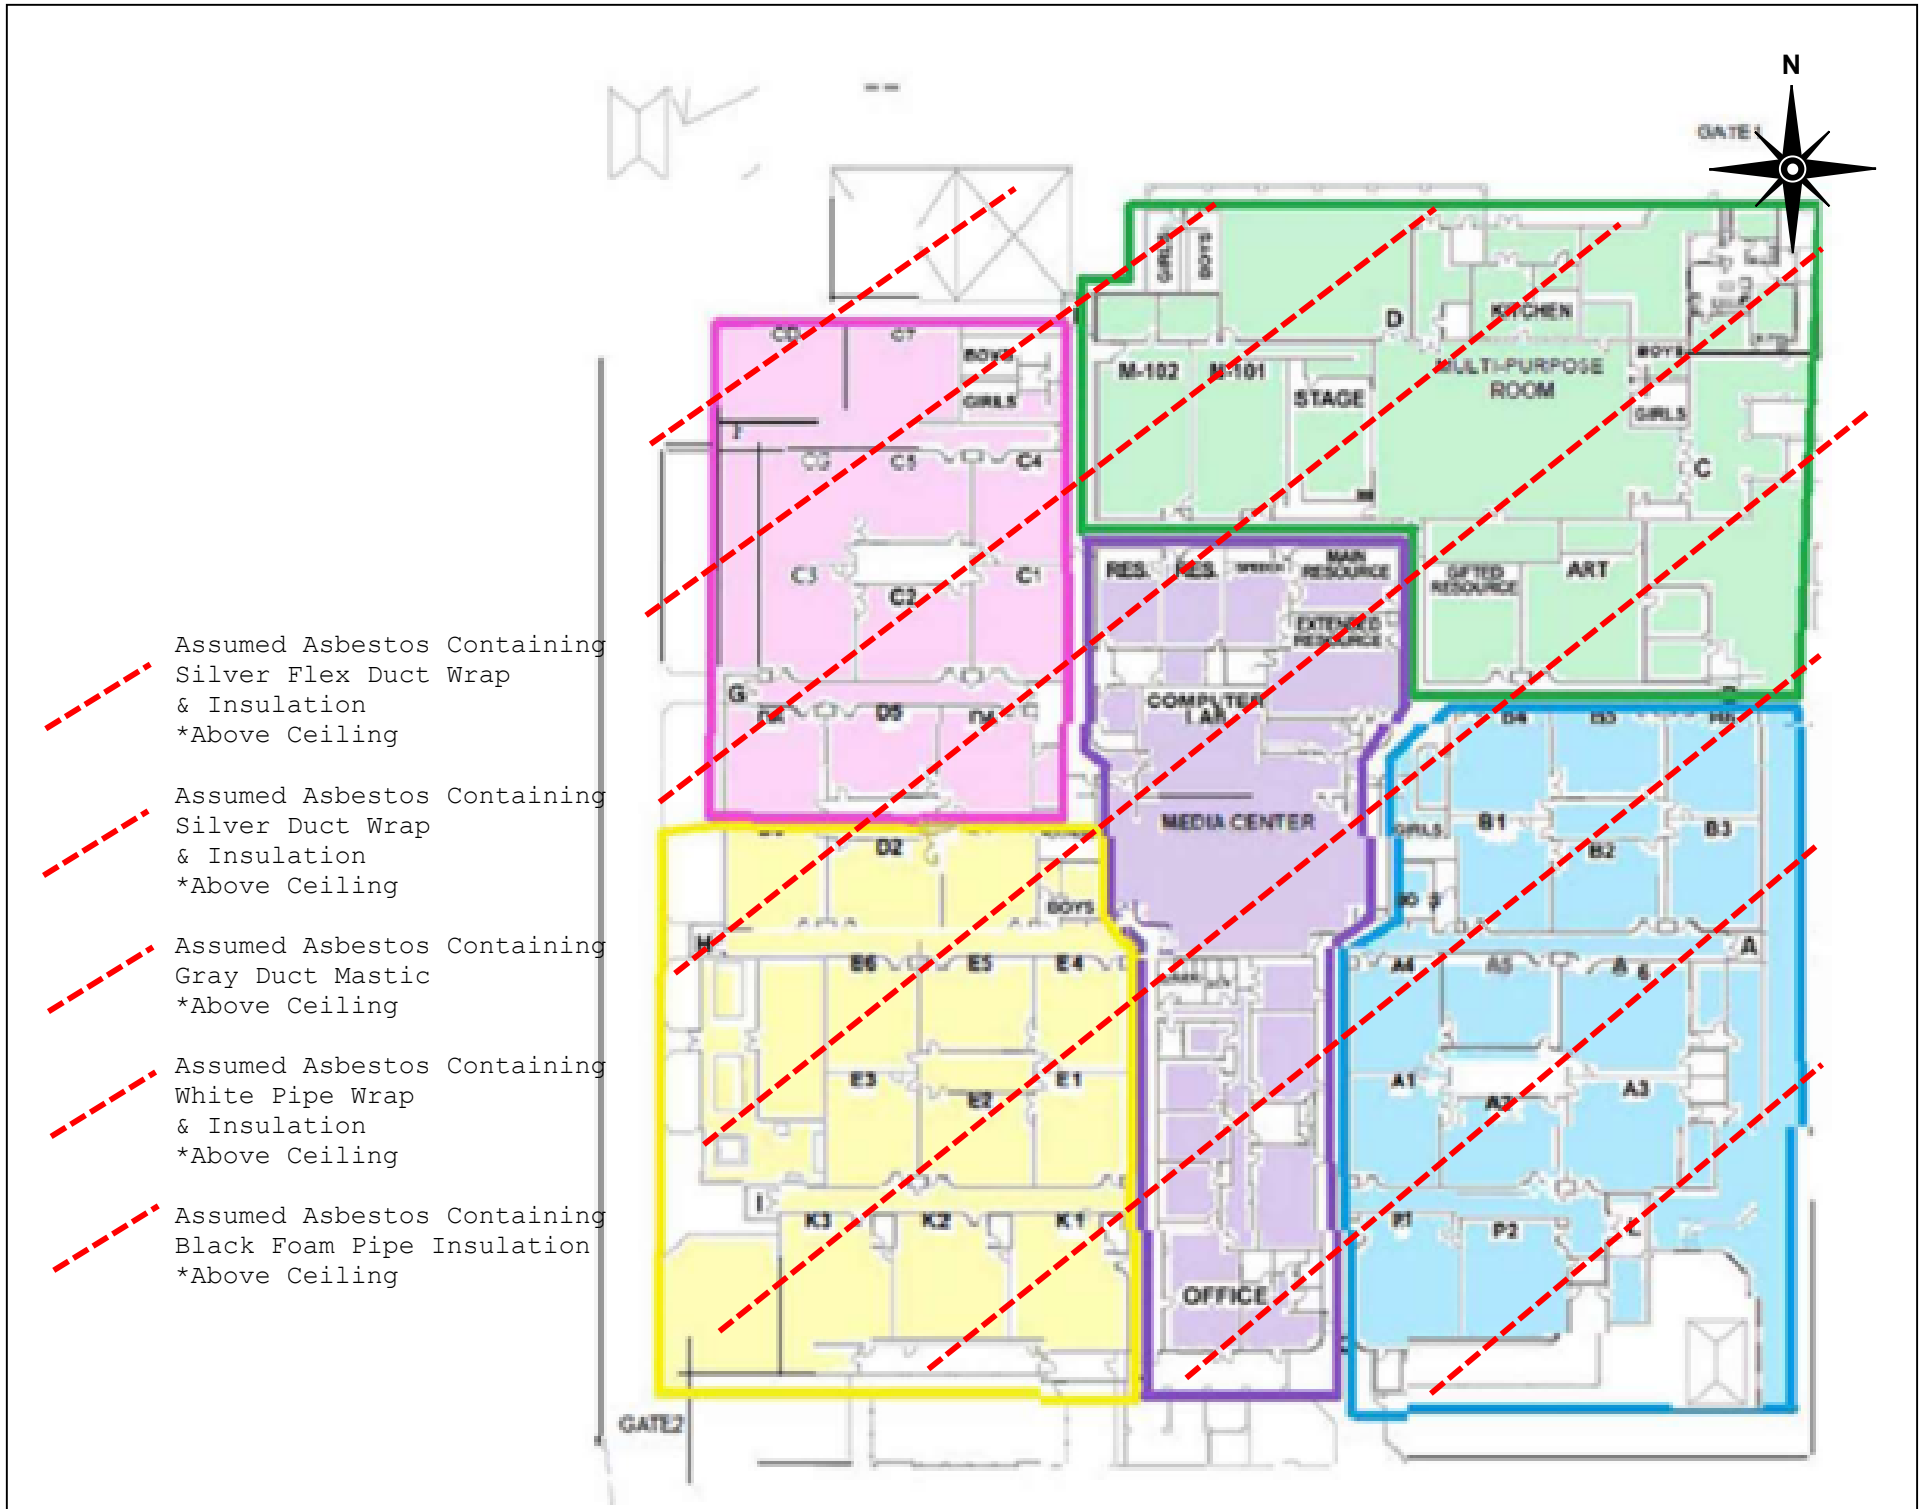
- Assumed Asbestos Containing Silver Flex Duct Wrap & Insulation
*Above Ceiling
- Assumed Asbestos Containing Silver Duct Wrap & Insulation
*Above Ceiling
- Assumed Asbestos Containing Gray Duct Mastic
*Above Ceiling
- Assumed Asbestos Containing White Pipe Wrap & Insulation
*Above Ceiling
- Assumed Asbestos Containing Black Foam Pipe Insulation
*Above Ceiling

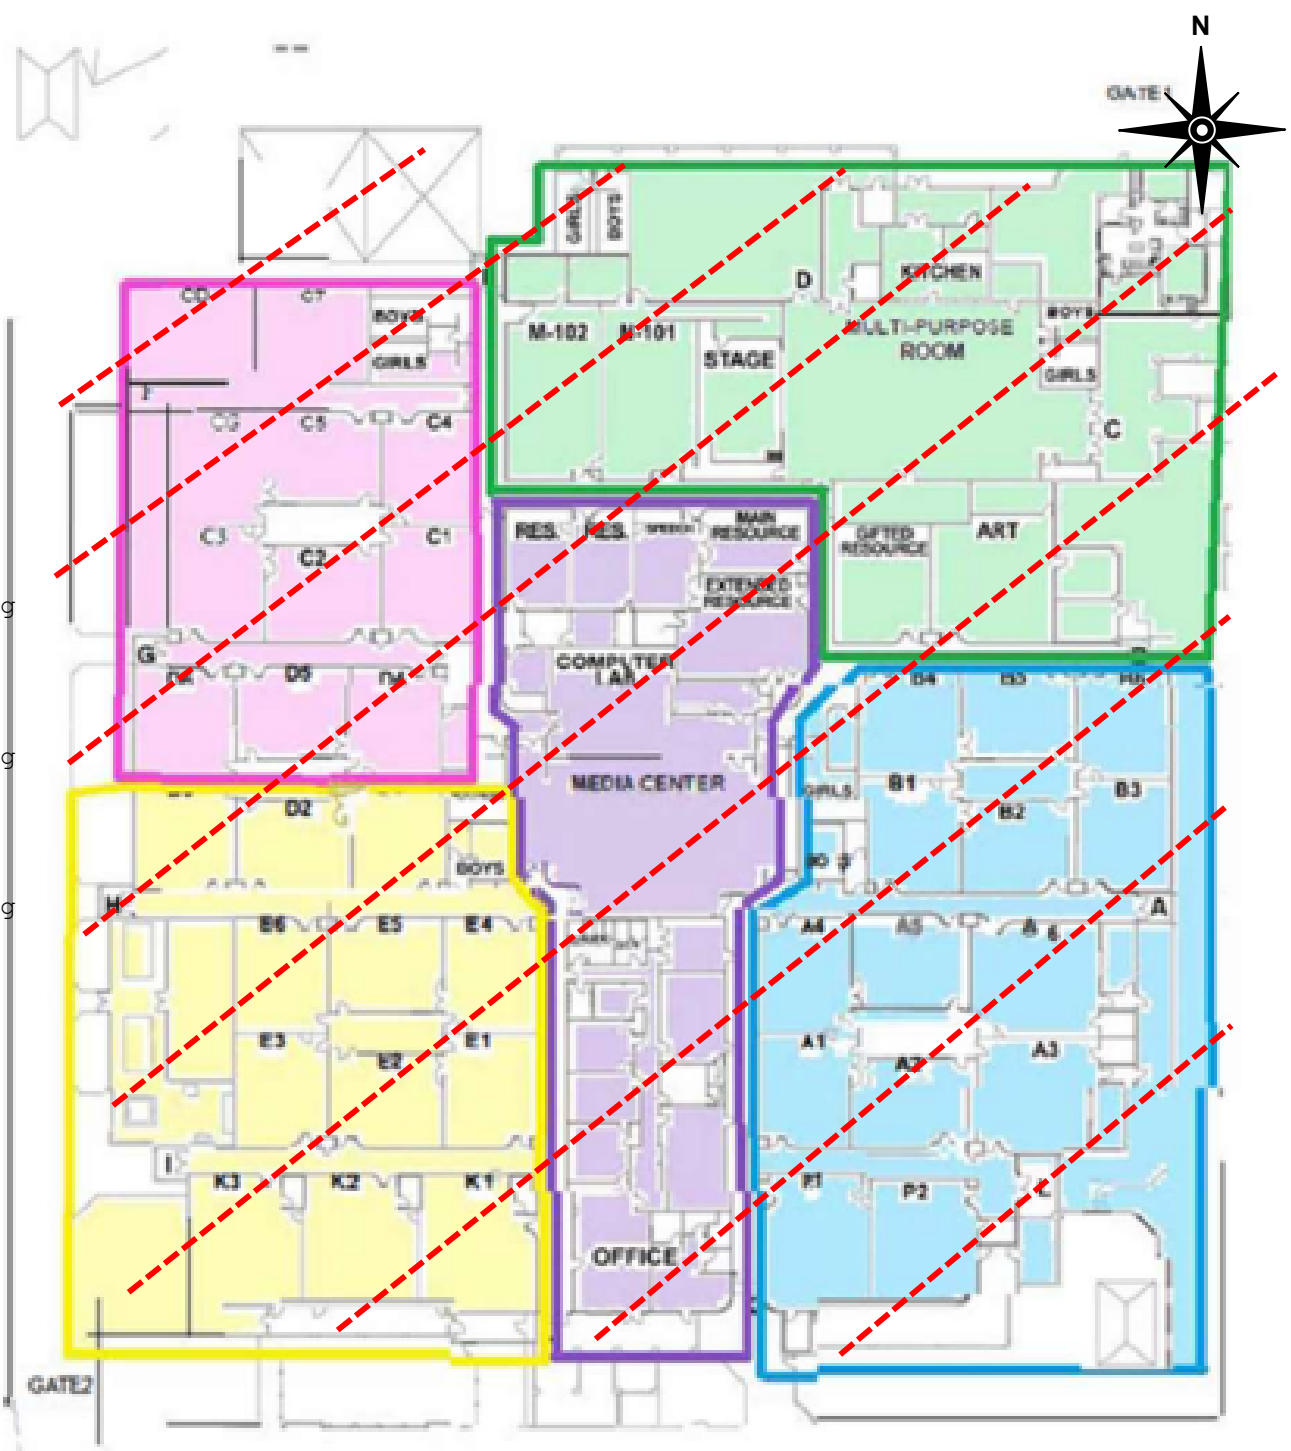
- Assumed Asbestos Containing Gray Fire Stop Caulking
*Above Ceiling
- Assumed Asbestos Containing Brown Fire Stop Caulking
*Above Ceiling
- Assumed Asbestos Containing Red Fire Stop Caulking
*Above Ceiling
