**AHERA ASBESTOS  
INSPECTION REPORT**

**KYRENE DE LOS CERRITOS LEADERSHIP ACADEMY  
1050 EAST CARVER ROAD  
TEMPE, AZ 85248**

Dominion Project Number: AZ1418.37

AHERA Inspection Date: July 2, 2025

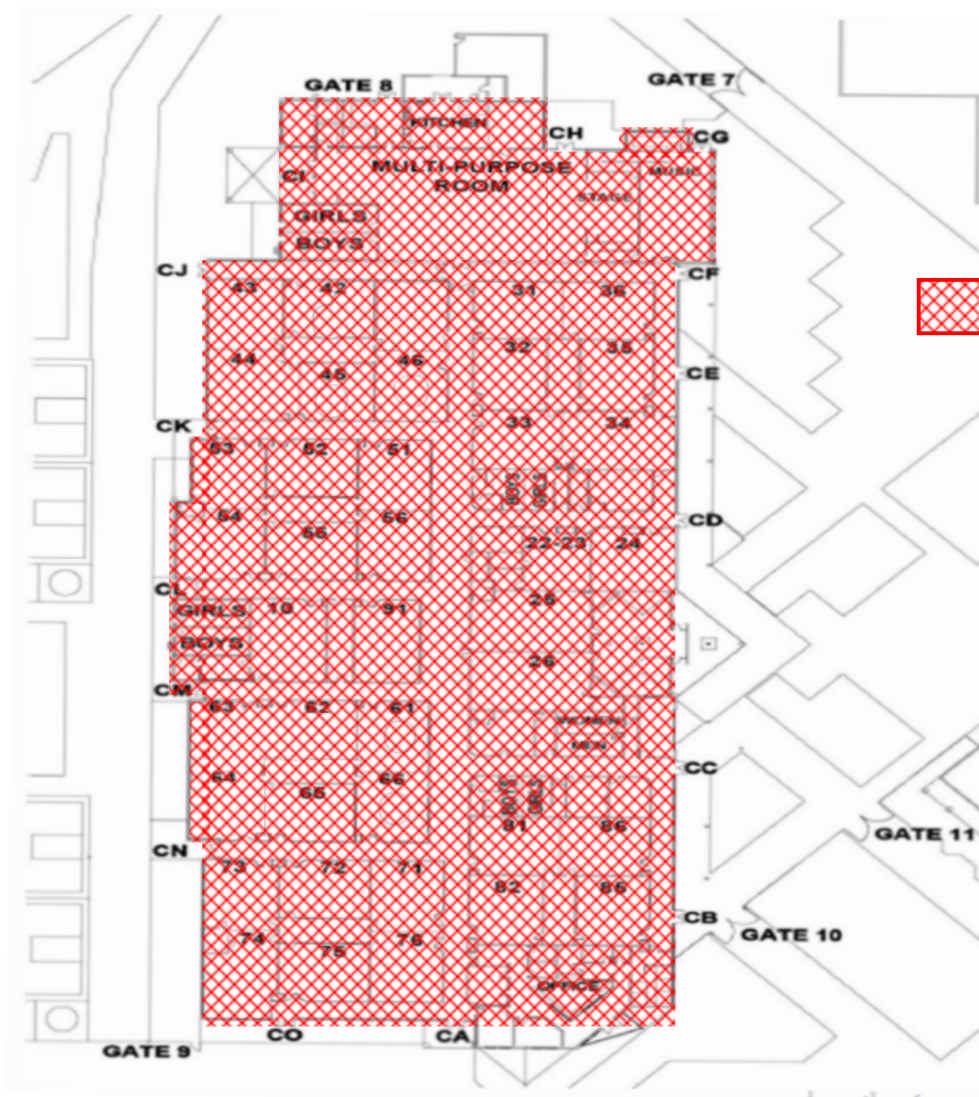
Main Bldg.

Assumed Asbestos-Containing  
Gray Multi- Color Carpet & Mastic  
Blue Cove Base & Mastic  
Orange Peel Drywall System  
New/Old 2"x2" Ceiling Tile  
Interior/Exterior Caulking  
Tacboard  
Ceiling Insulation Backing  
Silver Box Duct Wrap  
Silver Duct Wrap  
Silver Flex Duct Wrap  
Silver Duct Tape  
Gray Duct Mastic  
Gray Sink Coating  
White Pipe Wrap & mastic  
Black Pipe Foam Ins.  
White Duct Seam Tape & Mastic  
Unfinished Drywall System  
Black Flex Duct Wrap  
Red Fire Stop Caulking
