**AHERA ASBESTOS  
INSPECTION REPORT**

**KYRENE DEL CIELO ELEMENTARY SCHOOL  
1350 NORTH LAKESHORE DRIVE  
CHANDLER, ARIZONA 85226**

Dominion Project Number: AZ1418.38

AHERA Inspection Dates: July 9, 2025 and July 15, 2025

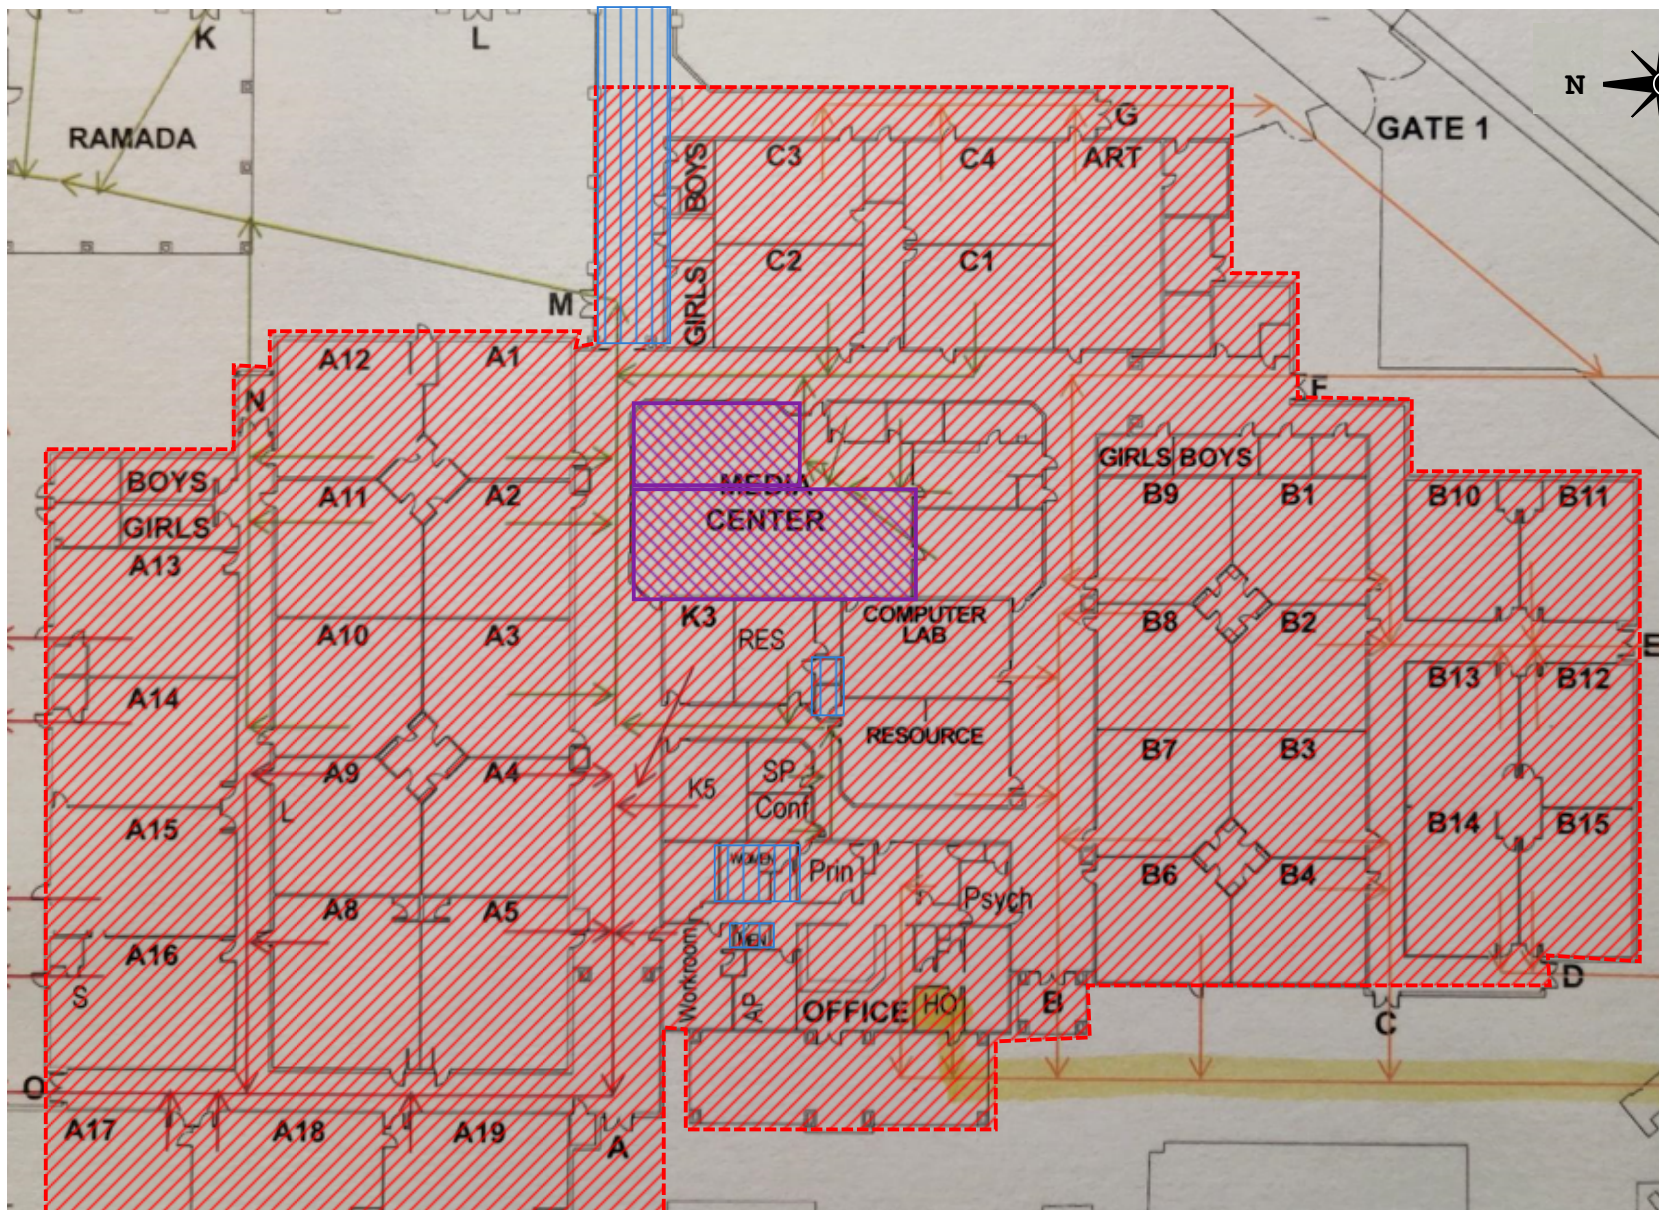
Assumed Asbestos-Containing

Beige Speckled 12" x 12" VCT  
& Mastic, Gray Sink Coating,  
Tacboard, Fixture Caulking,  
Glass Block Mortar, Brick & Mortar,  
Block & Mortar, & Plaster

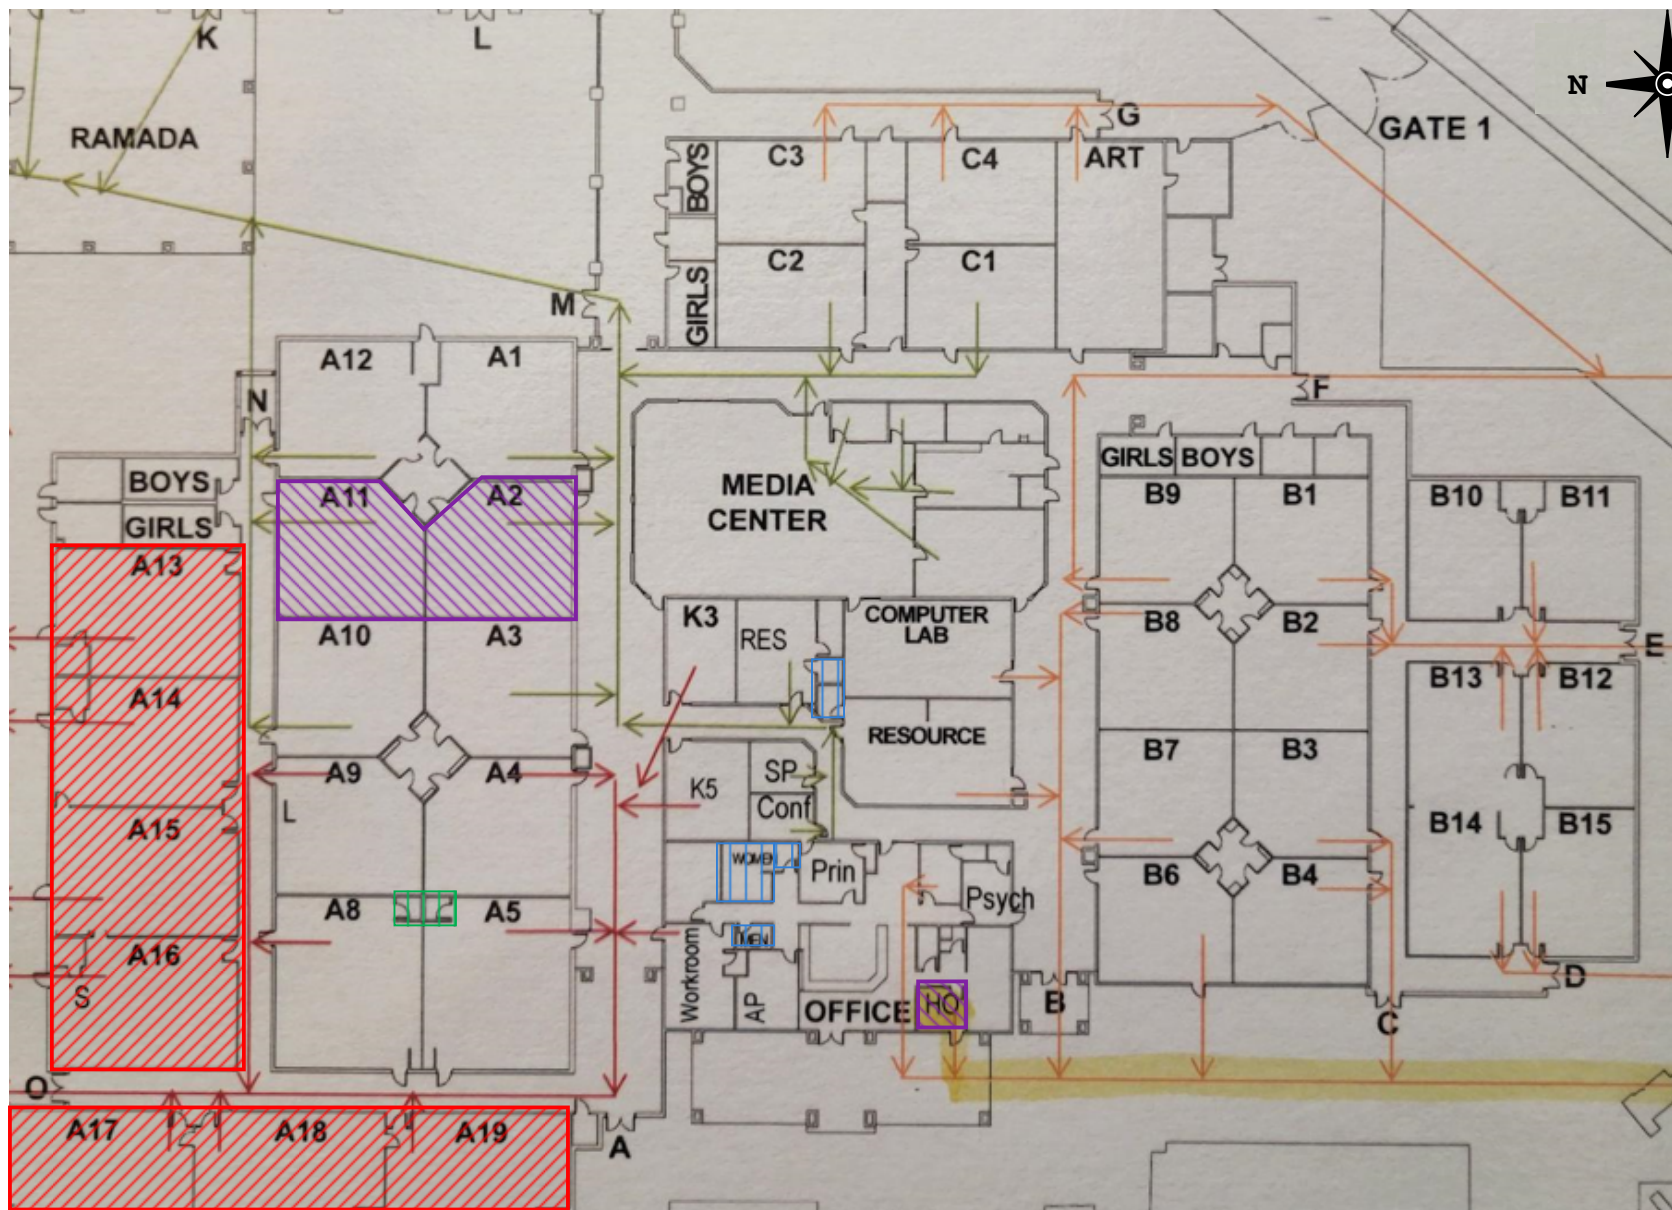
Assumed Asbestos-Containing

White w/Black 12" x 12"  
VCT & Mastic

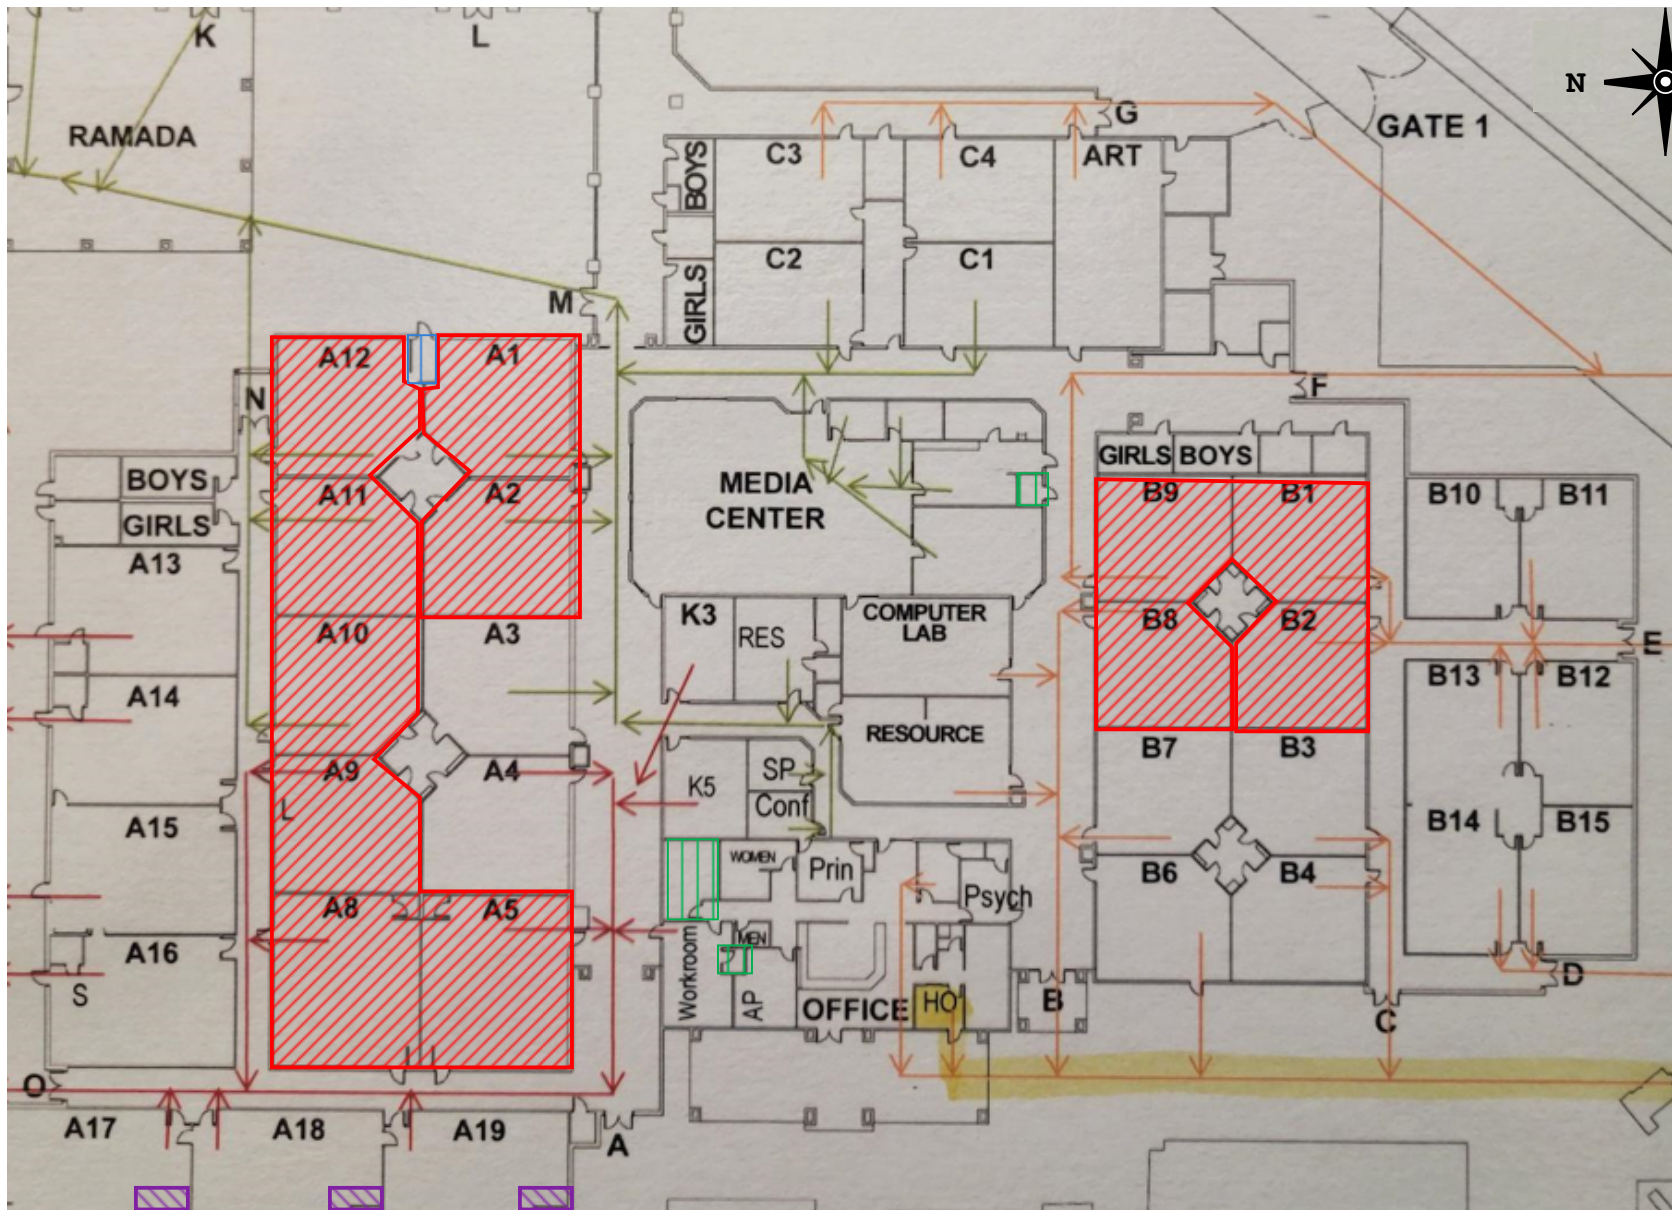
Assumed Asbestos-Containing  
White Sink Coating

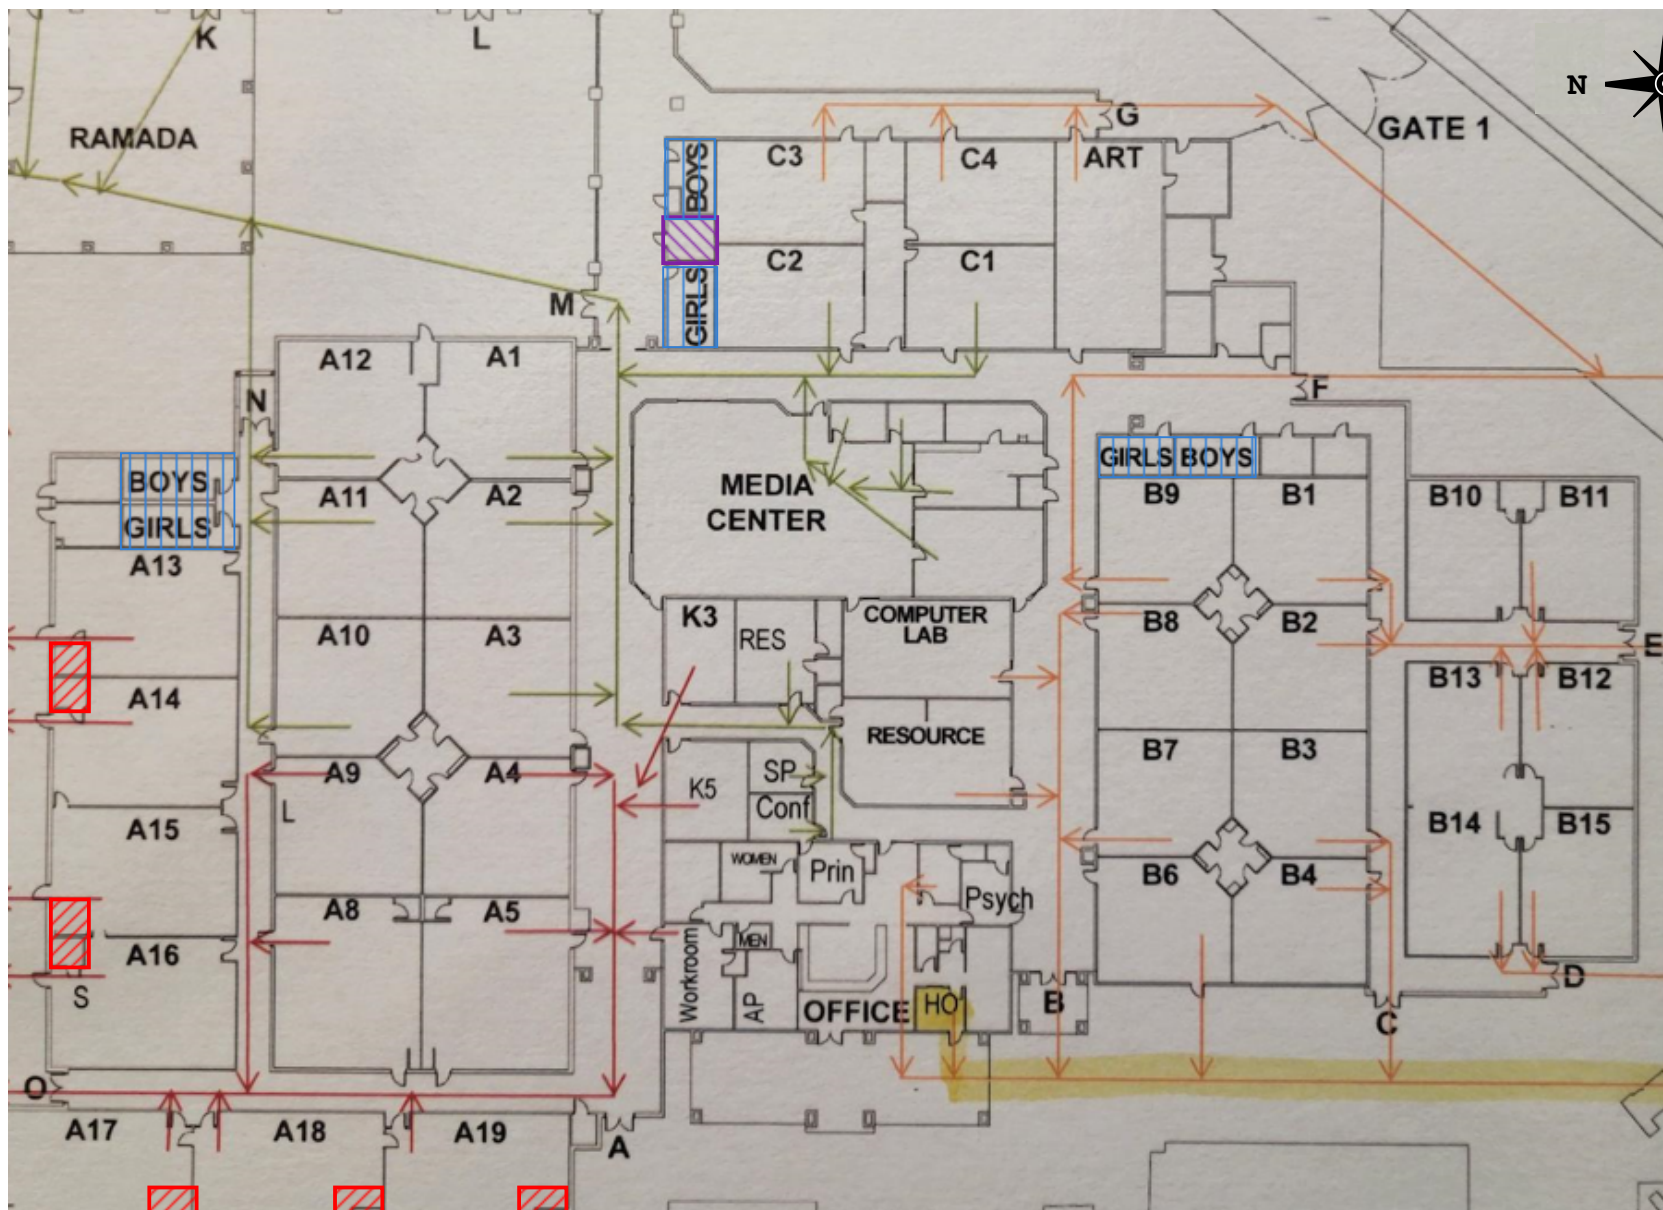
Assumed Asbestos-Containing

White 8" x 8" Ceramic Wall  
Tile, Grout, & Mastic
