**AHERA ASBESTOS  
INSPECTION REPORT**

**KYRENE MONTE VISTA ELEMENTARY SCHOOL  
15221 SOUTH RAY ROAD  
PHOENIX, ARIZONA 85048**

Dominion Environmental Consultants, Inc.  
20045 North 19<sup>th</sup> Avenue, Building 7  
Phoenix, Arizona 85027  
(623) 516-1415

AHERA Inspection Dates: July 21, 2025

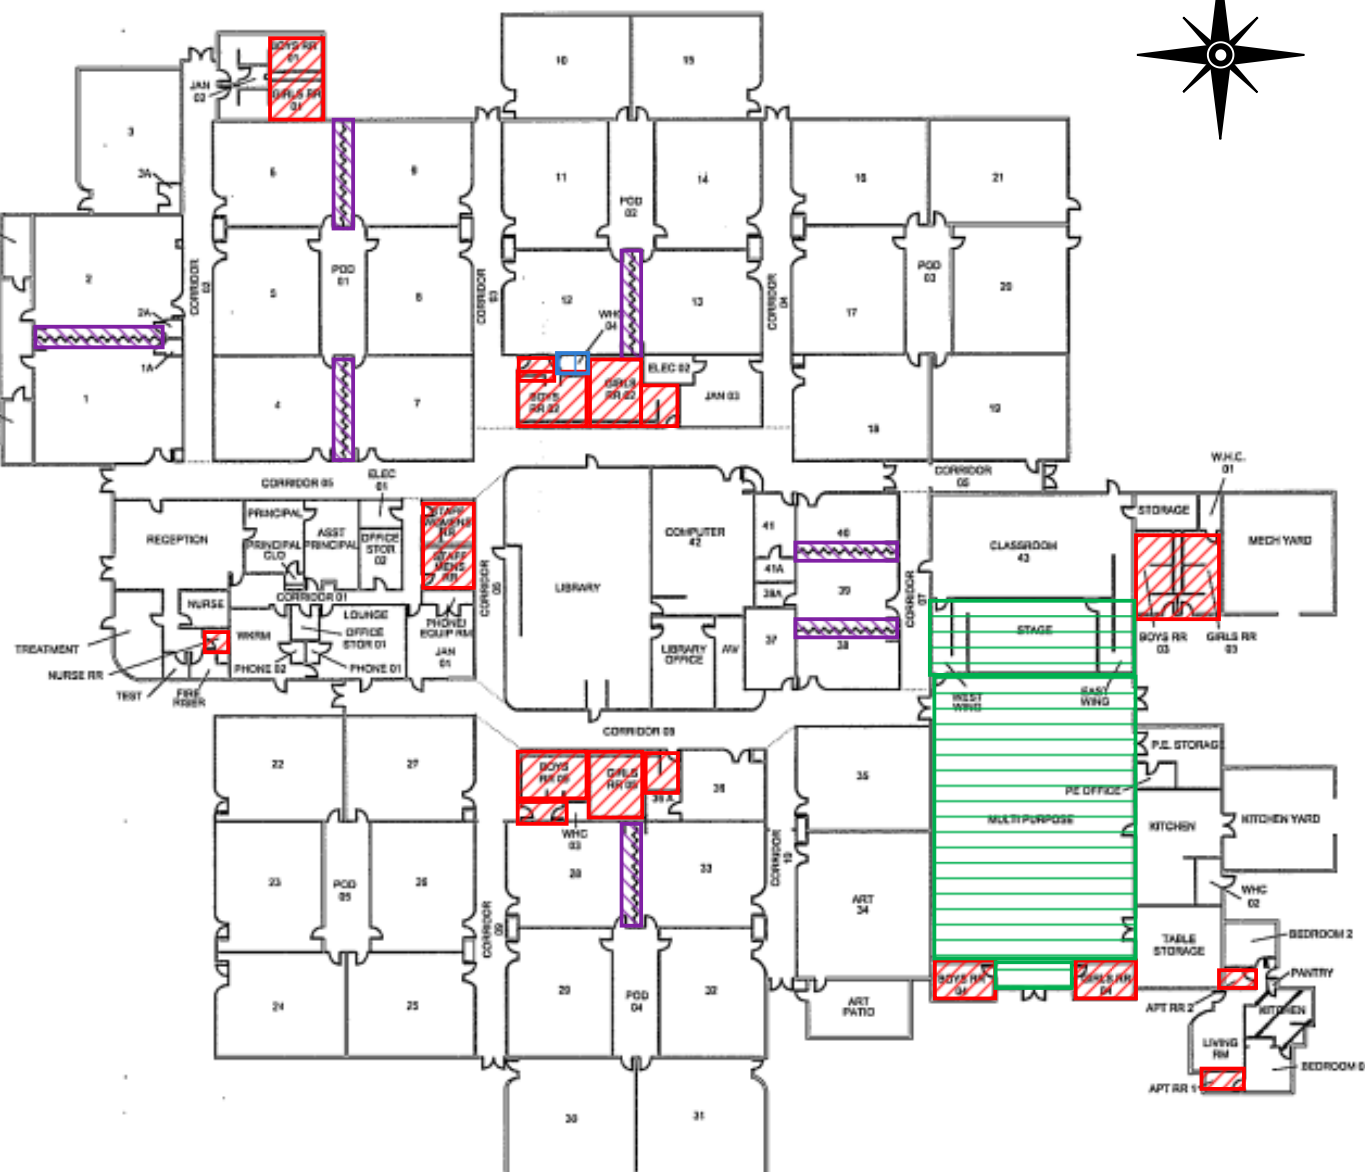
Assumed Asbestos-Containing Material Location Map (2)  
Kyrene Monte Vista Elementary School  
15221 South Ray Road, Phoenix, Arizona 85048

Assumed Asbestos-Containing

Black Cove Base & Mastic

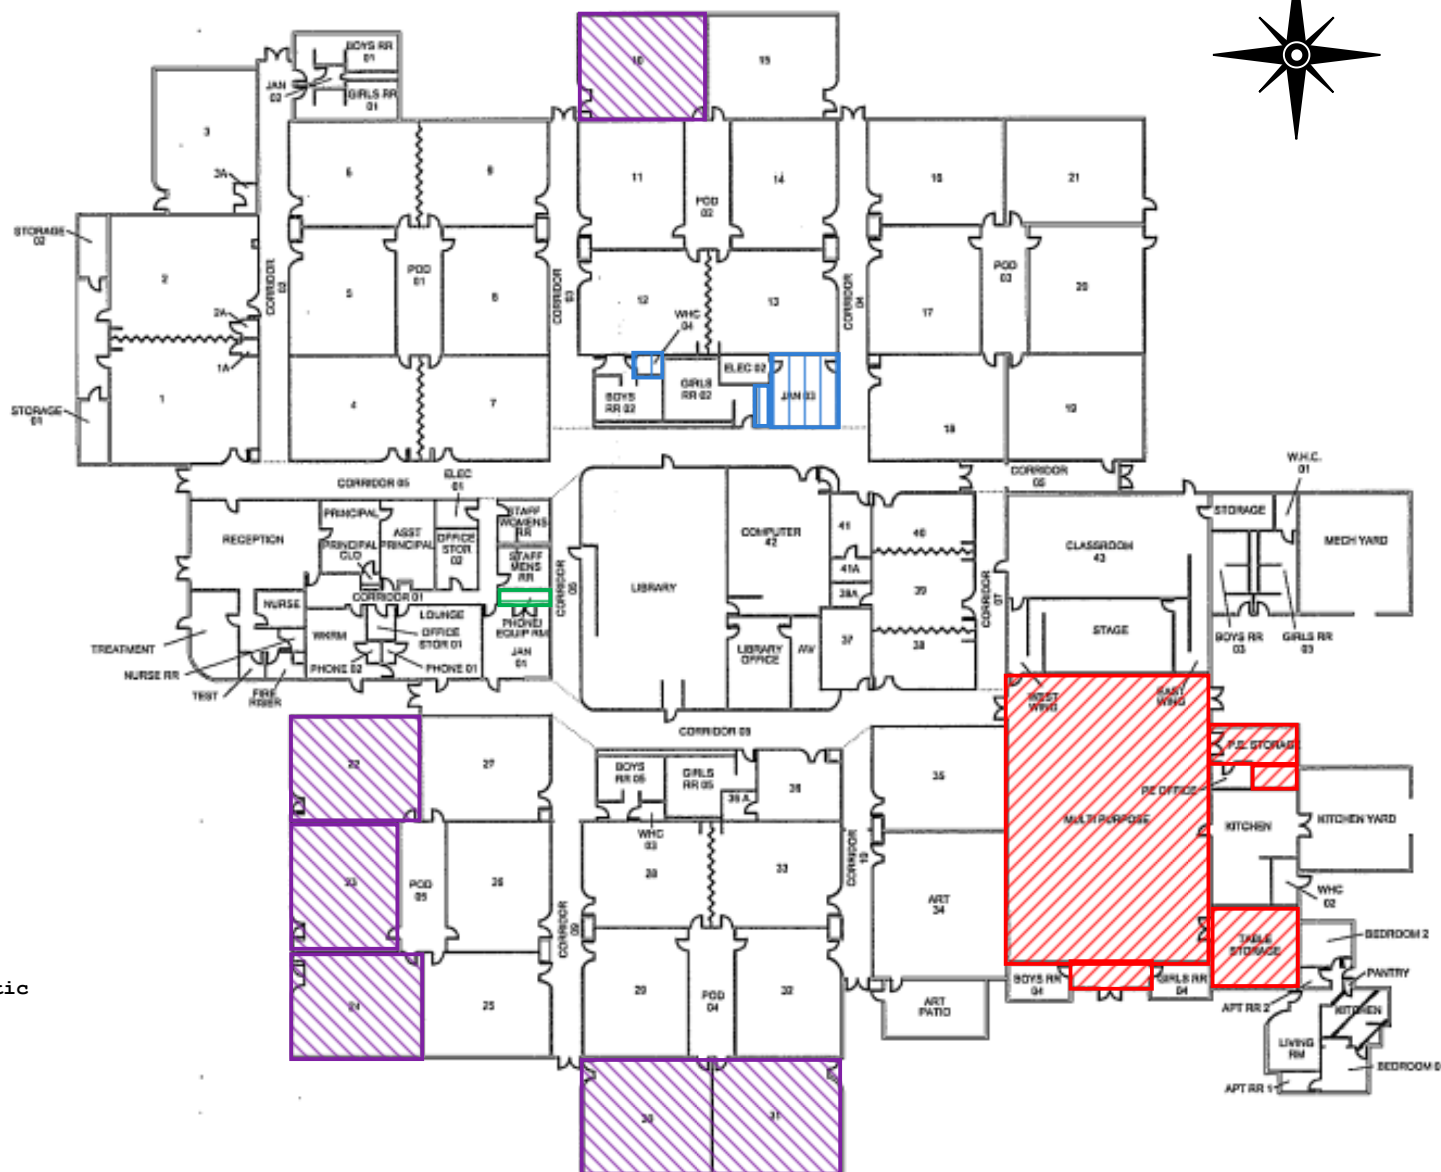
Assumed Asbestos-Containing Material Location Map (3)  
Kyrene Monte Vista Elementary School  
15221 South Ray Road, Phoenix, Arizona 85048

Assumed Asbestos-Containing  
Wallpaper

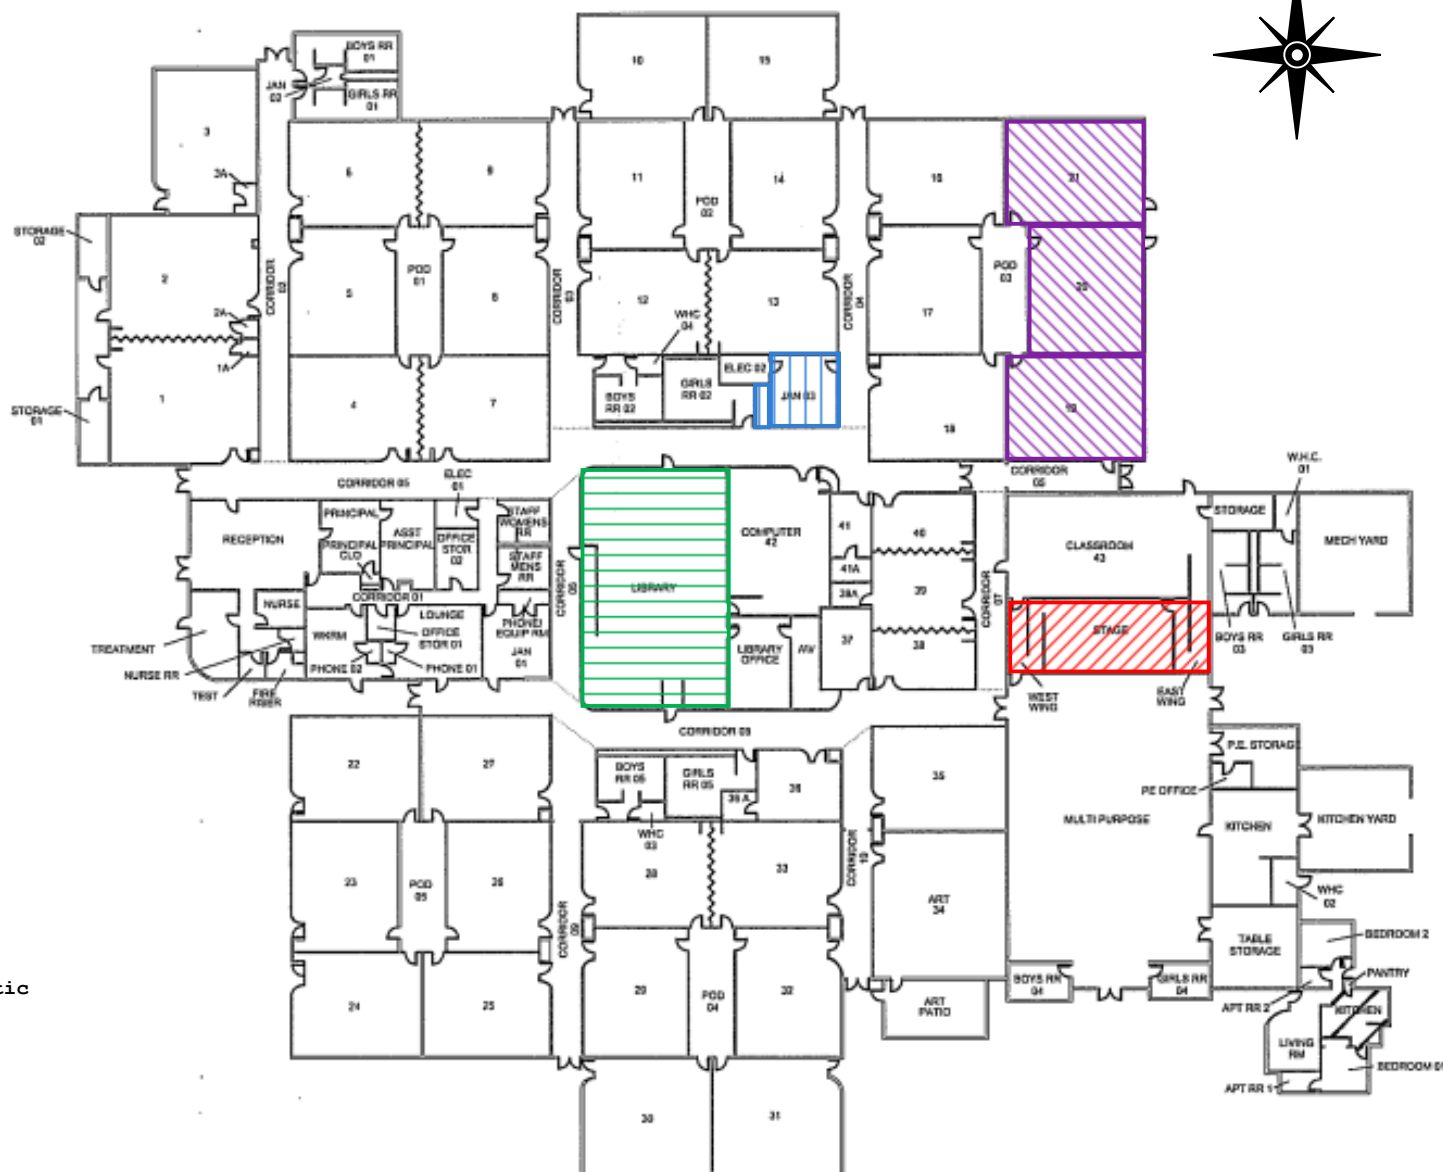
Assumed Asbestos-Containing Material Location Map (4)  
Kyrene Monte Vista Elementary School  
15221 South Ray Road, Phoenix, Arizona 85048

Assumed Asbestos-Containing  
Blue Carpet & Mastic
