**Kyrene Elementary School District  
8700 South Kyrene Road  
Tempe, Arizona 85284**

**AHERA ASBESTOS  
MANAGEMENT  
PLAN**

**KYRENE AKIMEL A-AL MIDDLE SCHOOL  
2720 EAST LIBERTY LANE  
PHOENIX, ARIZONA 85048**

March 11, 2025

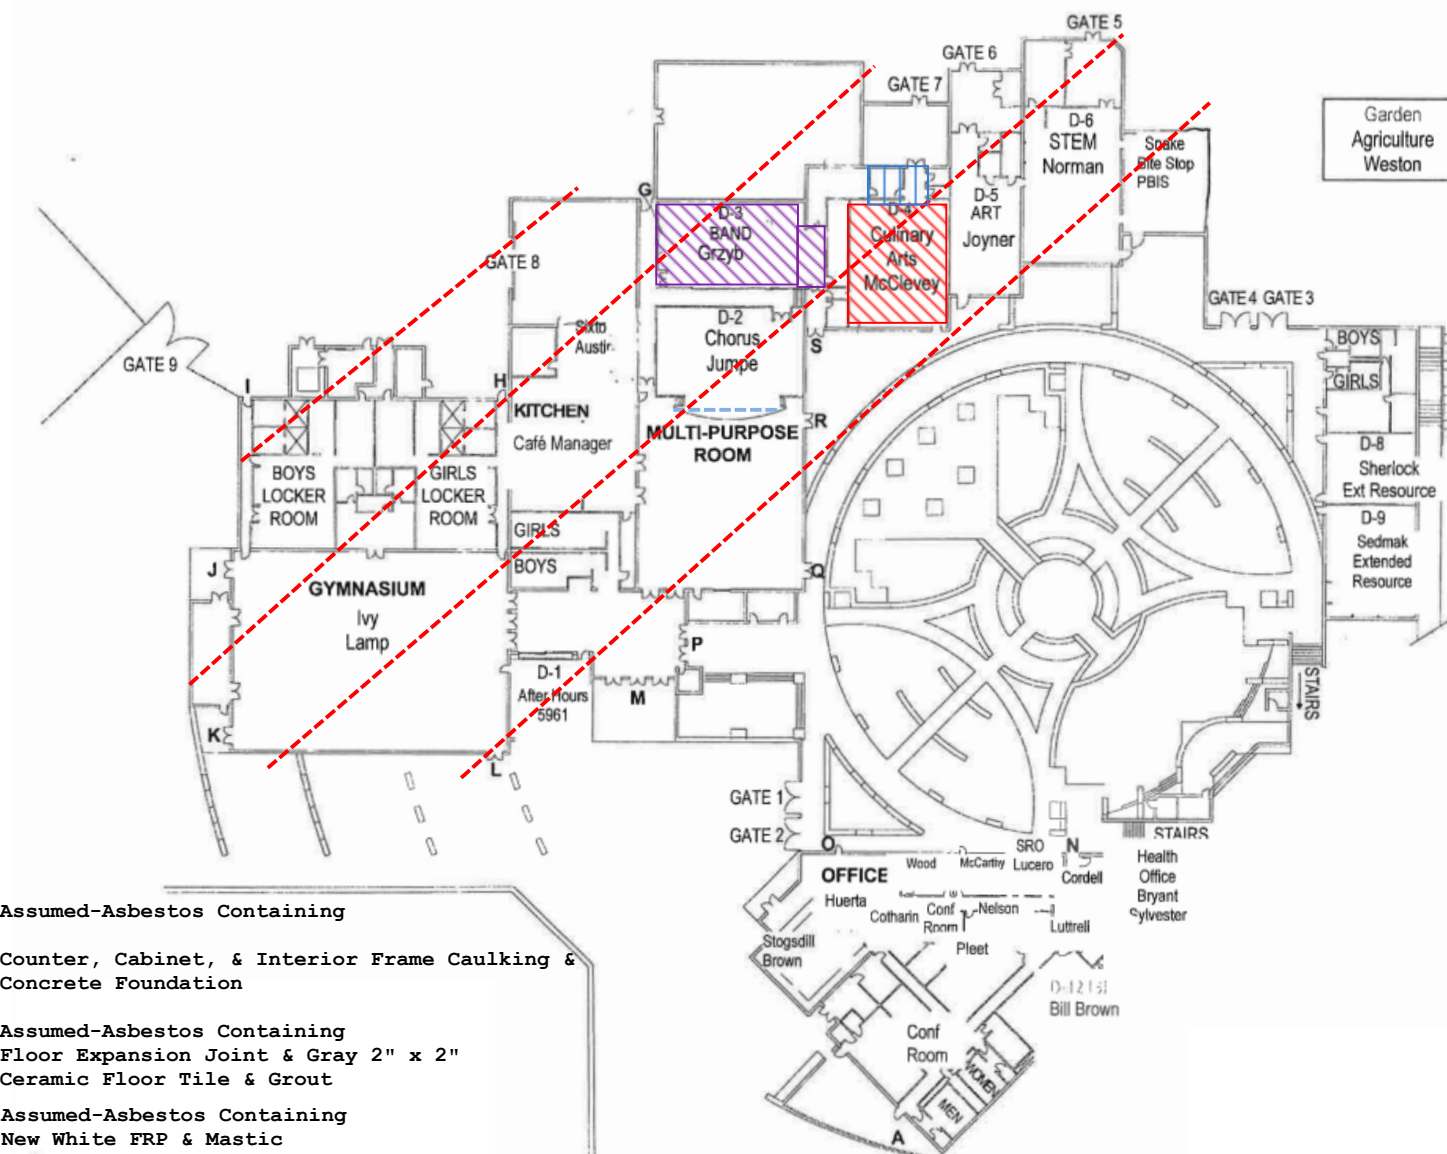
Counter, Cabinet, & Interior Frame Caulking & Concrete Foundation

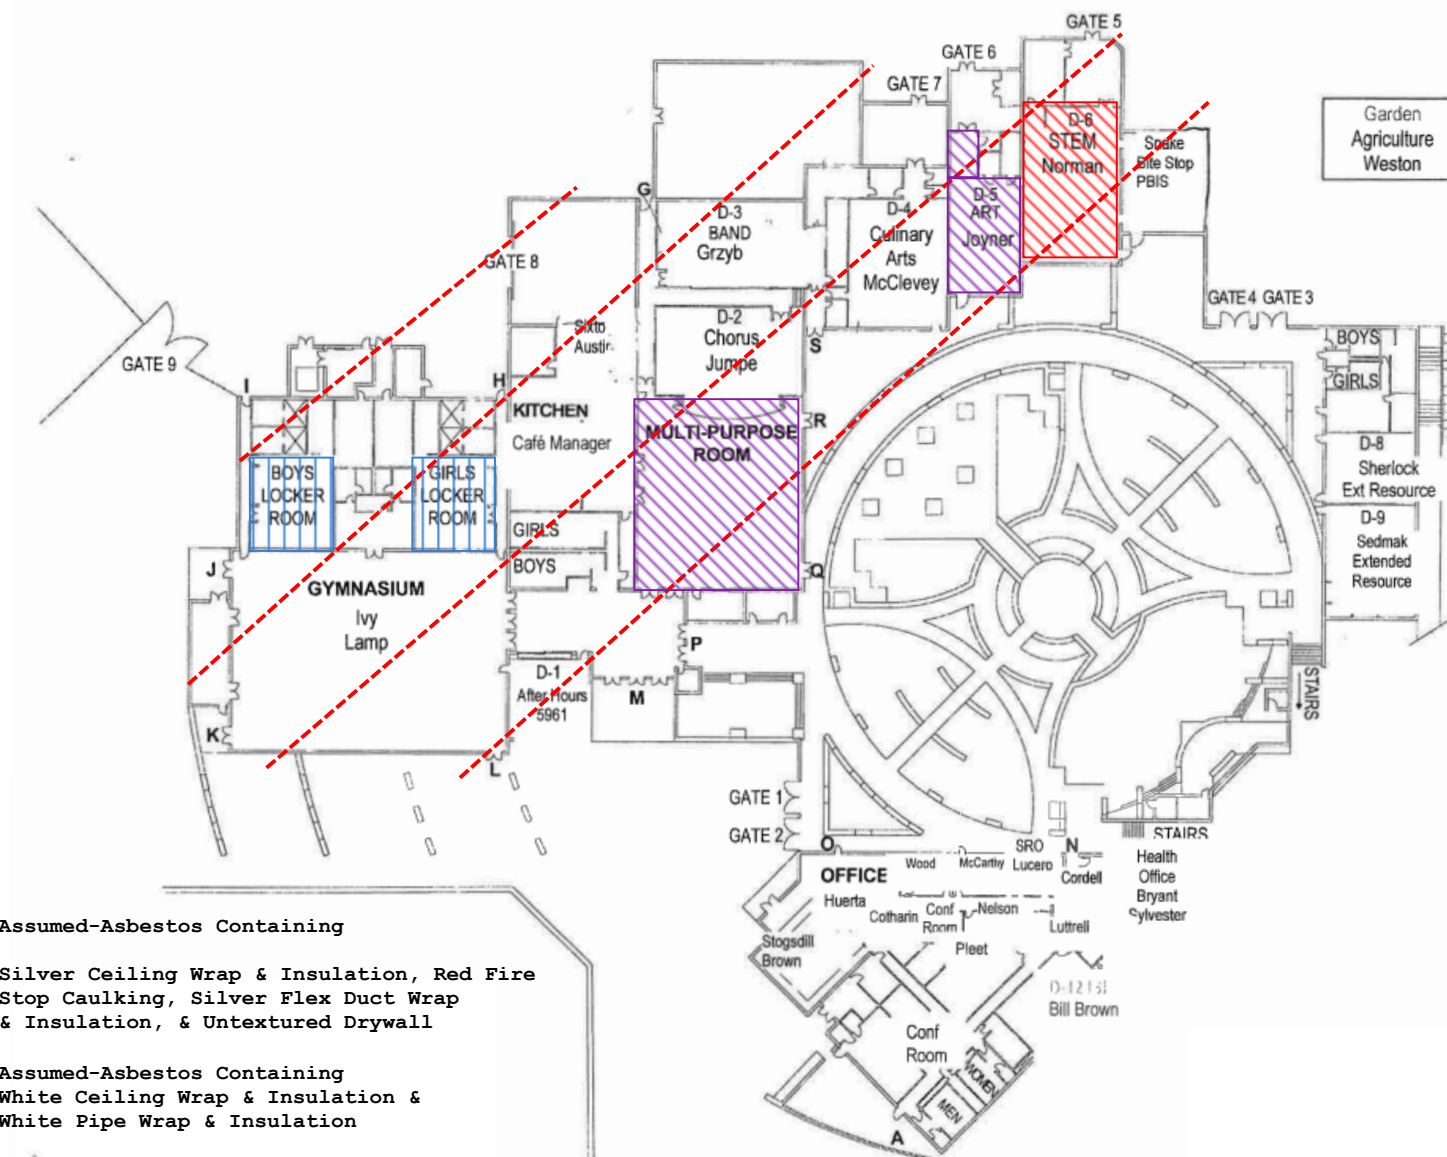
Silver Ceiling Wrap & Insulation, Red Fire Stop Caulking, Silver Flex Duct Wrap & Insulation, & Untextured Drywall

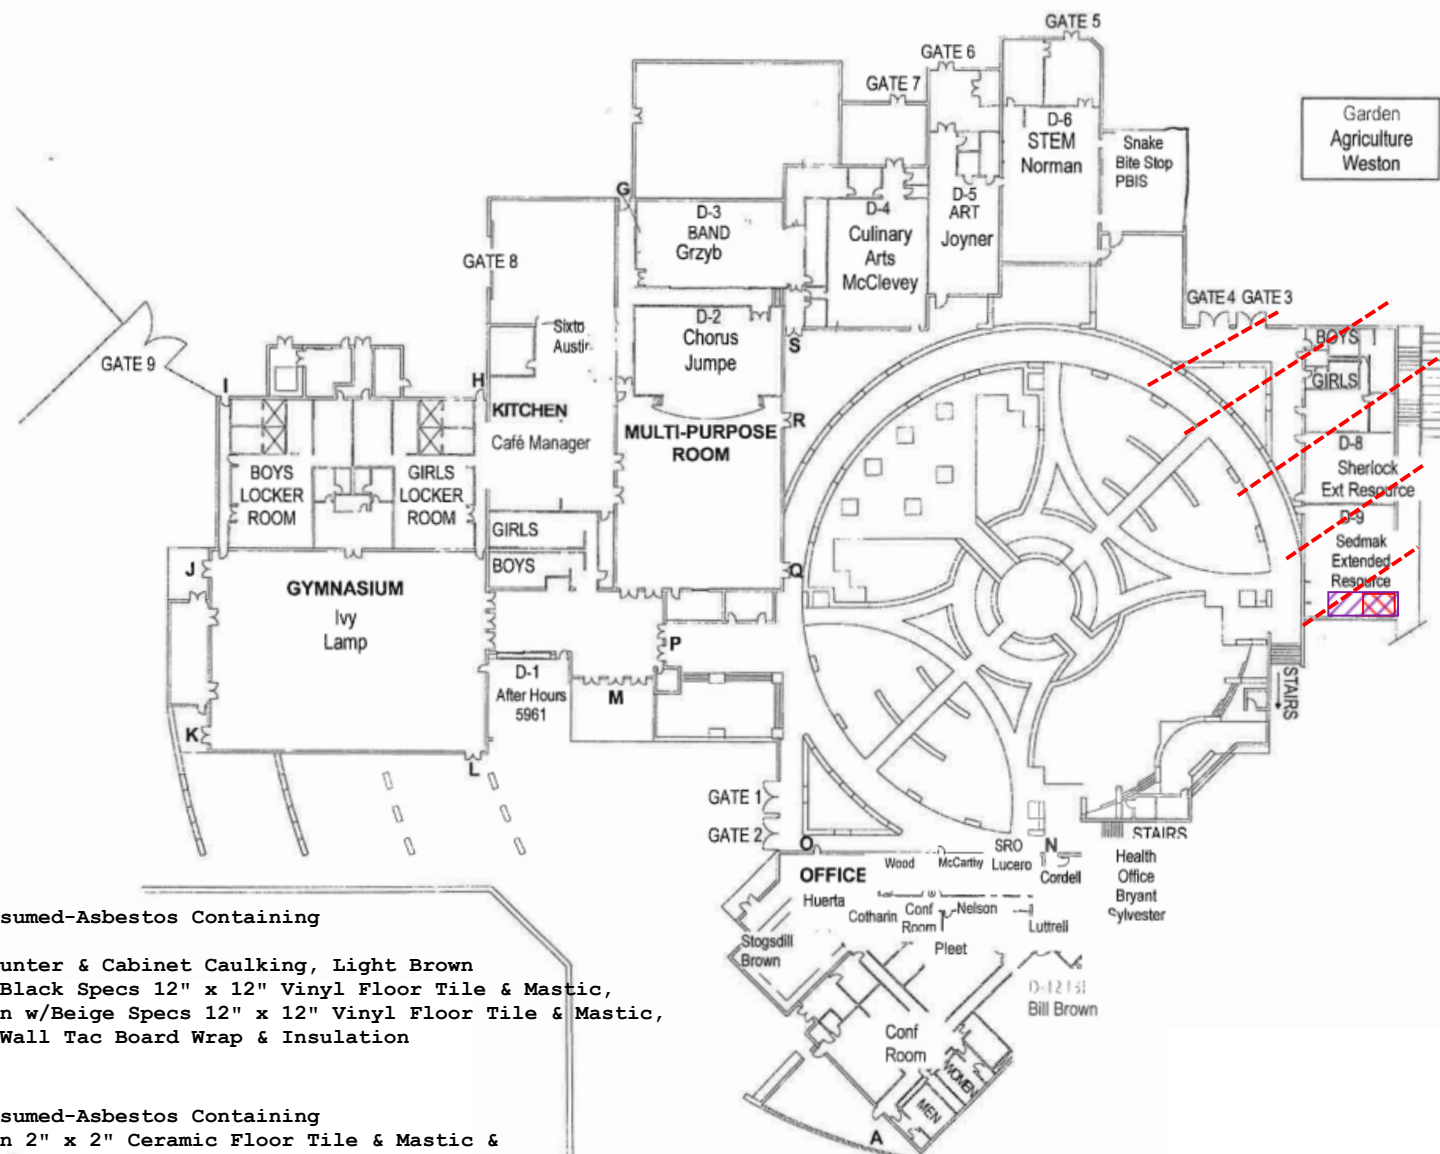
Counter & Cabinet Caulking, Light Brown  
w/Black Specs 12" x 12" Vinyl Floor Tile & Mastic,  
Tan w/Beige Specs 12" x 12" Vinyl Floor Tile & Mastic,  
& Wall Tac Board Wrap & Insulation

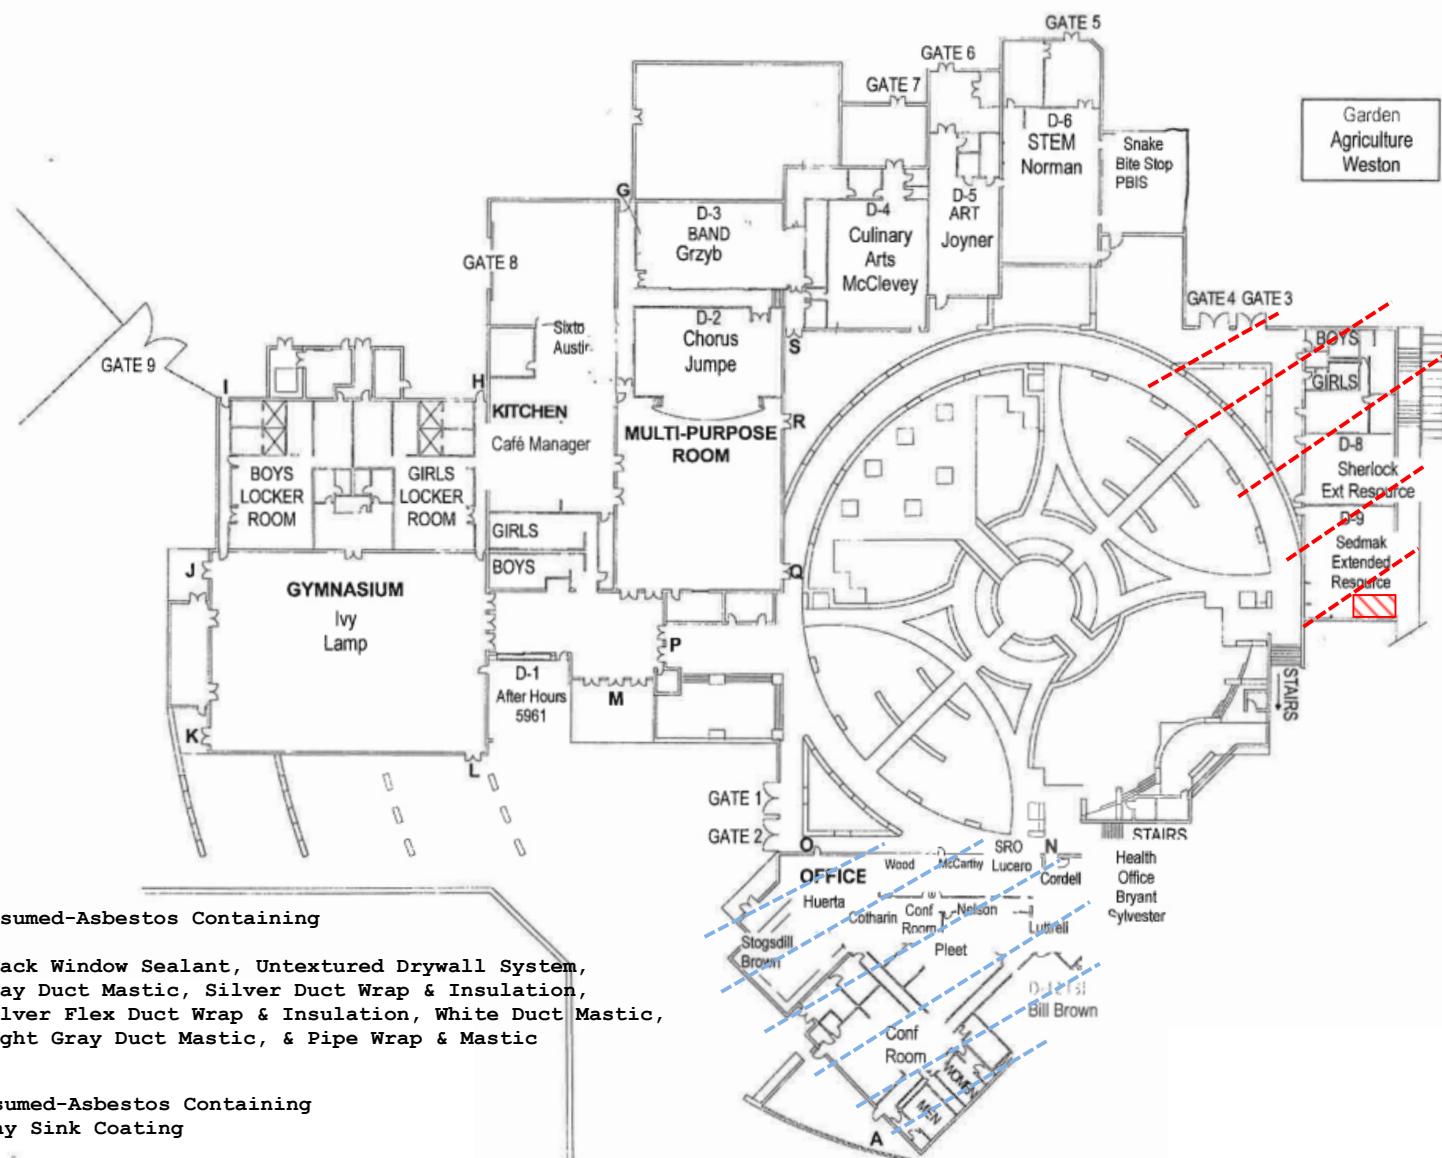
Black Window Sealant, Untextured Drywall System,  
Gray Duct Mastic, Silver Duct Wrap & Insulation,  
Silver Flex Duct Wrap & Insulation, White Duct Mastic,  
Light Gray Duct Mastic, & Pipe Wrap & Mastic

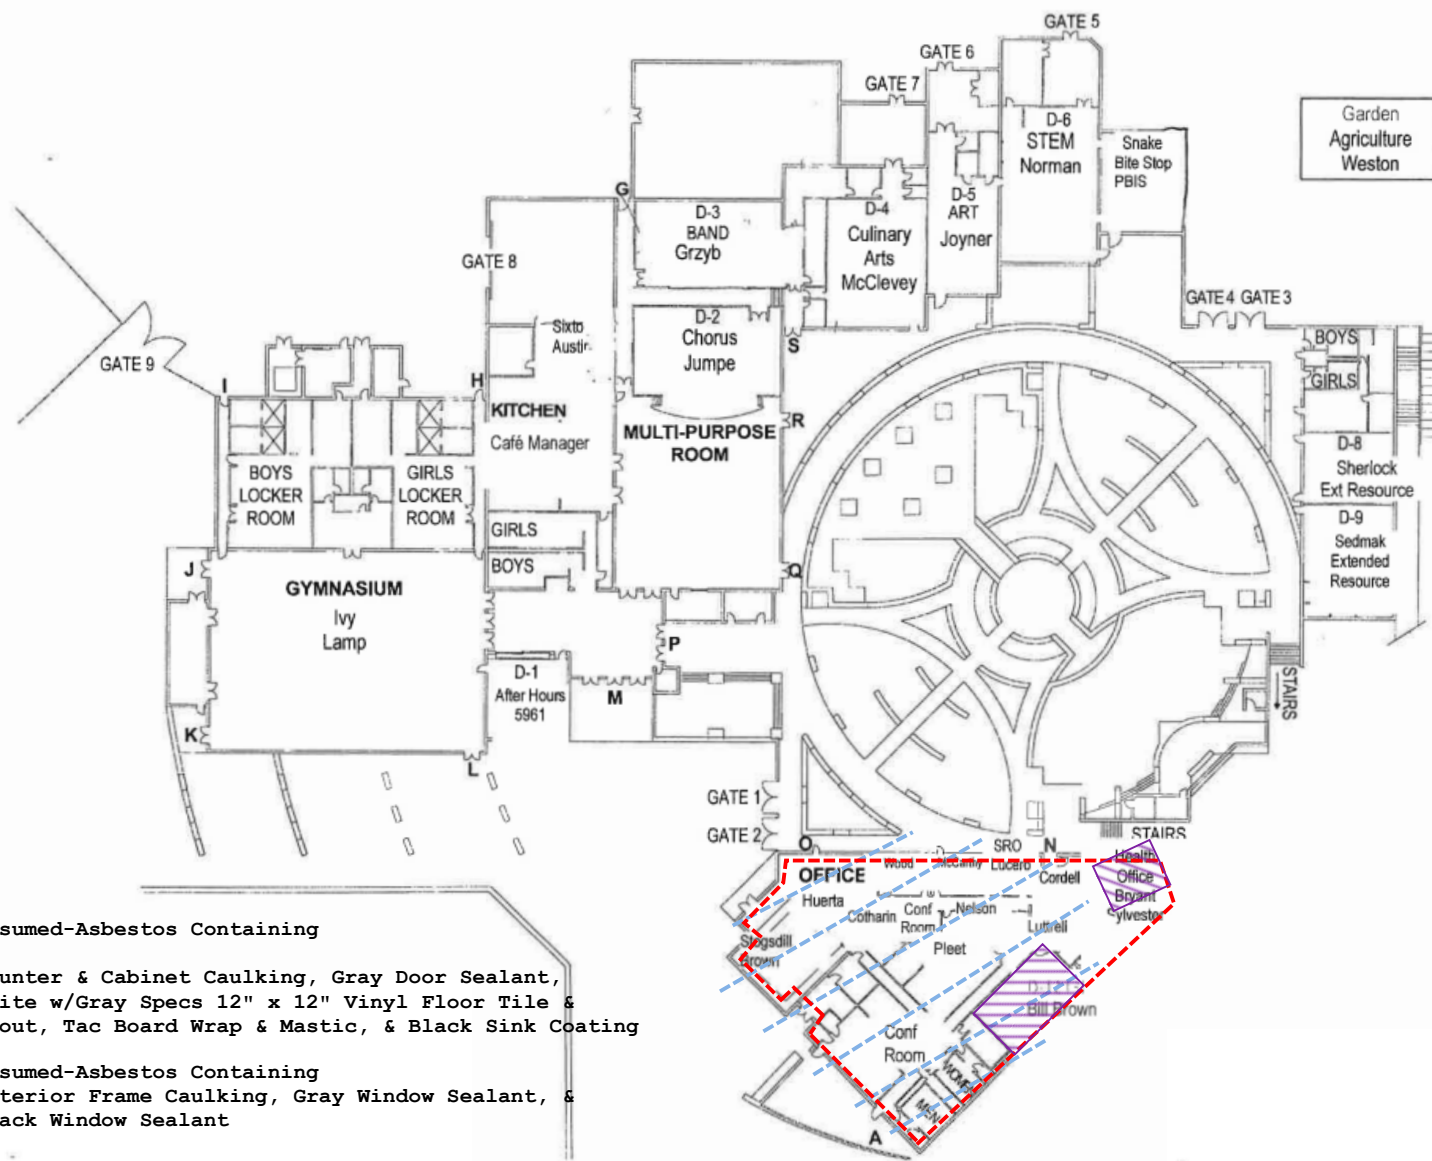
----- Counter & Cabinet Caulking, Gray Door Sealant, White w/Gray Specs 12" x 12" Vinyl Floor Tile & Grout, Tac Board Wrap & Mastic, & Black Sink Coating

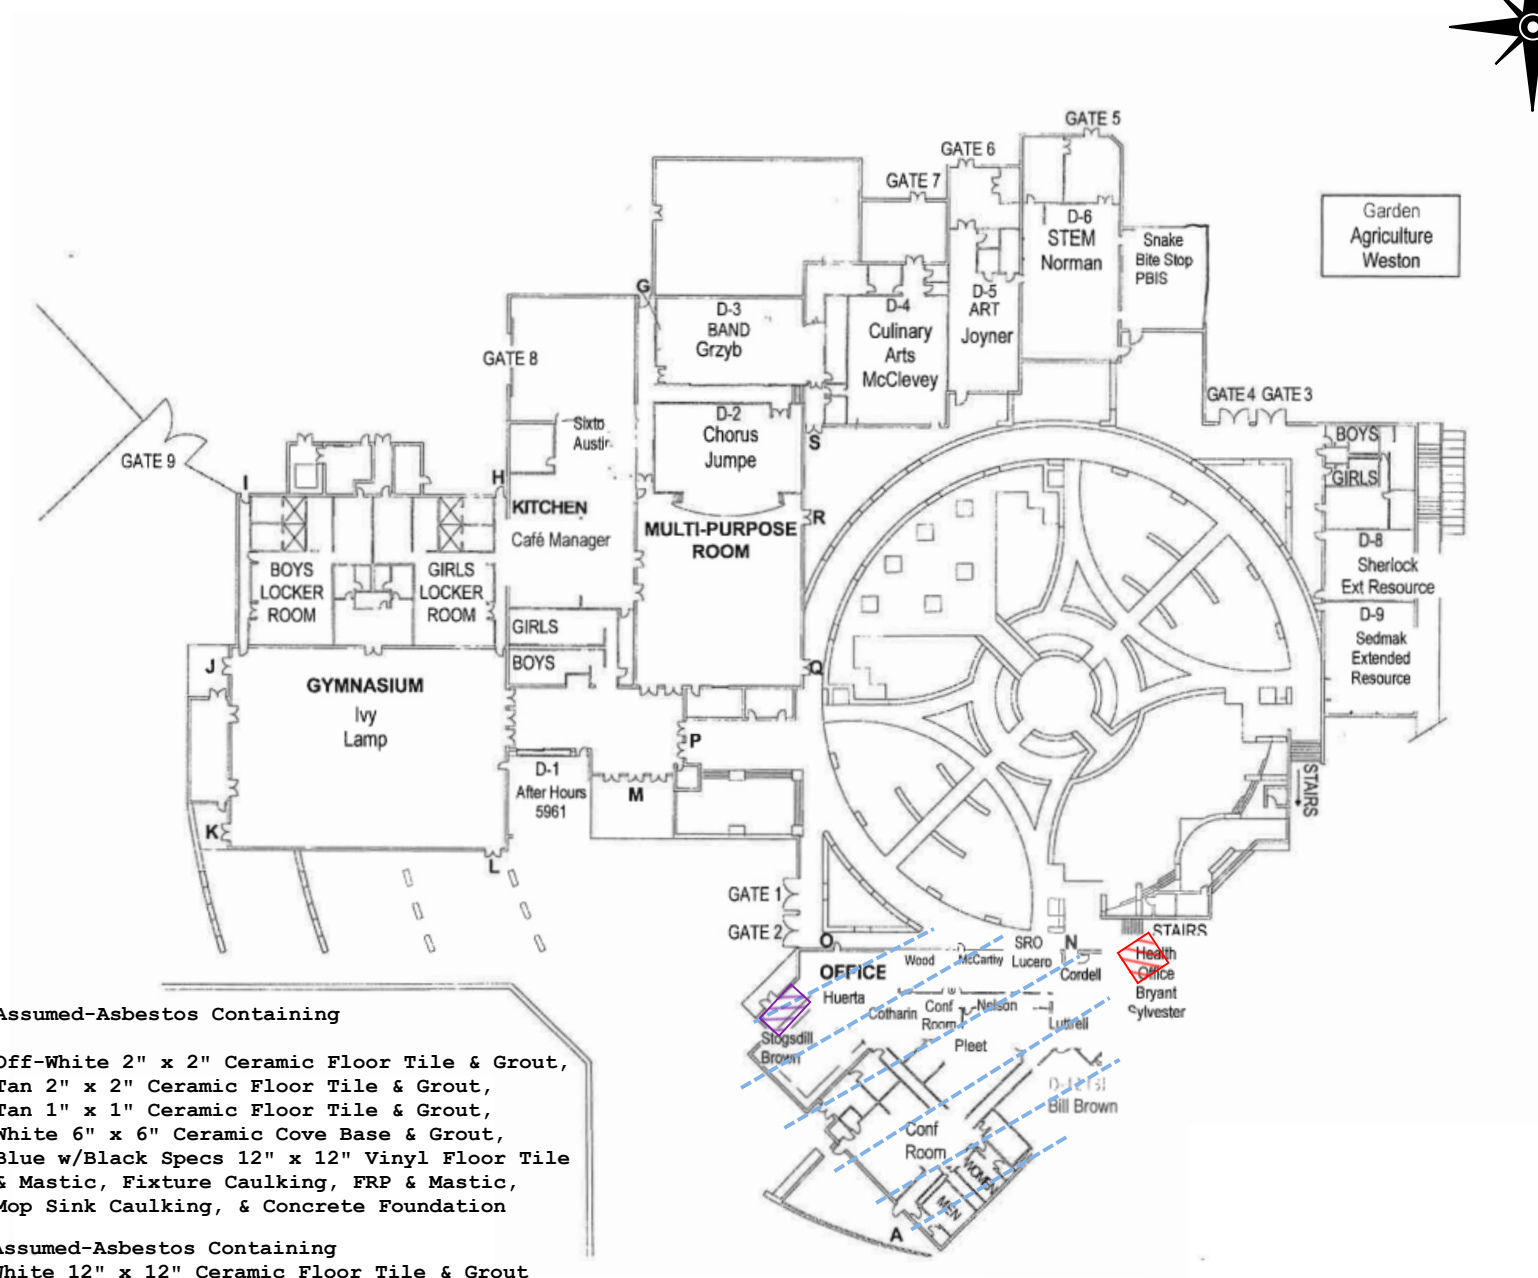
Off-White 2" x 2" Ceramic Floor Tile & Grout,  
Tan 2" x 2" Ceramic Floor Tile & Grout,  
Tan 1" x 1" Ceramic Floor Tile & Grout,  
White 6" x 6" Ceramic Cove Base & Grout,  
Blue w/Black Specs 12" x 12" Vinyl Floor Tile  
& Mastic, Fixture Caulking, FRP & Mastic,  
Mop Sink Caulking, & Concrete Foundation

Assumed-Asbestos Containing  
Beige Rough Texture Wallpaper

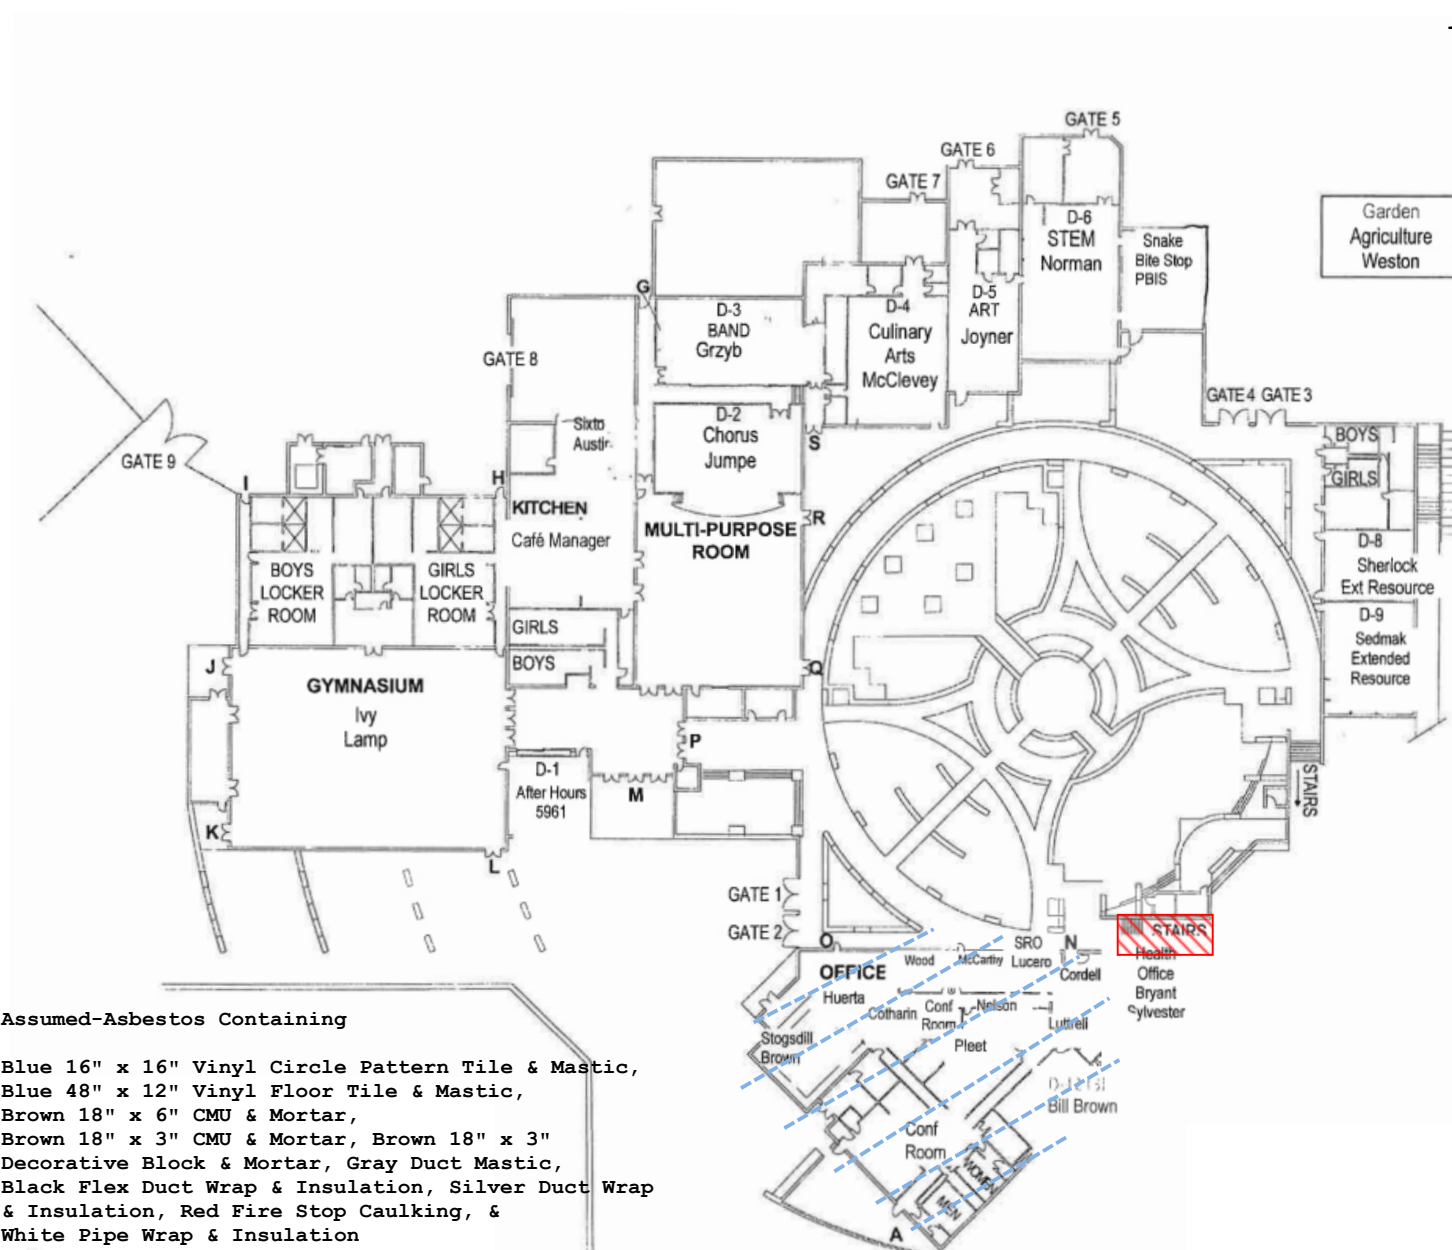
Blue 16" x 16" Vinyl Circle Pattern Tile & Mastic,  
Blue 48" x 12" Vinyl Floor Tile & Mastic,  
Brown 18" x 6" CMU & Mortar,  
Brown 18" x 3" CMU & Mortar, Brown 18" x 3"  
Decorative Block & Mortar, Gray Duct Mastic,  
Black Flex Duct Wrap & Insulation, Silver Duct Wrap  
& Insulation, Red Fire Stop Caulking, &  
White Pipe Wrap & Insulation

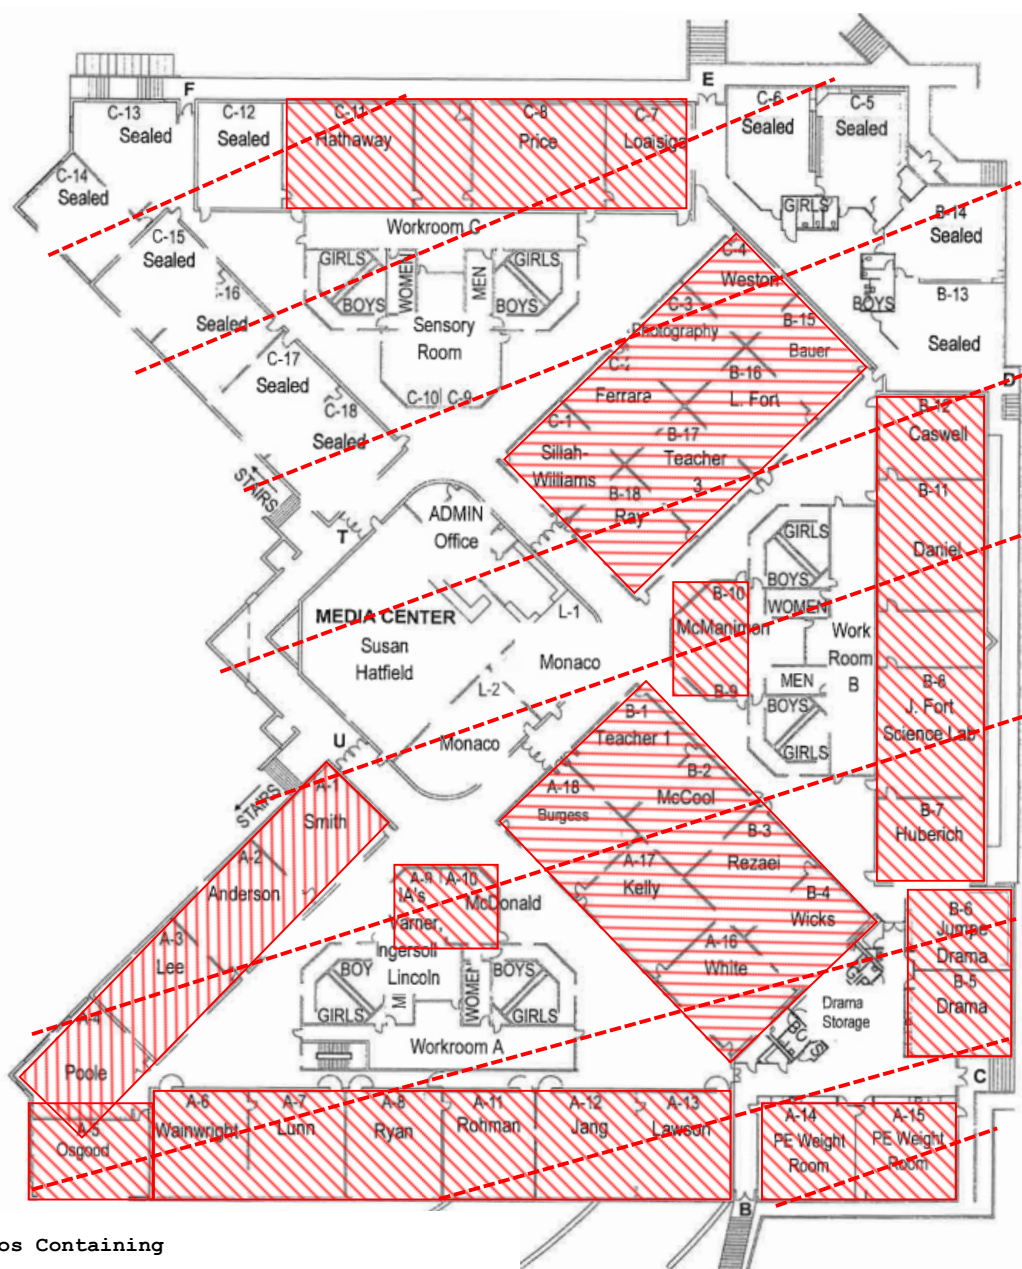
White Frame Caulking, Black Sink Coating,  
Off-White 2" x 2" Ceramic Floor Tile & Grout,  
Tan 2" x 2" Ceramic Floor Tile & Grout,  
Tan 1" x 1" Ceramic Floor Tile & Grout,  
Beige 2" x 2" Ceramic Wall Tile & Grout,  
Black 2" x 2" Ceramic Wall Tile & Grout,  
White 4" x 4" Ceramic Cove Base Tile & Grout,  
& Silver Caulking

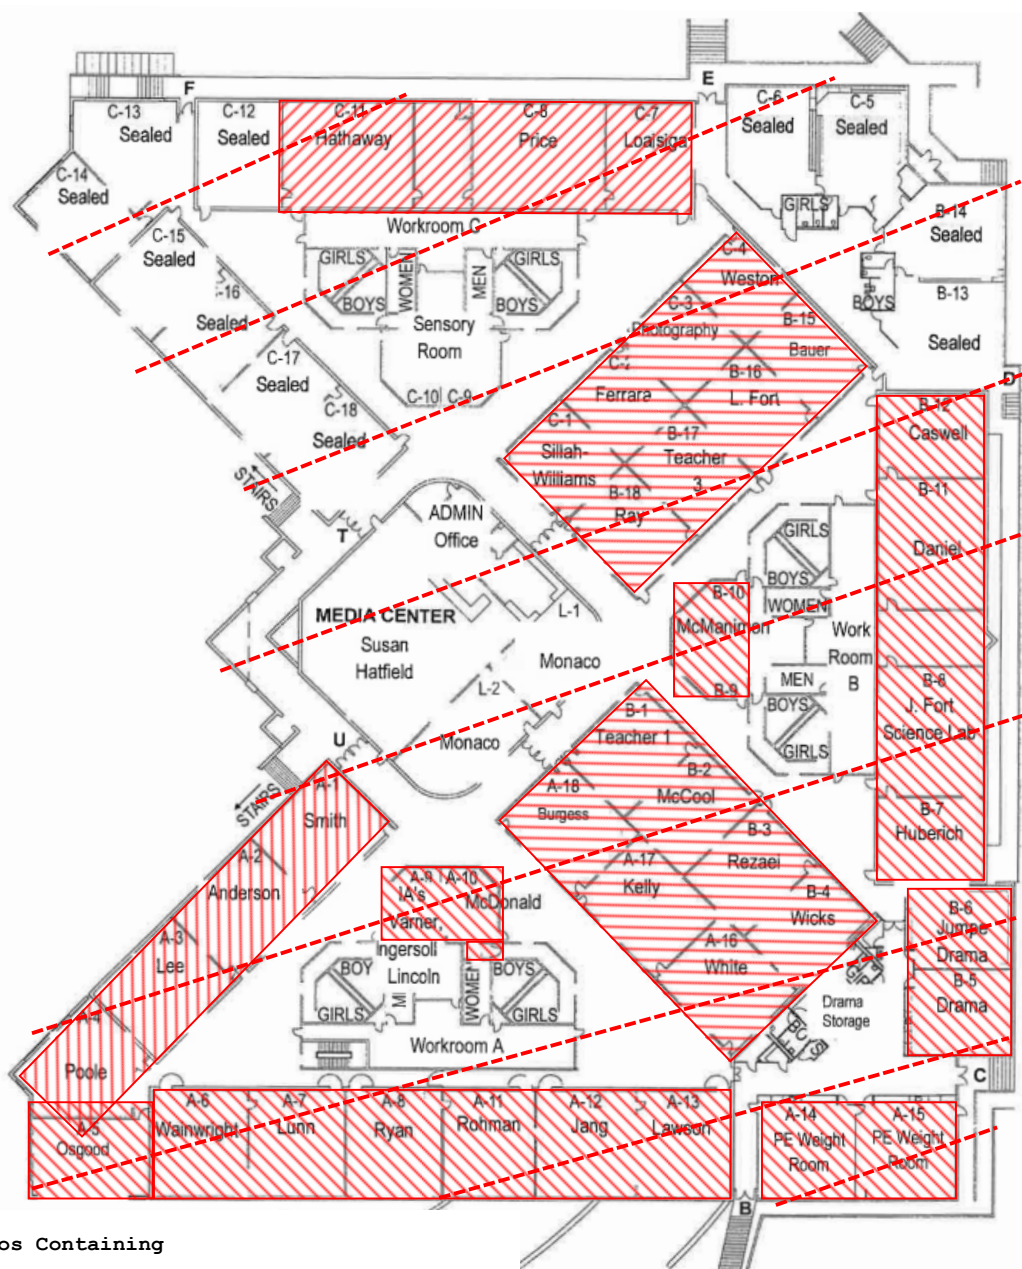
Concrete Foundation, Brown Expansion Joint, Untextured Drywall System, Gray Duct Mastic, Black Flex Duct Wrap & Insulation, Silver Duct Wrap & Insulation, Red Fire Stop Caulking, & Black 2" x 2" Carpet & Mastic

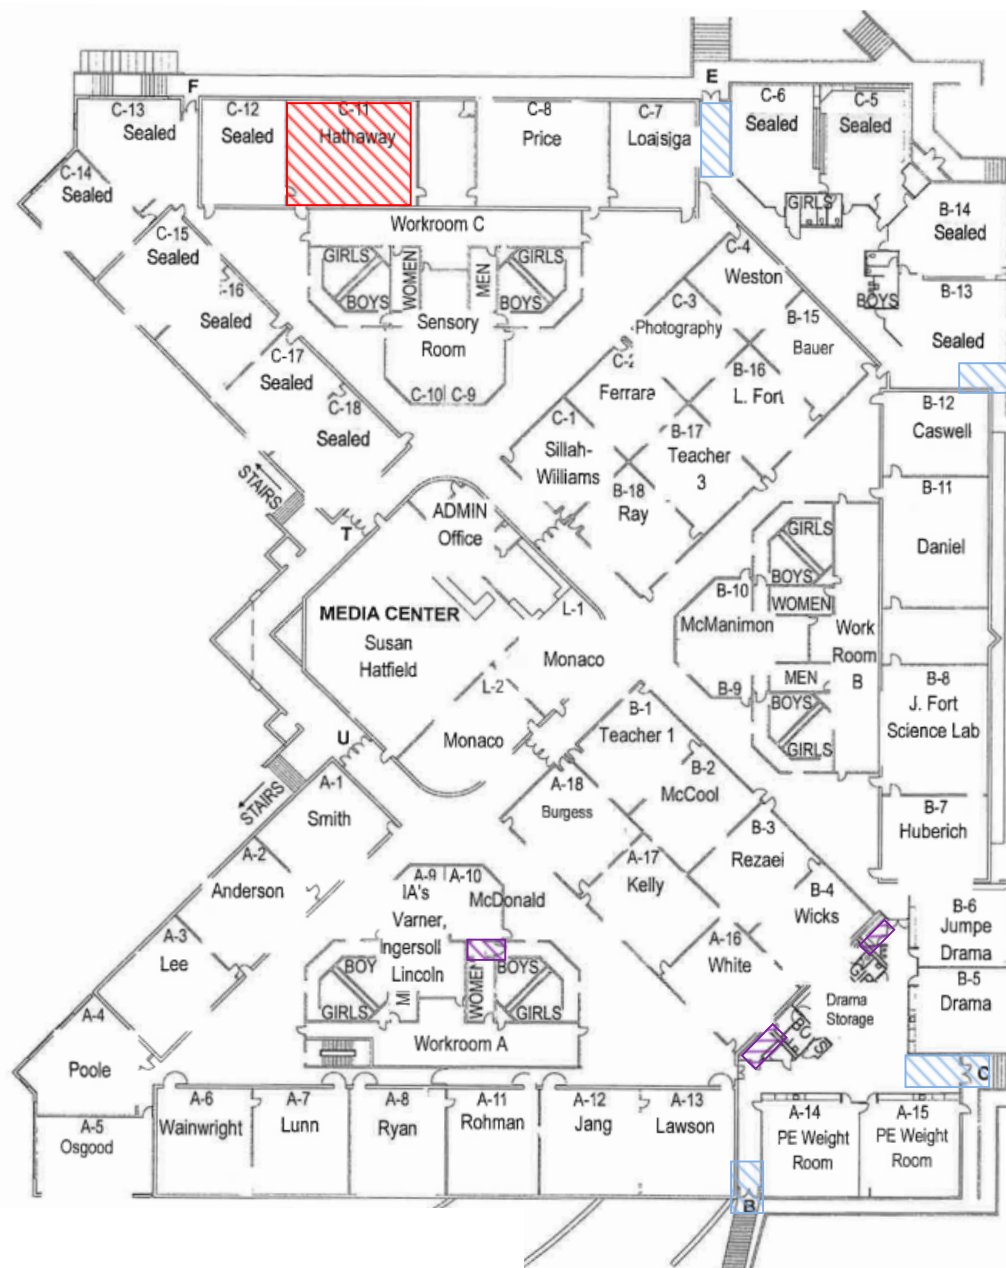
**Assumed-Asbestos Containing  
Skip Trowel Texture Drywall System**
