**AHERA ASBESTOS  
INSPECTION REPORT**

**KYRENE DE LA SIERRA ELEMENTARY SCHOOL  
1122 EAST LIBERTY LANE  
PHOENIX, ARIZONA 85048**

Dominion Project Number: AZ1418.52

Initial AHERA Inspection Date: March 3, 2025

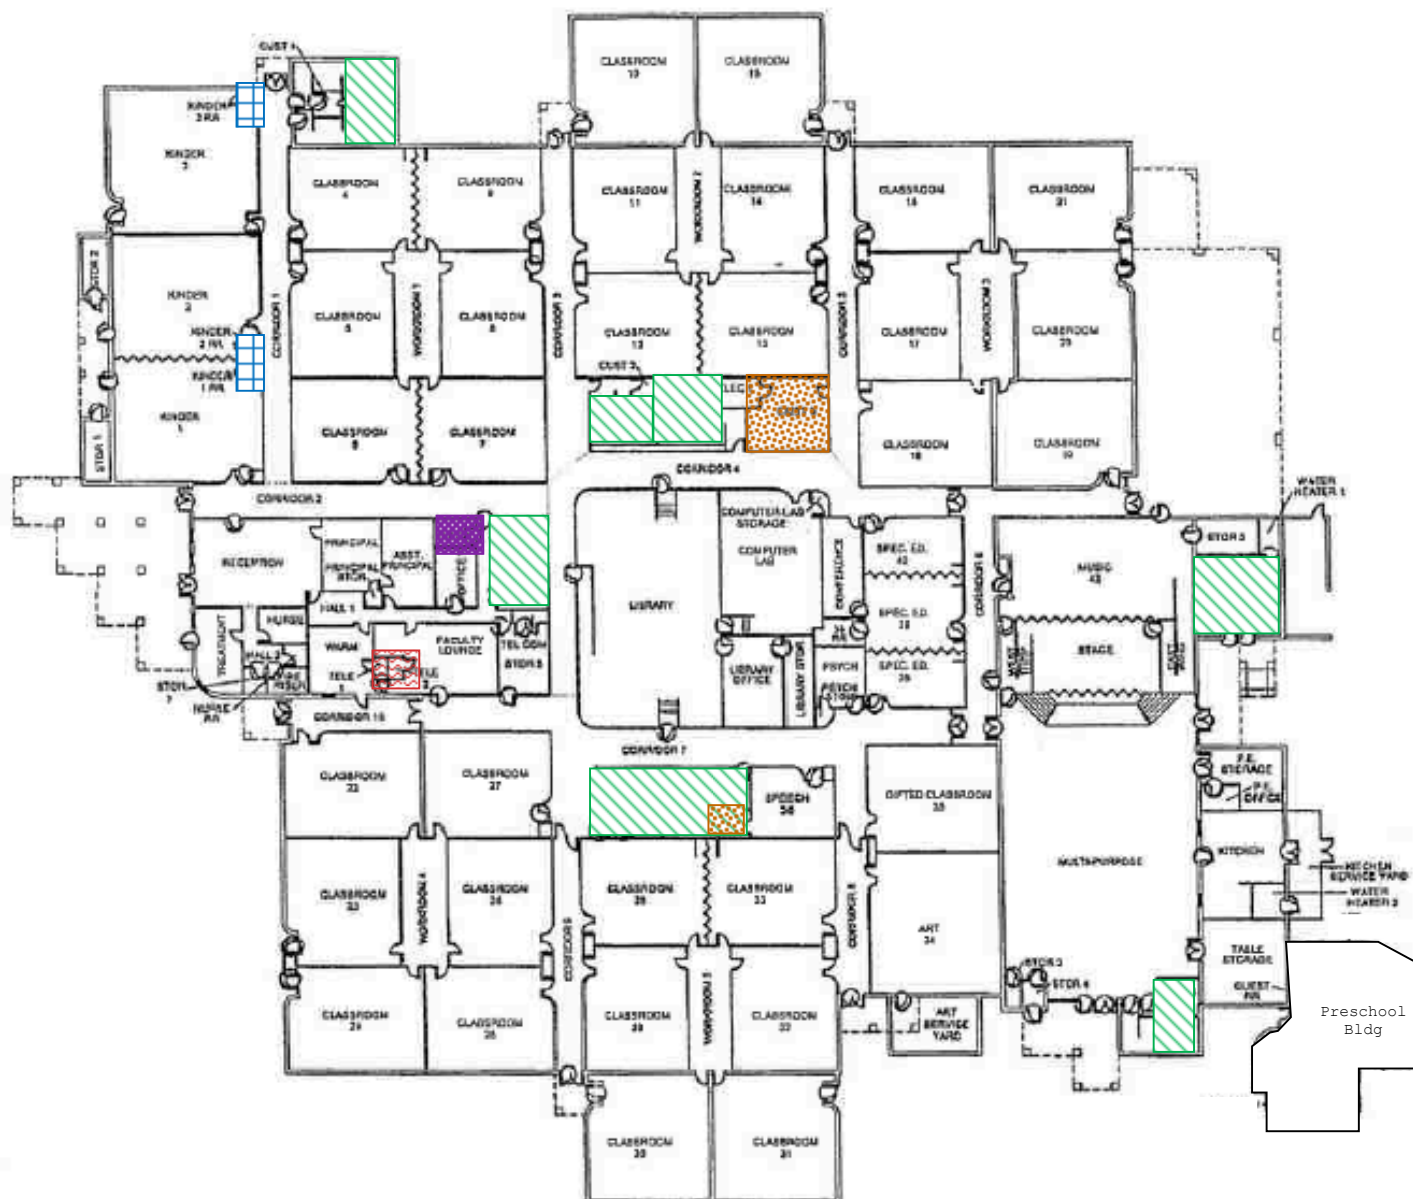
Assumed Asbestos Containing:  
Beige Speckled 12" x 12" VCT & Mastic

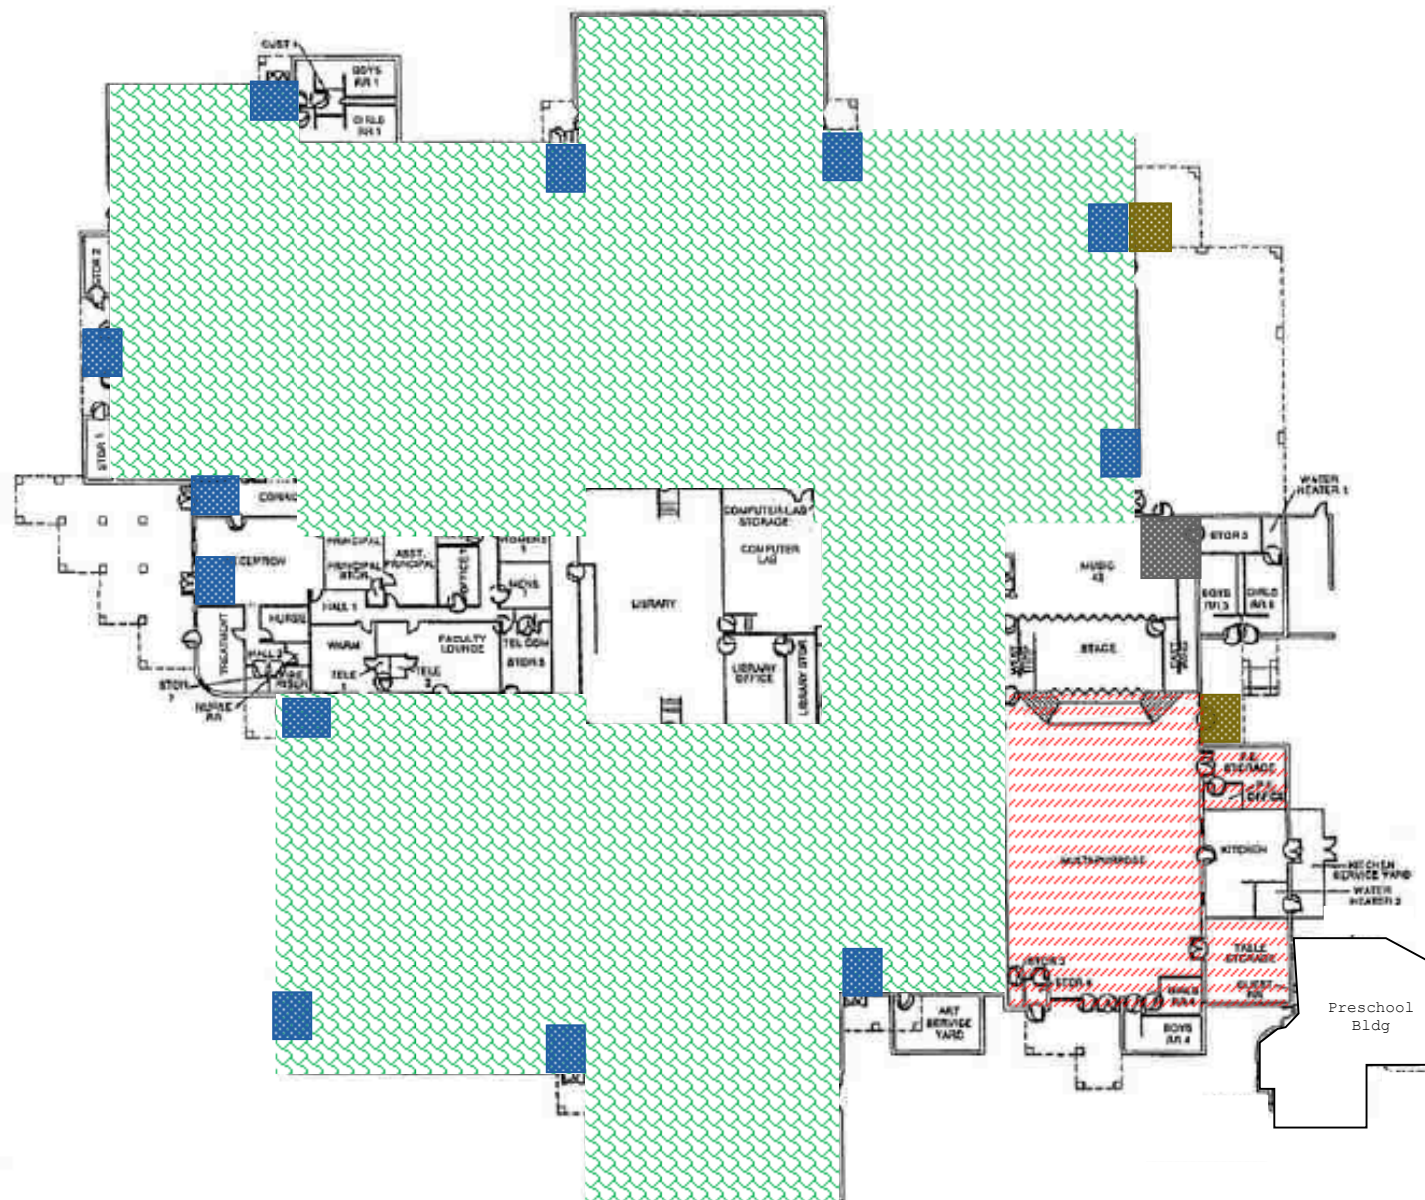
Assumed Asbestos Containing:  
 Brown w/ Tan 12" x 12" VCT & Mastic  
 Blue 12" x 12" VCT & Mastic  
 Tacboard & Mastic

Assumed Asbestos Containing:  
 Black Entry Carpet Squares & Mastic

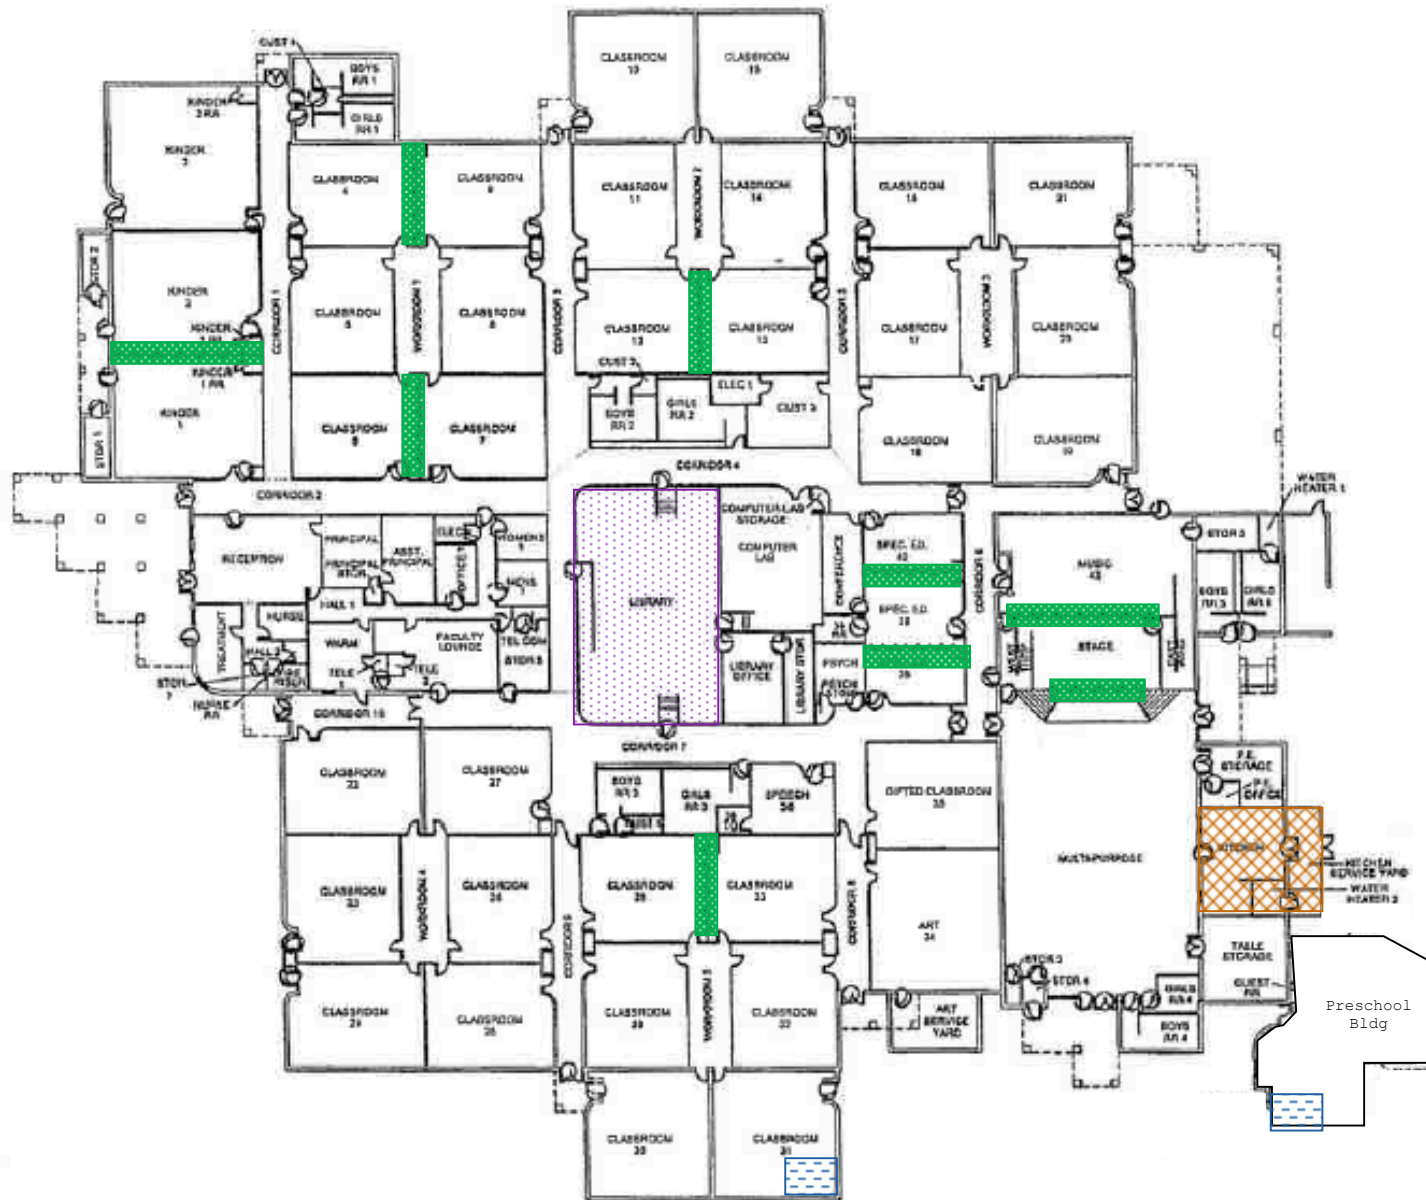
Assumed Asbestos Containing:  
 White w/ Black 12" x 12" VCT & Mastic  
 White 4" x 4" Ceramic Wall Tile, Grout, & Mastic

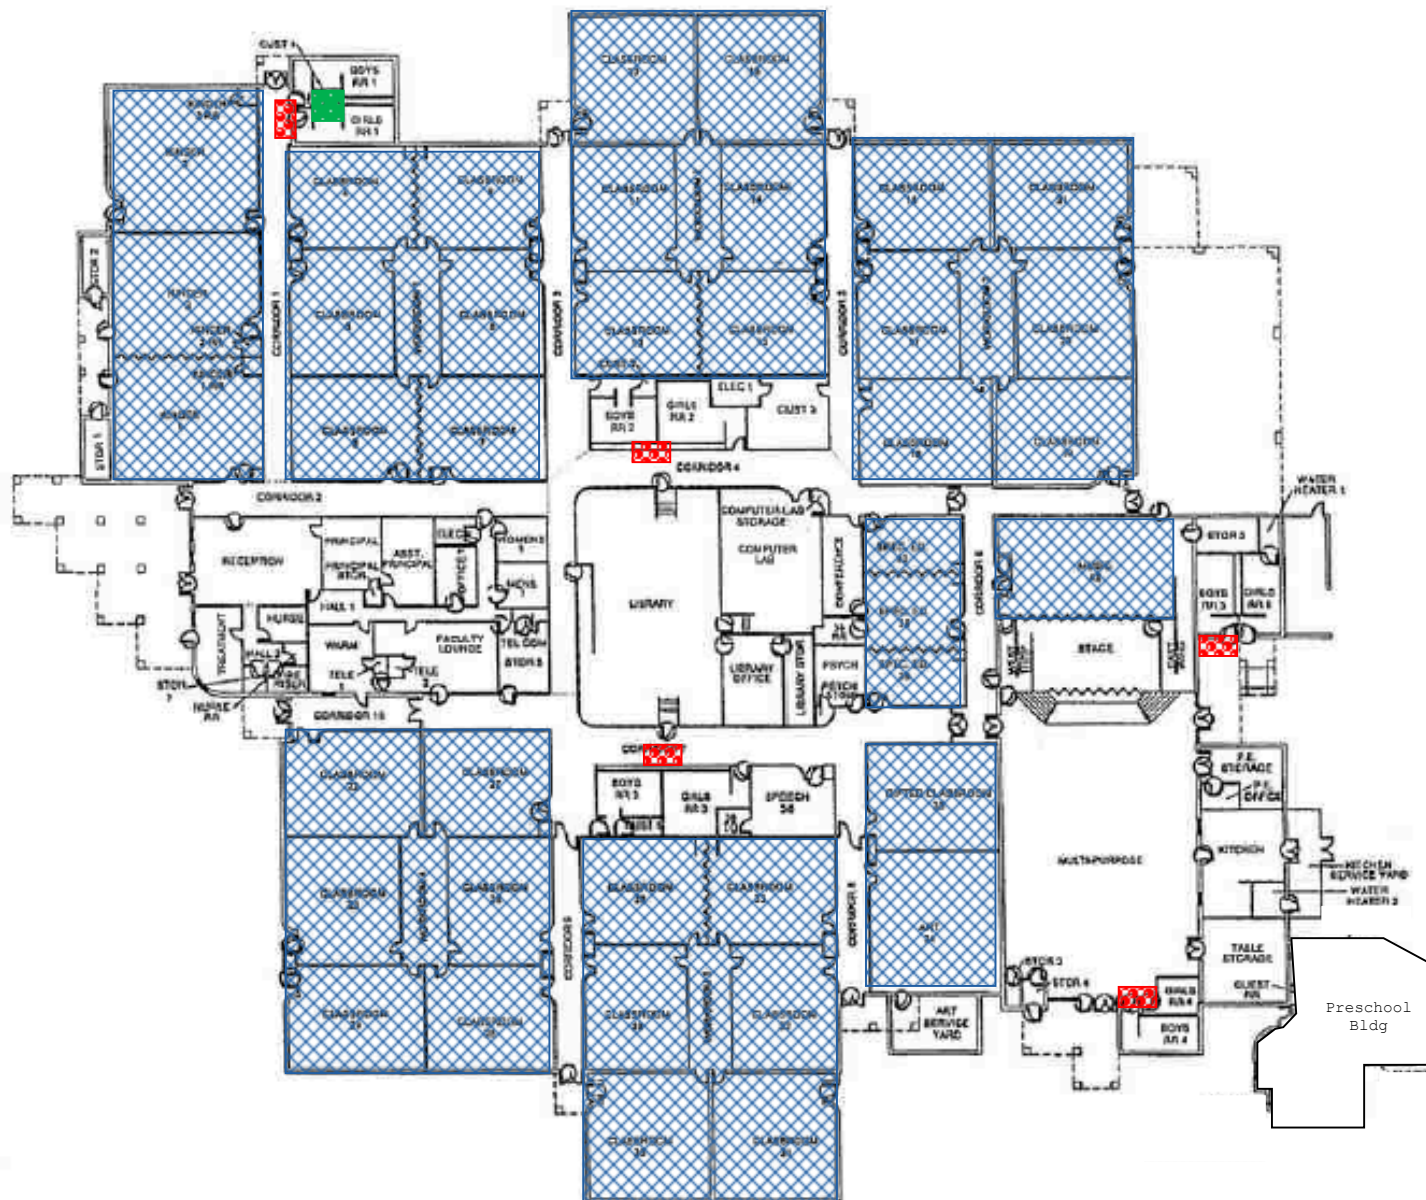
Assumed Asbestos Containing:  
Tan w/ Multi-Color Specks 12" x 12" VCT & Mastic

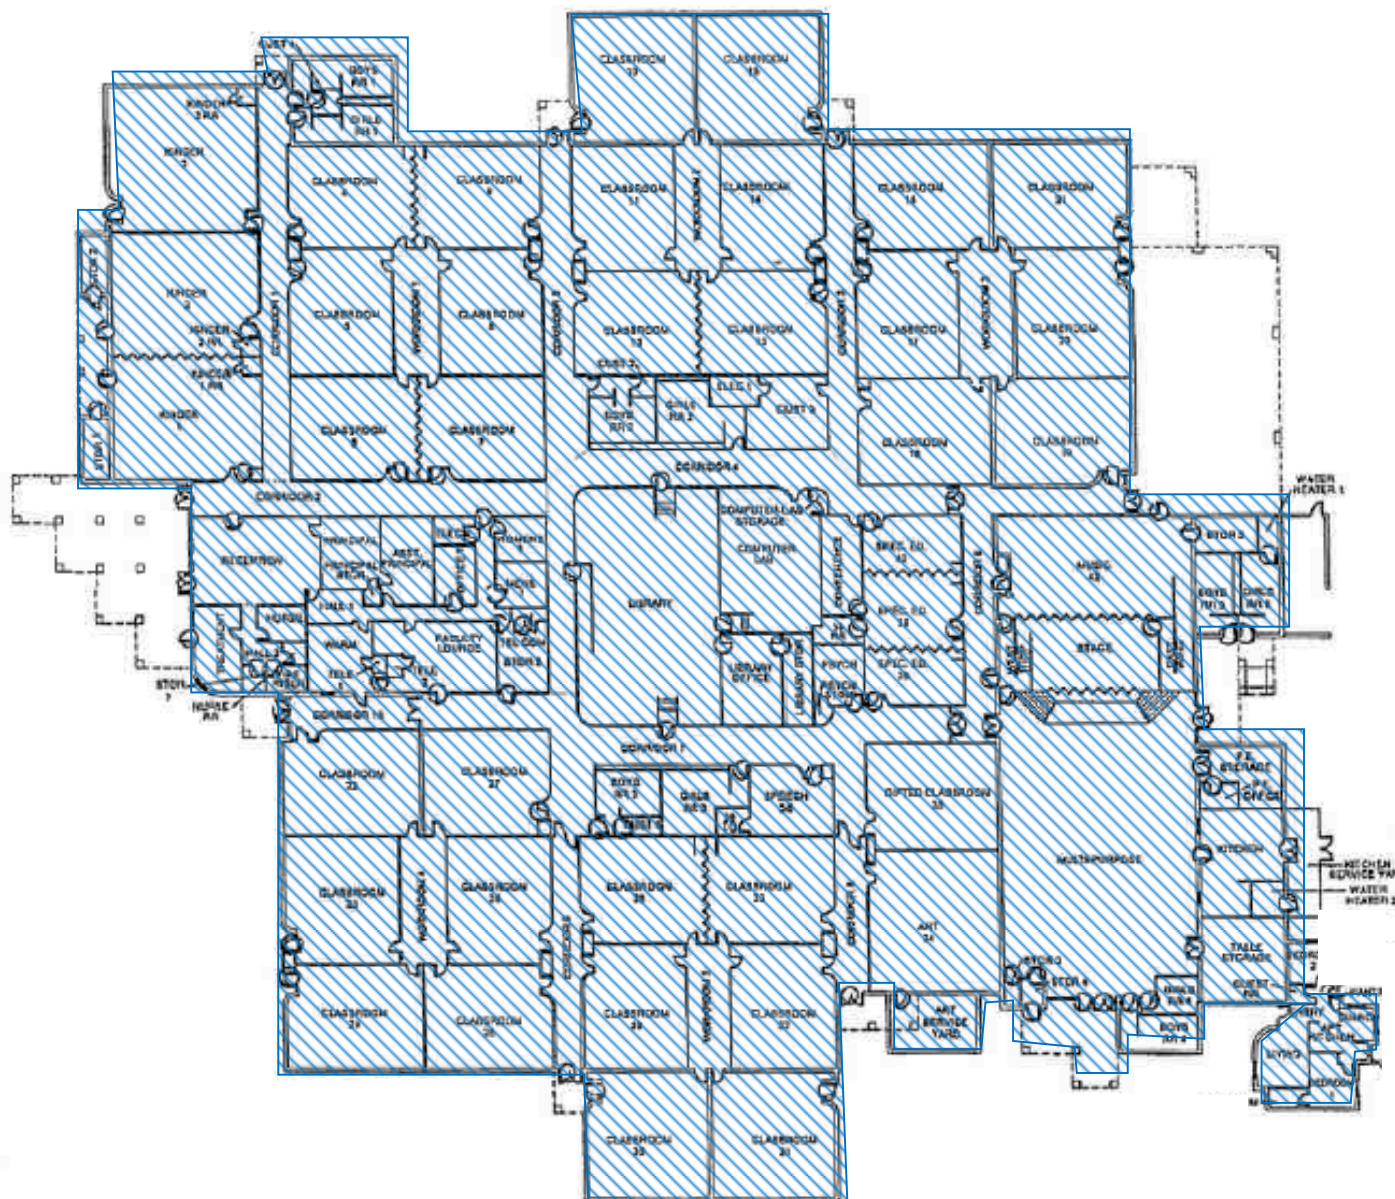
Assumed ACBM Location Map (5 of 6)  
Kyrene De La Sierra Elementary School  
1122 East Liberty Lane, Phoenix, AZ 85048

Assumed Asbestos Containing:  
Mortar for Glass Block  
Interior Caulking  
Exterior Caulking

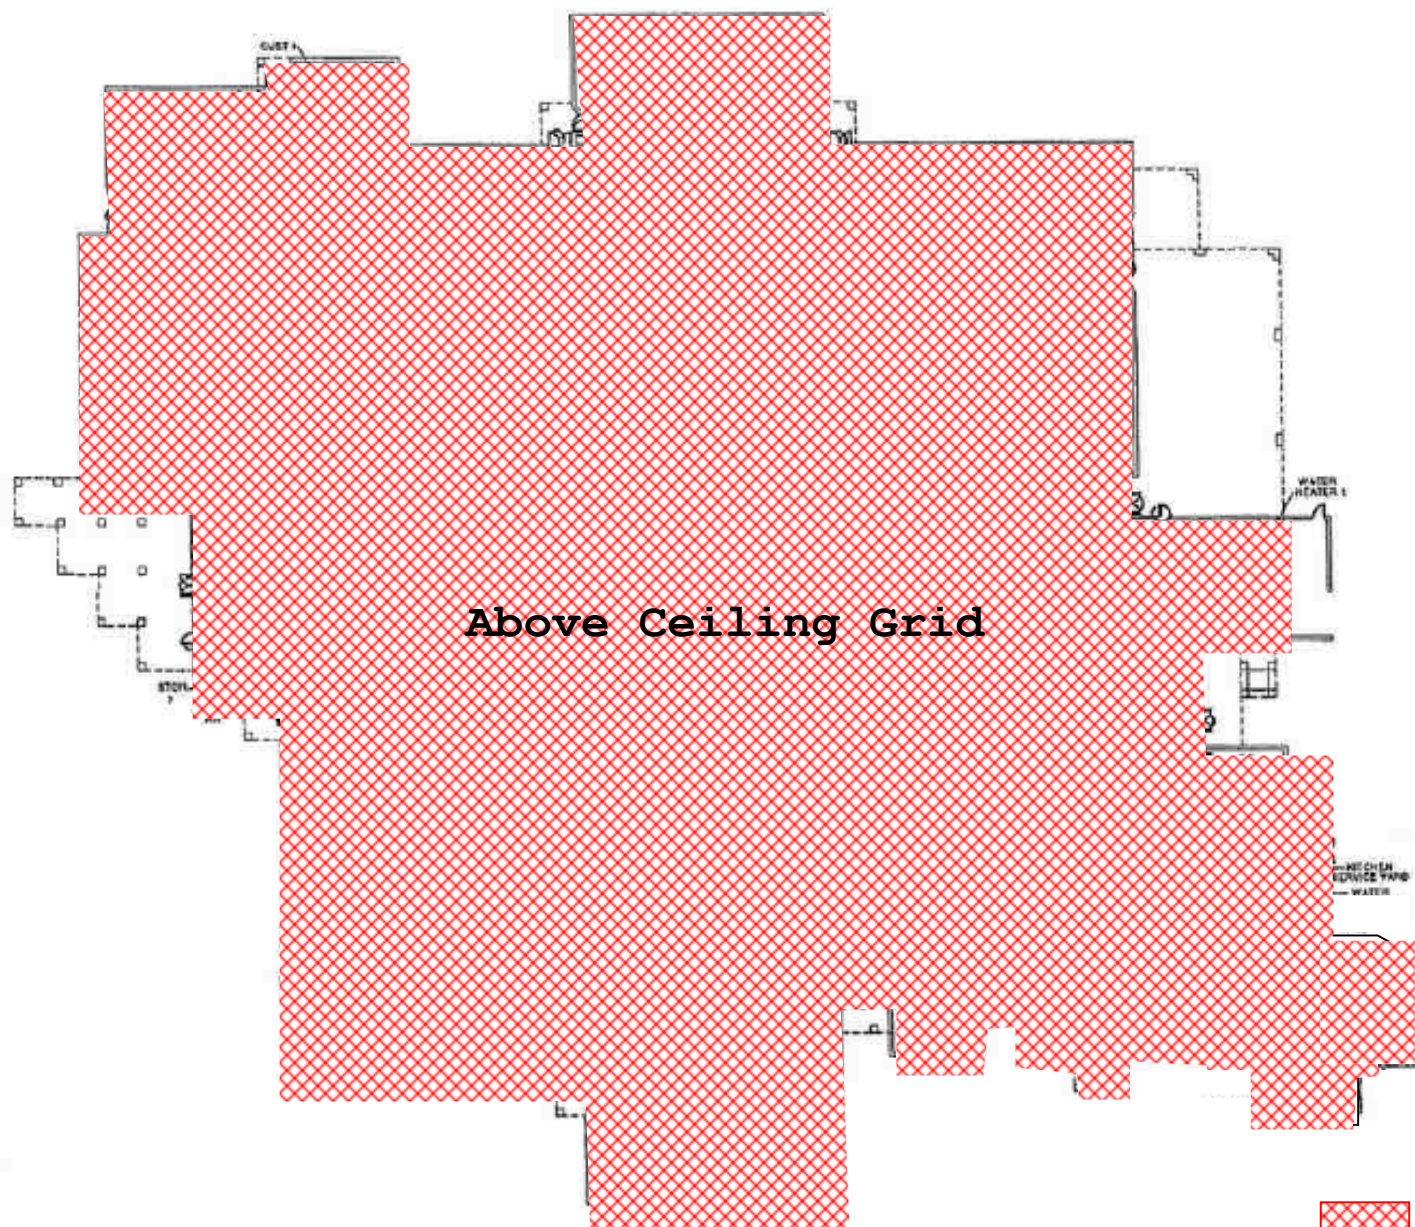
**Above Ceiling Grid**

Assumed Asbestos Containing:  
Silver Box Duct Wrap  
Silver Duct Wrap  
Silver Flex Duct Wrap  
White Duct Tape & Mastic  
Large Pipe Wrap & Mastic  
Small Pipe Wrap & Mastic  
Black Foam Pipe Wrap  
Unfinished Drywall  
Ceiling Insulation Backing  
Skylight Insulation Panel  
Silver Duct Tape
