**AHERA ASBESTOS  
INSPECTION REPORT**

**C.I. WAGGONER ELEMENTARY SCHOOL  
1050 EAST CARVER ROAD  
TEMPE, ARIZONA 85284**

Dominion Project Number: AZ1418.36

AHERA Inspection Date: June 4, 2025

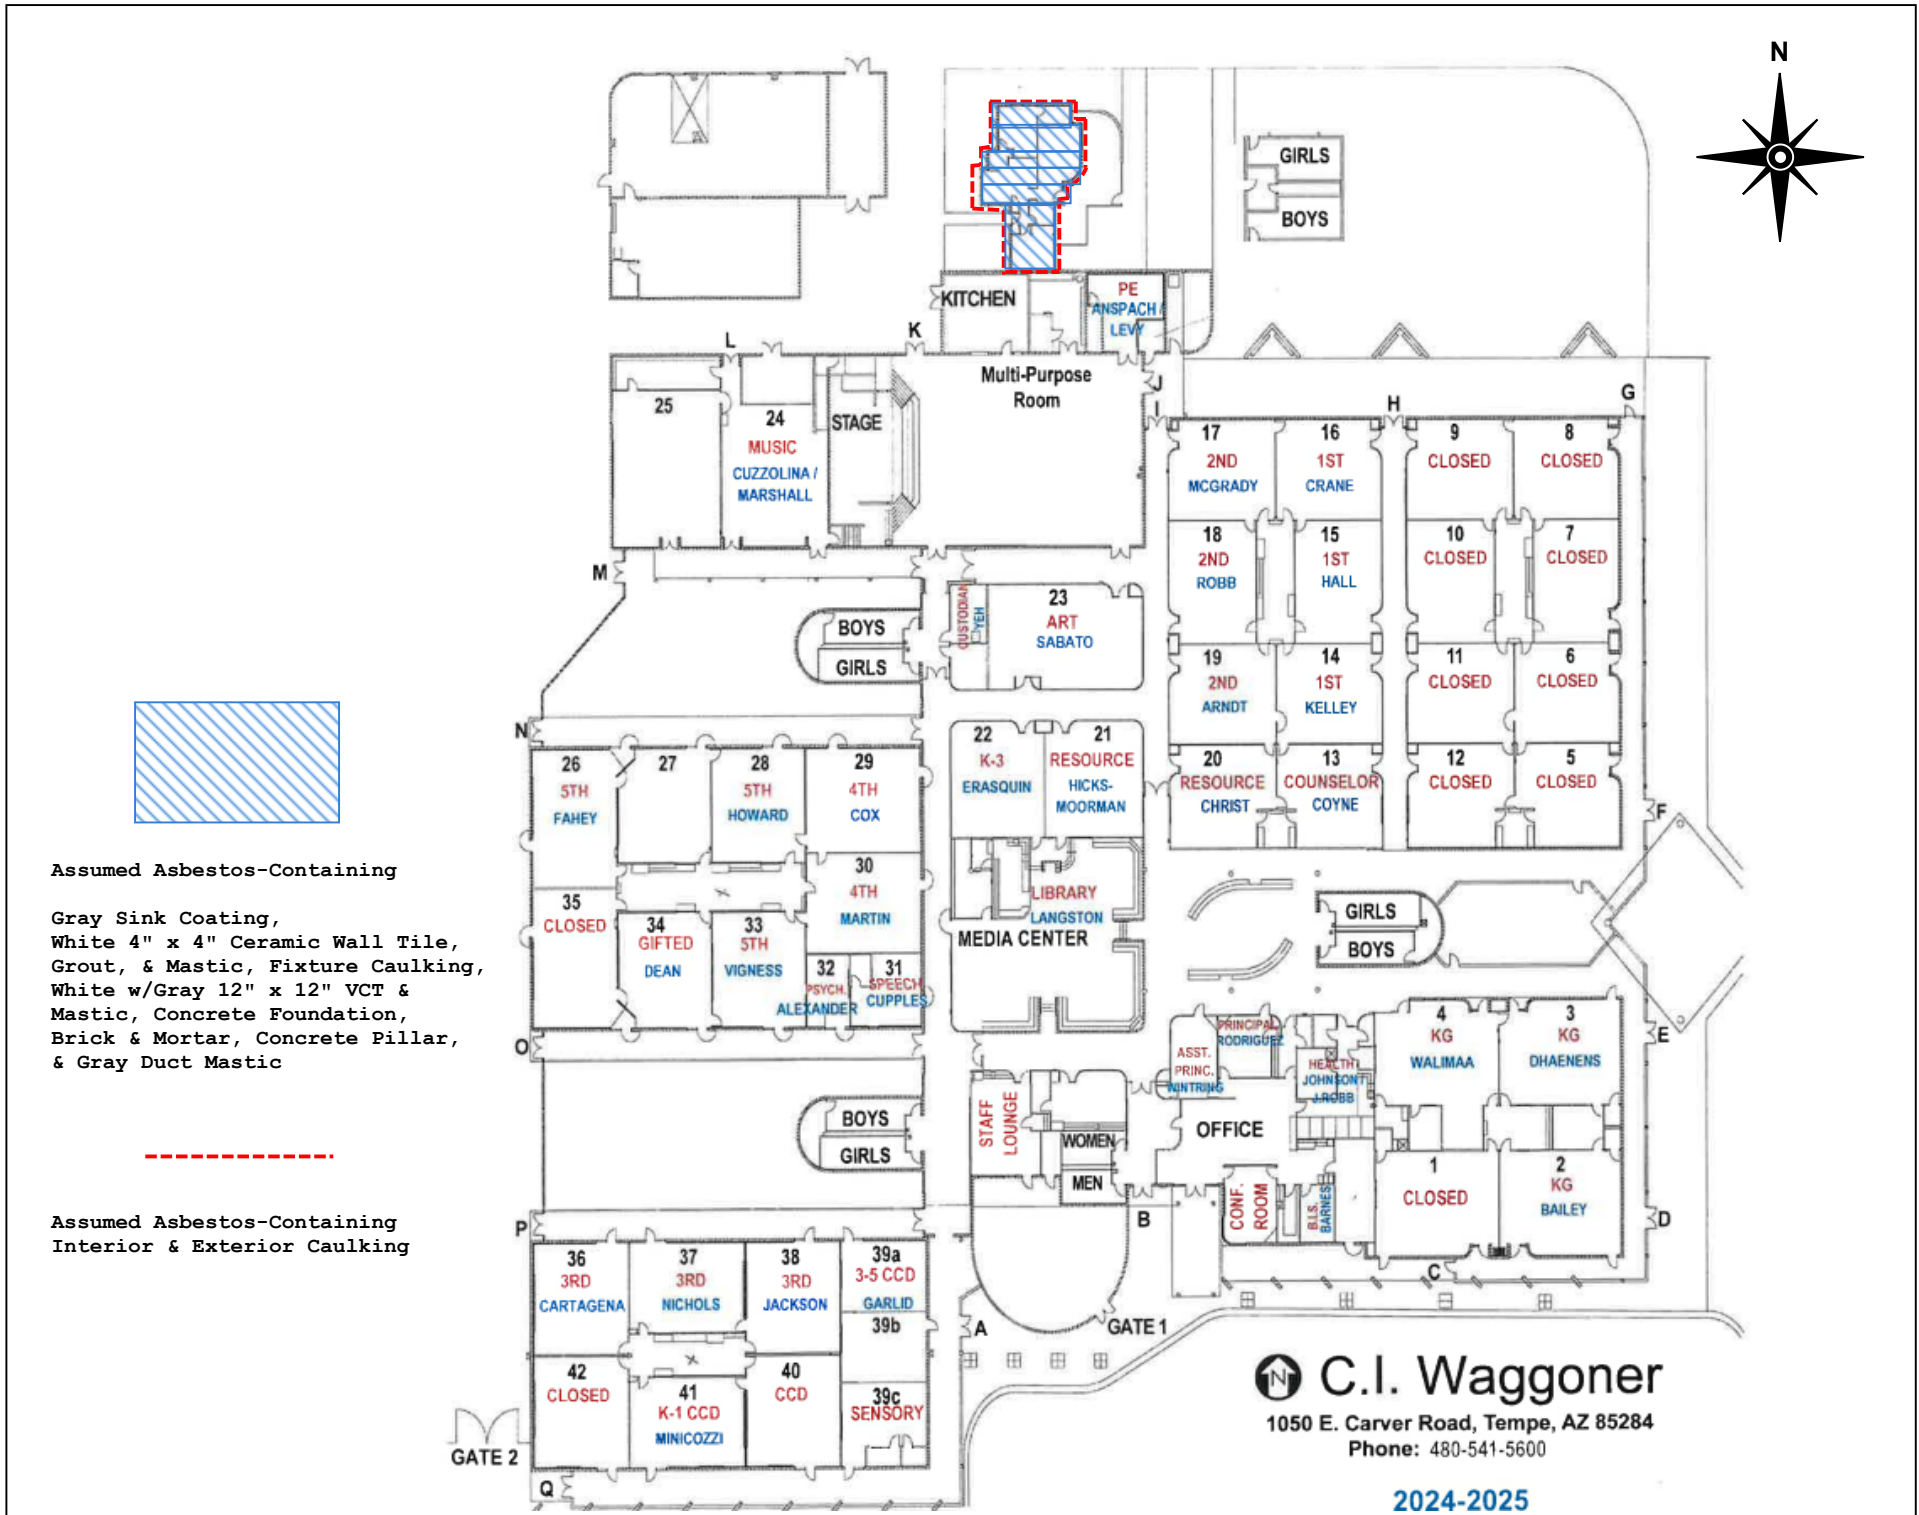
Assumed Asbestos-Containing Material Location Map (1)  
C.I. Waggoner Elementary School  
1050 East Carver Road, Tempe, Arizona 85284

Silver Duct Wrap & Insulation,  
Silver Flex Duct & Insulation,  
Large Silver Duct Wrap  
& Insulation,  
Large Silver Flex Duct Wrap  
& Insulation,  
Pipe Wrap, Mastic, & Insulation,  
Black Foam Pipe & Insulation,  
& Pink Wall Insulation &  
Backing

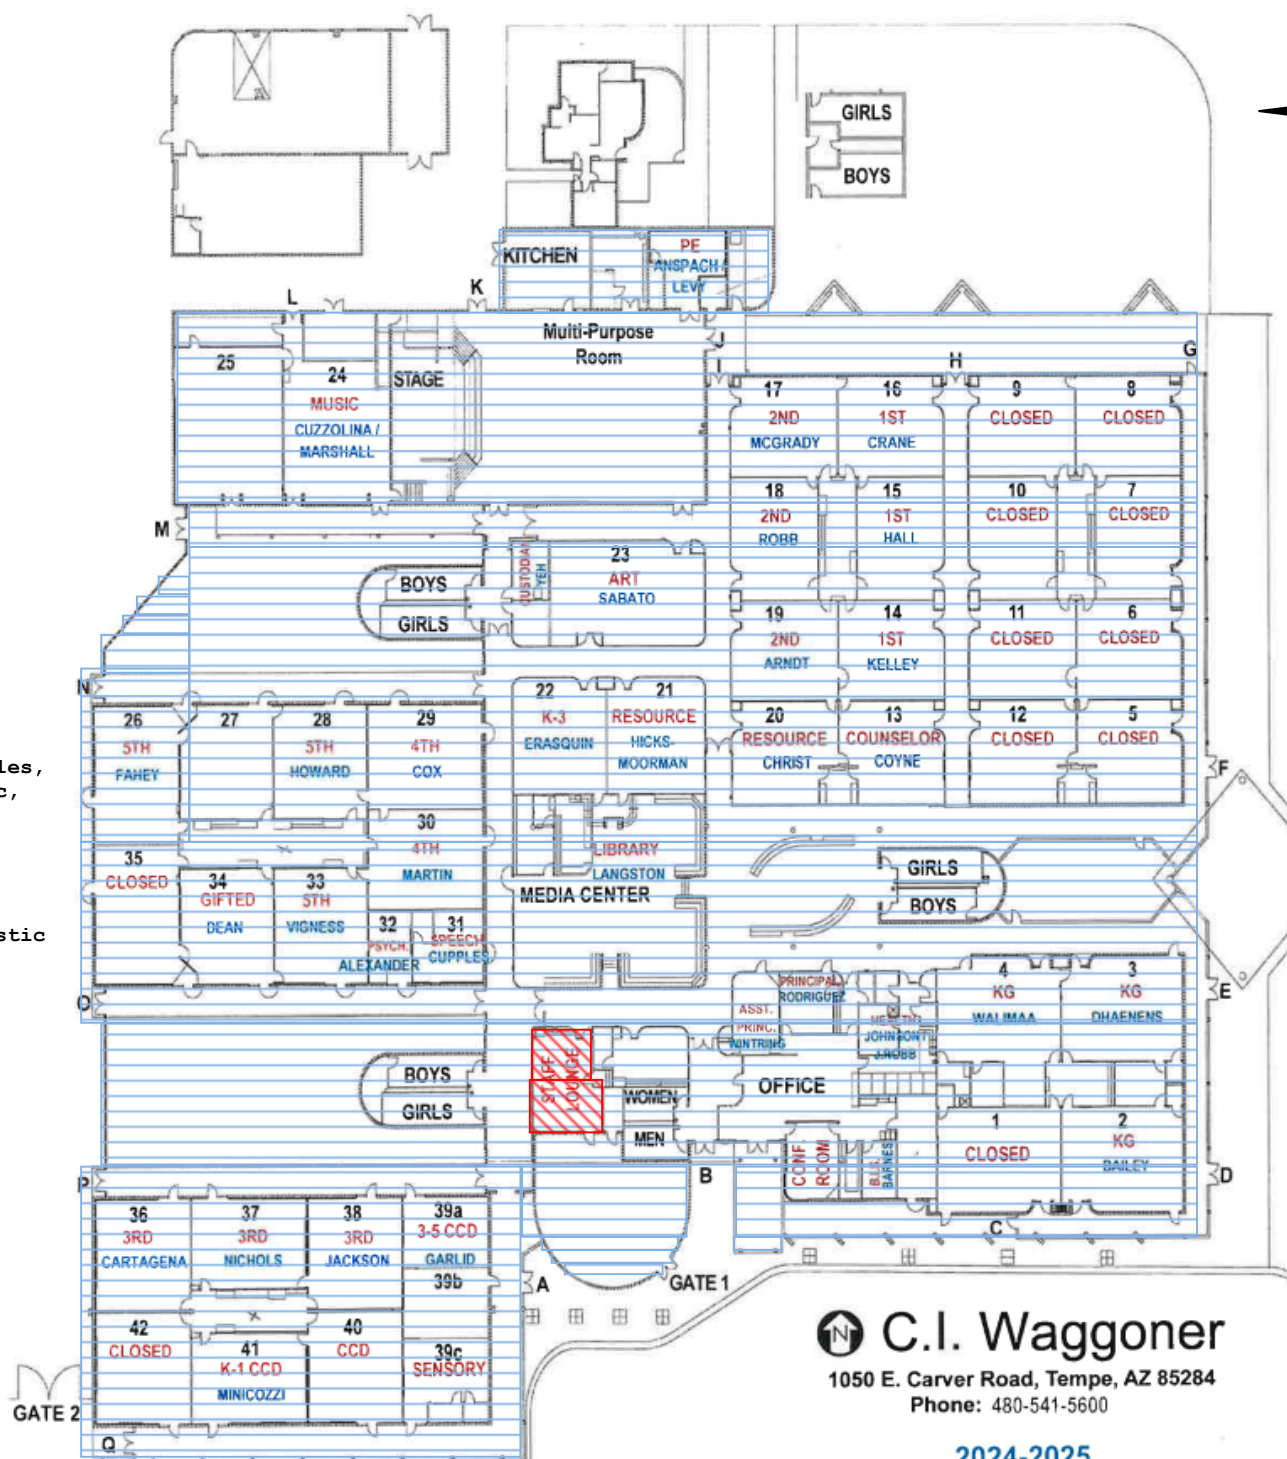
Dark, Light Blue, Teal & Tan  
8" x 8" Ceramic Wall Tile,  
Red & Gray Caulking for  
Ceramic Wall Tiles, Mosaic Tiles,  
& Mortar, Blue Carpet & Mastic,  
FRP & Mastic, Tan, Dark Blue,  
& Light Blue 2" x 2" Ceramic  
Floor Tile, Grout, & Thinset,  
Fixture Caulking,  
Dark Blue Carpet & Mastic,  
& Gray Soundboard, Grout & Mastic

Tan Multicolor 12" x 12"  
VCT & Mastic & Light Blue  
12" x 12" VCT & Mastic

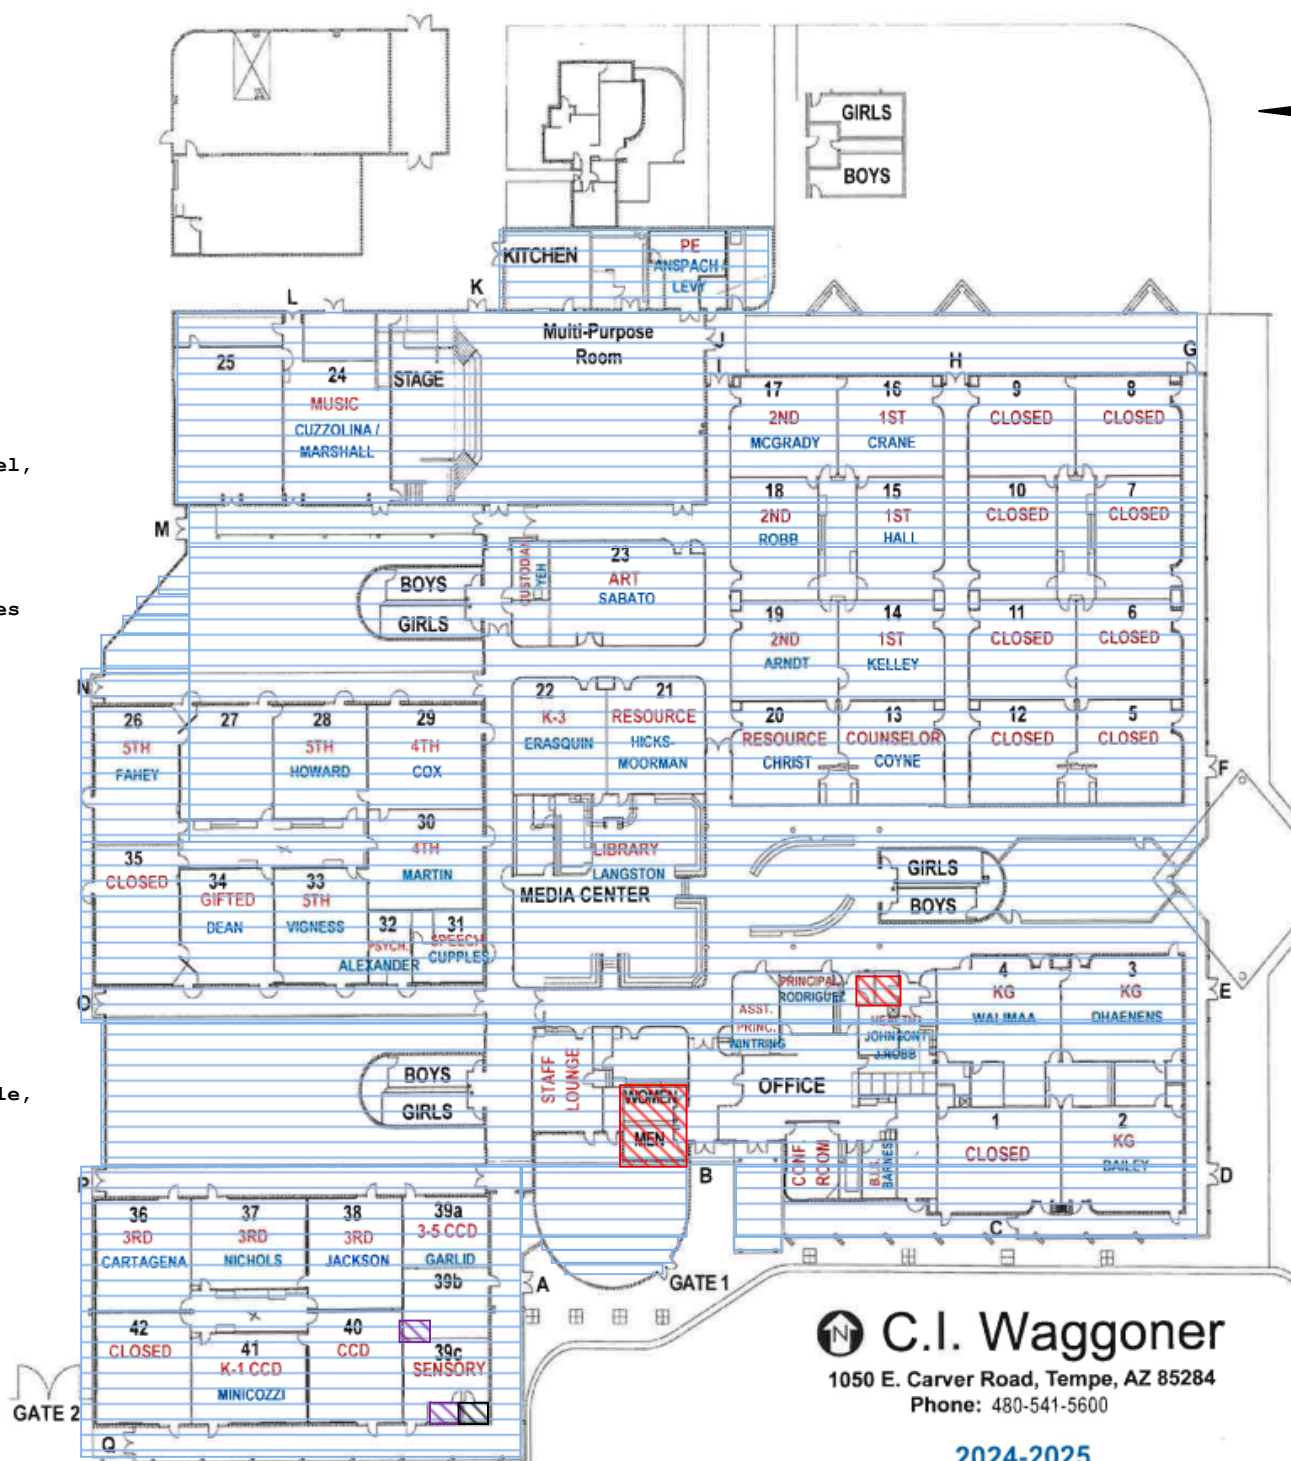
Assumed Asbestos-Containing Material Location Map (3)  
C.I. Waggoner Elementary School  
1050 East Carver Road, Tempe, Arizona 85284

Assumed Asbestos-Containing  
Gray 12" x 12" VCT & Mastic
