## GREENWICH PUBLIC SCHOOLS PERFORMANCE PLATFORM STAGE FACILITY ASSESSMENT

**GREENWICH PUBLIC SCHOOLS  
290 GREENWICH AVENUE  
GREENWICH, CT 06830**

**25558.00**

**June 27, 2025**

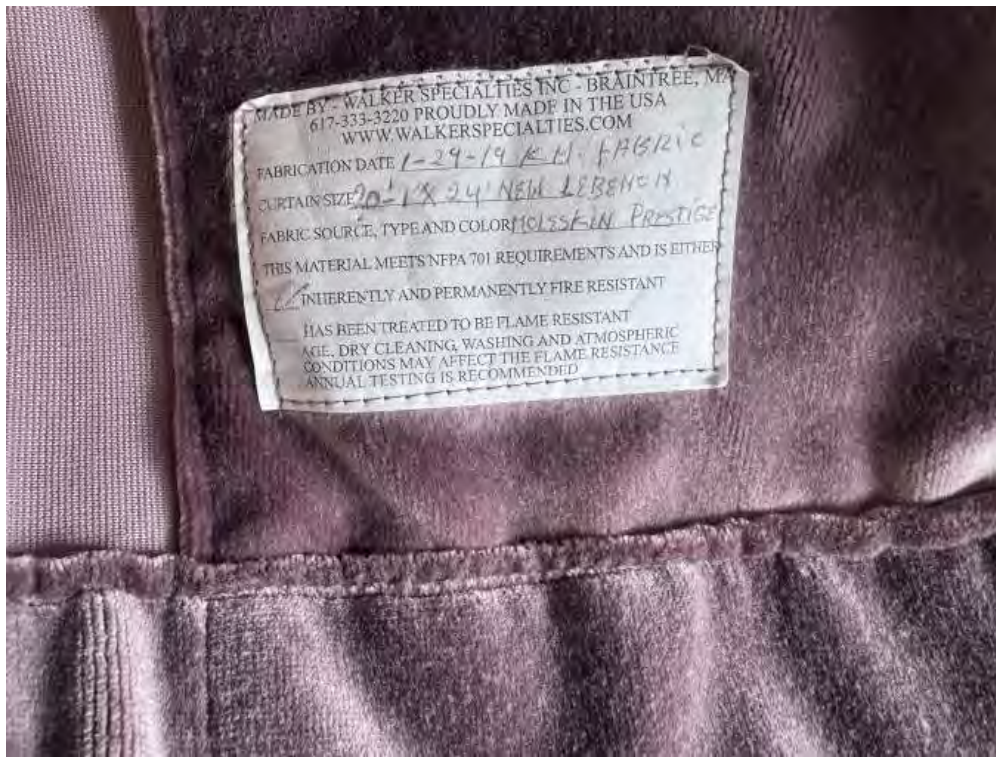
Lebanon School has a basic rigging system consisting of a valance, front main traveller curtain, side leg curtains on tracks and a rear traveller track. The front traveler track were in good working order. The front traveller floor pulley was missing the center bolt. The rigging is connected to a ceiling track system that is atypical for theatrical rigging, however, given the weight of the curtain tracks, I think this is an acceptable connection. Track connection rigging is acceptable but messy and should have excess chain removed. The lighting system on stage is architectural lights and offers little performance flexibility.

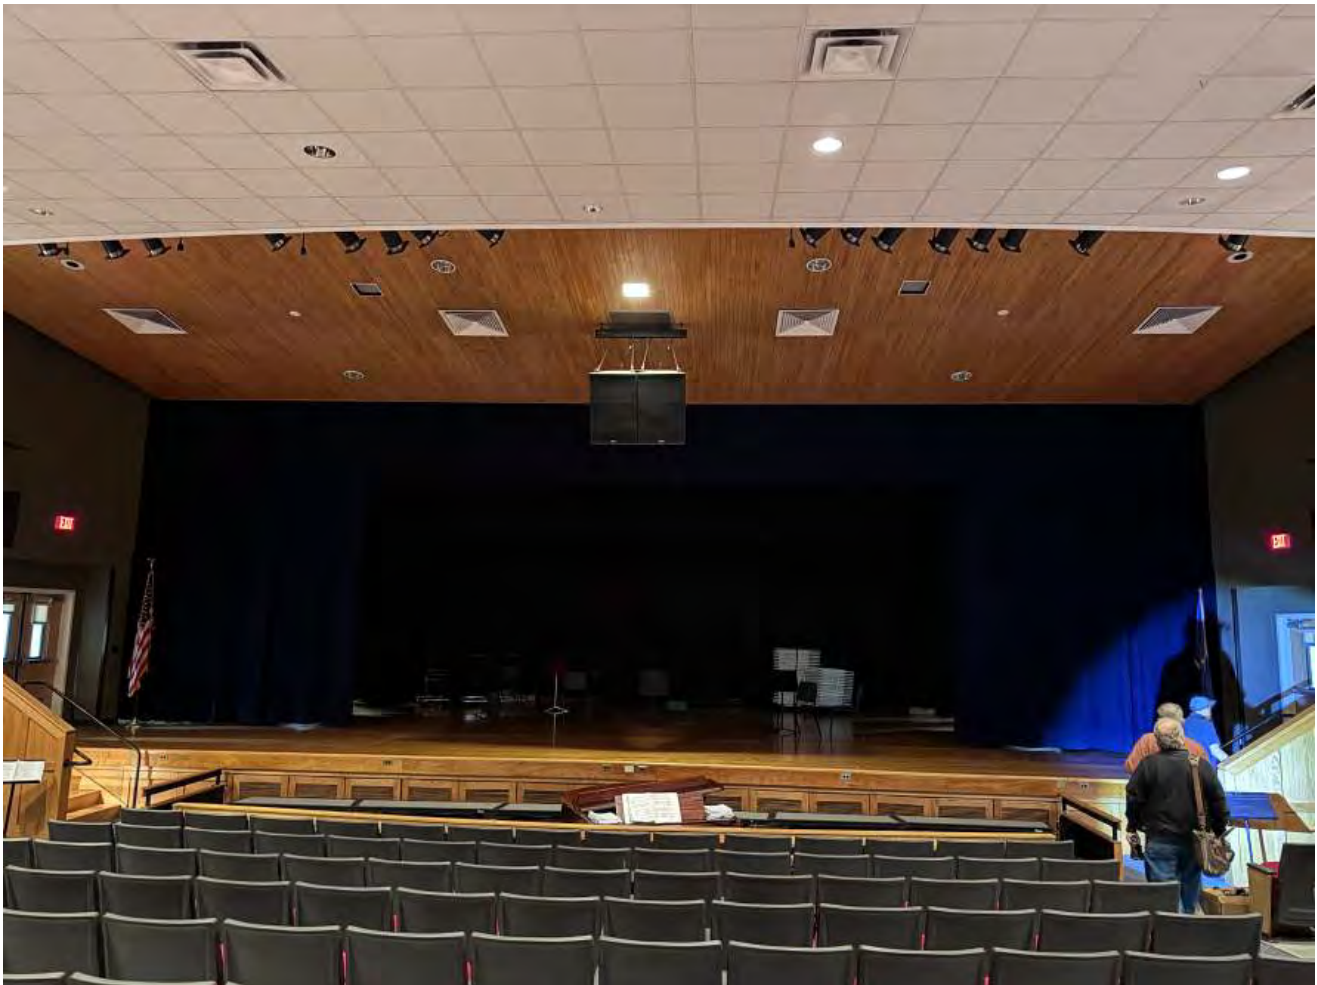
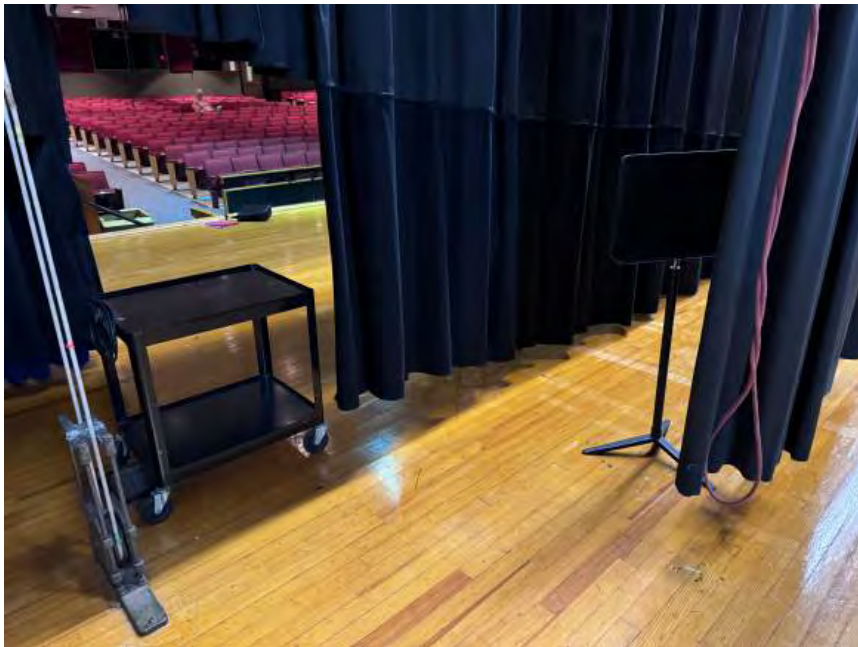
Western School has a full rigging system consisting of a valance, front main, mid and rear traveller curtain, side leg curtains on tracks and a rear traveller track. The front traveler track is improperly rigged with unrated chain

the carriers and pulleys are worn and need replacement. Several of the support battens are undersized and should be replaced. The most critical issue is the old hemp system. The system should be removed as soon as possible. The hemp rope can fail given the age of the system. The lines are not properly secured to the pin rails. The biggest risk is improper use of the system. The lines don't have a safety system preventing the lines from running if untied from the pin rail, this could lead to a batten crashing on the deck. The electric lift winches lack

safety braking systems and should be replaced.

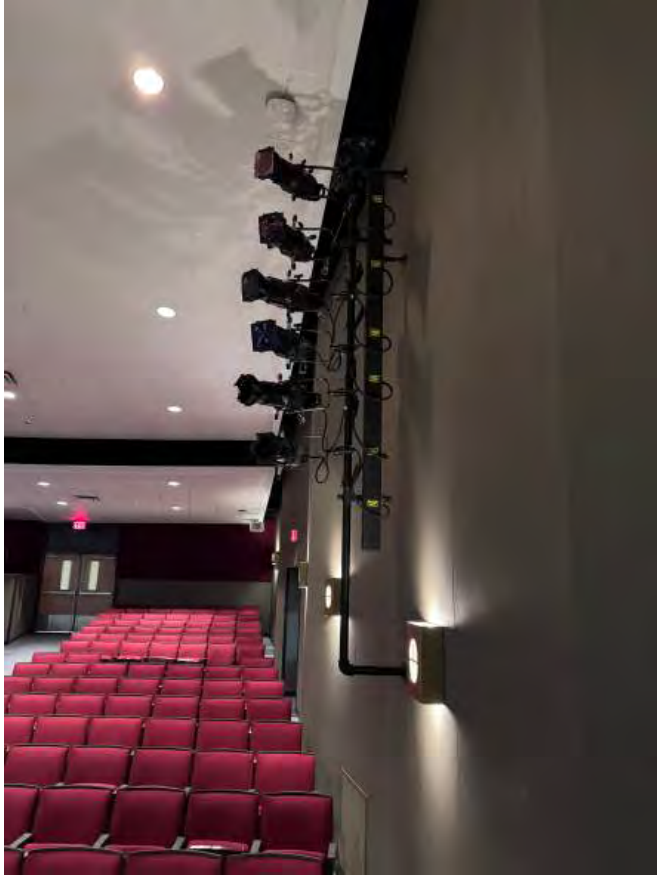
The house Torarm pipes are made with coupled sections which does not meet currently industry standards. The standard ANSI E1.4-2 requires that the pipe sections be welded or mechanically joined. It should be monitored periodically to see if there is any failure.

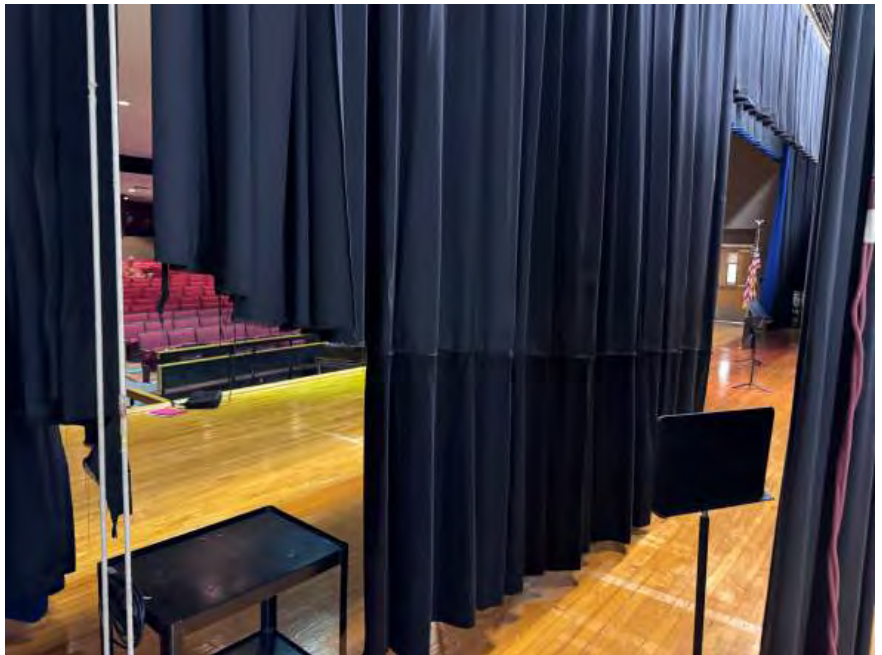
The drapes are listed as inherently and permanently flame retardant. Drapes appear worn and several of them are torn or stained. A significant number of them need replacement

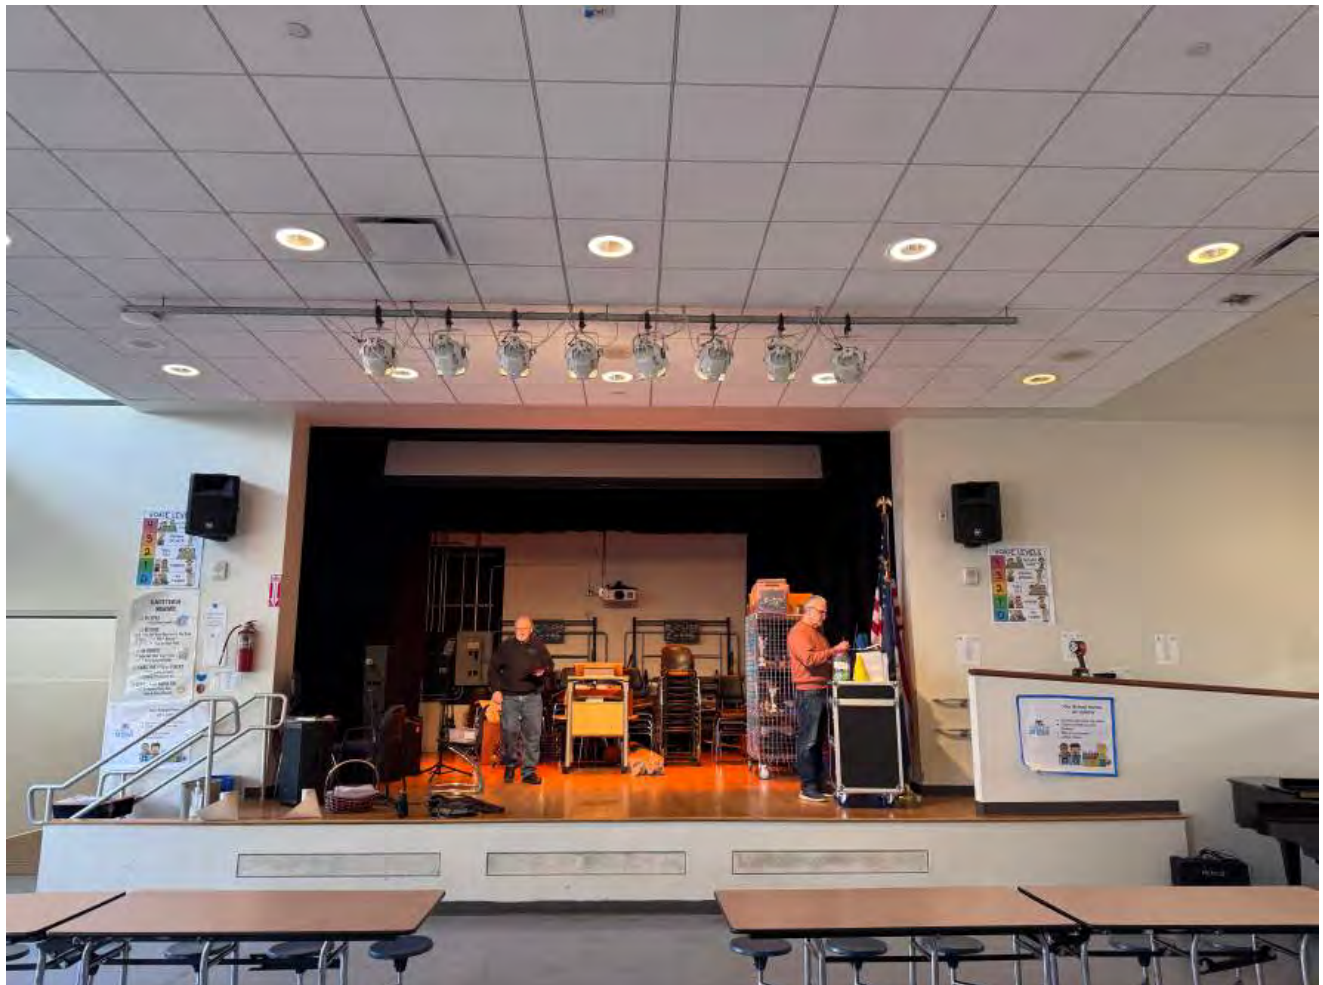
Hamilton Ave School has a basic rigging system consisting of a valance, front main traveller curtain, side leg curtains on tracks and a rear traveller track. The front traveler track were in good working order but operations stiff and should be updated. The supporting rigging pipes are undersized and not installed to current standards. Supporting unistrut was installed upside down.

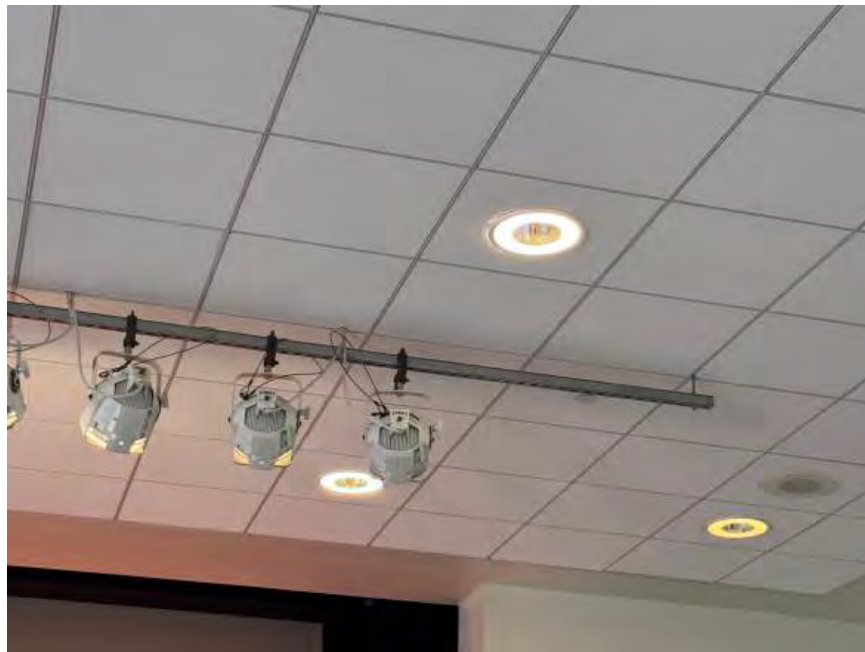
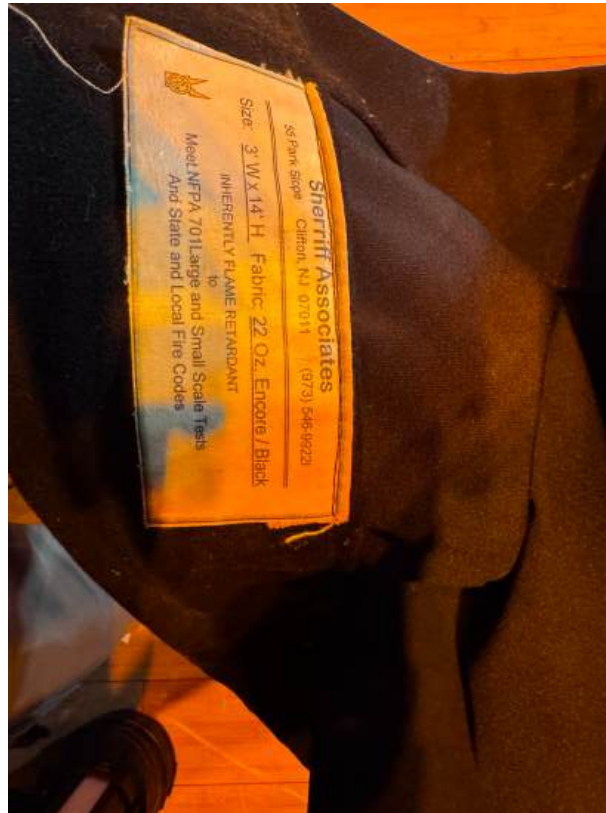
The lighting system on stage is significantly out of date and offers little performance flexibility.

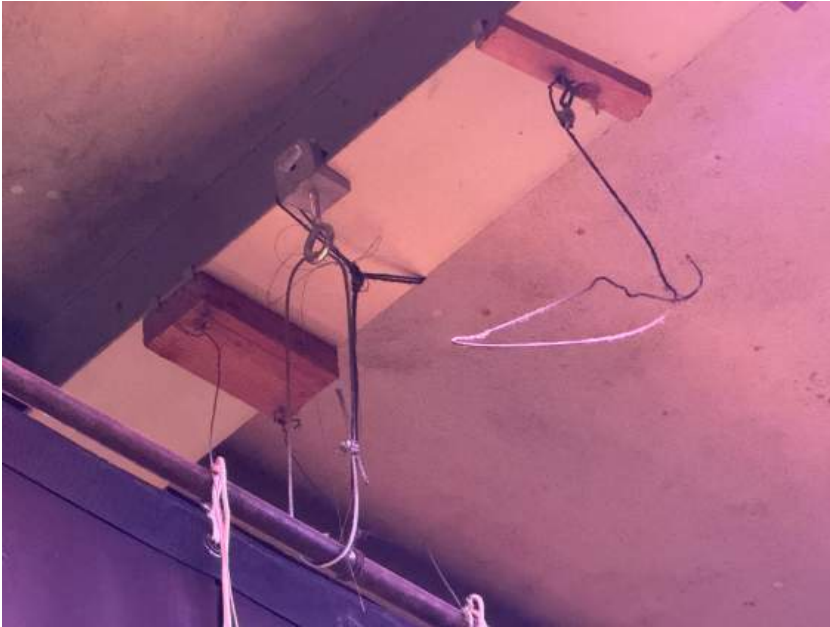
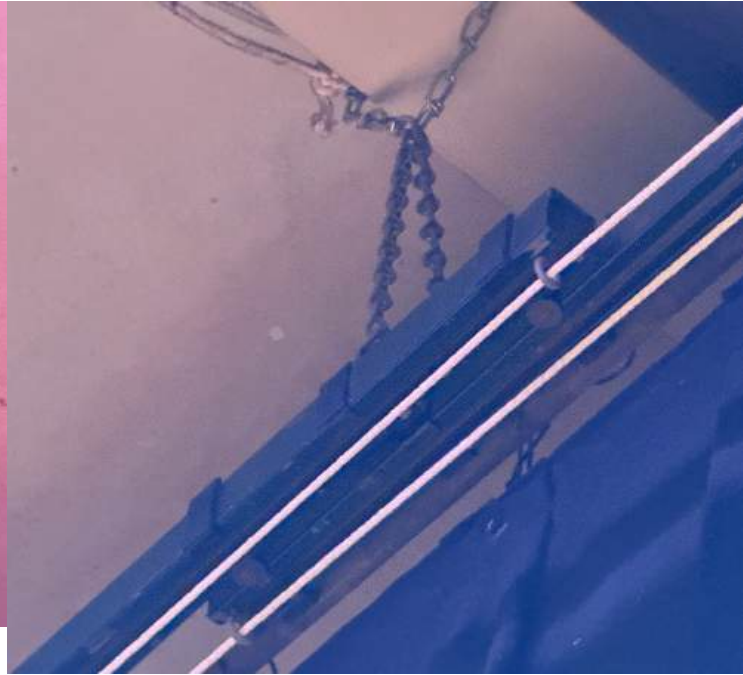
Julian Curtiss School has a basic rigging system hung from the building on steel I beams. All of the rigging is not up to current or acceptable industry standards and should be replaced. Current layout consists of a front main traveller curtain, valance, side leg curtains and a rear traveller tracks. The rigging on all of the tracks is in need of replacement. Several of the curtain pipes are undersized and hanging from chain and connections that are not rated for overhead use and should be replaced. Unrated chains are running through the beams and need to be replaced with rated beam clamps.

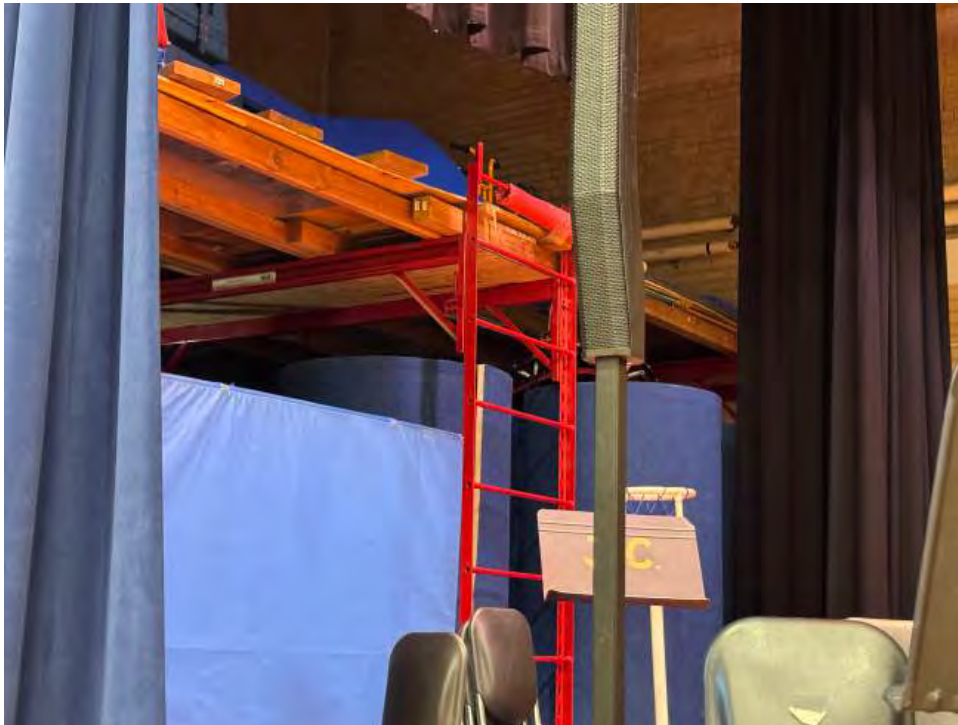
There is a loft on the stage right side that is built using baker scaffolding as the support structure. This should not be used outside of manufacturers recommendations. Use in this manner could lead to collapse and someone getting seriously hurt. I recommend removal.

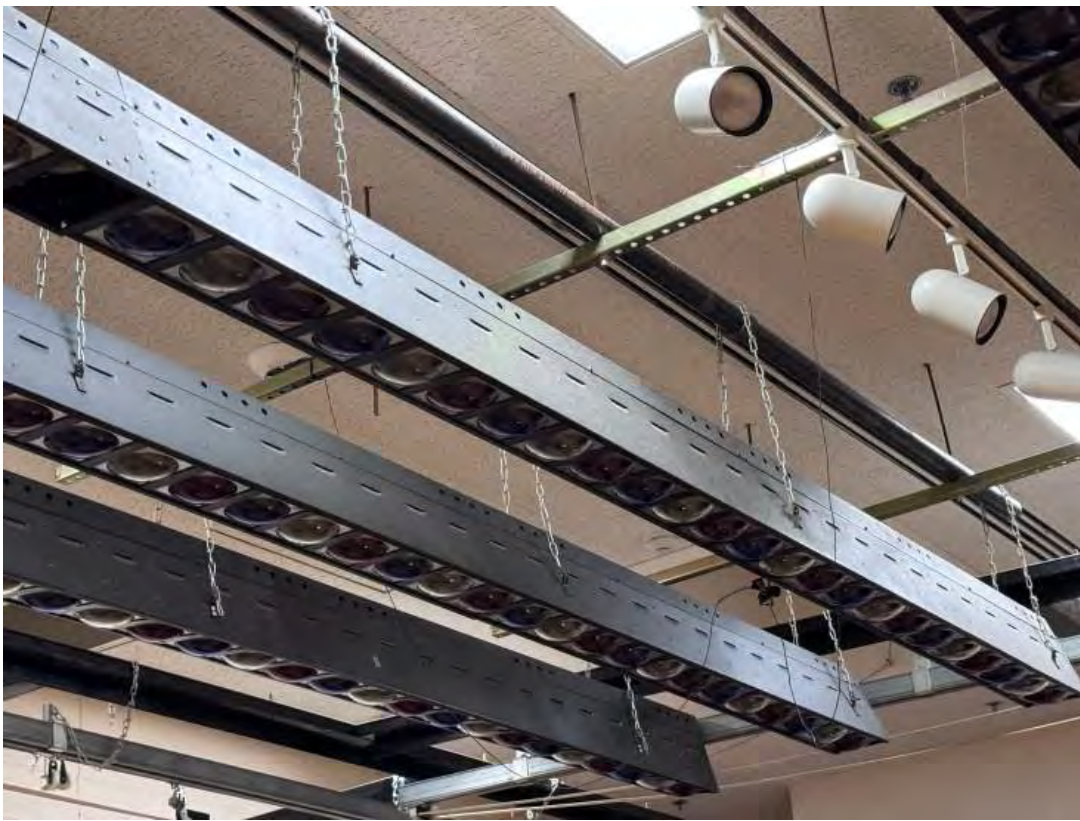
Cos Cob School has a basic rigging system hung from the building on a pipe grid system. All of the rigging is not up to current or acceptable industry standards and should be replaced. Current layout consists of a front main traveller curtain, valance, side leg curtains and a rear traveller tracks. The rigging on all of the tracks is in need of replacement. The lighting system is hanging from unrated chain and connectors that should be upgraded as soon as possible. The pipes are hanging from unistrut that was installed incorrectly. Several of the curtain pipes are oversized and hanging from chain and connections that are not rated for overhead use and should be replaced.

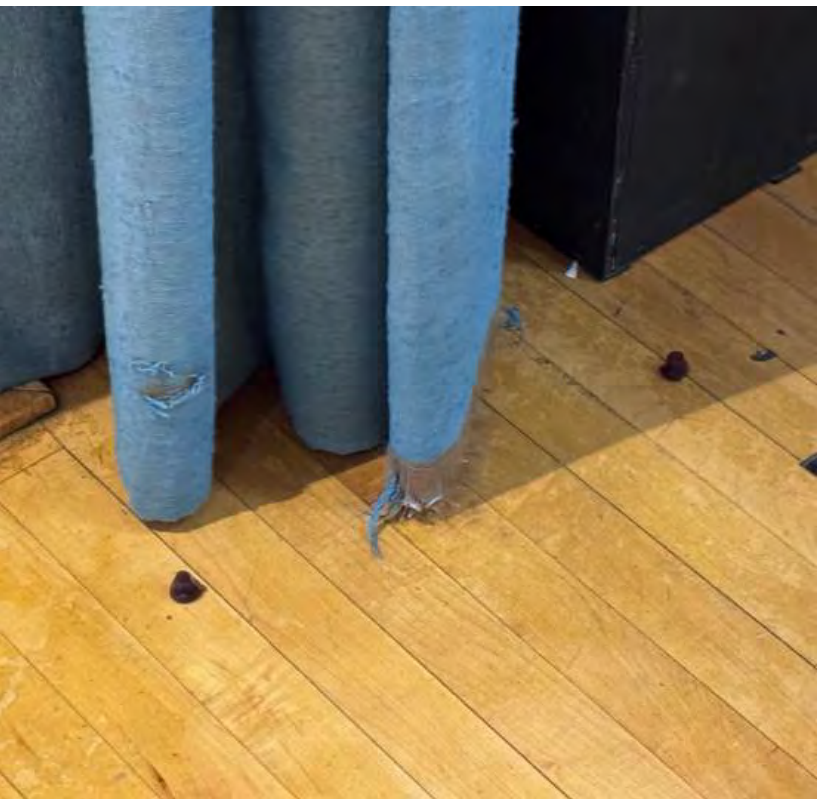
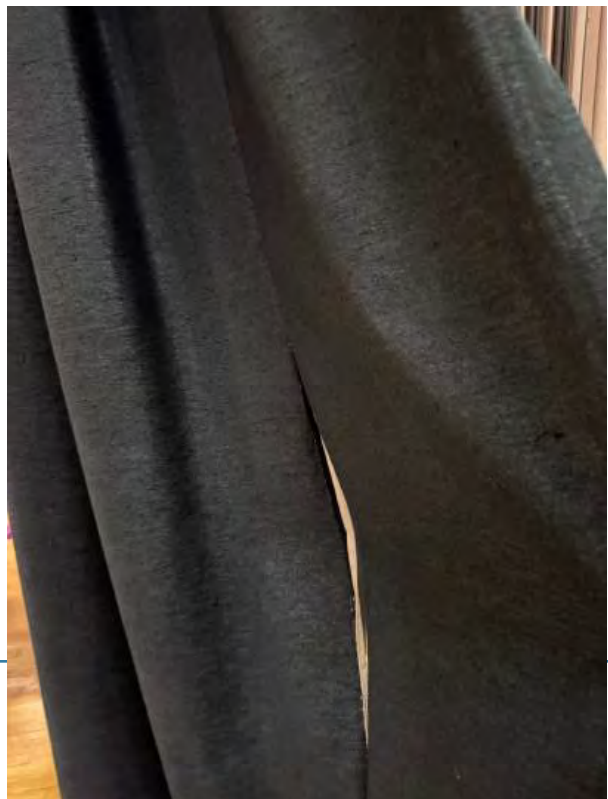
The drapes are in poor condition. The main curtain is worn and torn in several places. The rear and side curtains were in similar need of replacement.

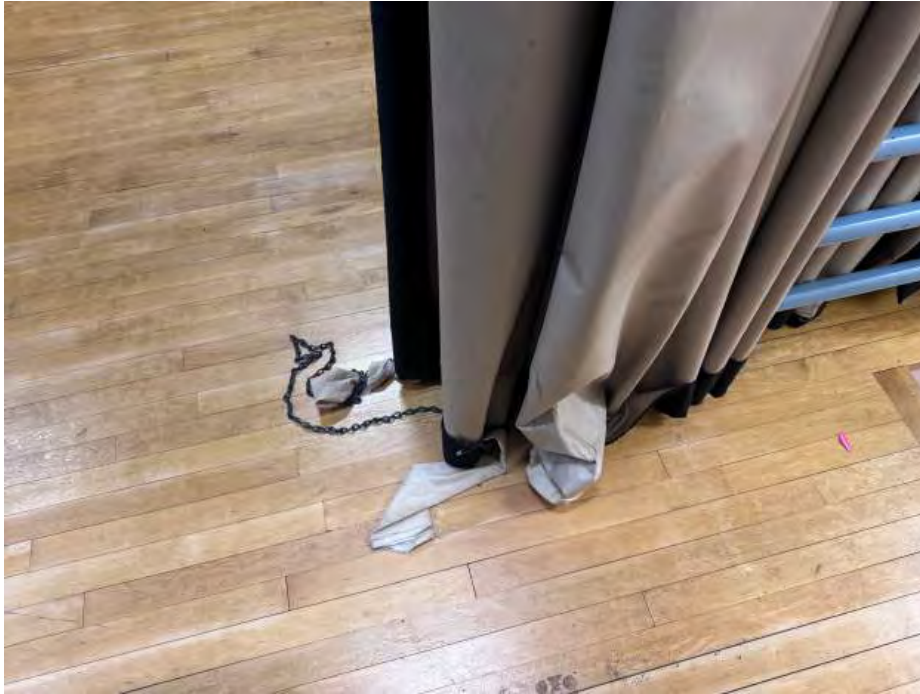
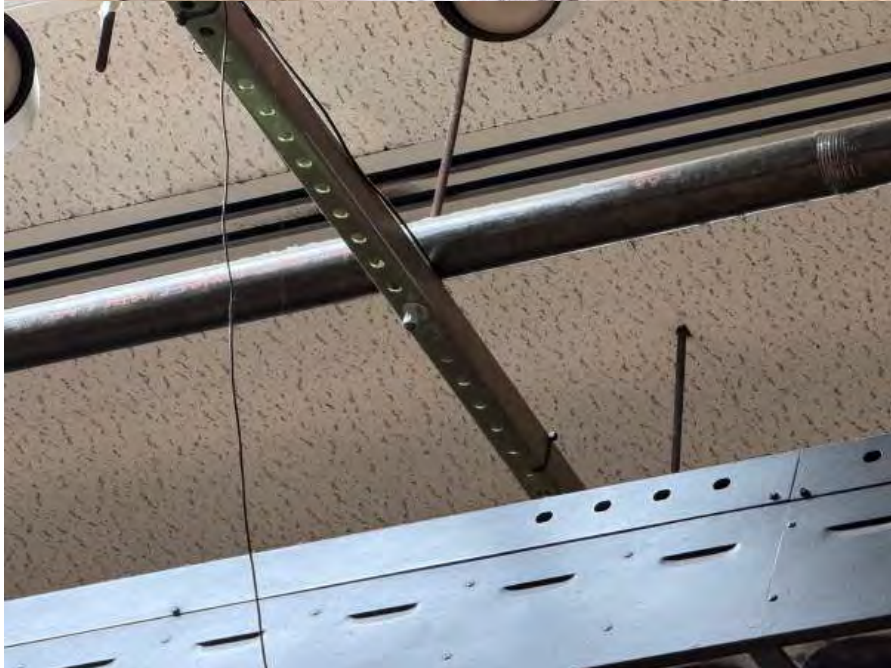
In summary, the rigging system is not in good working order or meets current industry standards. The rigging is with unrated chain and/or connections and should be replaced. The oversized pipes need to be replaced and hung with appropriate hardware. The curtain tracks need to be rerigged and need new drapes, several need updates on the track hardware. Lighting system needs to be hung properly with rated hardware and connections.

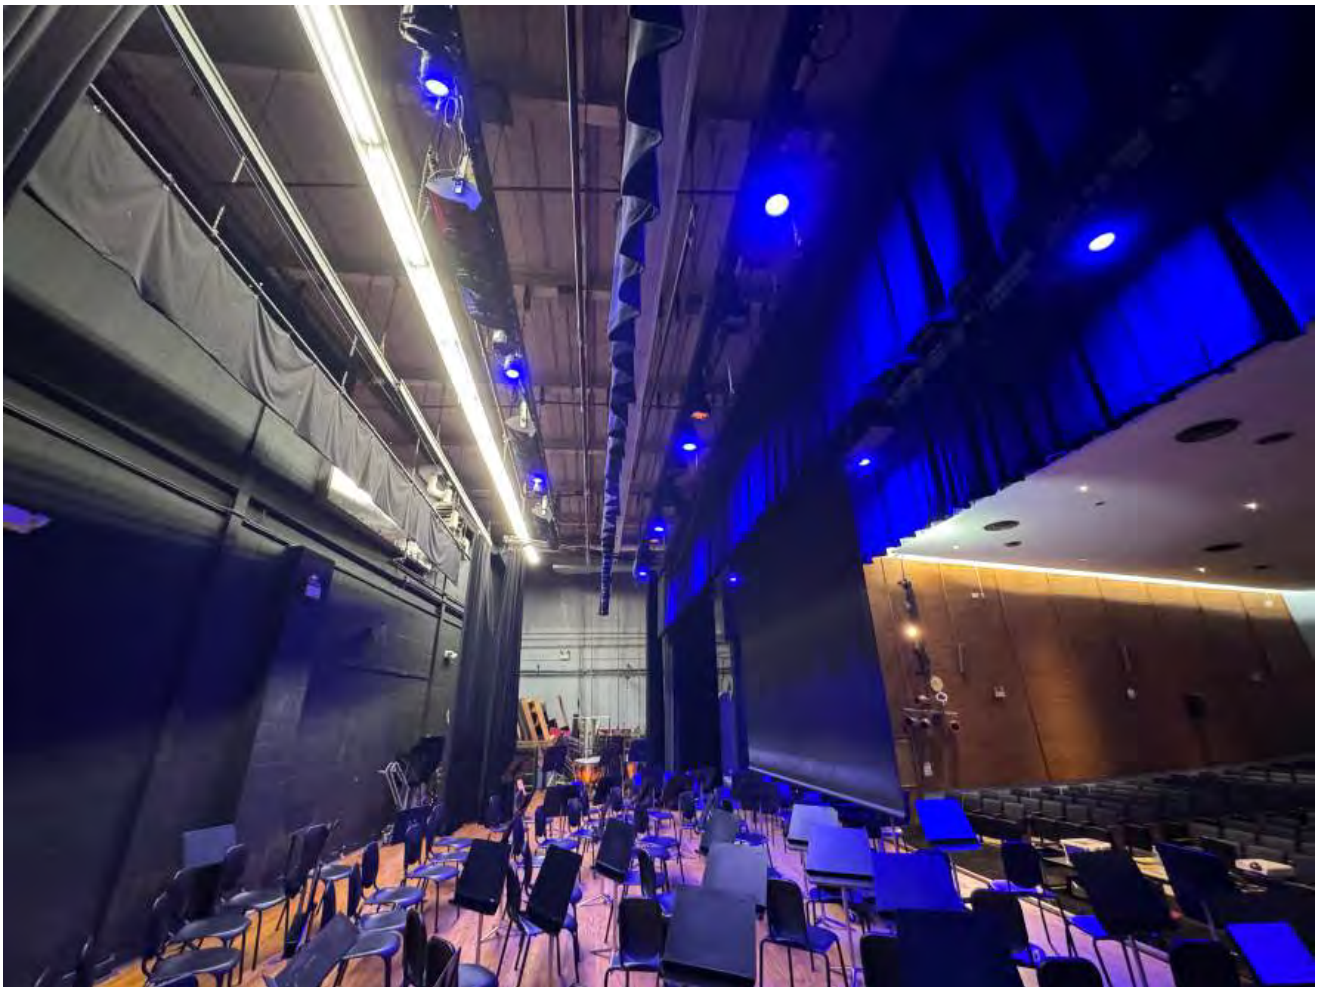
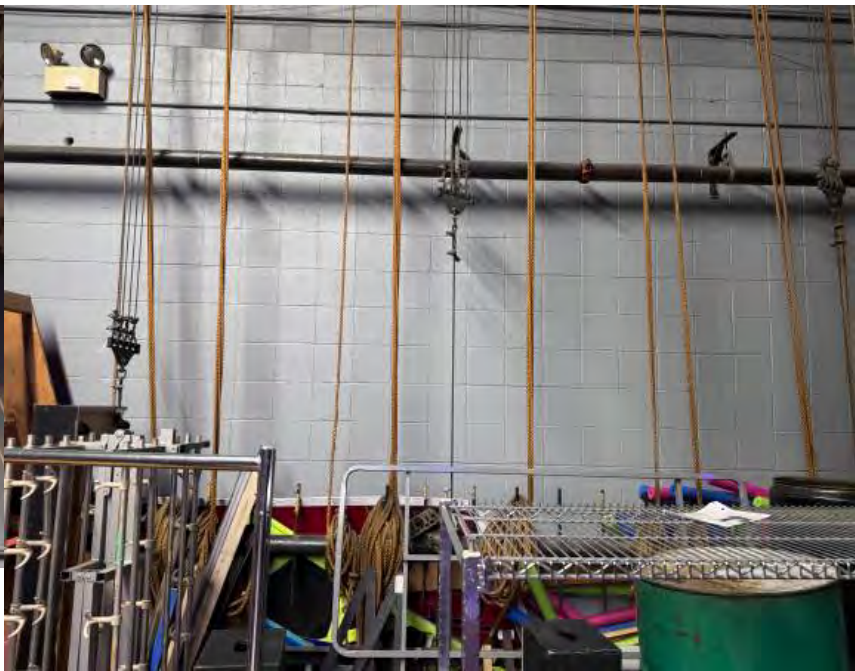
Eastern Middle School has a full rigging system consisting of a valance, front main, mid and rear traveller curtain, side leg curtains on tracks and a rear traveller track. The front traveler track is improperly rigged with unrated chain the carriers and pulleys are worn and need replacement. Several of the support battens are undersized and should be replaced. The most critical issue is the old hemp system. The system should be removed as soon as possible. The hemp rope can fail given the age of the system. The lines are not properly secured to the pin rails. The biggest risk is improper use of the system. The lines don't have a safety system preventing the lines from running if untied from the pin rail, this could lead to a batten crashing on the deck. The electric lift winches lack safety braking systems and should be replaced.

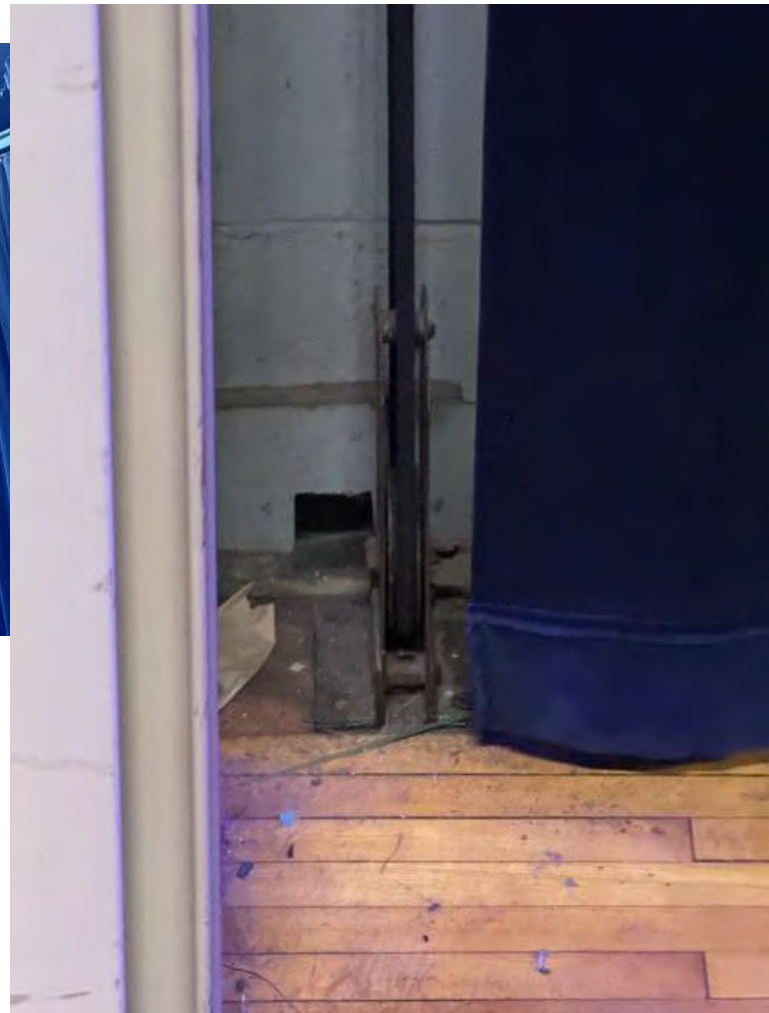
The drapes are listed as inherently and permanently flame retardant. Drapes appear worn and several of them are torn or stained. A significant number of them need replacement

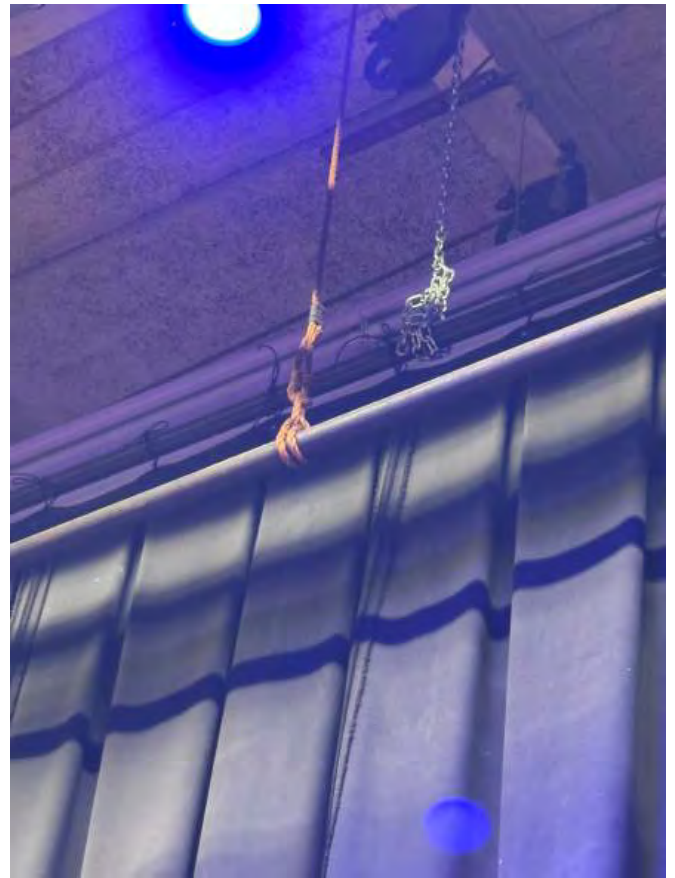
In summary, the rigging systems has several critical issues. The hemp system due to age or improper operation could lead to serious injury. The hand crank winches on the electrics lacks a redundant brake system. The tracks need to be rerigged with new carriers, pulleys and rope. Several of the battens are improperly sized and rigged with unrated chain. The front torarms are not up to current industry standards. A significant number of the drapes are worn, damaged and need replacement. Also, the main curtain and valance are hung in the wrong order and need to be reversed. I would recommend that any battens hanging on the old hemp system be dead hung from the beams and the hemp be removed from use until the rest of the systems can be brought to current standards.

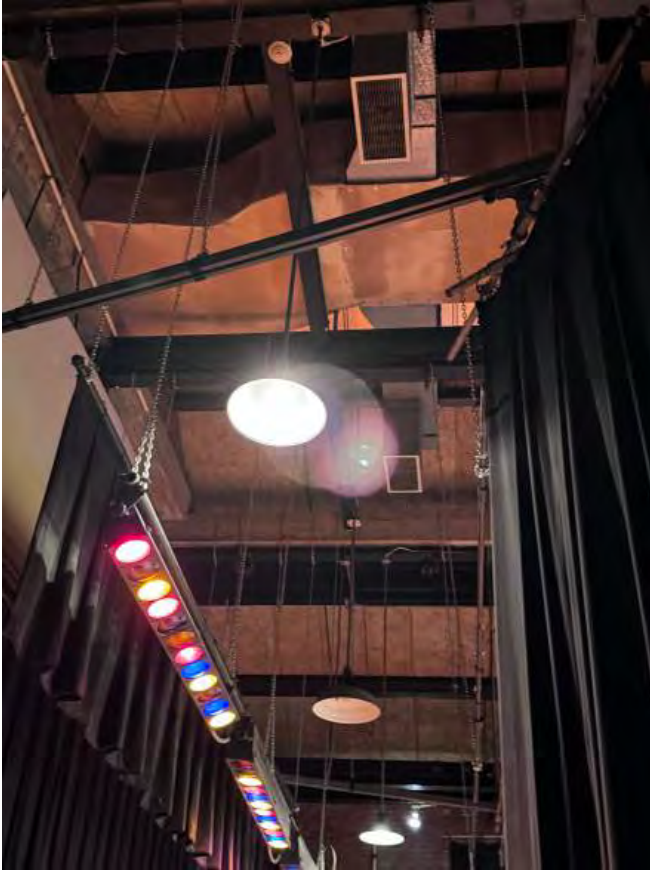
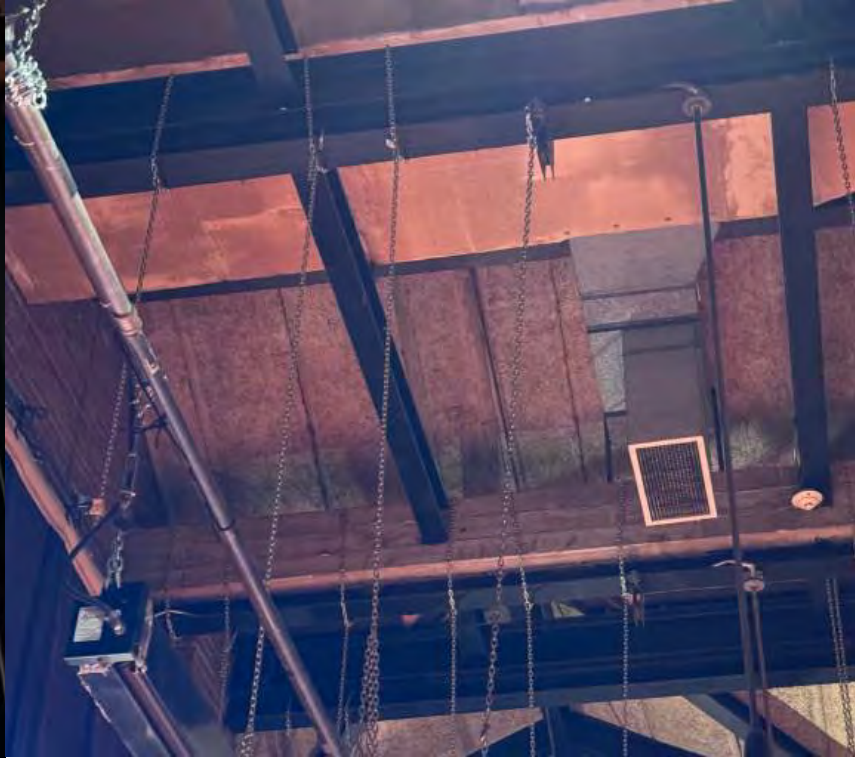
Riverside School has a basic rigging system hung from the building on steel I beams. All of the rigging is not up to current or acceptable industry standards and should be replaced. Current layout consists of a front main traveller curtain, valance, side leg curtains and a rear traveller tracks. The rigging on all of the tracks is in need of replacement. The lighting system is hanging from unrated chain and connectors that should be upgraded as soon as possible. Several of the curtain pipes are undersized and hanging from chain and connections that are not rated for overhead use and should be replaced. The curtains are hanging too high and need to be set properly.

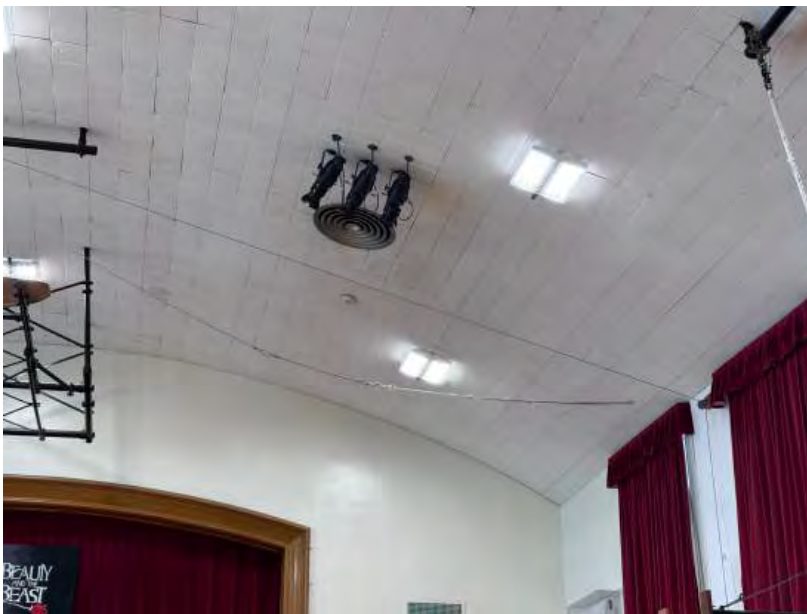
Front lighting positions gives limited options

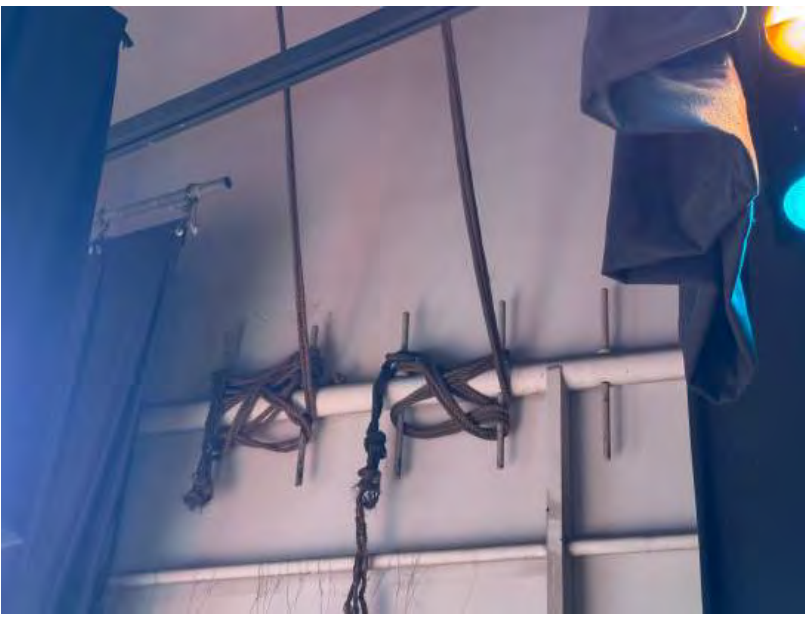
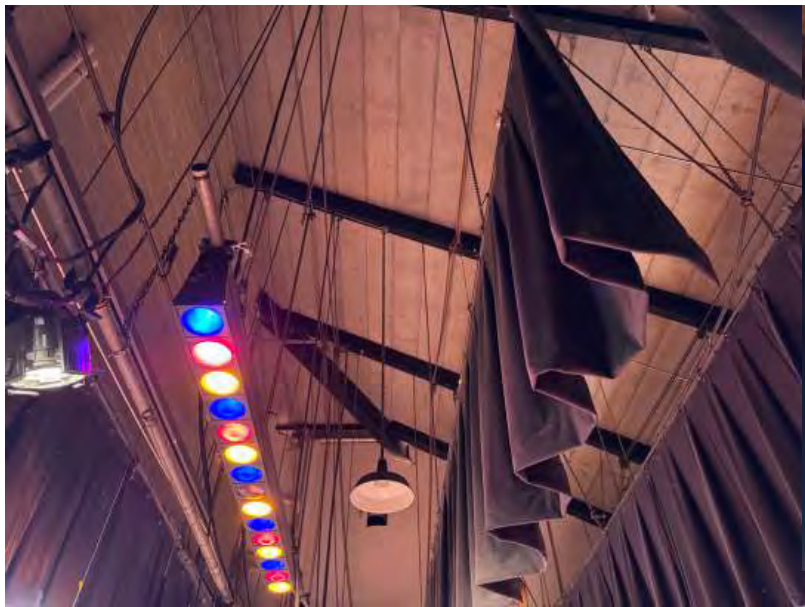
Riverside School has a basic rigging system hung from the building on steel I beams. All of the rigging is not up to current or acceptable industry standards and should be replaced. Current layout consists of a front main traveller curtain, valance, side leg curtains and a rear traveller tracks. The rigging on all of the tracks is in need of replacement. The lighting system is hanging from unrated chain and connectors that should be upgraded as soon as possible. Several of the curtain pipes are undersized, the wrong type of pipe and hanging from chain and connections that are not rated for overhead use and should be replaced. There is an old hemp rope system is use that should be removed immediately and replaced with rated rigging.

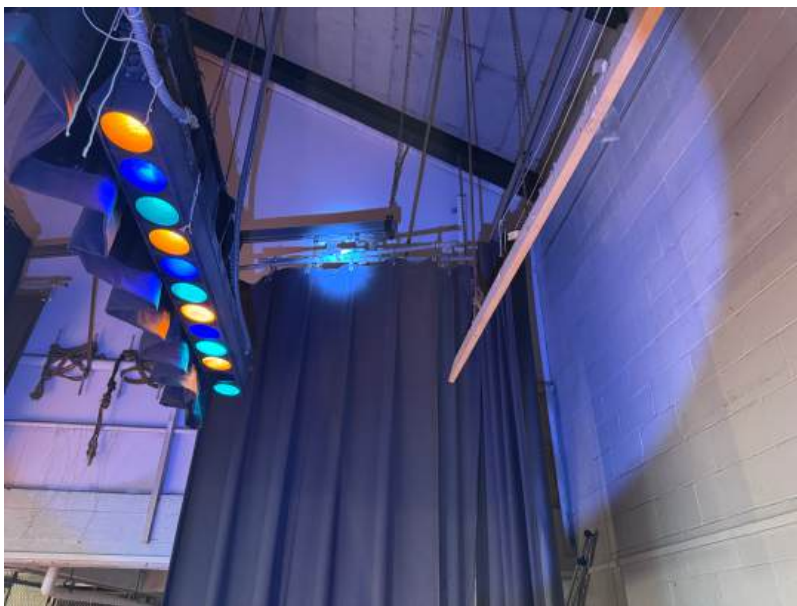
Use of wood beams for backdrops is not recommended for overhead. Immediate removal recommended.

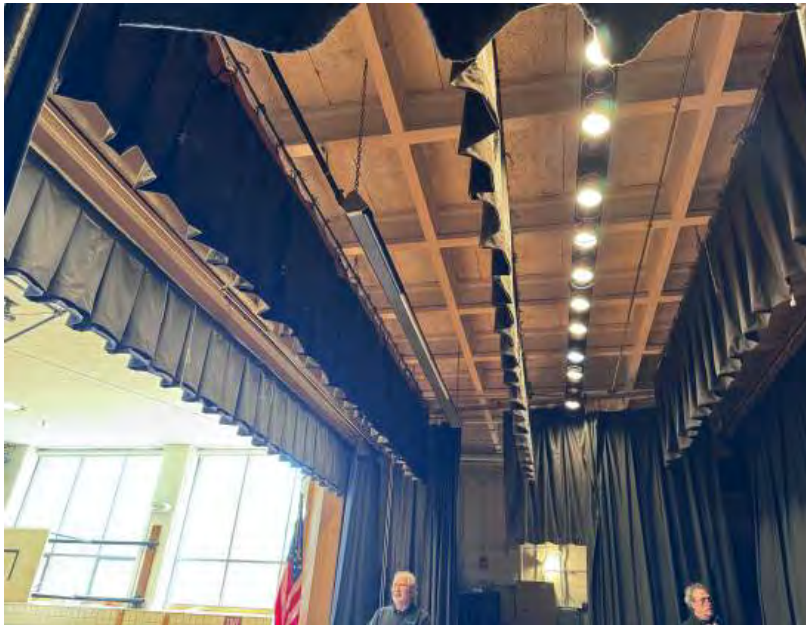
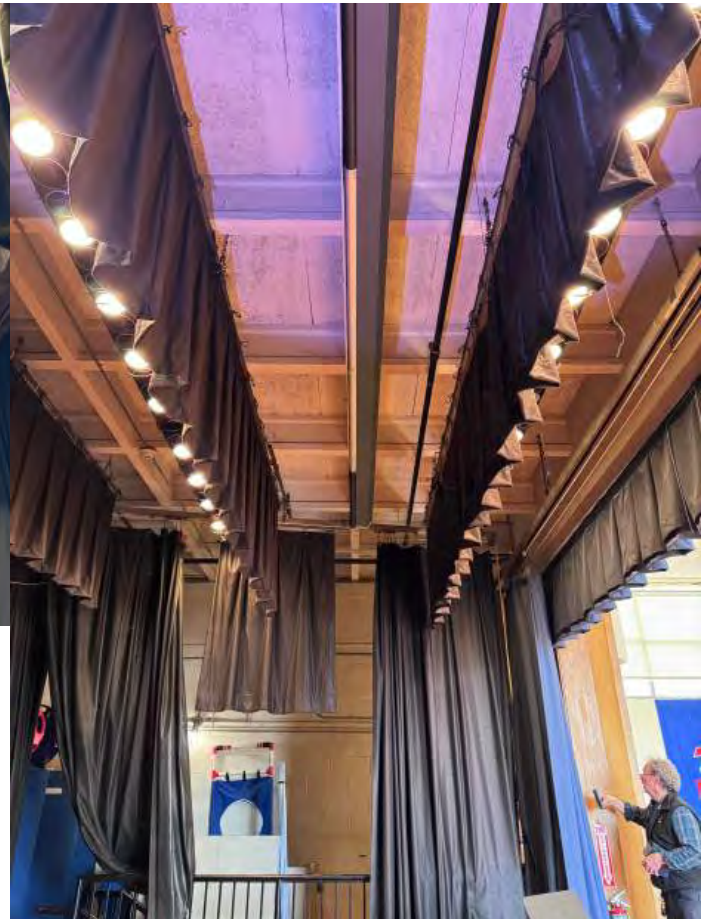
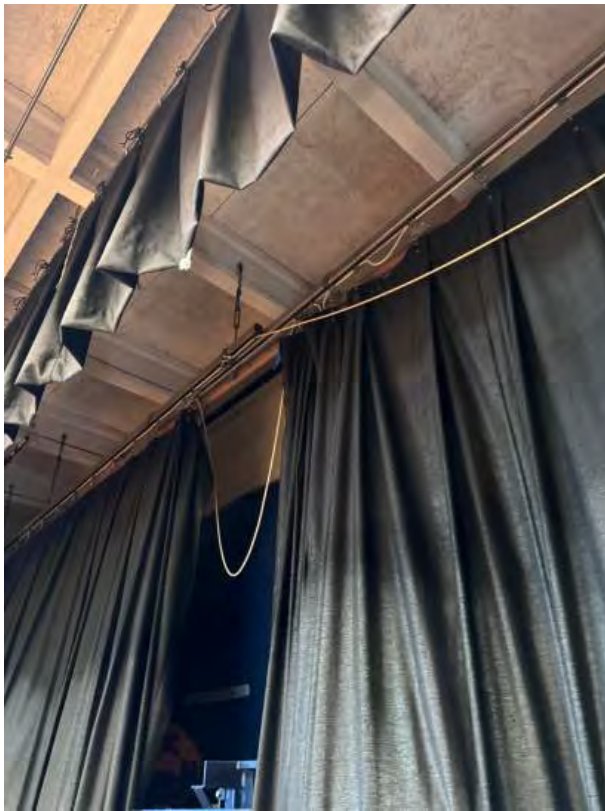
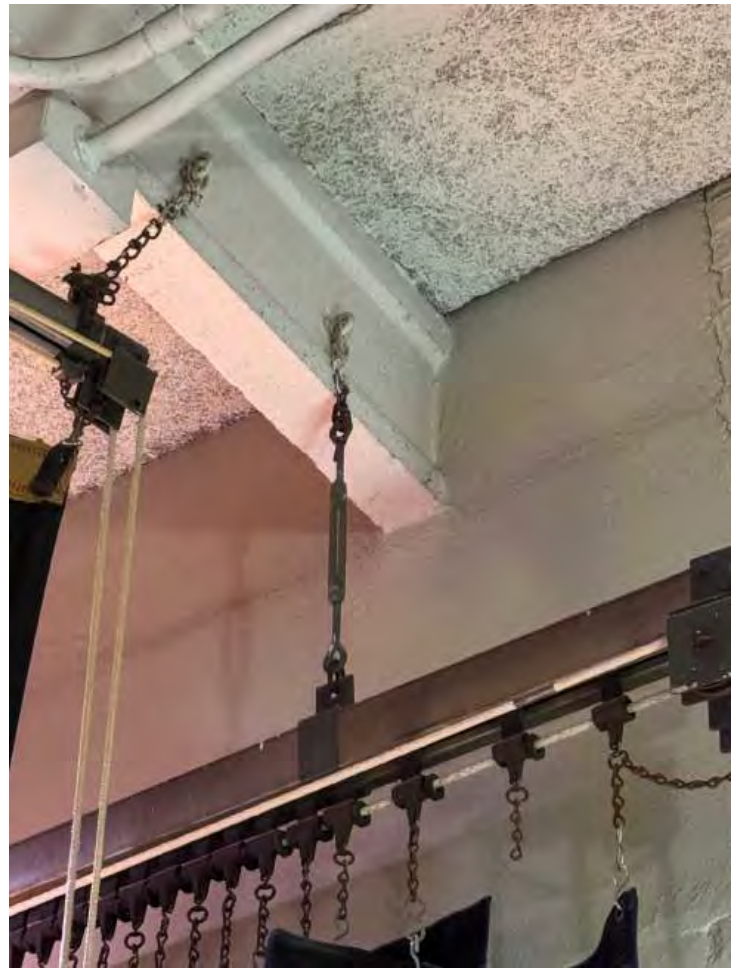
North Mianus School has a basic rigging system hung from the building on concrete encased beams. All of the rigging is not up to current or acceptable industry standards and should be replaced. Current layout consists of a valance, front main traveller curtain, side leg curtains and a rear traveller tracks. The rigging on all of
