## GREENWICH PUBLIC SCHOOLS PERFORMANCE PLATFORM STAGE FACILITY ASSESSMENT

**GREENWICH PUBLIC SCHOOLS  
290 GREENWICH AVENUE  
GREENWICH, CT 06830**

**25558.00**

**June 27, 2025**

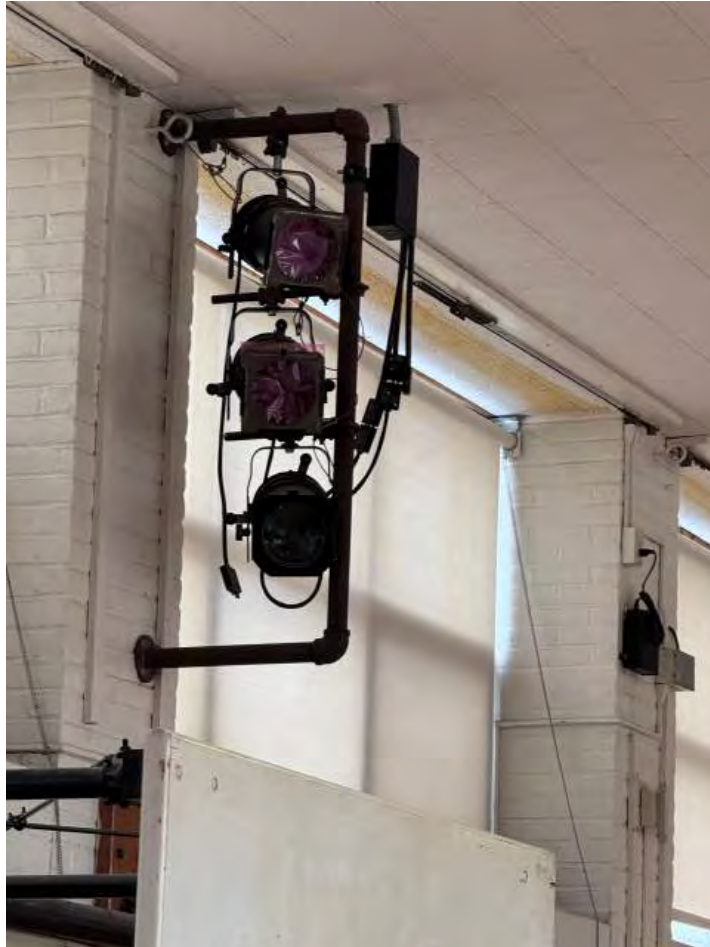
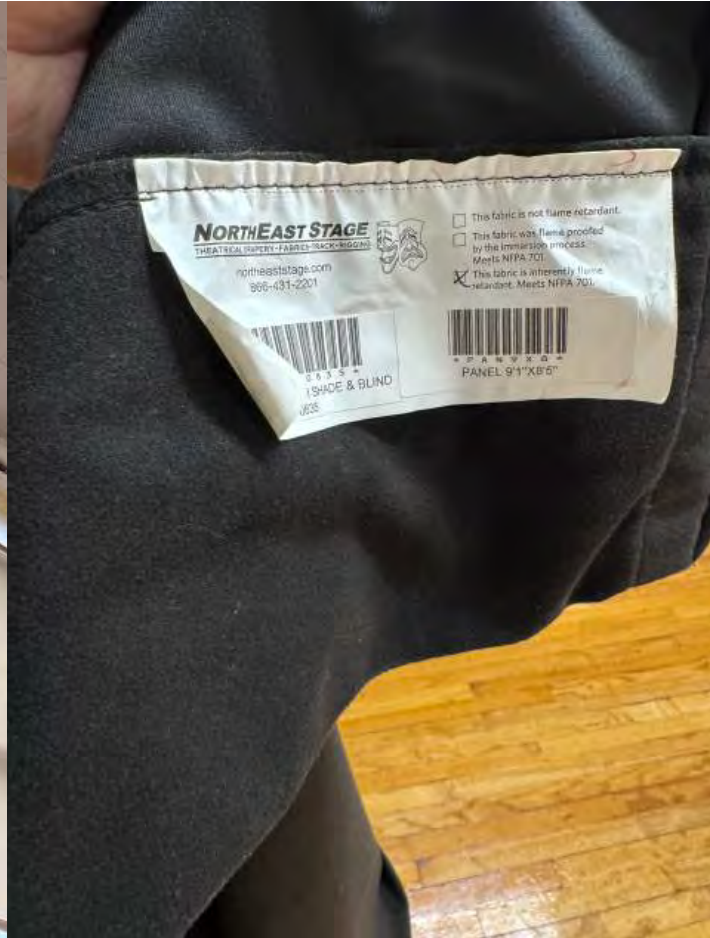
In summary, the rigging system is not in good working order or meets current industry standards. The Rigging is with unrated chain and connections and should be replaced. The curtain tracks need to be rigged and several need updates on the track hardware. Gym equipment should be stored in a way that doesn't damage the track system.

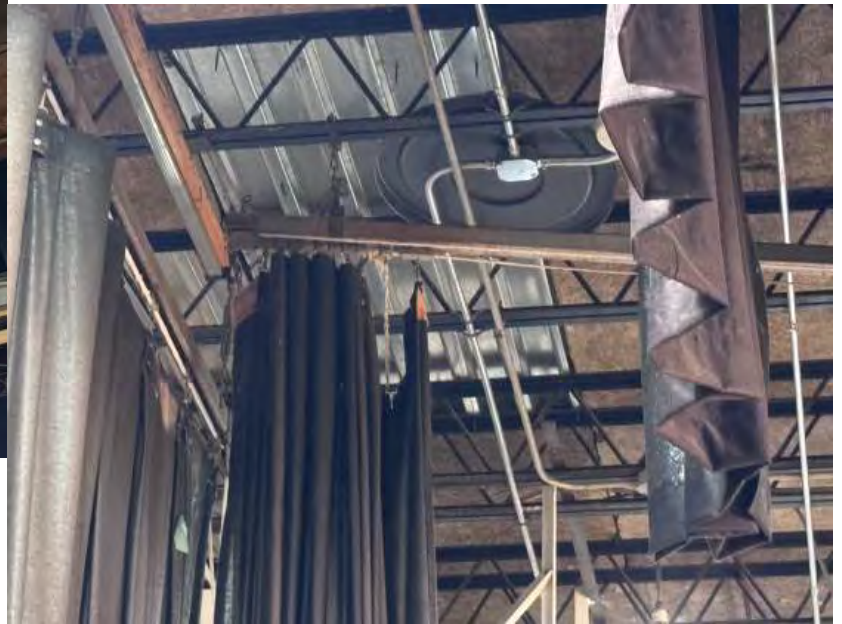
North street School has a basic rigging system hung from the building on light gauge open web steel joists. All of the rigging is not up to current or acceptable industry standards and should be replaced. Current layout consists of a valance, front main traveller curtain, side leg curtains and a rear traveller tracks. The rigging on all of the tracks is in need of replacement. Several of the curtain pipes are undersized and hanging from chain and connections that are not rated for overhead use and should be replaced. The main curtain and valance are switched, the valance should be hung in front of the main. Several of the drapes are torn or frayed and I couldn't find tags on the rear curtains to confirm fire rating. Non fire rated drapes should be removed.

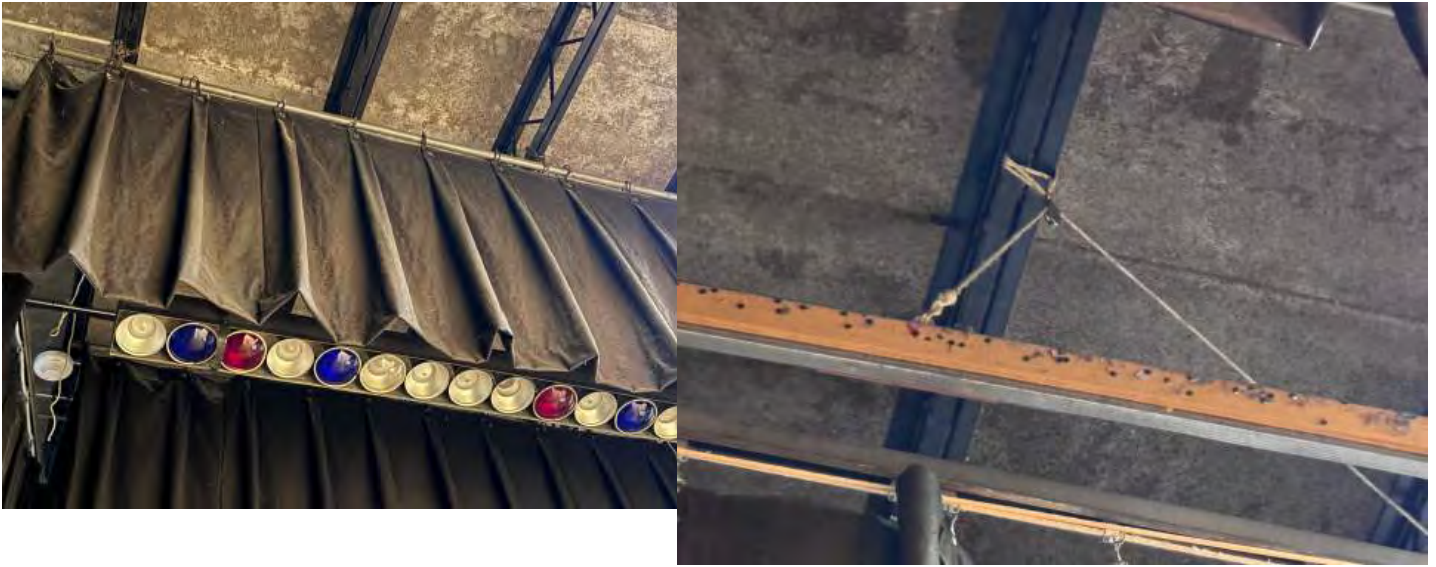
The lighting system on stage is significantly out of date. There is a DIY back drop beam hanging from rope pictured above that should be removed immediately.

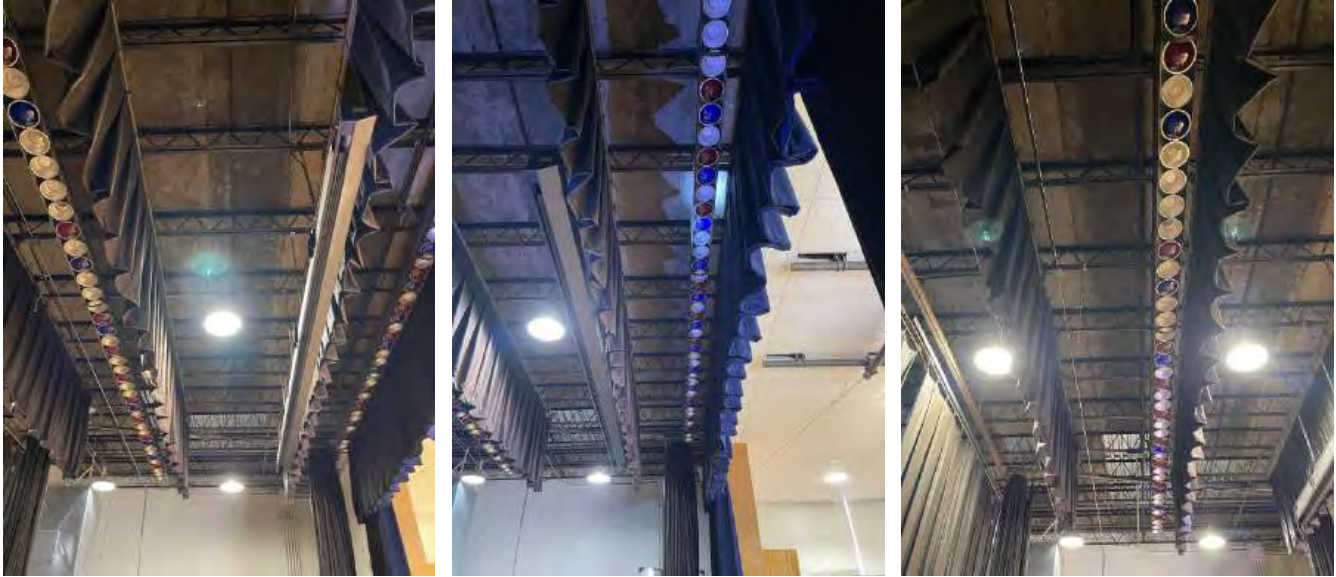
The house lights are gymnasium fixtures installed as recessed fixtures in the ceiling. They are not controlled by the theatrical lighting system.

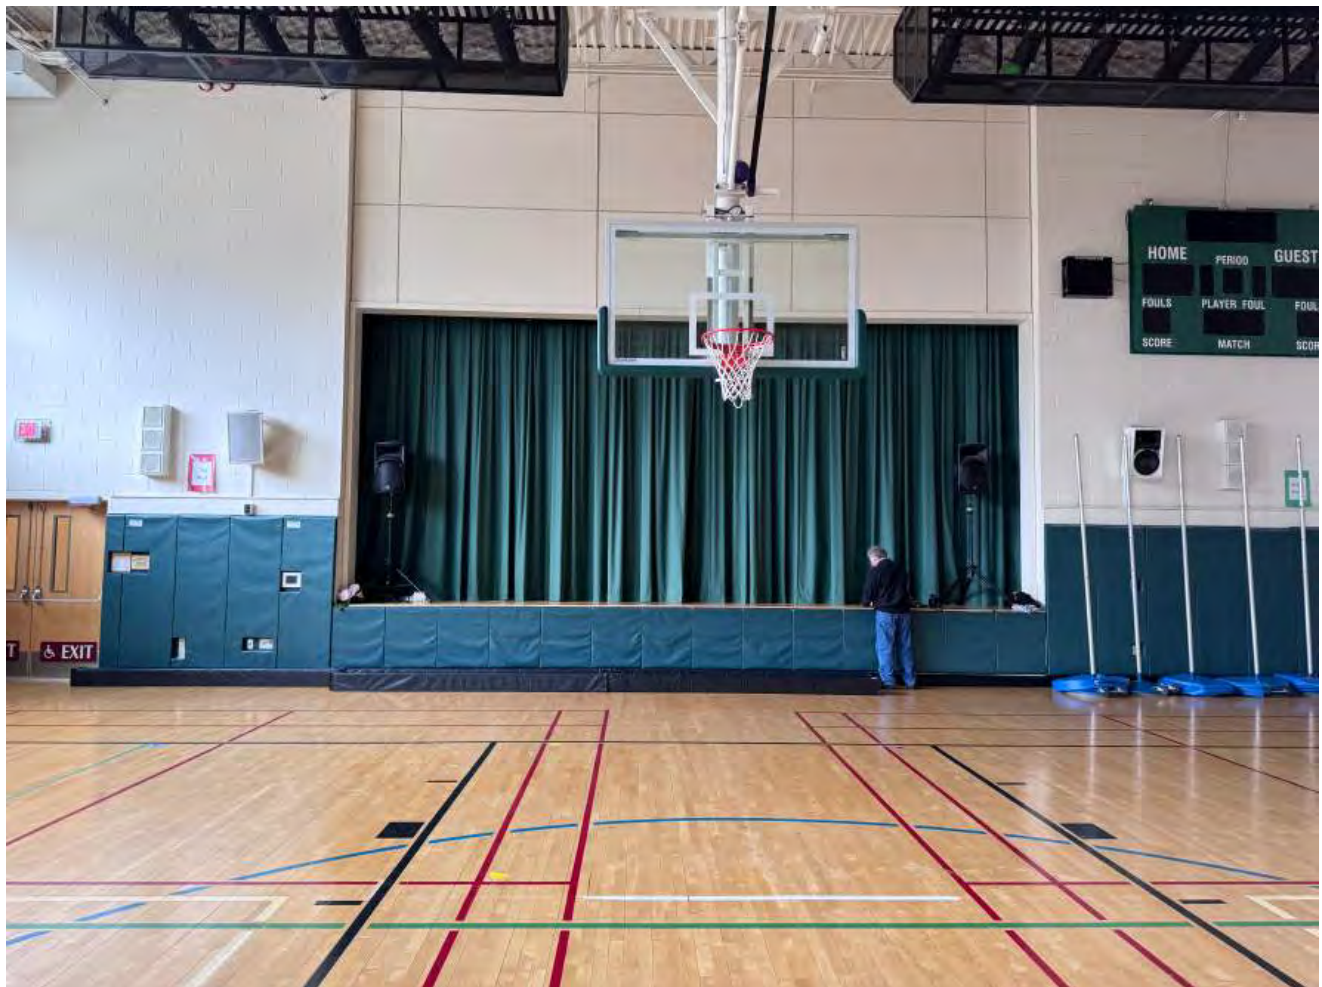
Hamilton Ave School has a basic rigging system hung from a pipe grid, consisting of a valance, front main traveller curtain, side leg curtains and a rear traveller tracks. The front traveler track is in good working order. I was unable to test the mid stage tracks operation because of chairs on stage. The Rear floor pulley is not installed properly under the track live end pulleys causing difficulty in operation and the pulley to bend.( Pictured below) The lighting system on stage is significantly out of date.

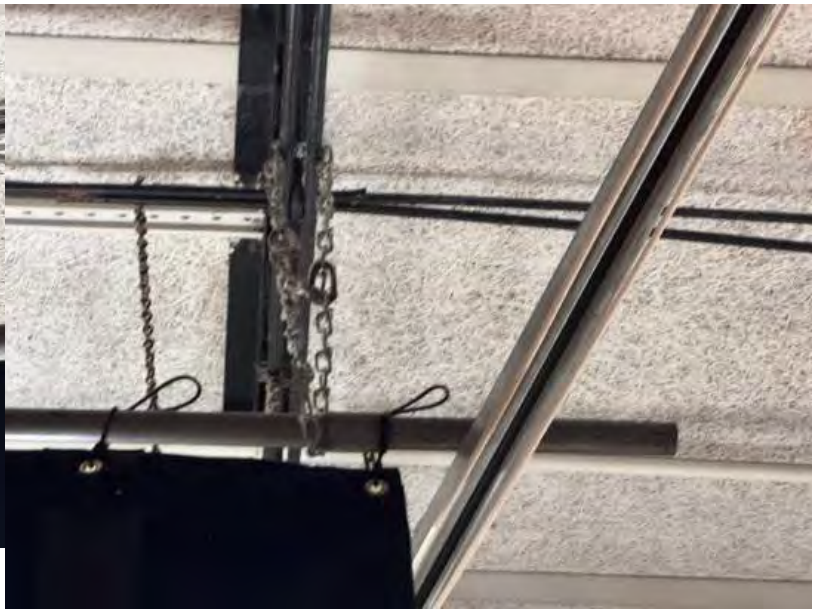
Parkway School has a basic rigging system hung from the building on light gauge open web steel joists. All of the rigging is not up to current or acceptable industry standards and should be replaced. Current layout consists of a front main traveller curtain, valance, side leg curtains and a rear traveller tracks. The rigging on all of the tracks is in need of replacement. Several of the curtain pipes are undersized and hanging from chain and connections that are not rated for overhead use and should be replaced. The main curtain and valance are switched, the valance should be hung in front of the main curtain. There is a hand crank winch attached to the electrics that should be removed immediately, none of the lines are terminated properly either on the winch or on the electrics.

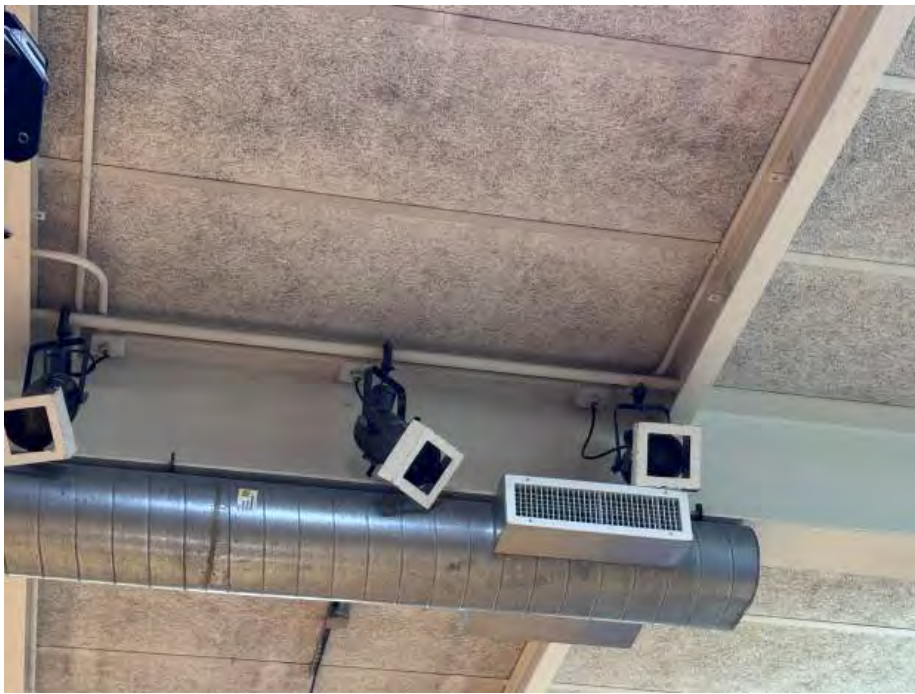
The lighting system on stage is significantly out of date.

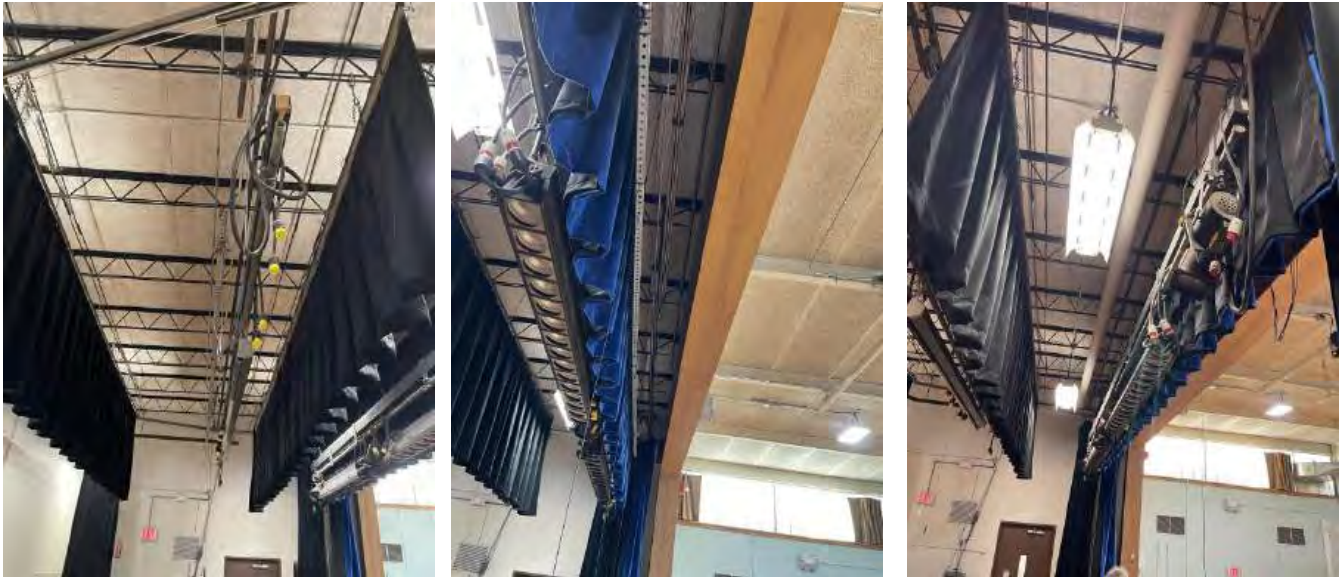
There is a screen hung from an existing stage electrics pipe, making it unusable for lighting.

The house lights are newer high bay LED fixtures. They are not controlled by the theatrical lighting system.
