**BUILDING ENVELOPE EVALUATION  
FOR  
THE TOWN OF SOUTHAMPTON POLICE STATION  
8 EAST STREET, SOUTHAMPTON, MA  
MI-2516-001**

**FINAL DRAFT**

**January 2021**

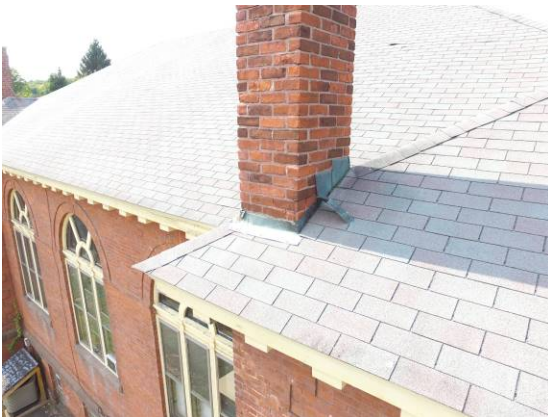
Step flashing at chimney requires repair.

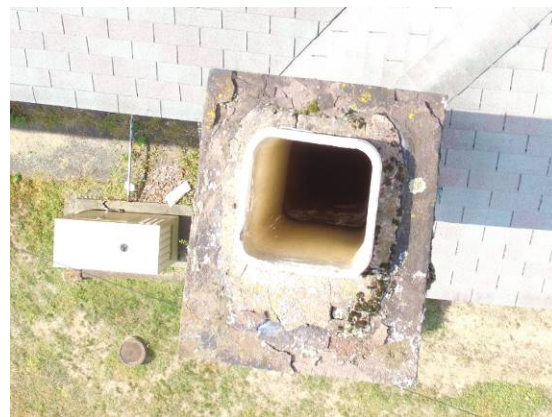
Deteriorated masonry around chimney cap.

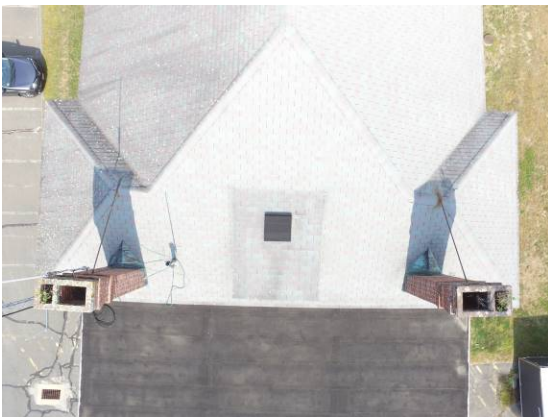
South Chimneys – vegetation, support  
(Examine cricket and flashing behind each chimney.)

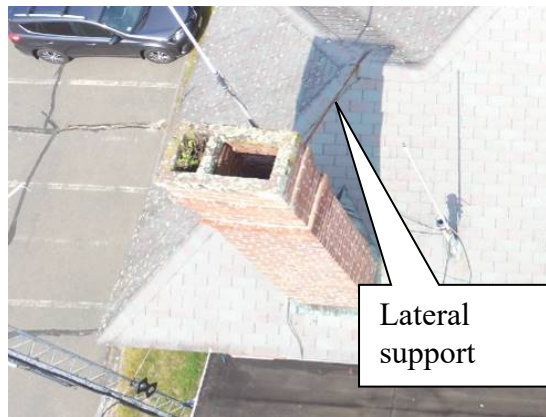
Remove vegetation  
(Review lateral supports for chimneys.  
Paint supports to retard rust and staining.)

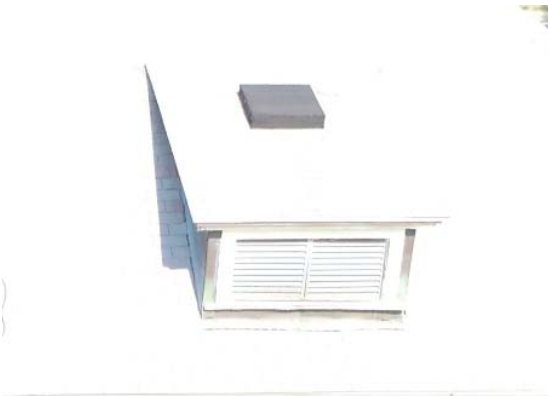
Southerly Shed Dormer  
(Possible Roof Access Scuttle, black.)

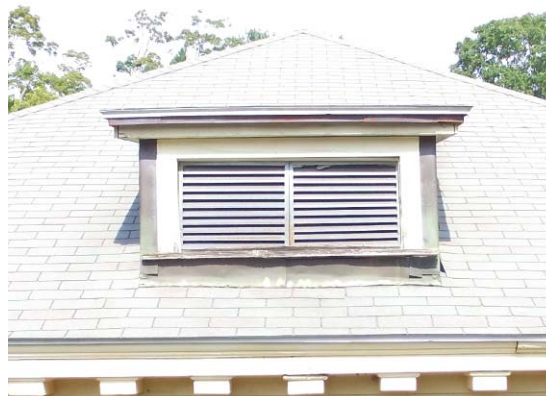
Dormer Elevation  
(Repair Flashing)

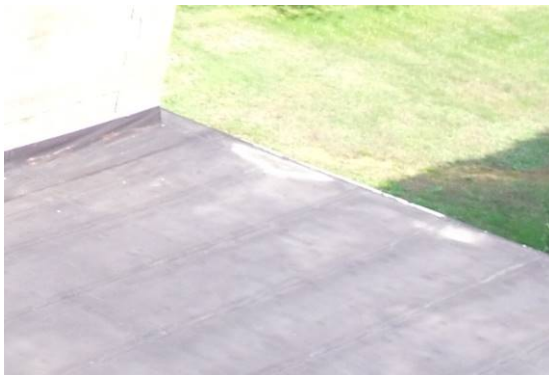
Minor evidence of debris/ponding  
(Research depression in insulation)

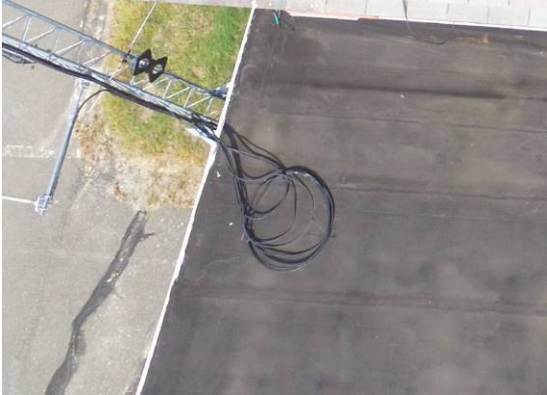
Coiled cable  
(Provide roofing mat or additional layer of  
roofing below cable for a wear layer.)

| Roof mat under cables | \$ 500 - \$ 700 |

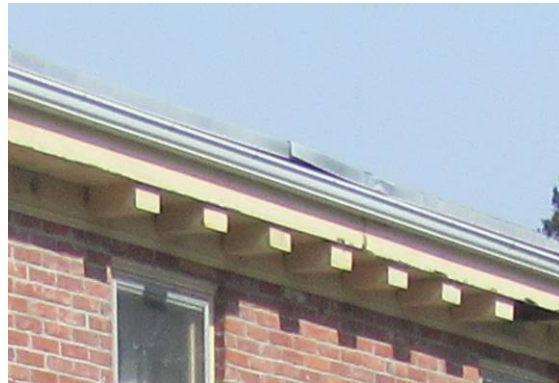
Damaged roof metal edge trim/fascia

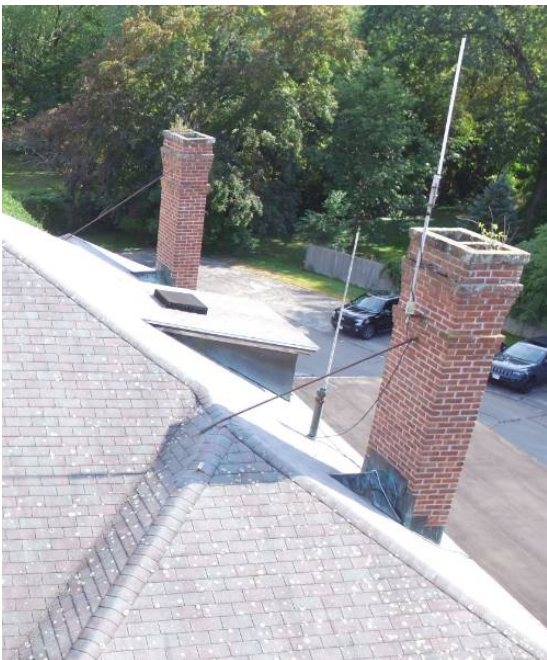
South Chimneys

Review chimneys for repointing  
(Being used for support of antennas)

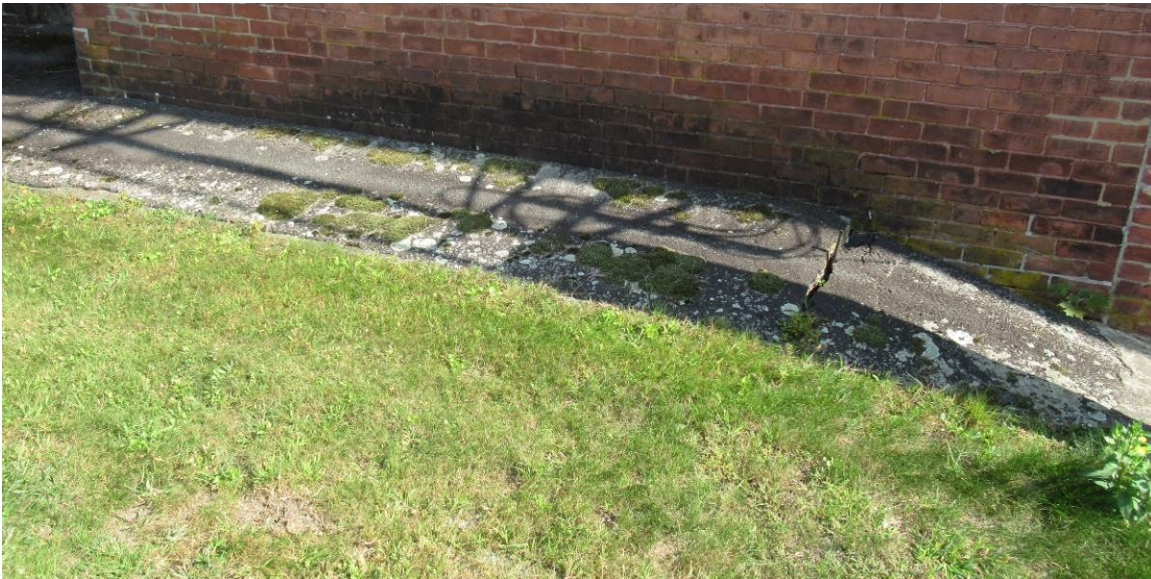
Paving added along the perimeter of the building (West Side)

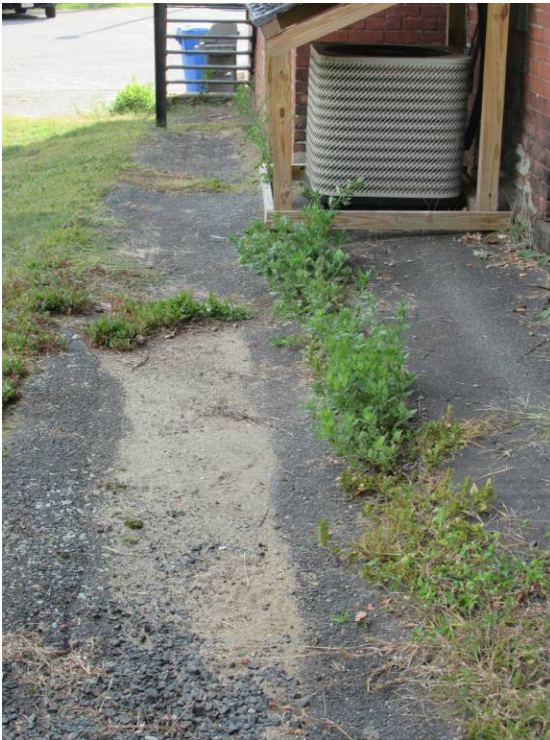
Paving added along the perimeter of the building (East Side)

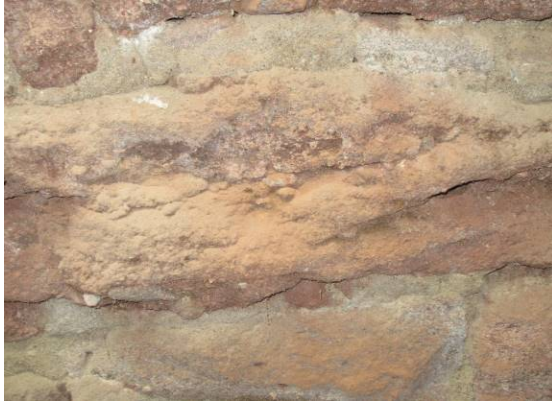
The presence of moisture and the deteriorating effect on the foundation and brickwork is also visible in the unfinished walls of the boiler room. The walls exhibit moisture and the bricks and grout joints are deteriorating to a sand-like consistency.

Foundation deterioration

At a point in the near future (the sooner, the better for the building and indoor air quality) consideration should be given to fully excavating the perimeter of the building and seal/waterproof the subsurface exterior walls. Consideration should also be given to a wall drainage system and footing drains to evacuate groundwater.

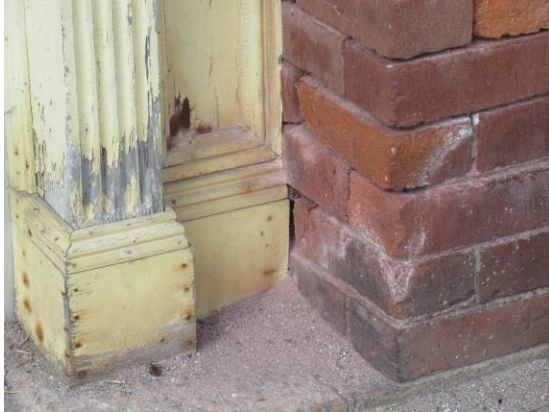
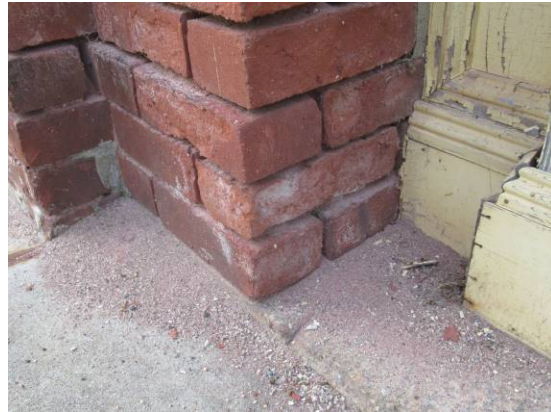
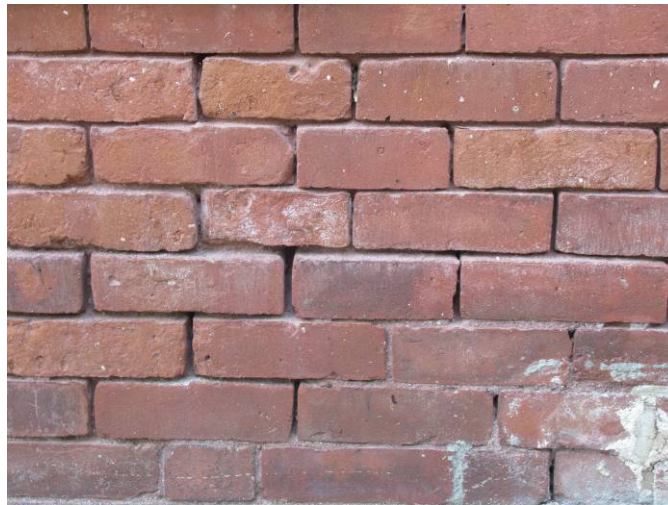
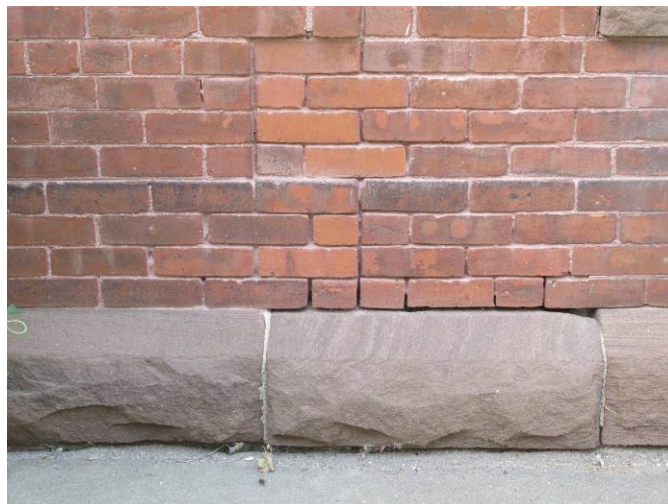
The greatest amount of brick veneer damage is along the base of the north elevation. There has been significant grout degradation and noteworthy voids are present. Further deterioration will result in moisture migration into the building.

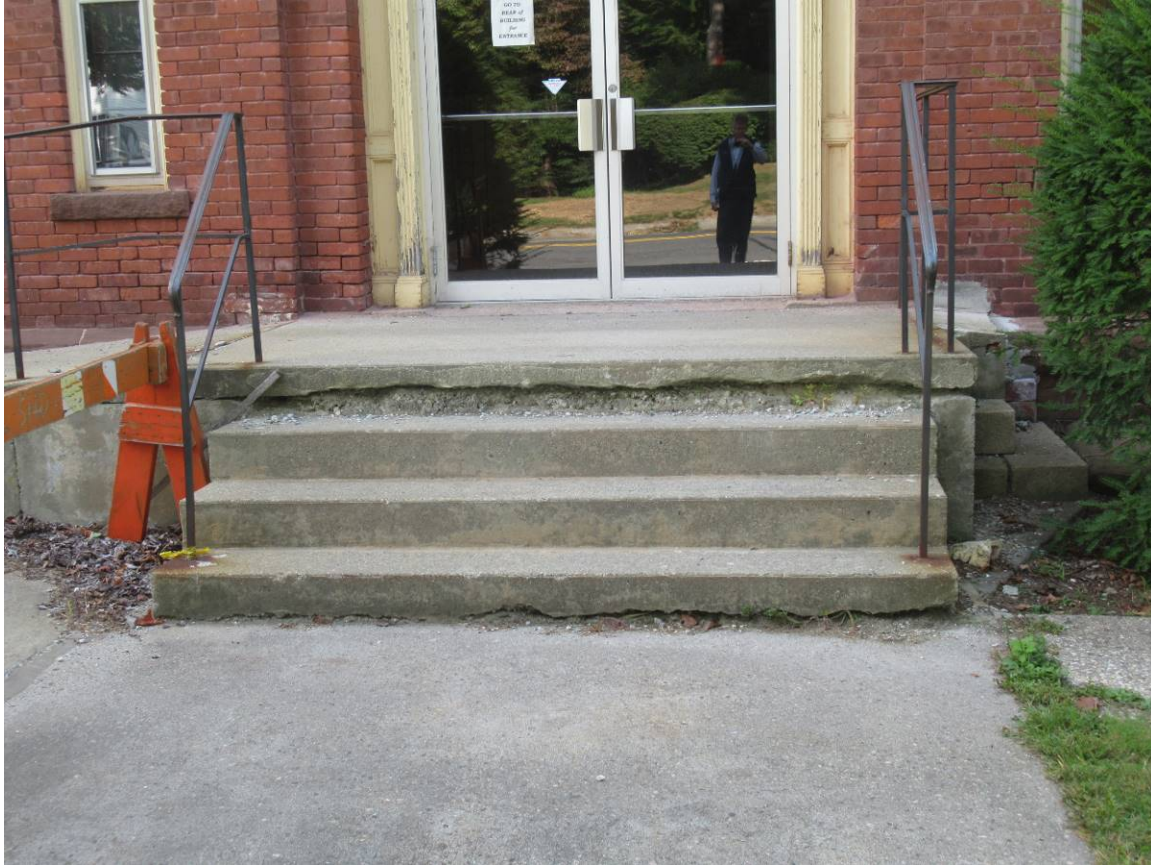
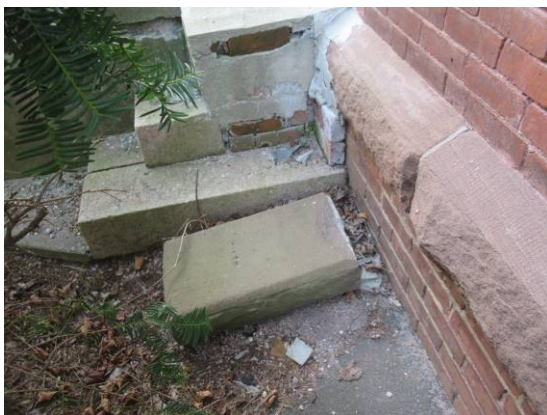
The front entrance stairs and porch assembly has undergone uneven settlement that has moved several major components. It was reported that the present condition has been the same for many years.

Removed stone

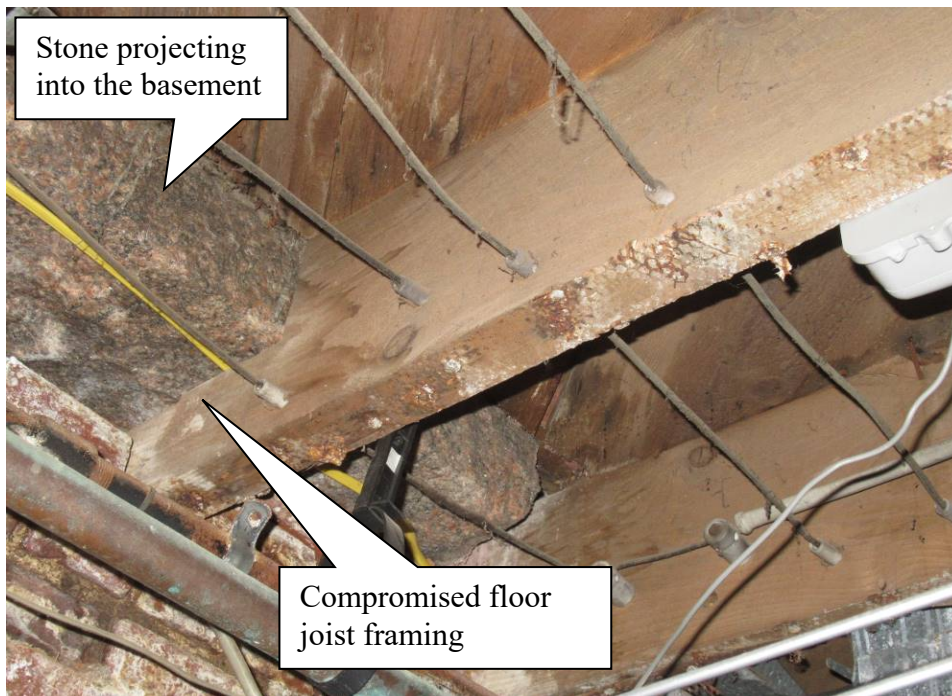
The stone that was originally used for the construction of the front porch projects into the basement (in the boiler room) and the wood framing had been 'notched', weakening the floor framing. It appears that the poured concrete ramp and porch alteration encapsulated what appears to be granite stone.

It was reported that water infiltrates the basement in this area. A new solution should be employed to make the basement watertight and keep the construction for the front porch solely on the exterior.

Compromised floor joist framing and lack of waterproofing of building envelope.

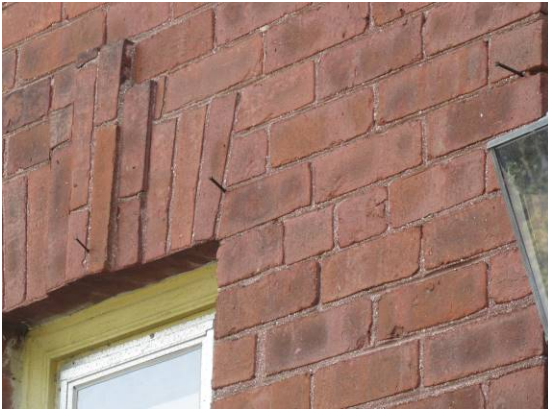
Miscellaneous projecting items (nails) should be removed and the grout joints repaired.

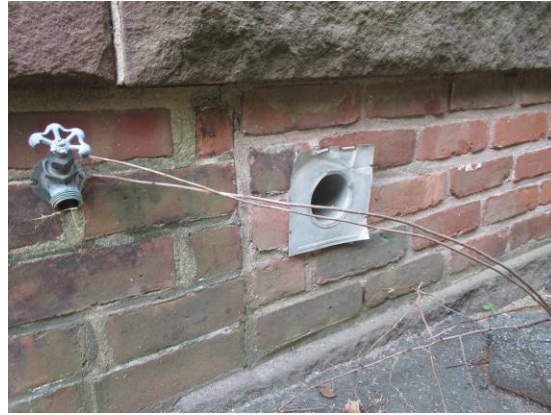
Wall penetrations should be weatherproof and vermin proof.

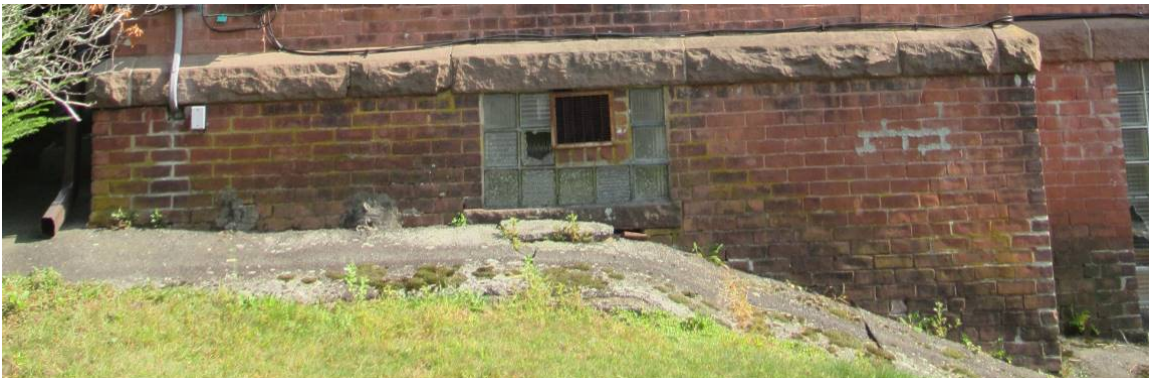
Moisture damage and algae growth on base of wall

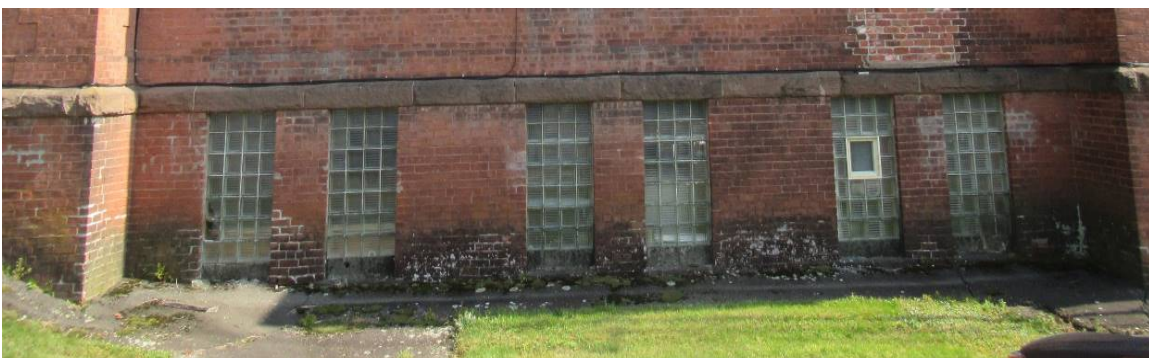
Moisture damage and algae growth on base of wall

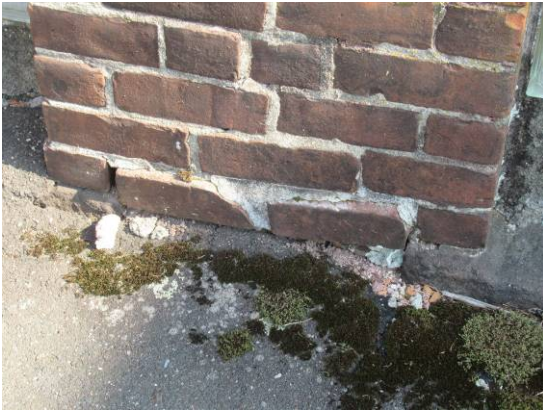
Brick damage

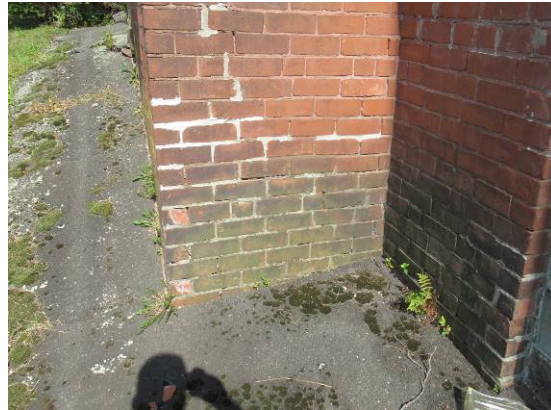
Brick damage and grout degradation

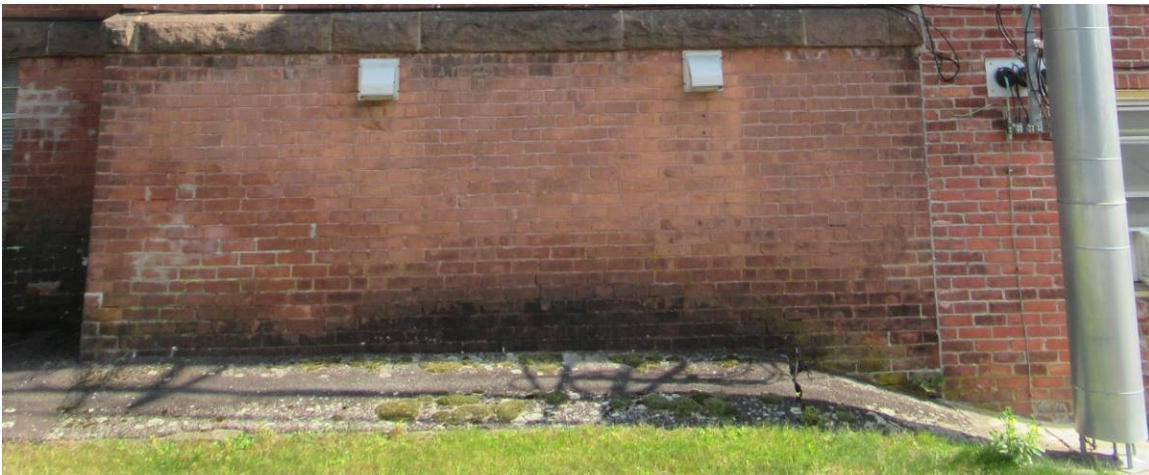
Moisture damage and algae growth on base of wall

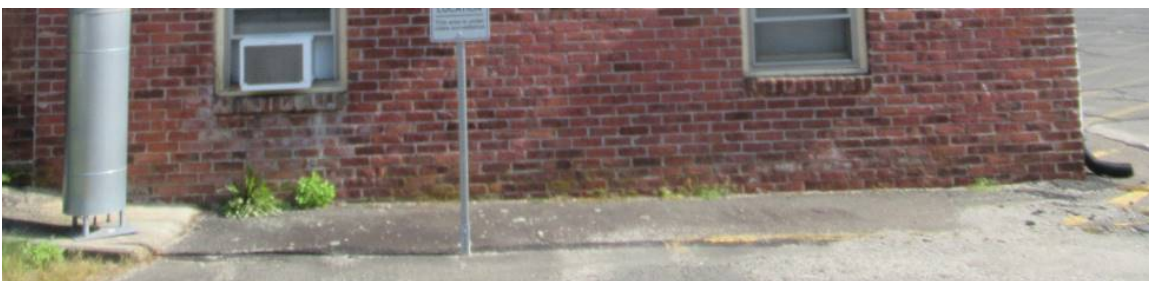
Moisture damage and algae growth on base of wall (1960 Addition)

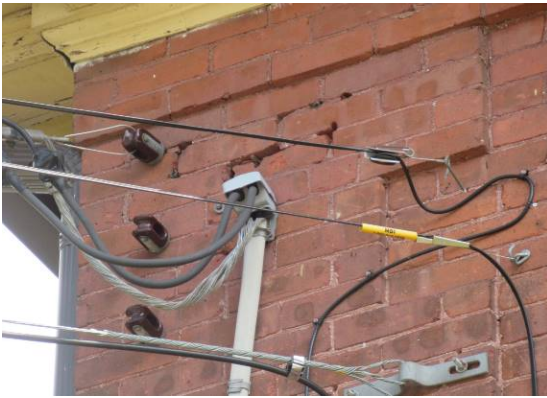
Abandoned penetrations should be grouted.

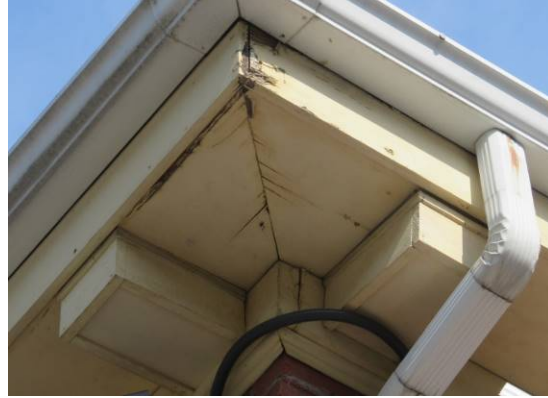
Repair/replace rotted/damaged woodwork.

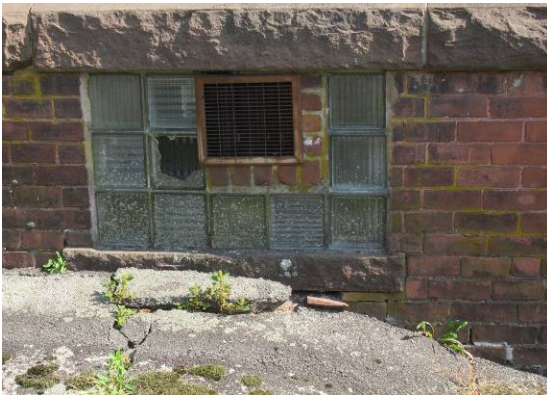
Broken glass blocks should be replaced or the entire window assembly replaced.

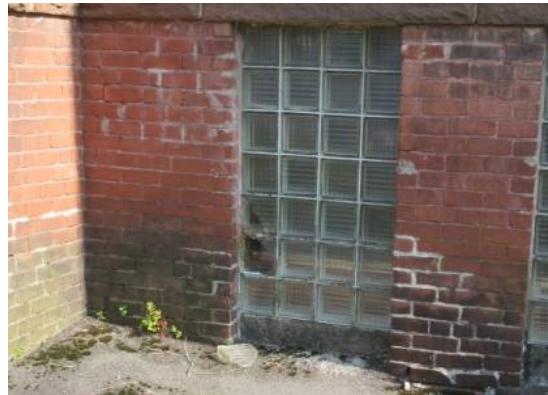
Broken glass blocks should be replaced or the entire window assembly replaced.

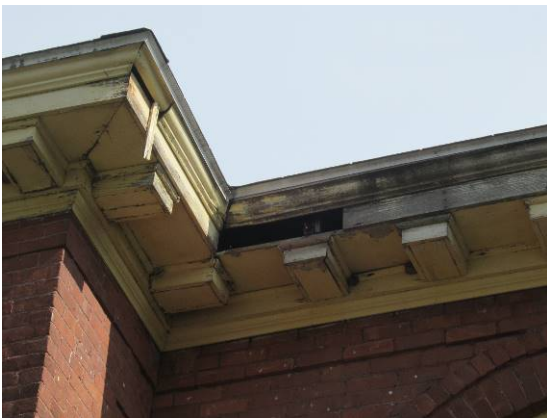
Repair/replace rotted woodwork.

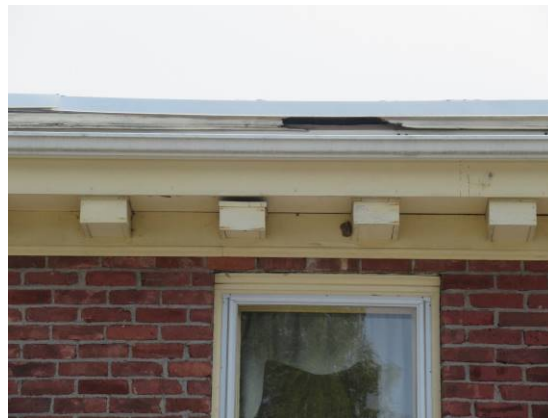
Repair/replace rotted/damaged woodwork.

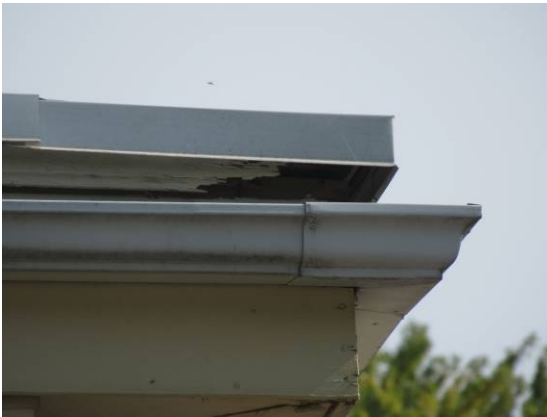
Repair/replace rotted woodwork.

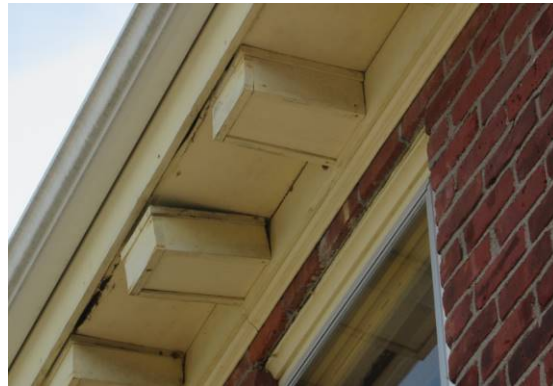
Repair/replace rotted/damaged woodwork.

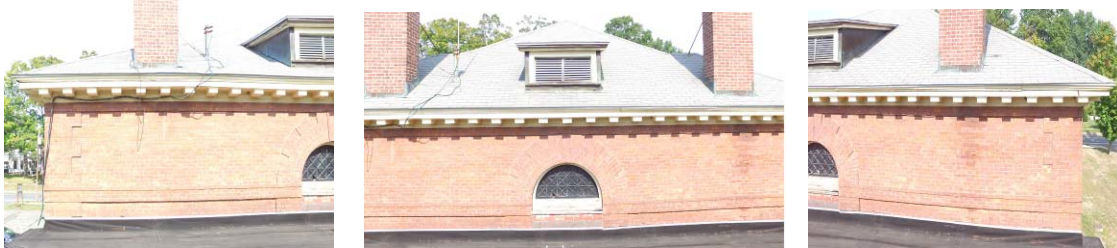
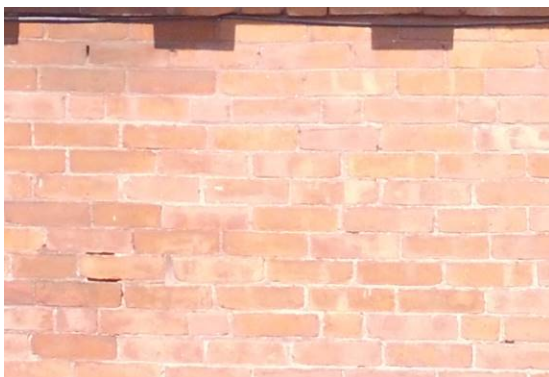
Minor repointing is required.

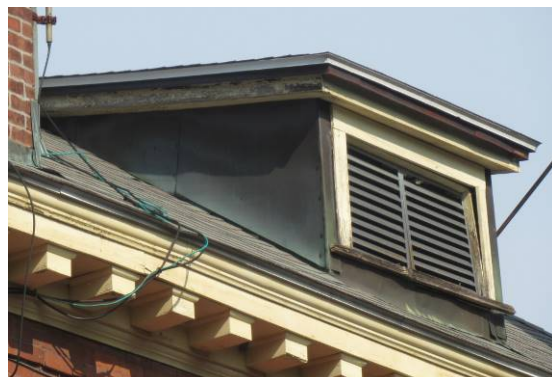
Dormer sides and louver require repair.

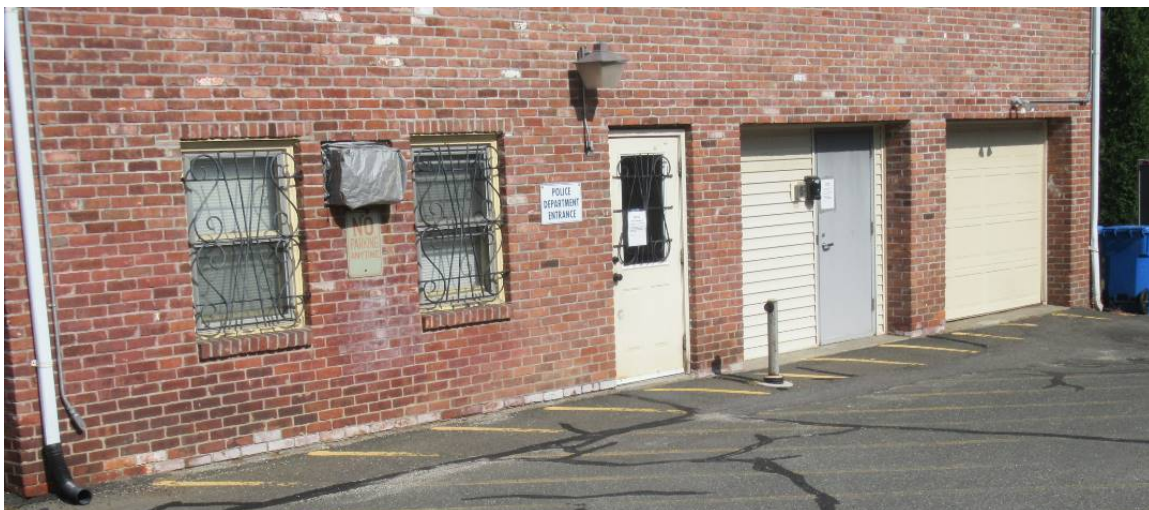
It was reported that ice forms in the driveway from roof water run-off. When the repaving/resurfacing of the parking lot is to occur, consideration should be given to altering grade away from the building and possibly subsurface drainage for the roof water.

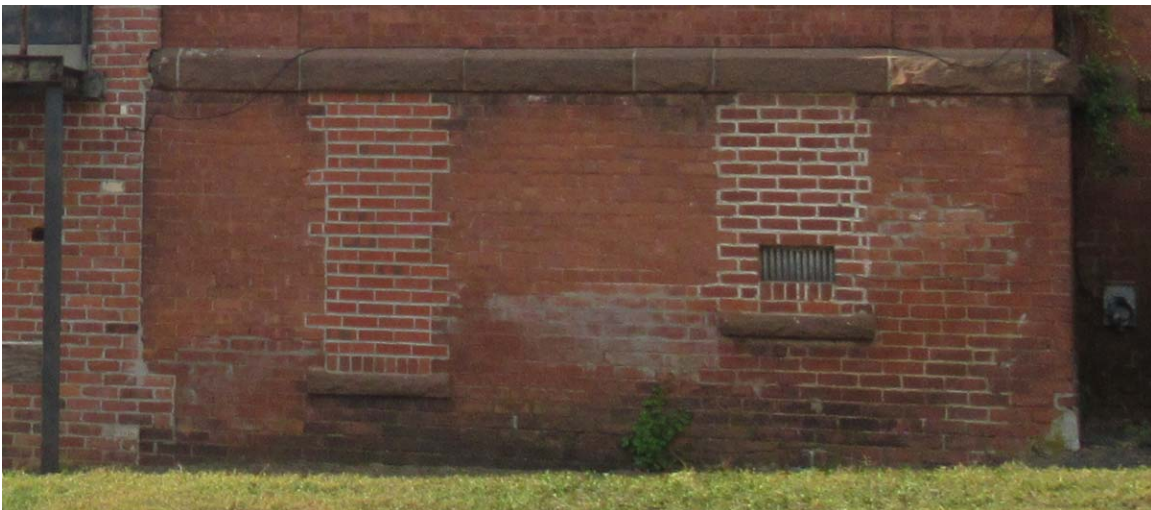
Moisture damage and algae growth on base of wall

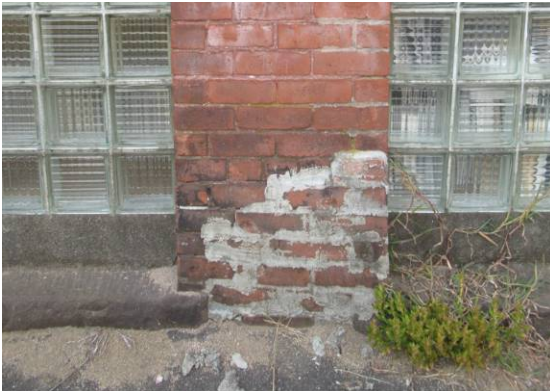
Moisture damage

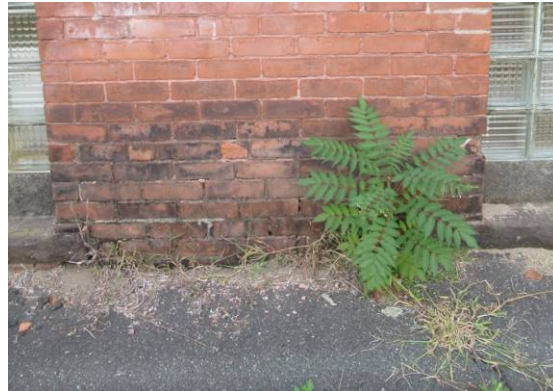
Moisture damage

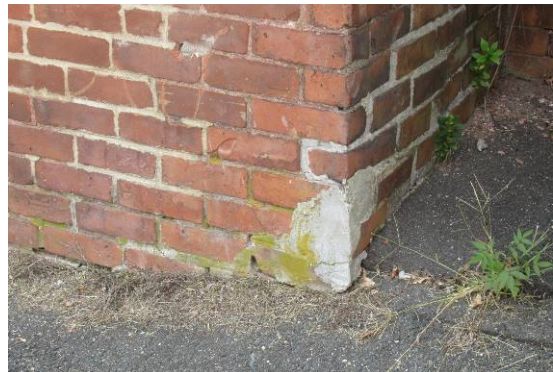
Brickwork and mortar deterioration

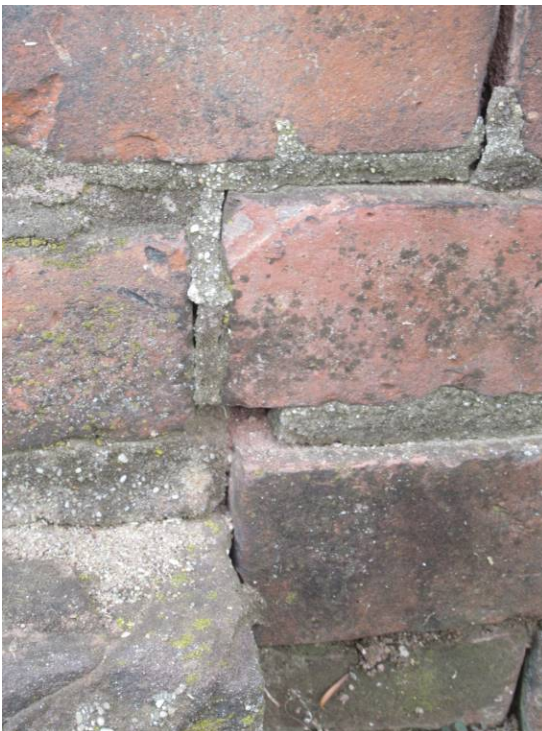
Mortar deterioration

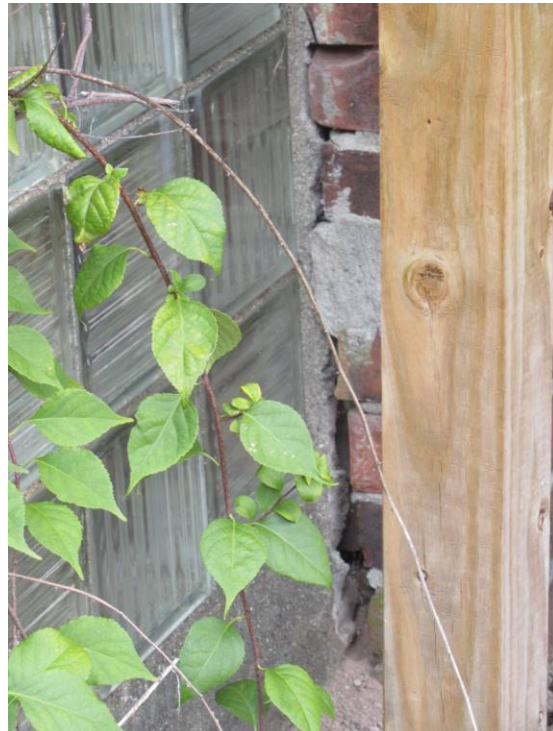
Mortar deterioration

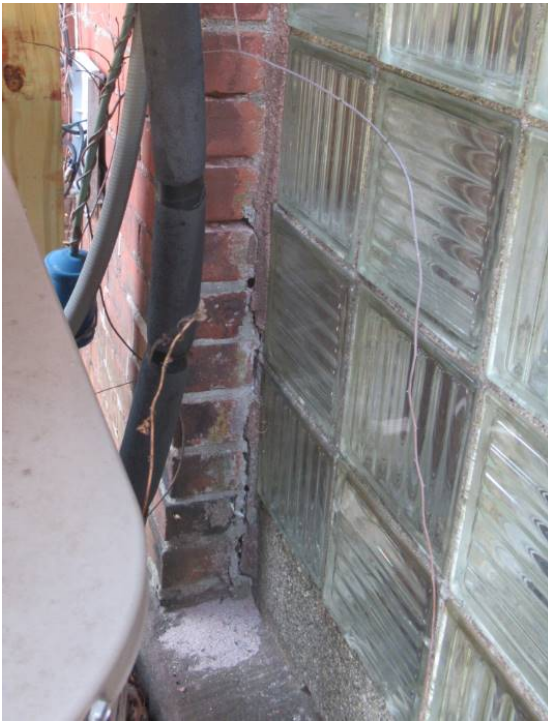
Mortar deterioration

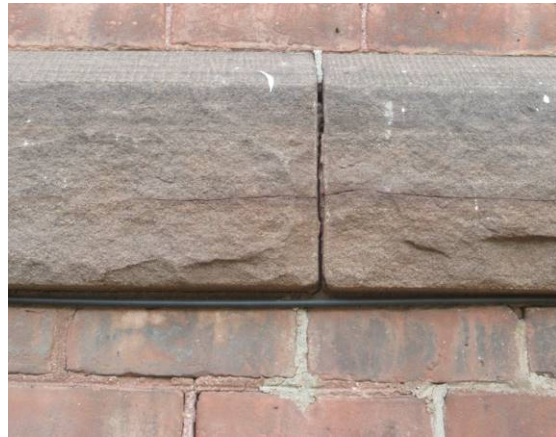
Mortar joint deterioration

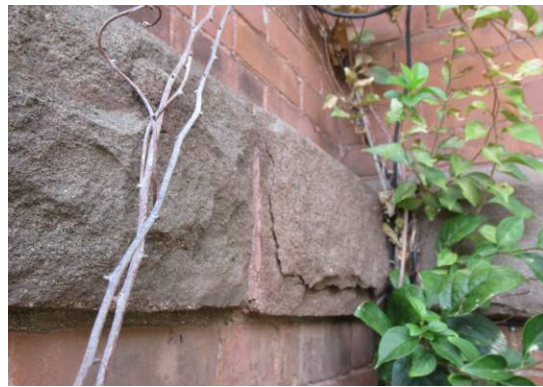
Stone spalling/deterioration

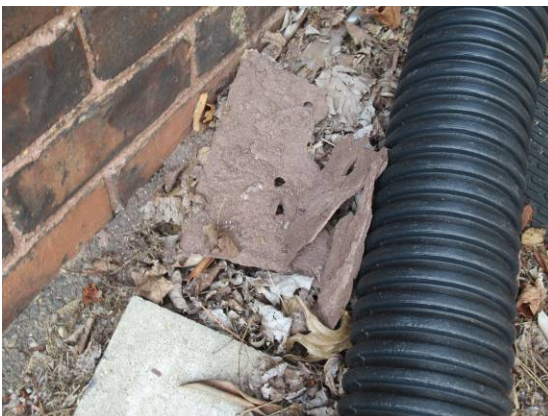
Spalled face of stone on the ground

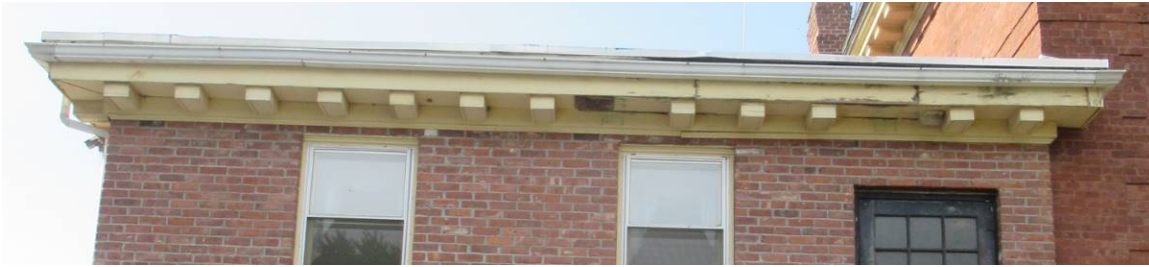
Repair/replace rotted/damaged woodwork.

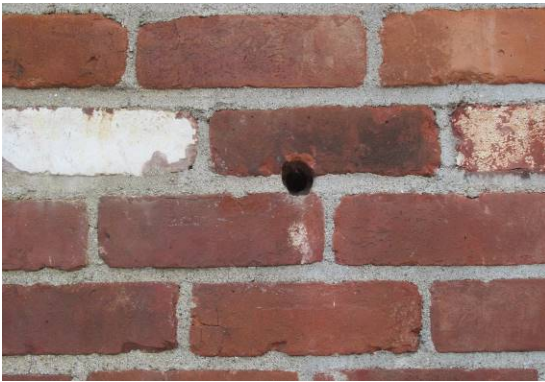
Seal penetration

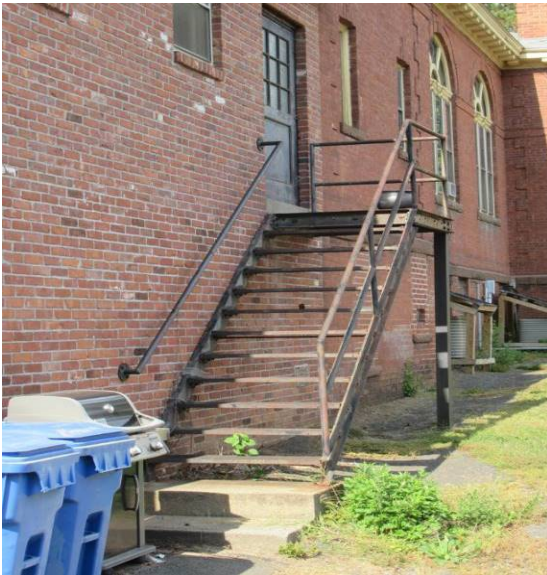
There is one fire escape assembly from the upper level meeting room to grade. It is located on the east side of the building. It requires minor repairs and repainting for weather protection. There are egress obstructions (plastic bucket with sand, gas grille and trash containers) that should be removed to provide a clear path of travel to grade. There is no emergency egress lighting present on the exterior of the building to illuminate the egress to grade and it should be added.

Fire escape
