**AHERA ASBESTOS  
INSPECTION REPORT**

**KYRENE TRADITIONAL ACADEMY  
3375 WEST GALVESTON STREET  
CHANDLER, ARIZONA 85226**

Dominion Project Number: AZ1418.58

AHERA Inspection Dates: August 18, 2025

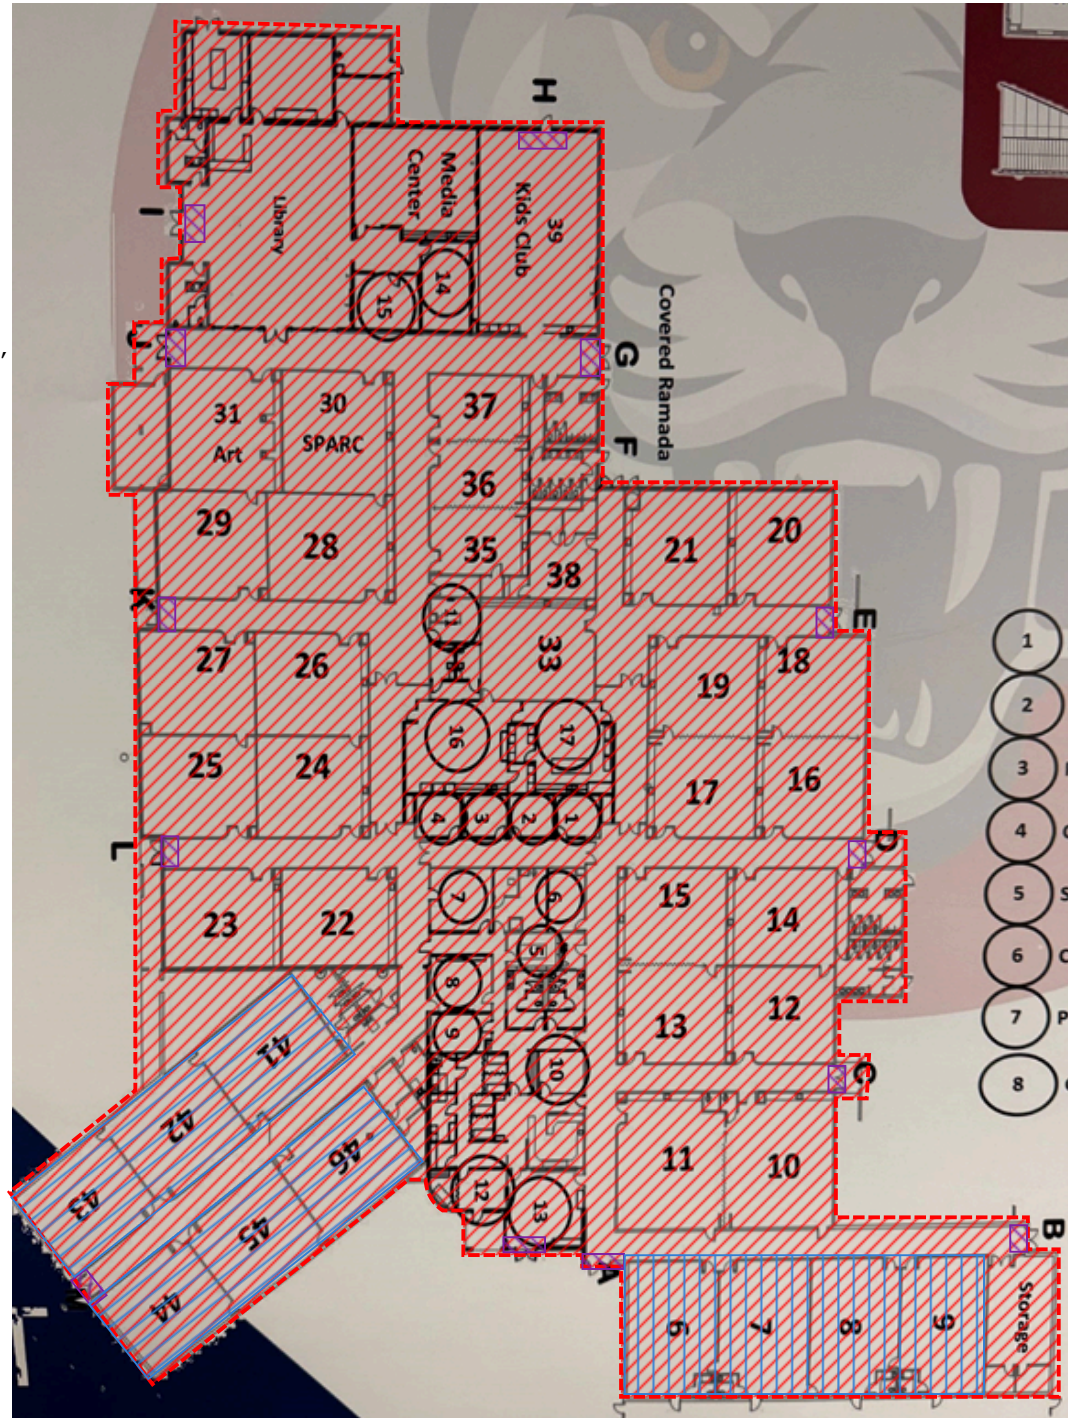
Assumed Asbestos-Containing Material Location Map (1)  
Kyrene Traditional Academy  
3375 West Galveston Street, Chandler, Arizona 85226

Black Sink Coating & White w/Gray  
Specks 12" x 12" Vinyl Floor Tile  
(VCT) & Mastic

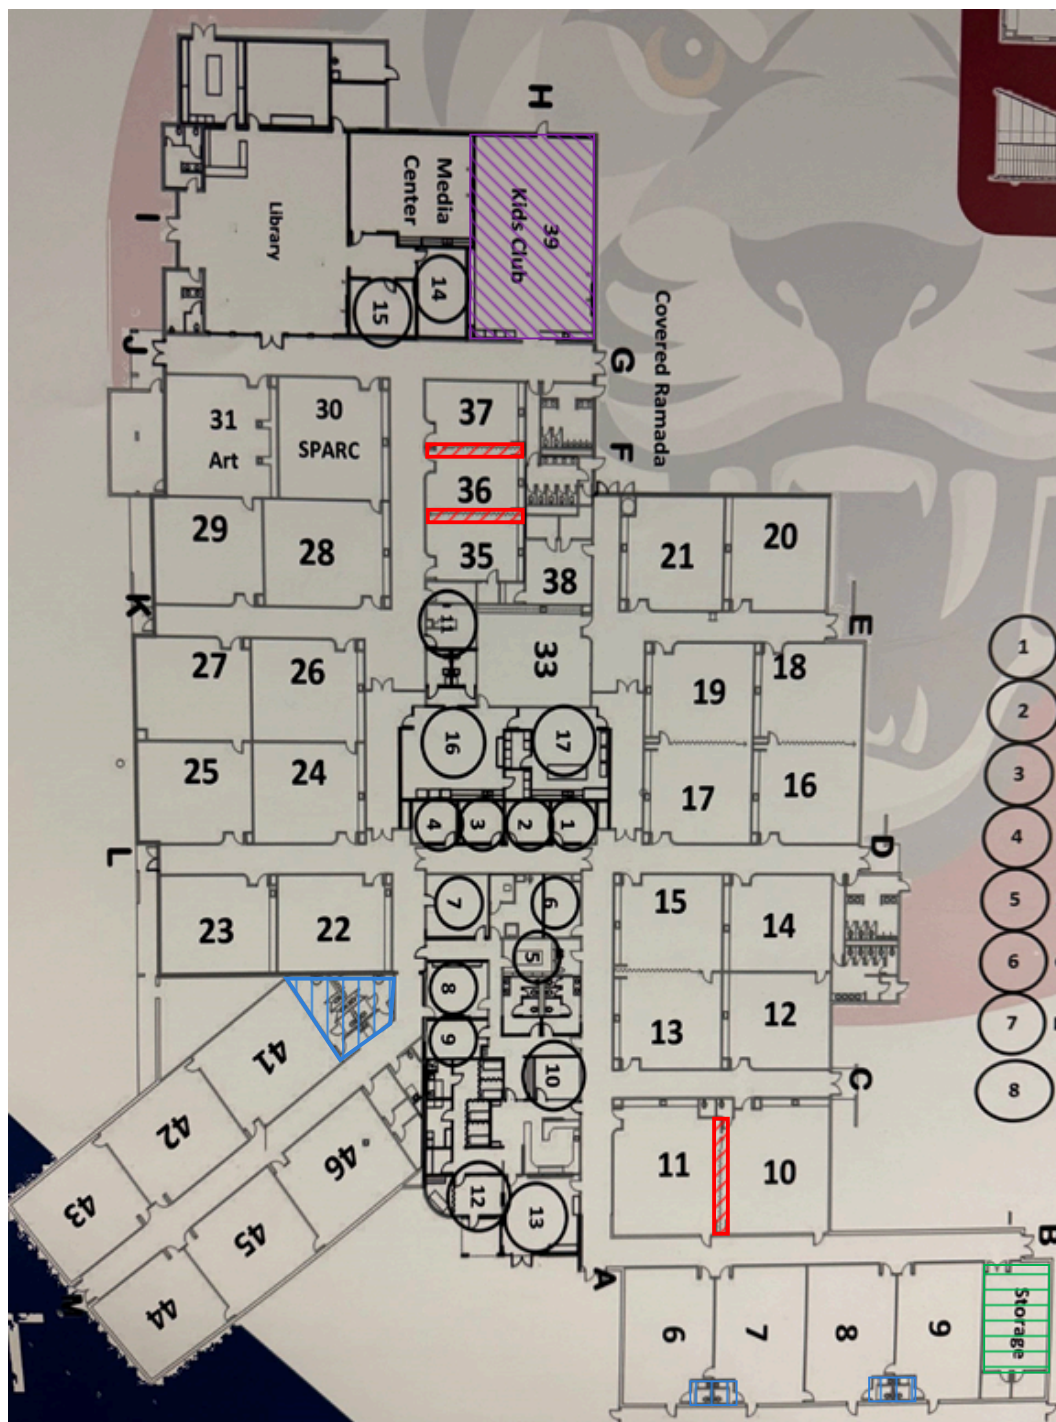
Assumed Asbestos-Containing Material Location Map (2)  
Kyrene Traditional Academy  
3375 West Galveston Street, Chandler, Arizona 85226

Assumed Asbestos-Containing  
Gray Floor Paint

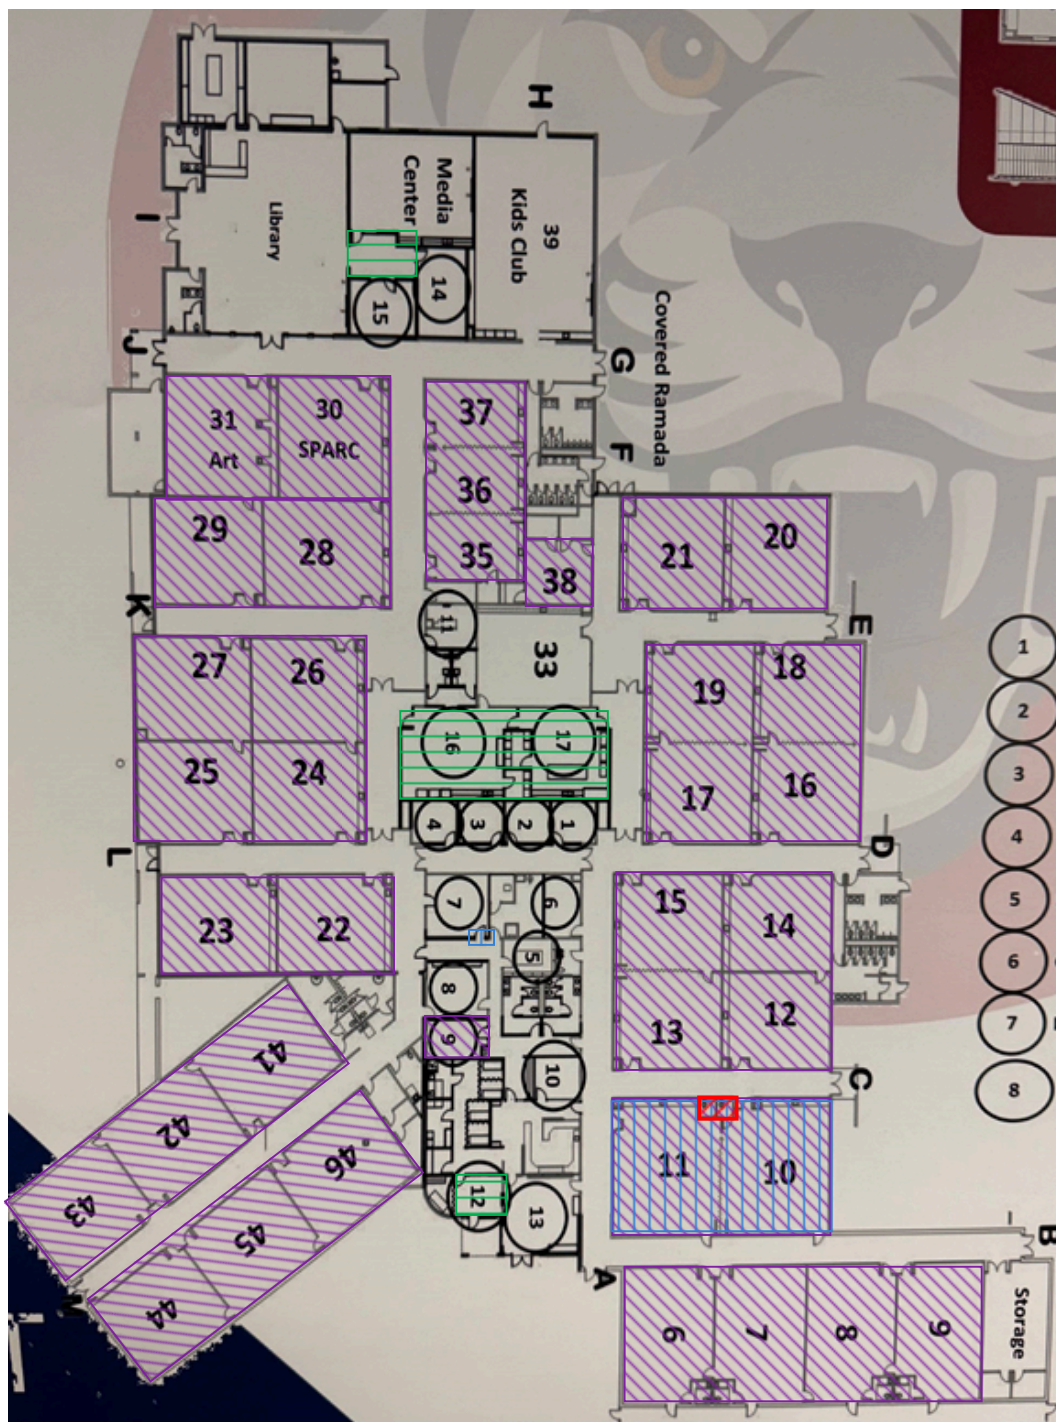
Assumed Asbestos-Containing Material Location Map (3)  
Kyrene Traditional Academy  
3375 West Galveston Street, Chandler, Arizona 85226

Black Vinyl Flooring & Mastic

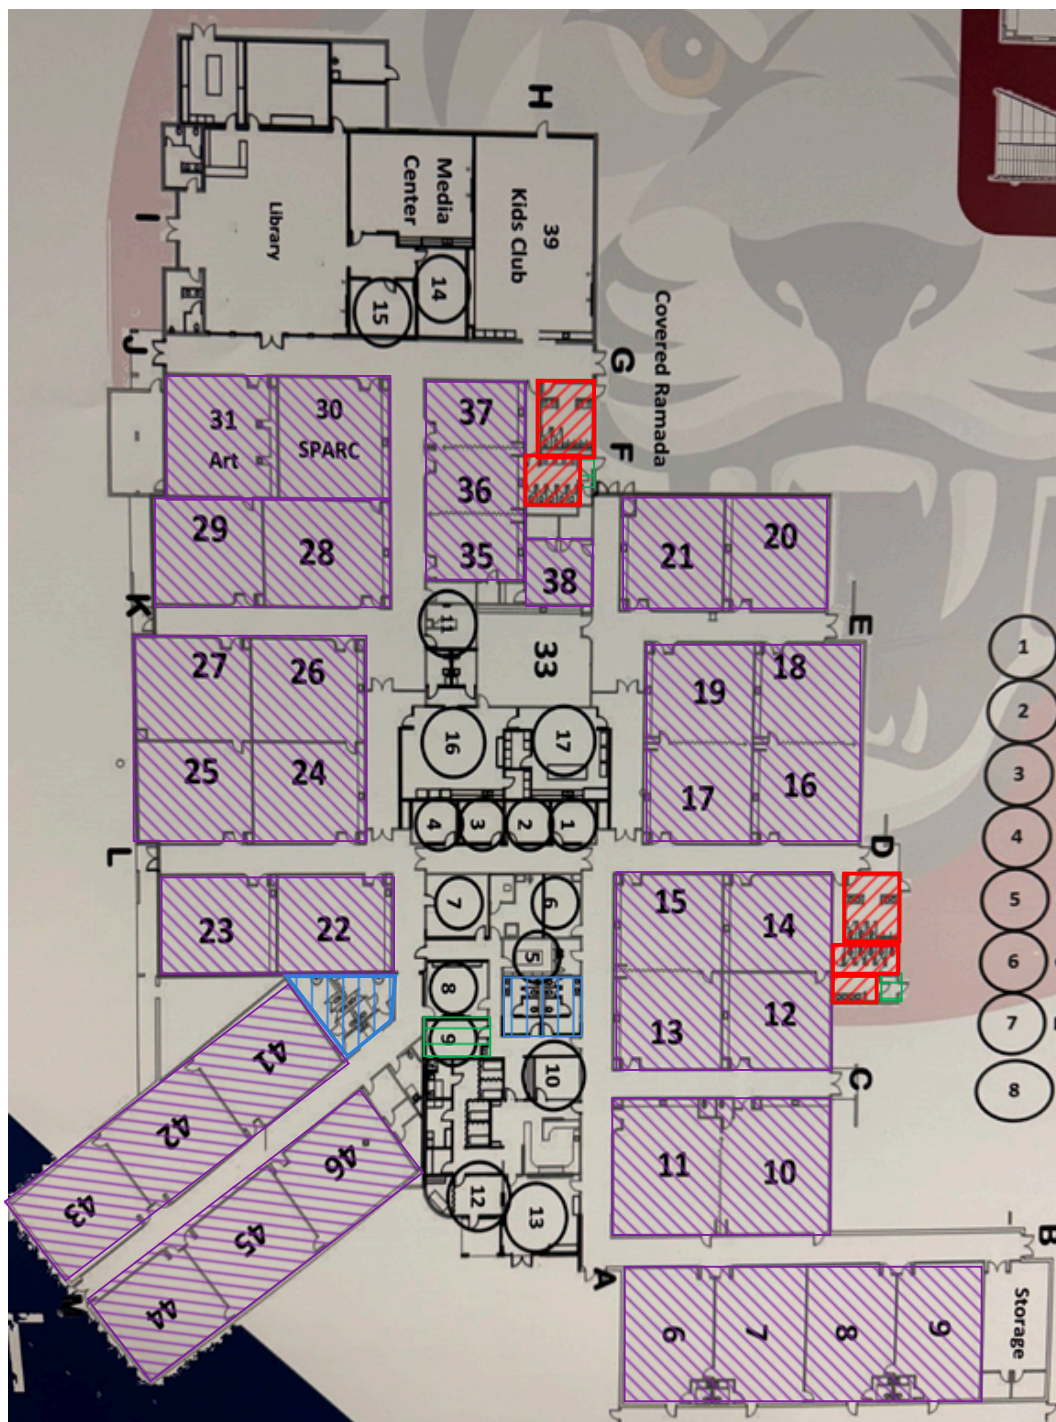
Assumed Asbestos-Containing Material Location Map (4)  
Kyrene Traditional Academy  
3375 West Galveston Street, Chandler, Arizona 85226

Fiberglass Reinforced Plastic  
(FRP) & Mastic

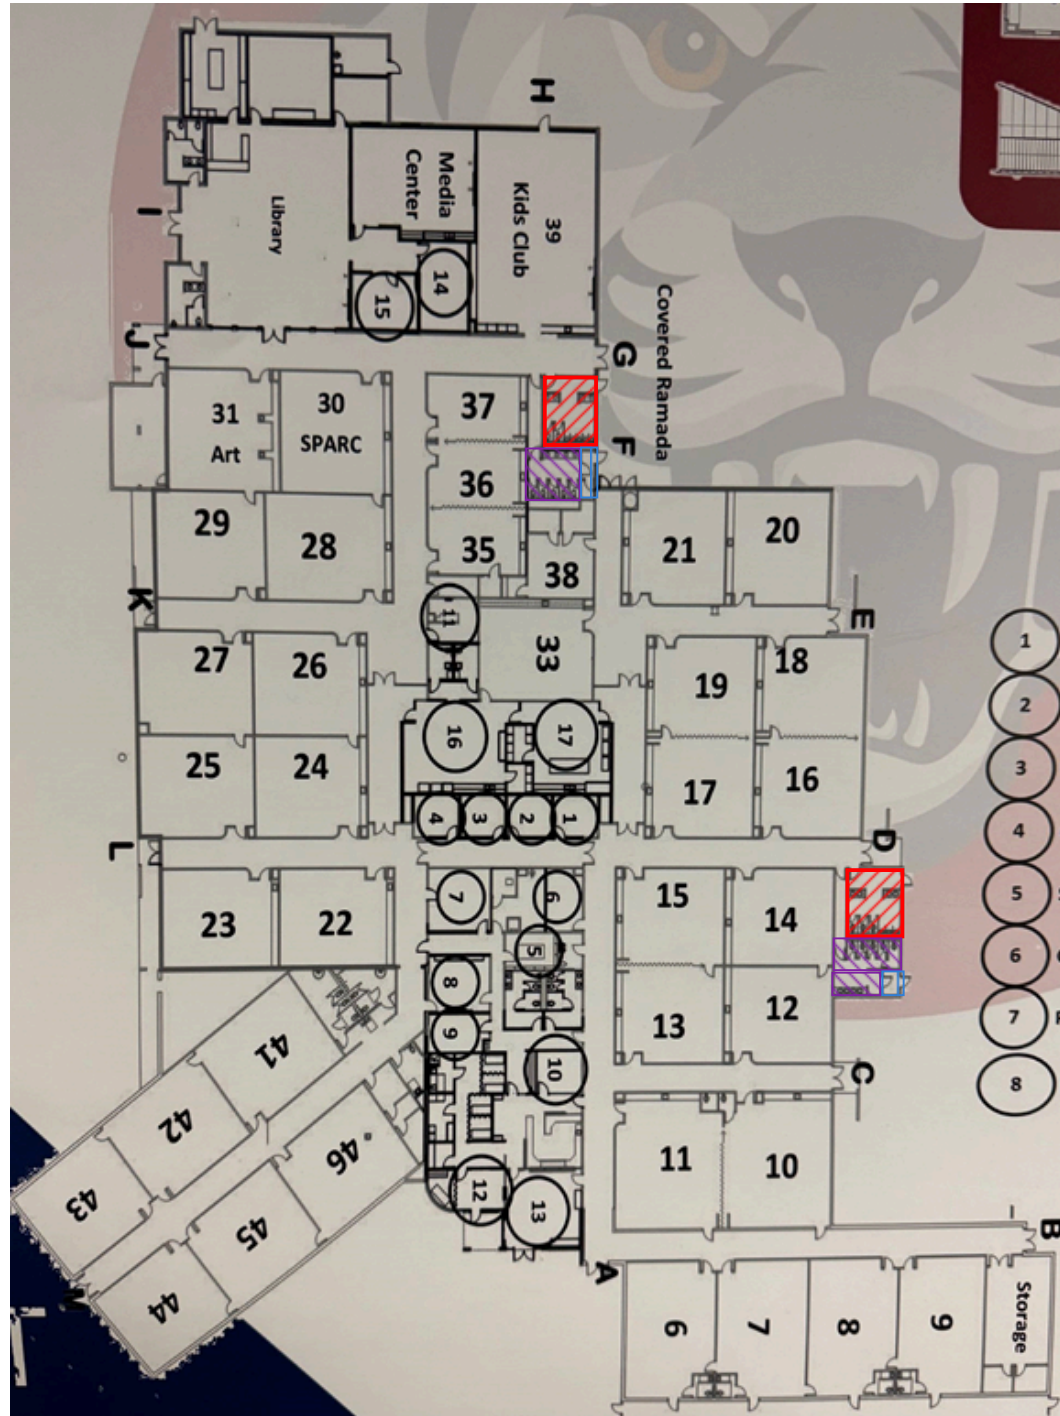
Assumed Asbestos-Containing Material Location Map (5)  
Kyrene Traditional Academy  
3375 West Galveston Street, Chandler, Arizona 85226

Skip Trowel Drywall System

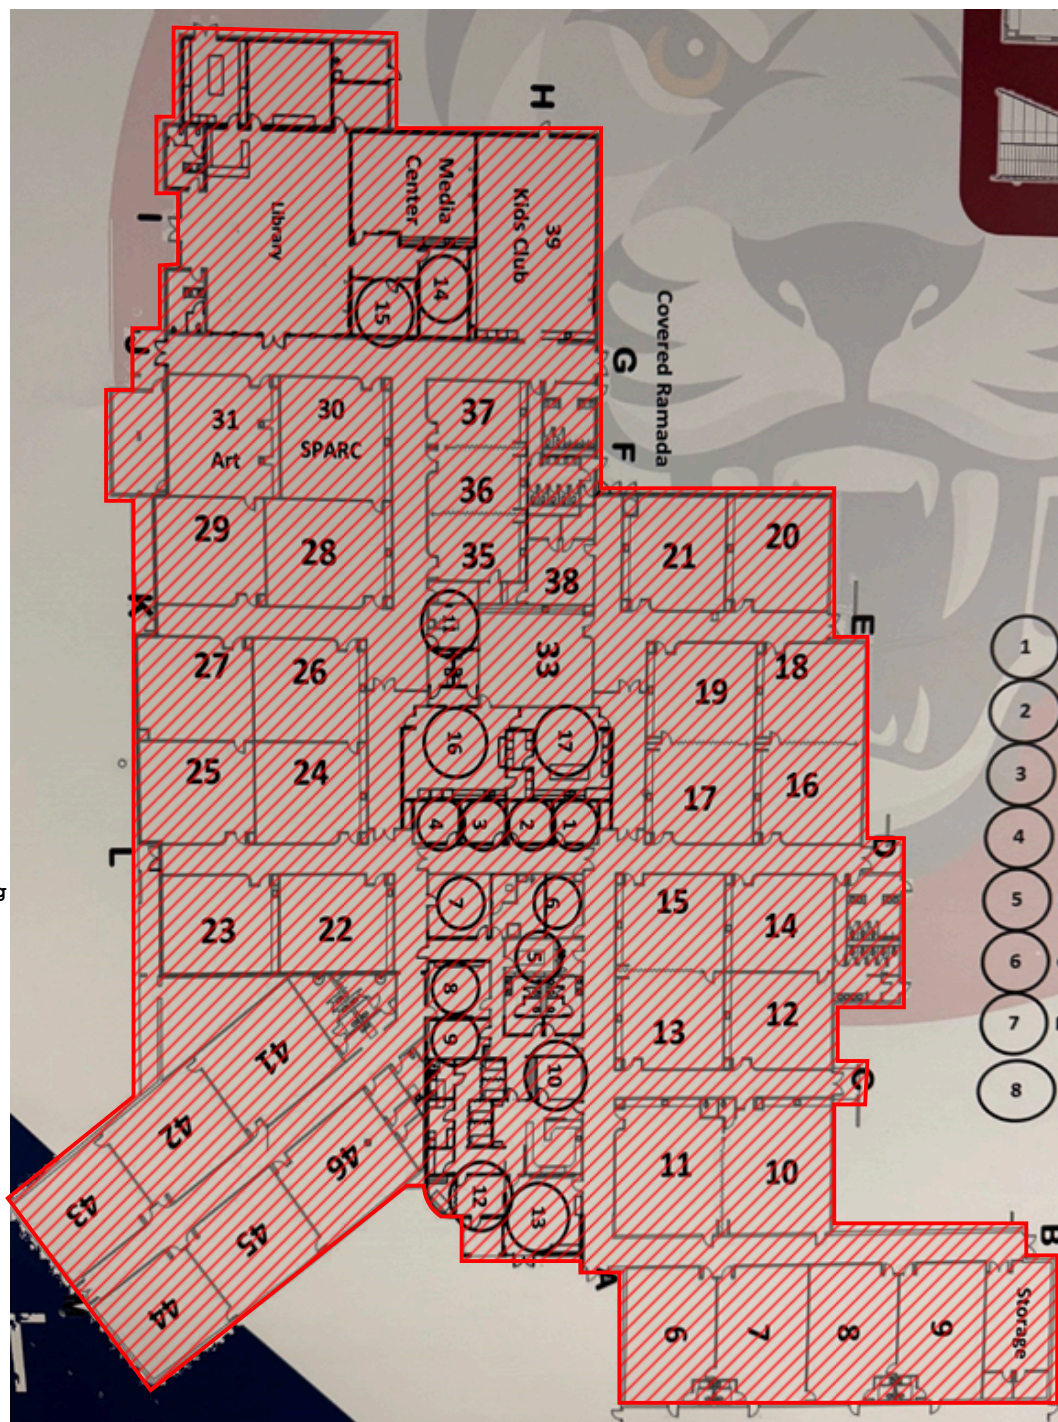
Assumed Asbestos-Containing Material Location Map (6)  
Kyrene Traditional Academy  
3375 West Galveston Street, Chandler, Arizona 85226

Silver Box Duct Wrap, Gray Flex Duct Wrap, Skylight Insulation Panel, Insulation for Skylight Insulation Panel, Silver Duct Tape, Ceiling Insulation, Ceiling Insulation Backing for Ceiling Insulation, Black Pipe Foam, Unfinished Drywall System, Gray Duct Mastic, Large Pipe Wrap & Mastic, Small Pipe Wrap & Mastic, Silver Flex Duct Wrap, Silver Duct Wrap, & Brown Fire Stop Caulking

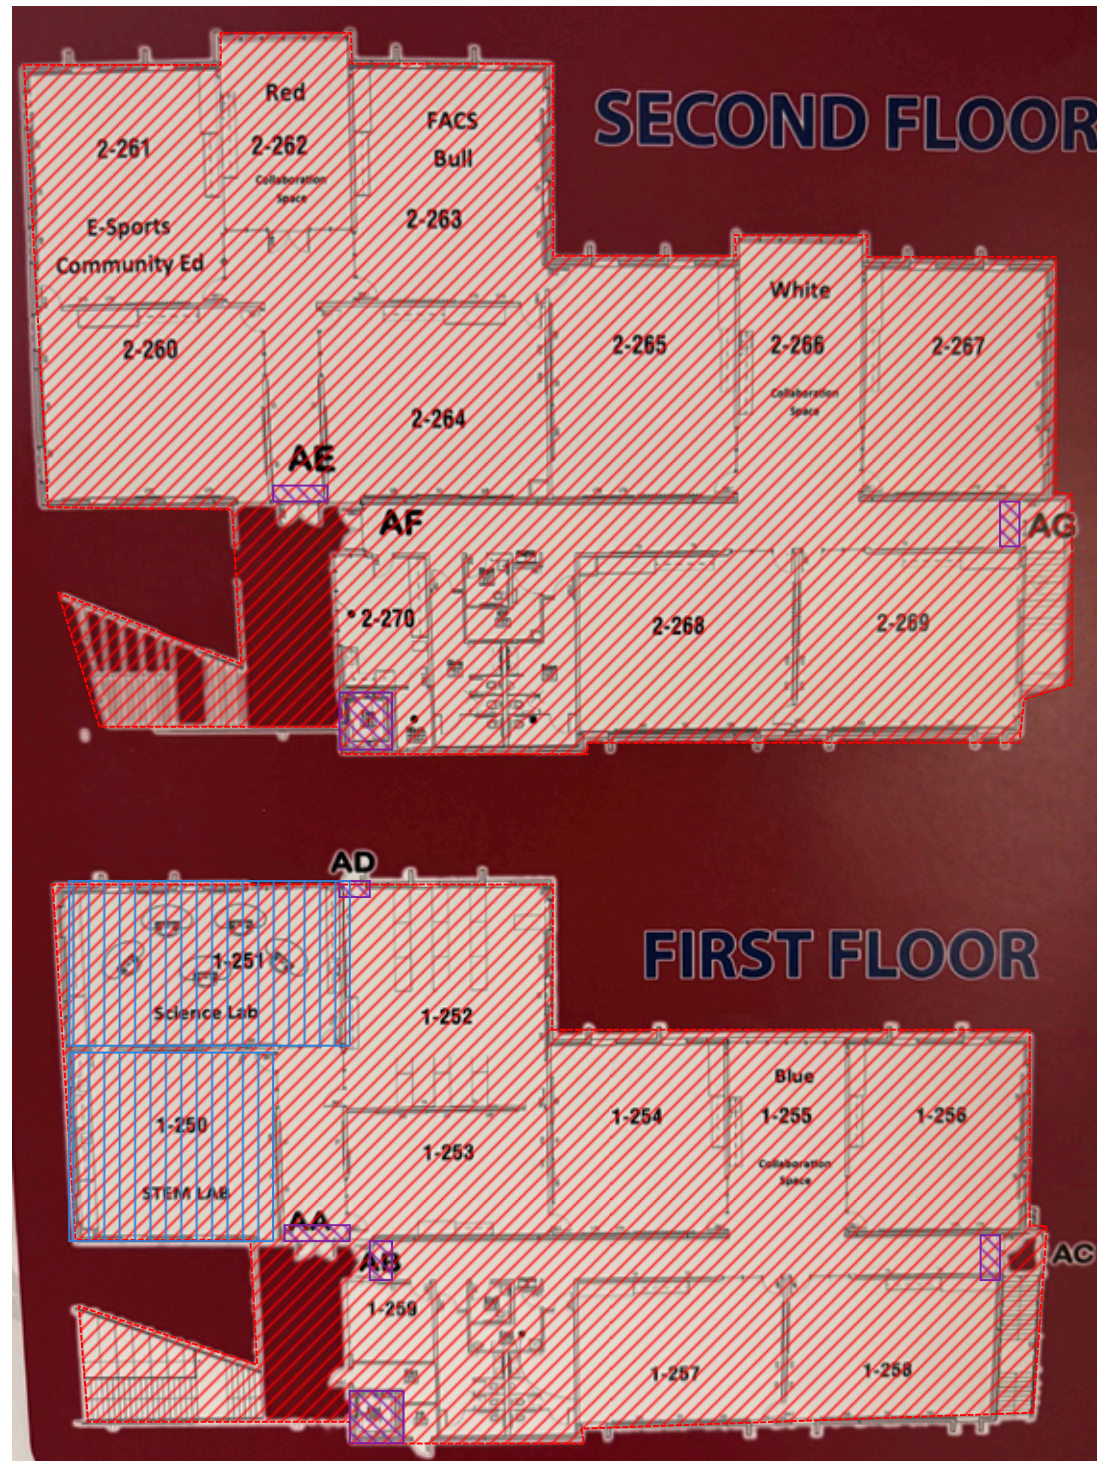
Assumed Asbestos-Containing Material Location Map (1)  
Kyrene Traditional Academy  
3375 West Galveston Street, Chandler, Arizona 85226

Black Countertops

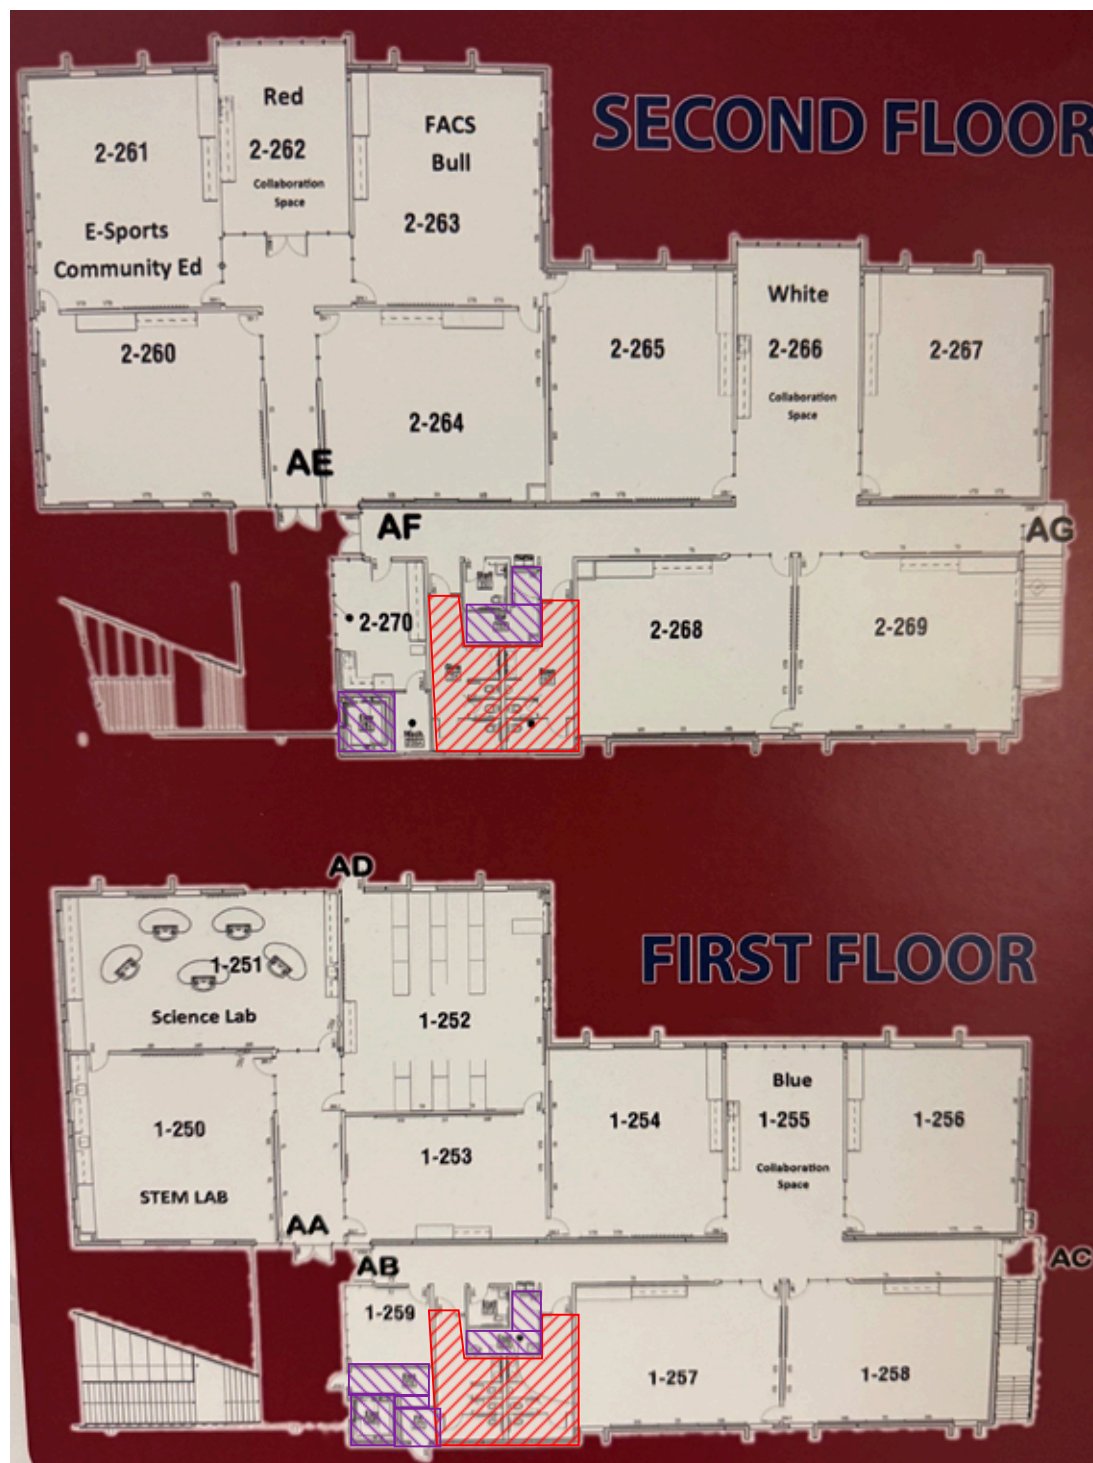
Tan 4" x 4" Ceramic Wall Tile,  
Blue 4" x 4" Ceramic Wall Tile,  
Red 4" x 4" Ceramic Wall Tile, Grout &  
Mastic for Wall Tiles, Expansion  
Joints for Blocks, Blue Floor Coating,  
& Fixture Caulking

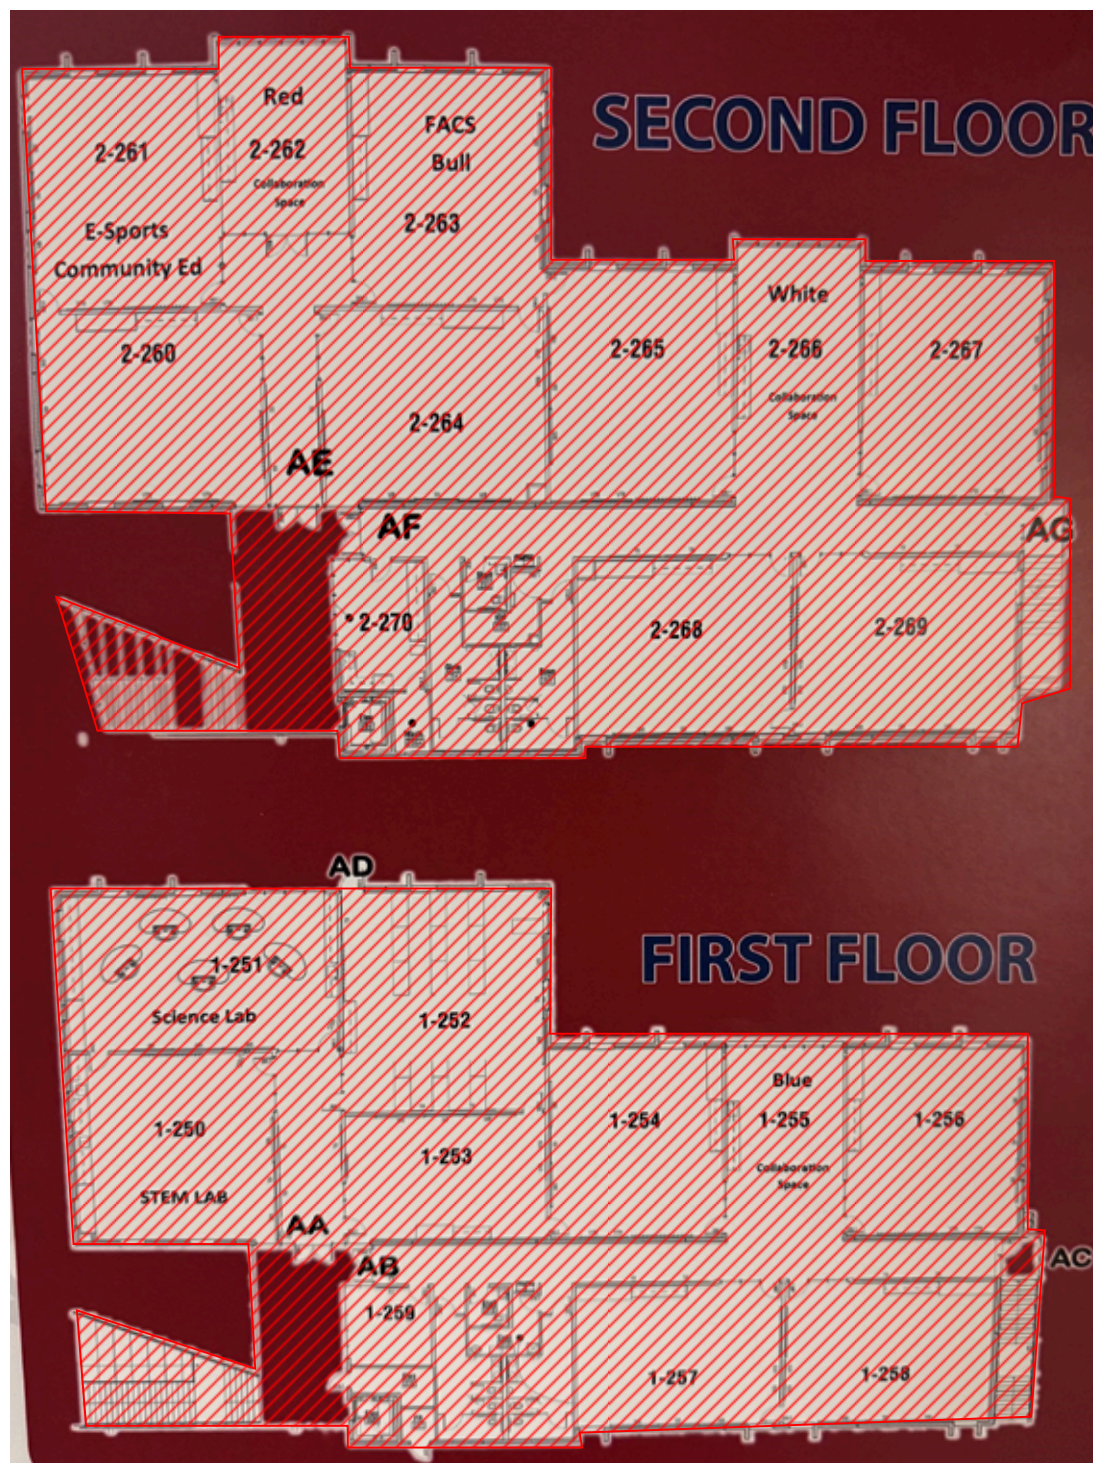
Red Fire Stop Caulking,  
Large Pipe Wrap & Mastic,  
Small Pipe Wrap & Mastic,  
Silver Flex Duct Wrap,  
Silver Duct Wrap, Silver Duct Tape,  
Gray Duct Mastic, Unfinished Drywall  
System, & Black Pipe Foam

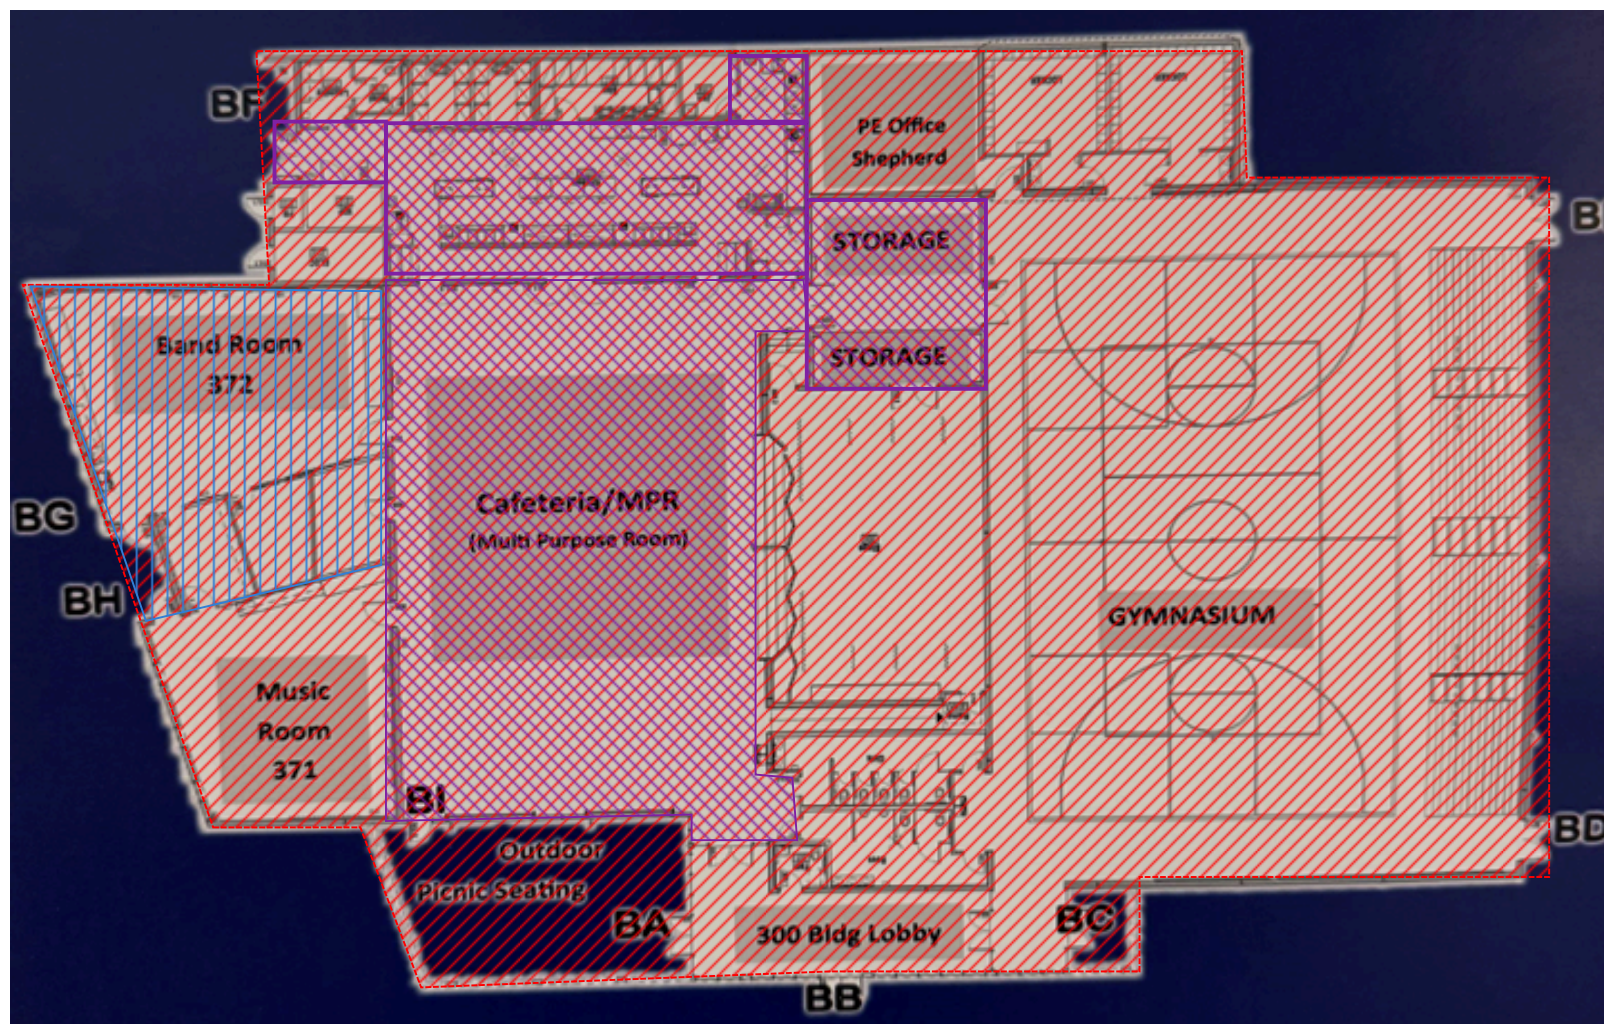
Assumed Asbestos-Containing  
Expansion Joint, Interior Caulking, &  
Tac board & Mastic

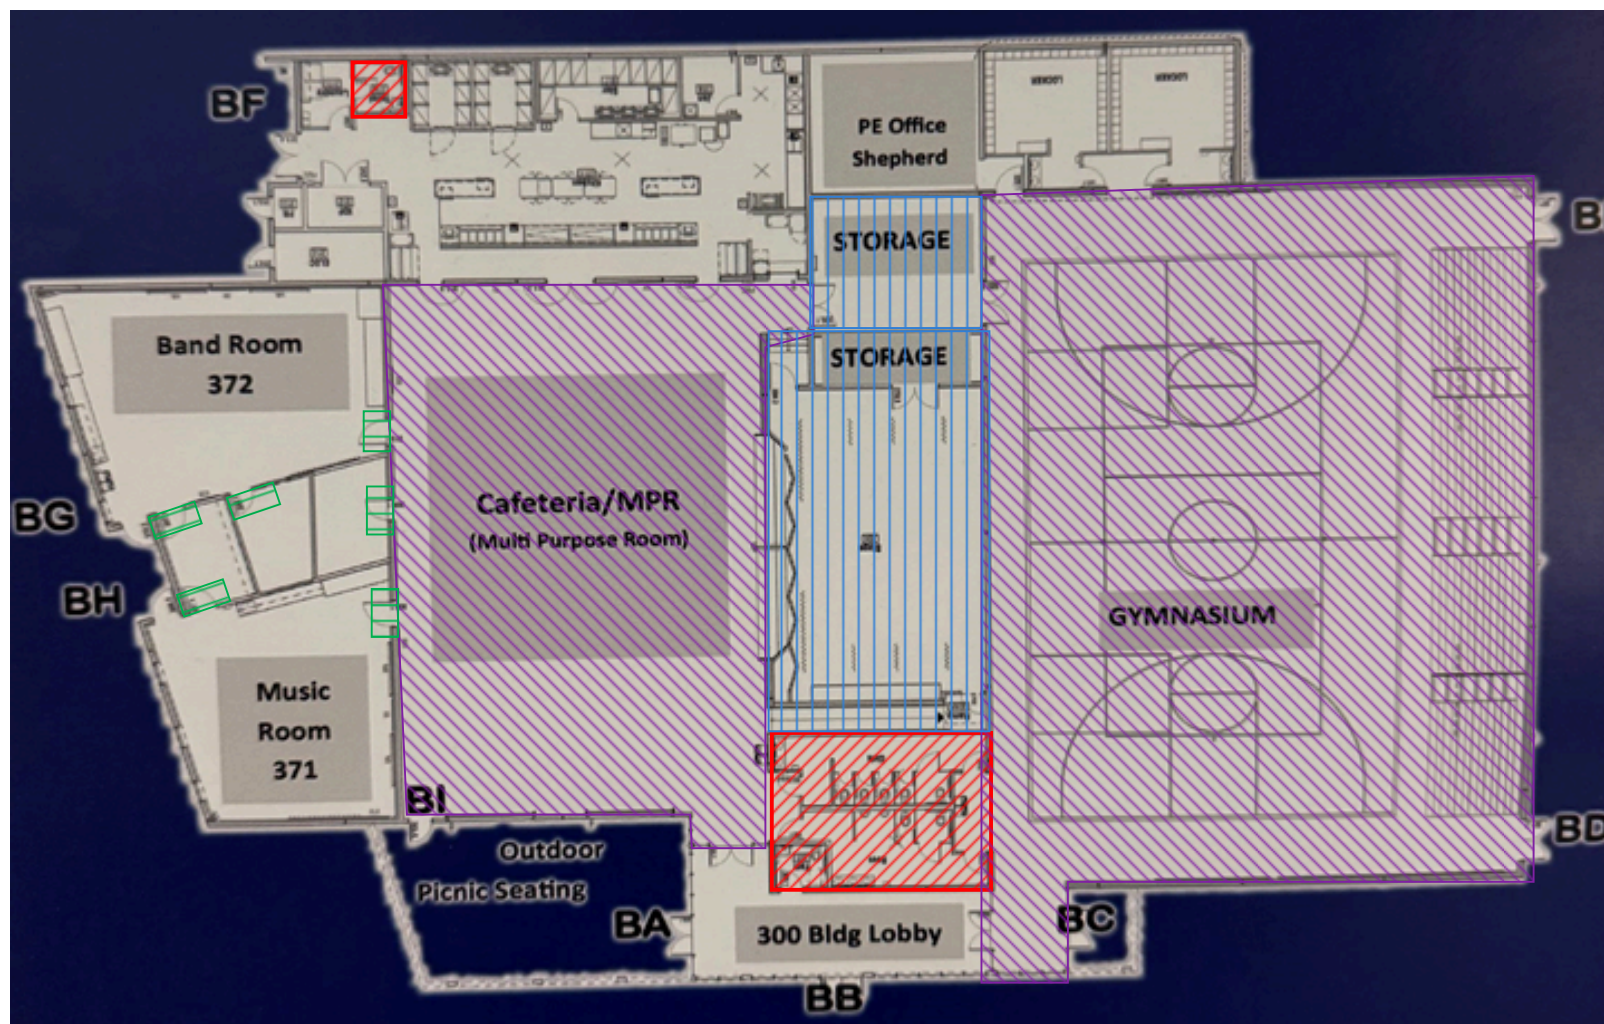
Tan 4" x 4" Ceramic Wall Tile, Grout, & Mastic,  
Blue 4" x 4" Ceramic Wall Tile, Grout, & Mastic,  
Red 4" x 4" Ceramic Wall Tile, Grout, & Mastic, &  
Fixture Caulking

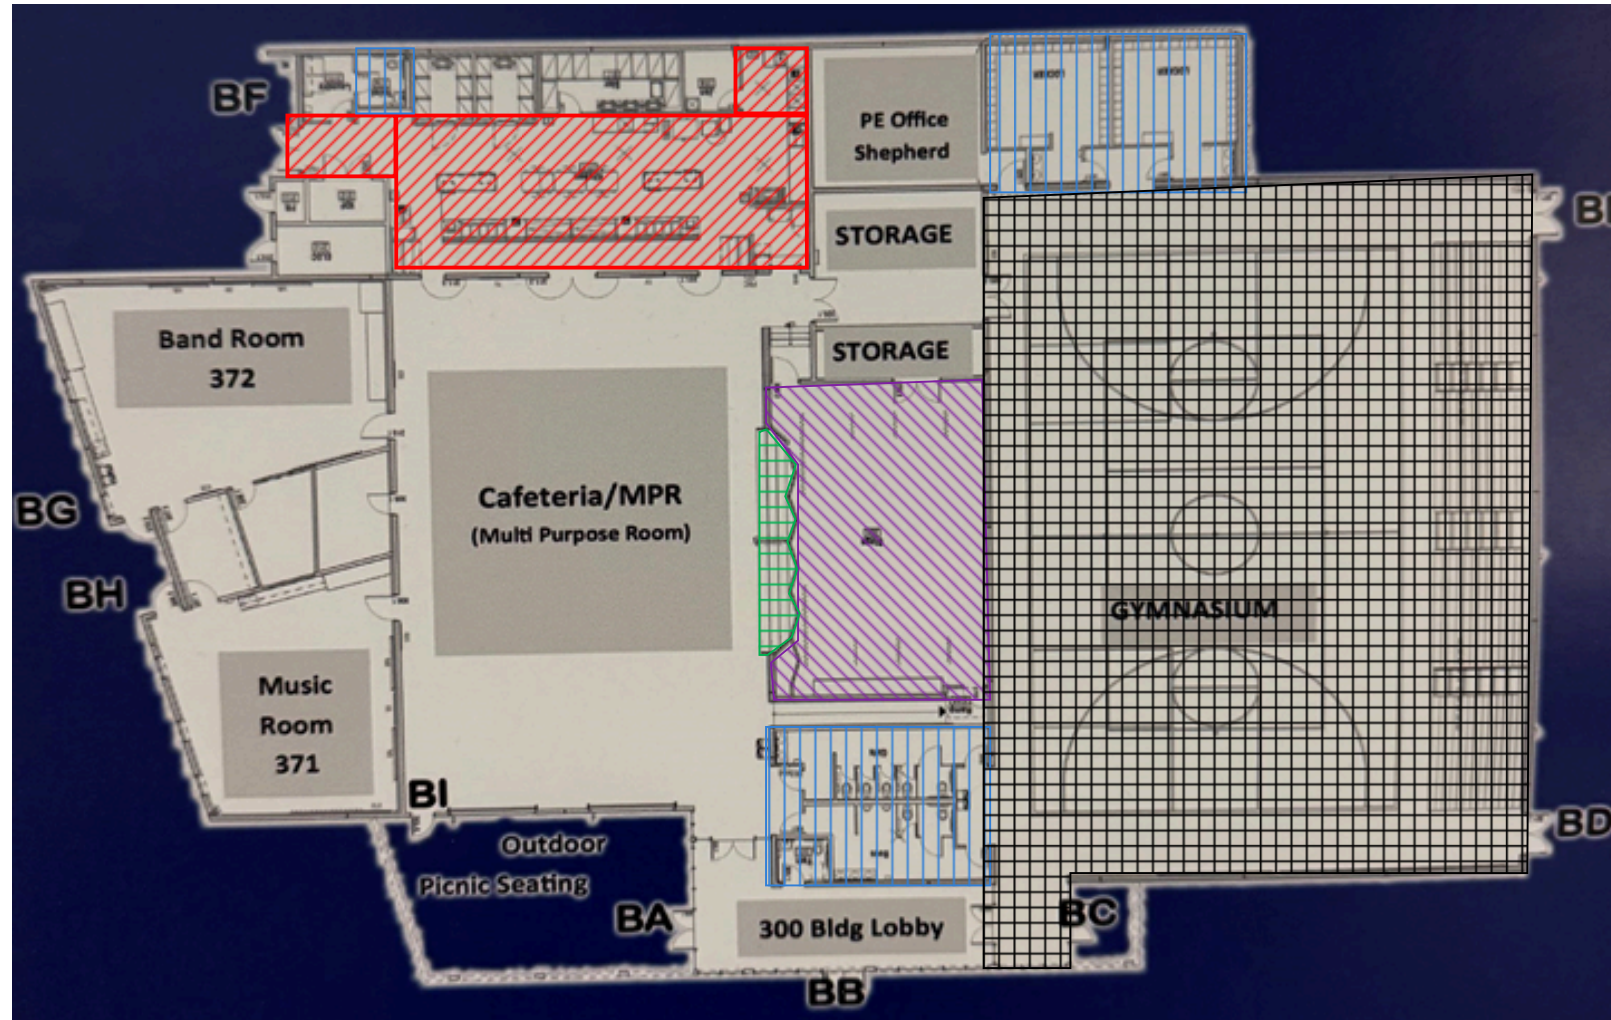
Assumed Asbestos-Containing  
Fiberglass Reinforced Plastic (FRP) & Mastic &  
2' x 4' Drywall Ceiling Tile

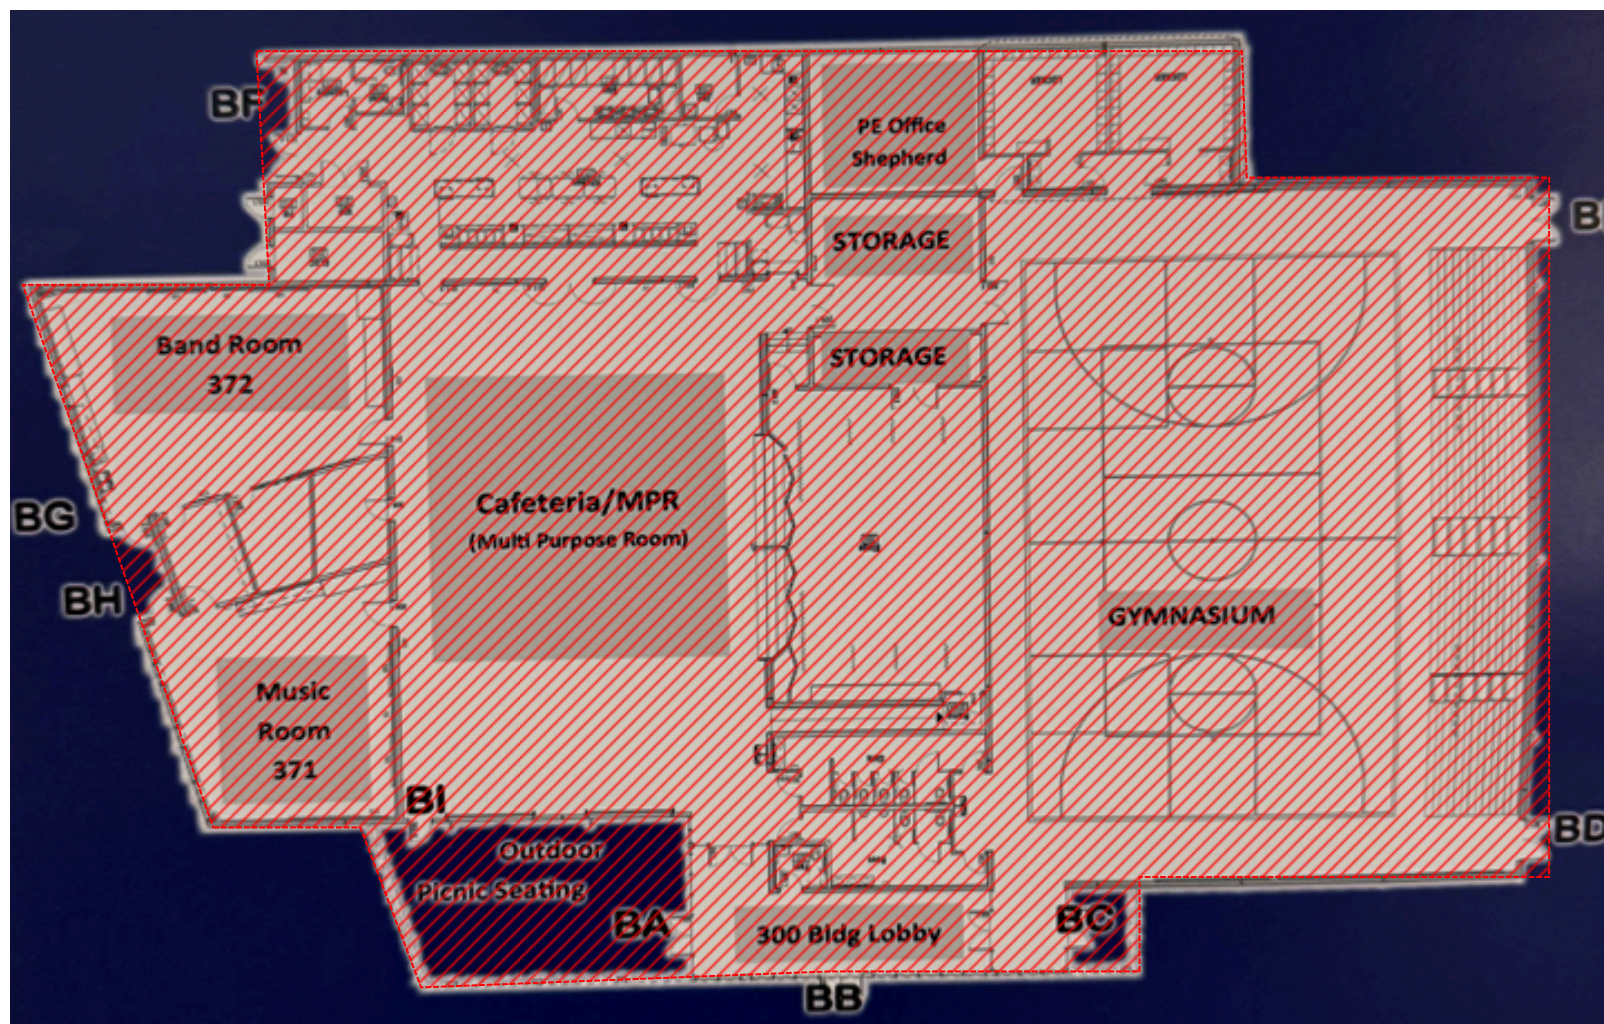
Silver Flex Duct Wrap, Silver Duct Wrap, Gray Duct Mastic, Black Pipe Foam Insulation, Unfinished Drywall, Large Pipe Wrap & Mastic, Small Pipe Wrap & Mastic, & Silver Duct Tape
