**AHERA ASBESTOS  
INSPECTION REPORT**

**KYRENE DE LOS NINOS  
1330 EAST DAVA DRIVE  
TEMPE, ARIZONA 85226**

Dominion Project Number: AZ1418.49

AHERA Re-Inspection Date: August 12, 2025

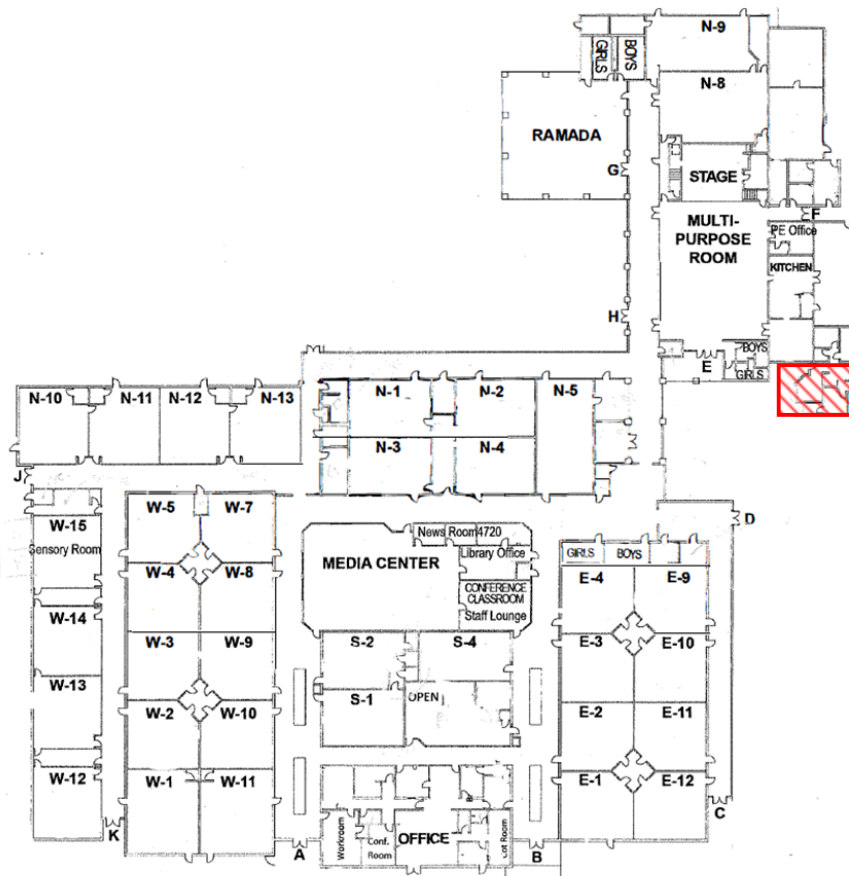
Assumed Asbestos-Containing Map (1)  
Kyrene De Los Ninos Elementary School  
1330 E Dava Dr, Tempe, AZ 85283

**Assumed Asbestos-Containing  
Wood Vinyl Flooring & Mastic  
Gray Cove Base & Mastic  
Tan Carpet & Mastic  
White 4"x4" Ceramic Wall Tile  
(Grout & Mastic)**

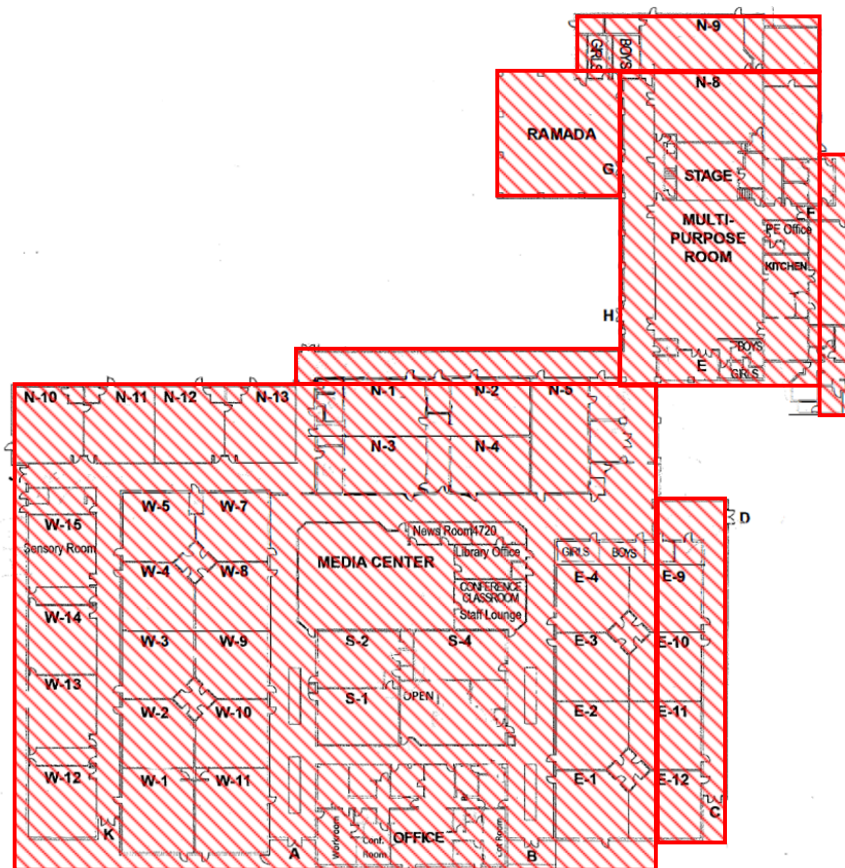
Assumed Asbestos-Containing Map (2)  
Kyrene De Los Ninos Elementary School  
1330 E Dava Dr, Tempe, AZ 85283

- Assumed Asbestos-Containing  
Brick & Mortar  
Block & Mortar  
Stucco  
Silver Box Duct Wrap  
Silver Duct Wrap  
Silver Flex Duct Wrap  
Ceiling Insulation & Mastic  
Skylight Insulation Panel  
Silver Duct Tape  
Large Pipe Wrap & Mastic  
Small Pipe Wrap & Mastic  
Gray Duct Mastic  
Black Foam Pipe Insulation  
Unfinished Drywall System  
Interior Caulking  
Exterior Caulking  
Black Window Glazing  
Glass Block Mortar  
Beige Speckled 12"x12" VCT  
(Mastic)  
Gray Floor Coating  
Fixture Caulking

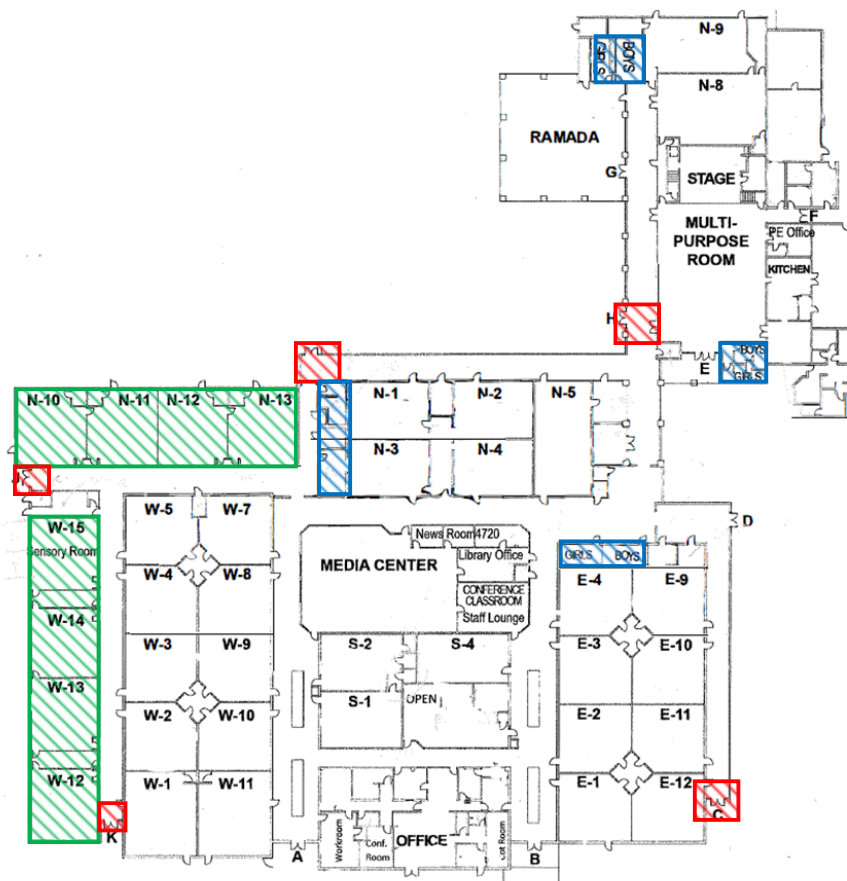
**Assumed Asbestos-Containing  
Dark Blue Entry Carpet Square  
Mastic for Entry Carpet**

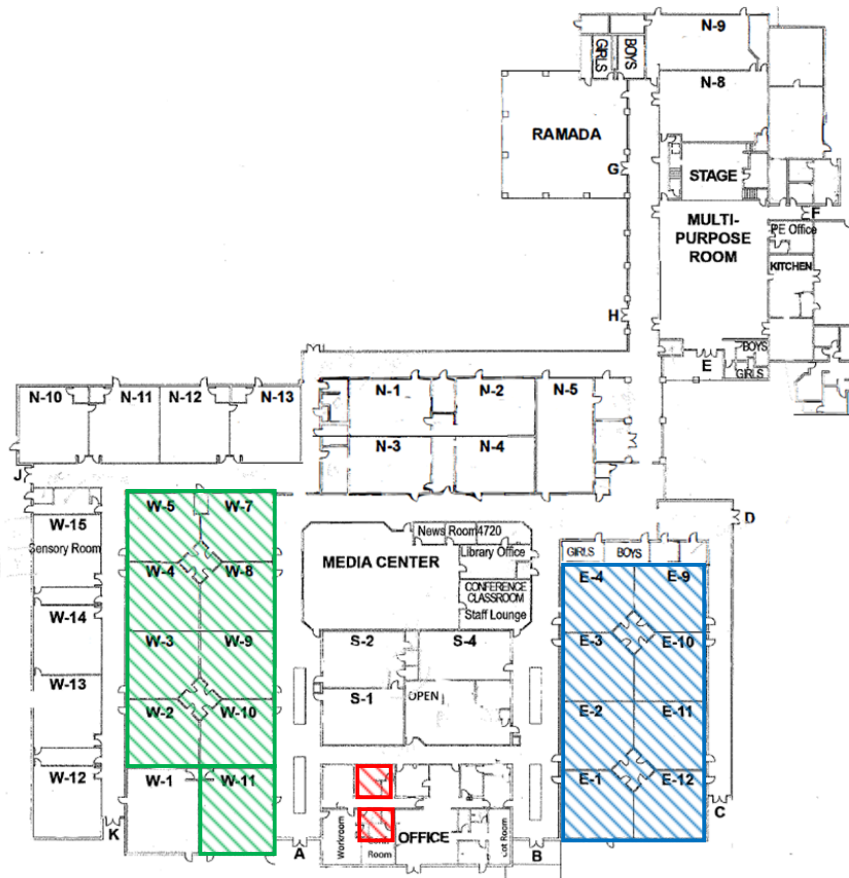
**Assumed Asbestos-Containing  
Pink 4"x4" Ceramic Wall Tile  
Pink 4"x6" Ceramic Cove Base Tile  
(Grout & Mastic)**

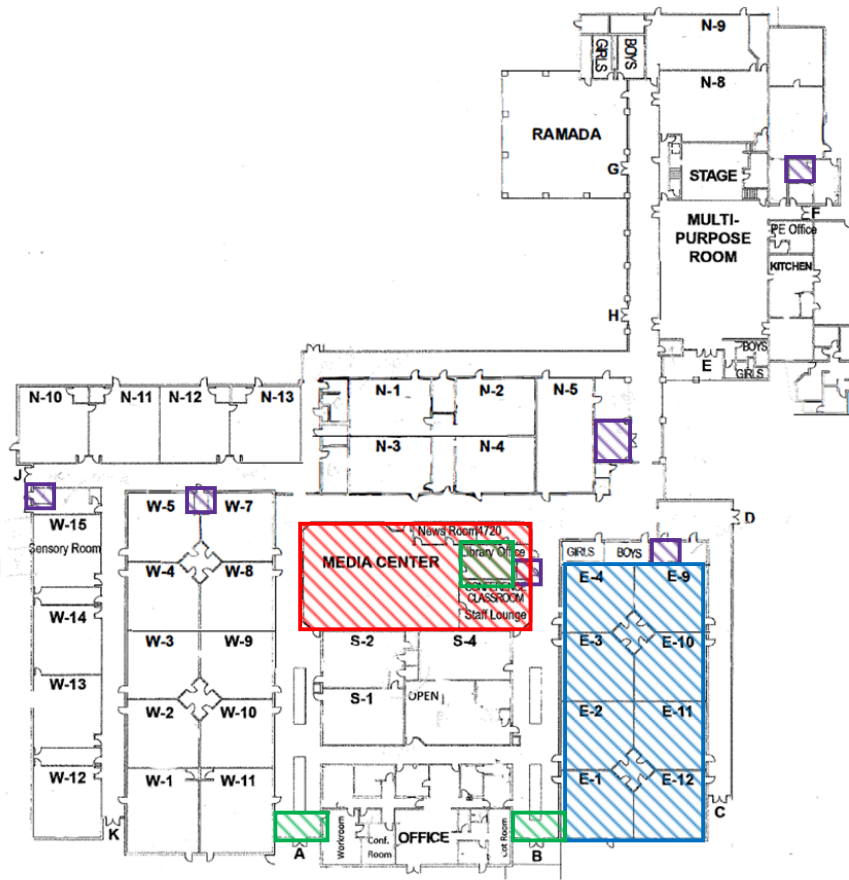
**Assumed Asbestos-Containing  
Gray Cove Base & Mastic**

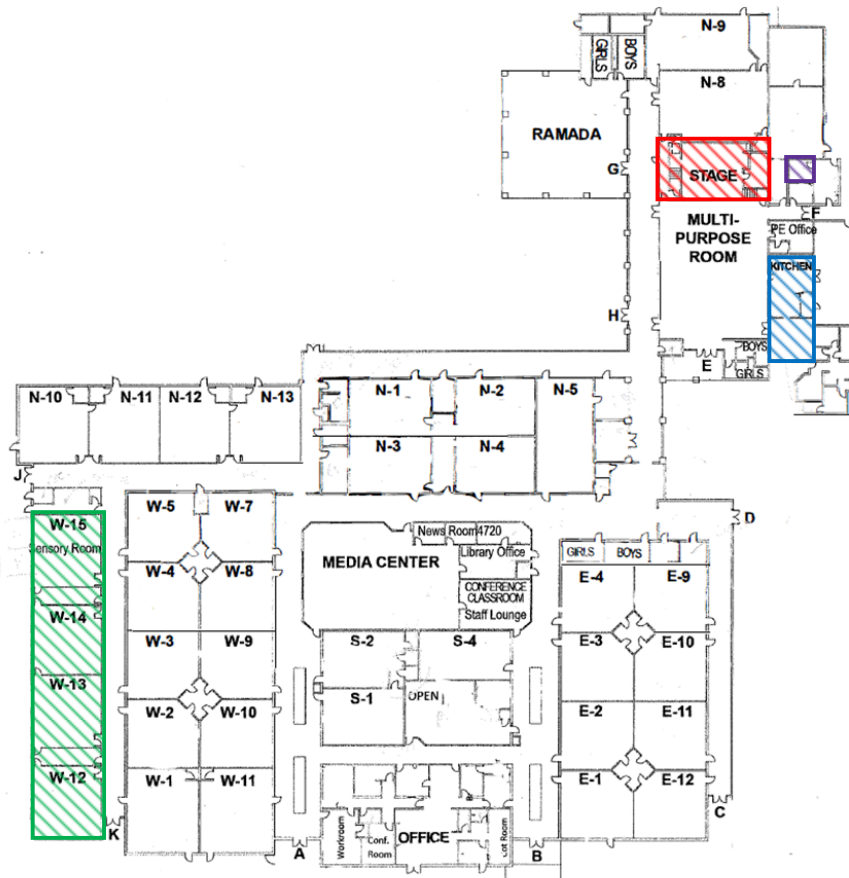
**Assumed Asbestos-Containing  
Divider Wall  
White w/ Tan Speck 12"x12" VCT  
Red Stair Tread  
(Mastic)**

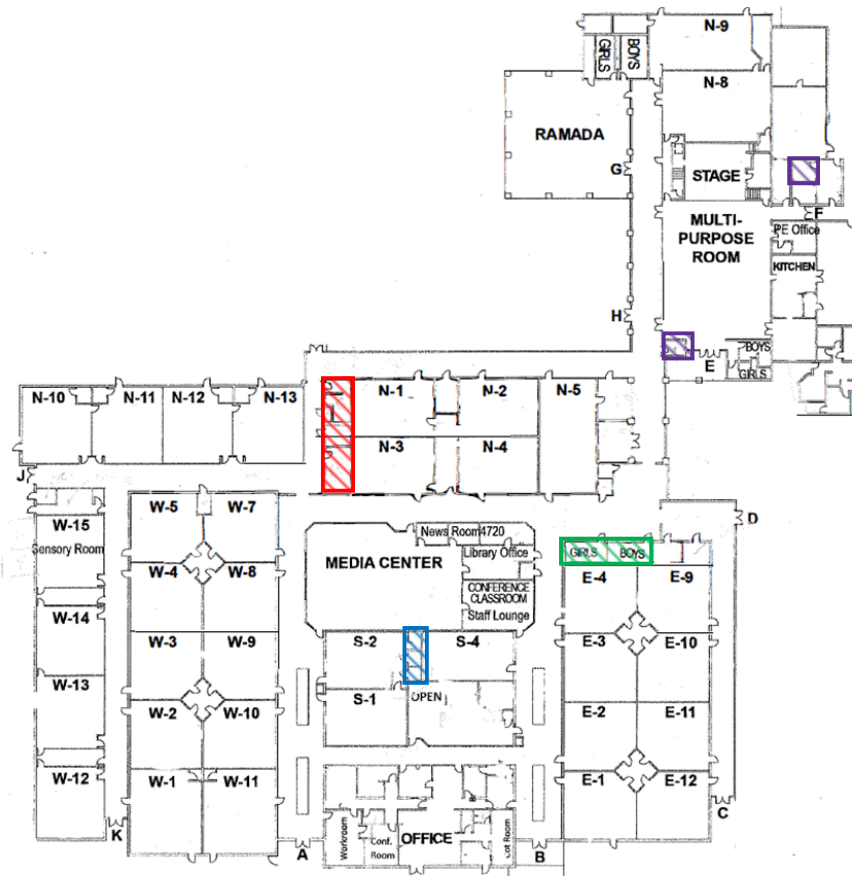
Assumed Asbestos-Containing  
White 8"x8" Ceramic Wall Tile  
Off-White 4"x4" Ceramic Wall Tile  
(Grout & Mastic)

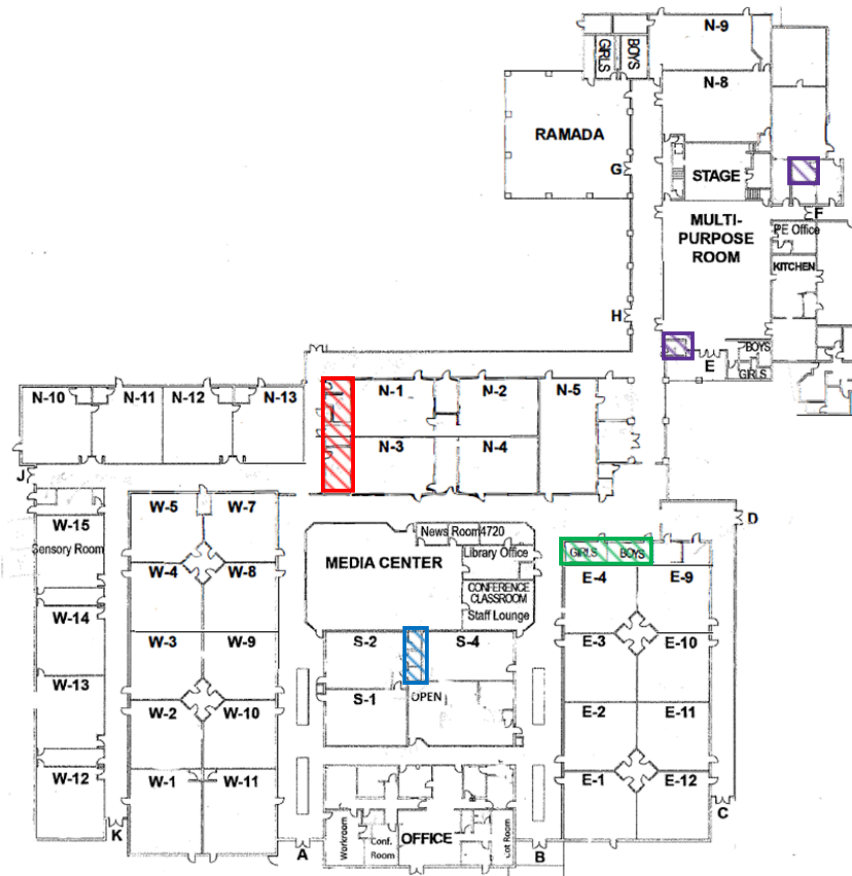
Assumed Asbestos-Containing  
White 8"x8" Ceramic Wall Tile  
Off-White 4"x4" Ceramic Wall Tile  
(Grout & Mastic)

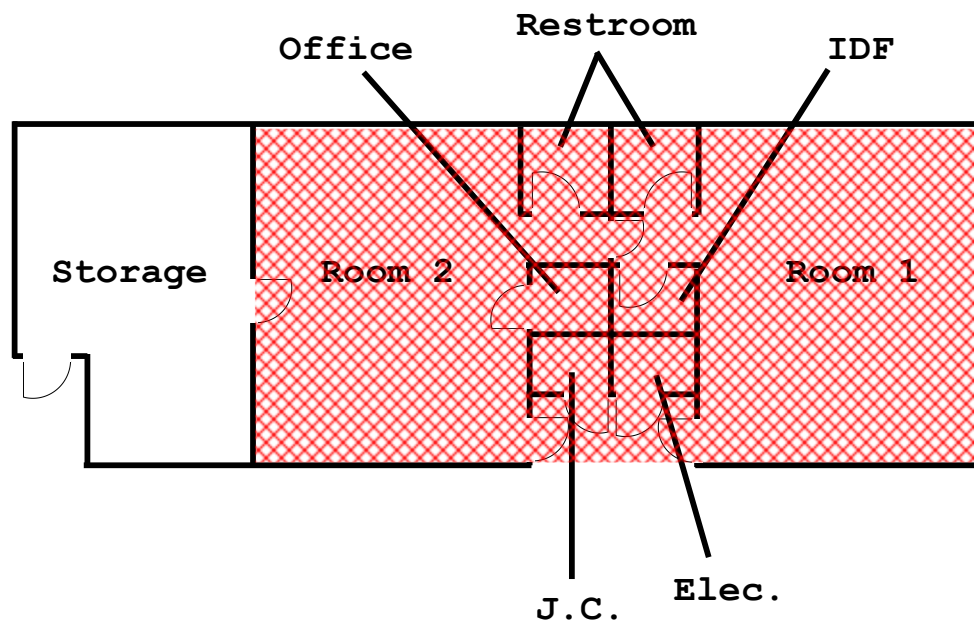
**Assumed Asbestos-Containing**

**Interior Caulking**

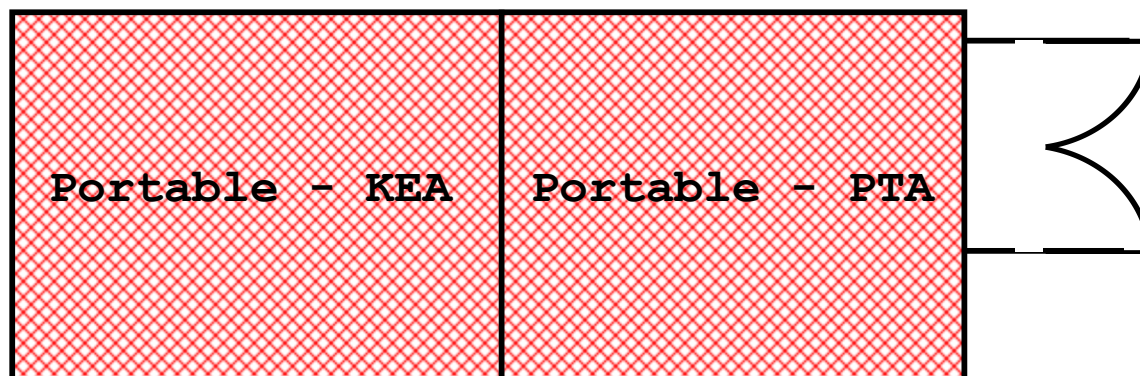
Assumed Asbestos-Containing  
Gray/Black Carpet & Mastic  
Blue Cove Base & Mastic  
Tacboard & Mastic  
Door Frame Caulking  
Ceiling Insulation  
Backing for Ceiling Insulation  
Silver Duct Tape  
Gray Flex Duct Wrap
