# ACCESSIBILITY ASSESSMENT

## ADA TITLE III ASSESSMENT

Centennial Elementary School

March 4, 2025

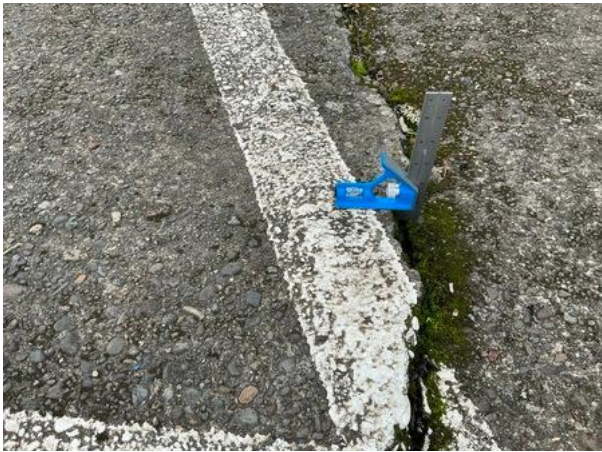
| Access aisle has a crack for the 7/8" vertical change and open surface areas in excess of 1/2". | | |

| The sidewalk should be removed (sections that are heaved, cracked etc) and repaired. Changes in level of 1/4" high maximum shall be permitted to be vertical. Changes in level between 1/4" high minimum and 1/2" high maximum shall be beveled with a slope not steeper than 1:2. Changes in level greater than 1/2" shall be ramped. | | |

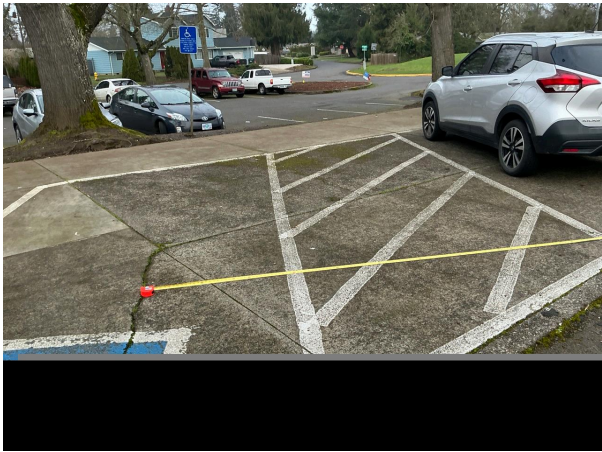
| <b>Site Conditions</b> | Diagonal striping is 30" on center. |

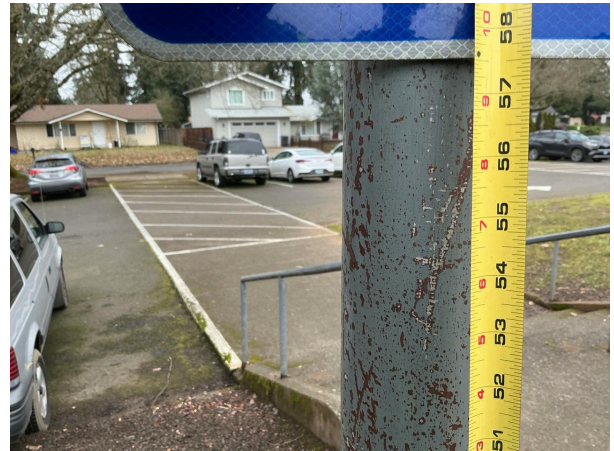
Photos for Barrier ID: AX553349

| Site Conditions | Bottom edge of signage measures 57-3/4" off ground surface. |

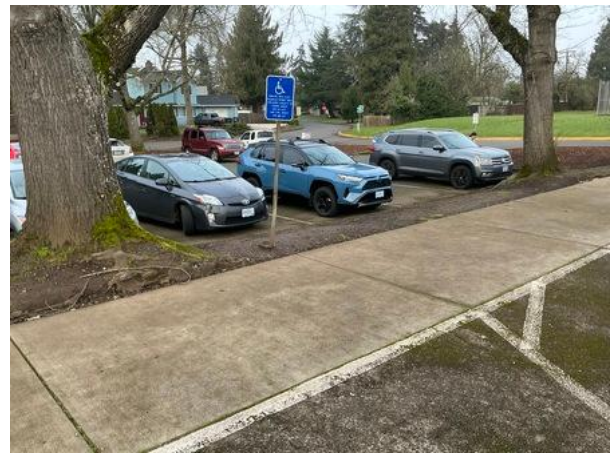
Photos for Barrier ID: AX553312

| <b>Site Conditions</b> | Bottom edge of sign measures 58" above ground surface. |

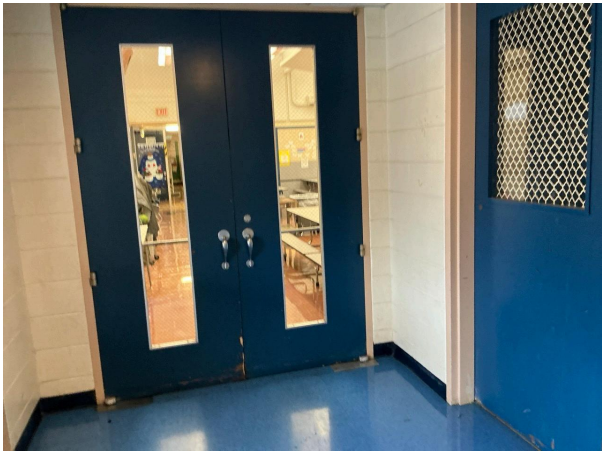
| Site Conditions | Force to open is 16 pounds at each door. |

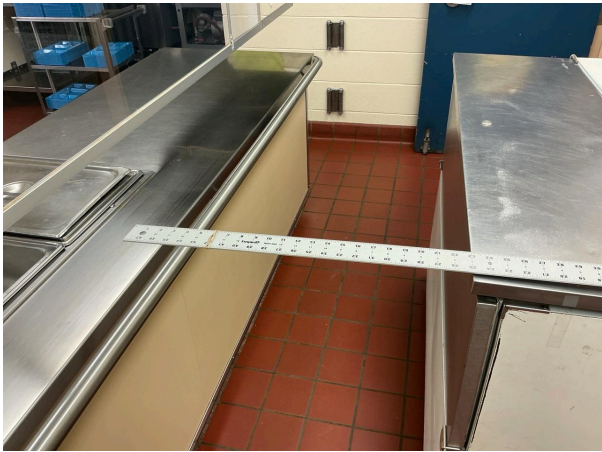
| <b>Site Conditions</b> | Service line pathway is 23" width between tray counter and refrigeration unit. |

relocate refrigeration unit outside of pathway width or provide a compliant surface on the accessible route to the end of service line and to all dining areas required to be compliant. A compliant surface In restaurants and cafeterias shall be firm, stable and slip resistant. [Advisory 302.1 General. A stable surface is one that remains unchanged by contaminants or applied force, so that when the contaminant or force is removed, the surface returns to its original condition. A firm surface resists deformation by either indentations or particles moving on its surface. A slip-resistant surface provides sufficient frictional counter force to the forces exerted in walking to permit safe ambulation.] An accessible route shall be provided to all dining areas, including raised or sunken dining areas, and outdoor dining areas. [EXCEPTIONS: 1. In buildings or facilities not required to provide an accessible route between stories, an accessible route shall not be required to a mezzanine dining area where the mezzanine contains less than 25 percent of the total combined area for seating and dining and where the same decor and services are provided in the accessible area. 2. In alterations, an accessible route shall not be required to existing raised or sunken dining areas, or to all parts of existing outdoor dining areas where the same services and decor are provided in an accessible space usable by the public and not restricted to use by people with disabilities. 3. In sports facilities, tiered dining areas providing seating shall be required to have accessible routes serving at least 25 percent of the dining area provided that accessible routes serve seating and each tier is provided with the same services.] [Advisory 206.2.5 Restaurants and Cafeterias Exception 2. Examples of "same services" include, but are not limited to, bar service, rooms having smoking and non-smoking sections, lotto and other table games, carry-out, and buffet service. Examples of "same decor" include, but are not limited to, seating at or near windows and railings with views, areas designed with a certain theme, party and banquet rooms, and rooms where entertainment is provided.] An accessible route is minimum 36" wide, minimum 1:20 (5%) running slope and minimum 1:48 (2.08%) cross slope.

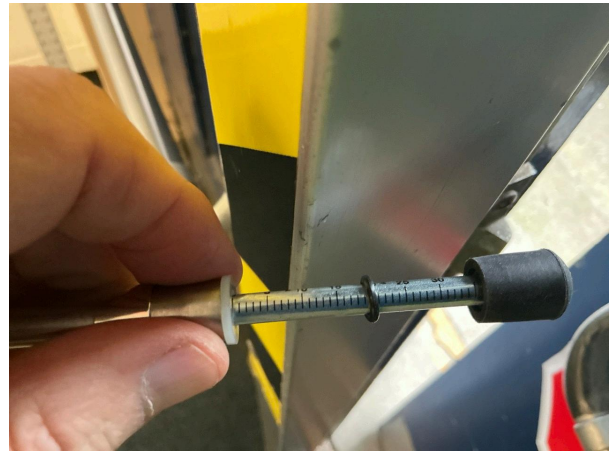
Photos for Barrier ID: AX553346

| <b>Site Conditions</b> | Force to open is in excess of 19 pounds in each door. |

Adjust the closer/opener or replace with a door which requires no more force to open and close than the minimum allowable force required by the appropriate administrative authority. The force at the latch, the force to set the door in motion, and the force to fully open the door shall be the minimum allowable. These forces do not apply to the force required to retract latch bolts or disengage other devices that hold the door or gate in a closed position.

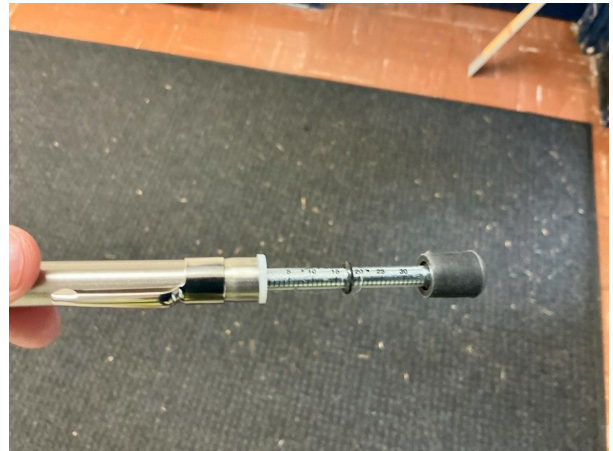
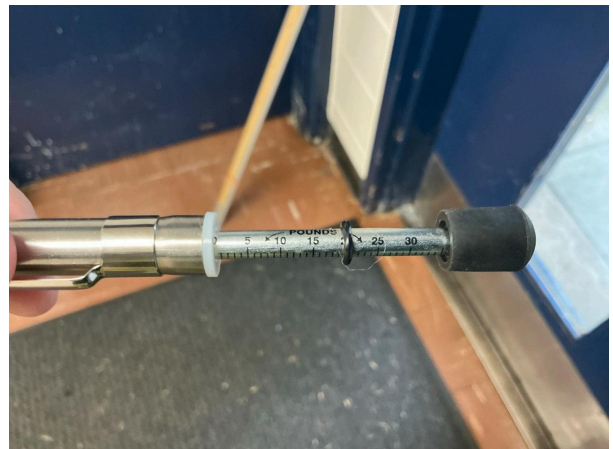
Photos for Barrier ID: AX553335

| Site Conditions | Force to open is in excess of 17 pounds on both doors. |

Adjust the closer/opener or replace with a door which requires no more force to open and close than the minimum allowable force required by the appropriate administrative authority. The force at the latch, the force to set the door in motion, and the force to fully open the door shall be the minimum allowable. These forces do not apply to the force required to retract latch bolts or disengage other devices that hold the door or gate in a closed position.

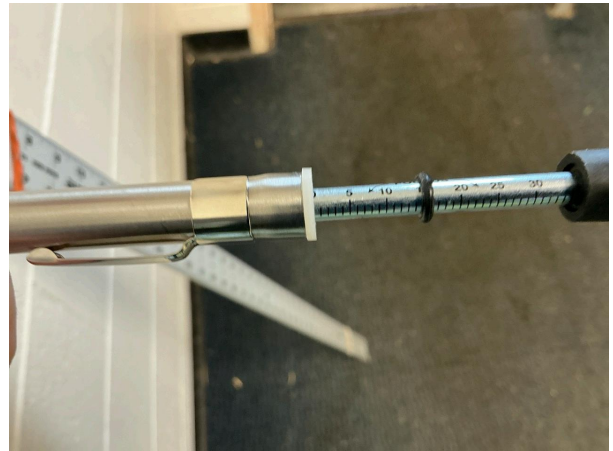
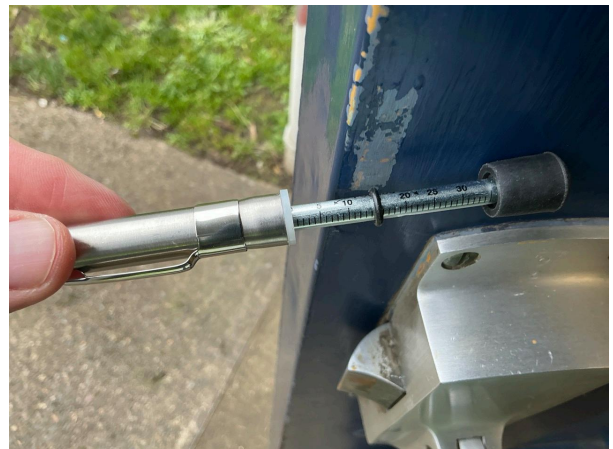
Photos for Barrier ID: AX553341

| Site Conditions | Force to open is 15 pounds in each door. |

Adjust the closer/opener or replace with a door which requires no more force to open and close than the minimum allowable force required by the appropriate administrative authority. The force at the latch, the force to set the door in motion, and the force to fully open the door shall be the minimum allowable. These forces do not apply to the force required to retract latch bolts or disengage other devices that hold the door or gate in a closed position.

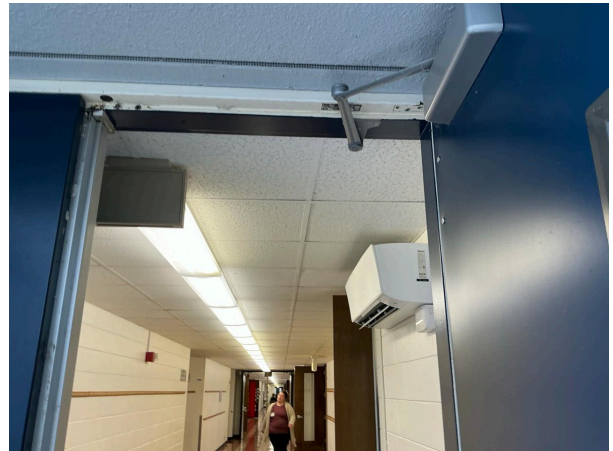
Photos for Barrier ID: AX553338

| Site Conditions | Force to open is 16 pounds in each door. |

Adjust the closer/opener or replace with a door which requires no more force to open and close than the minimum allowable force required by the appropriate administrative authority. The force at the latch, the force to set the door in motion, and the force to fully open the door shall be the minimum allowable. These forces do not apply to the force required to retract latch bolts or disengage other devices that hold the door or gate in a closed position.

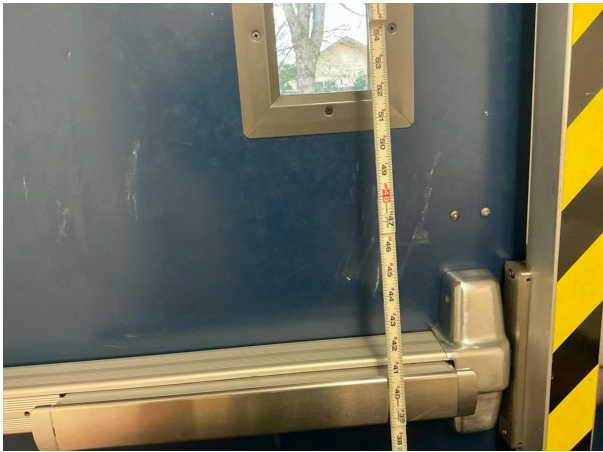
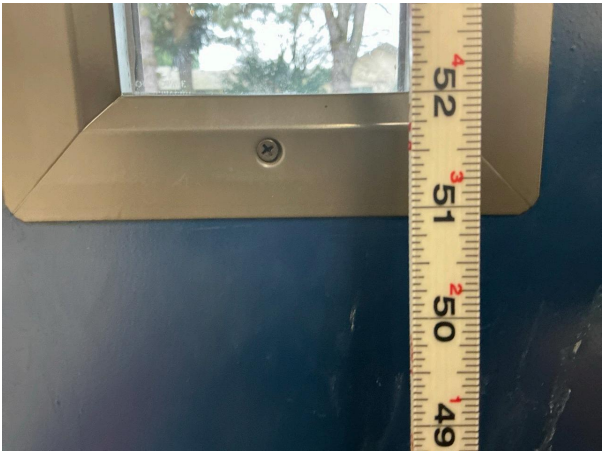
| Site Conditions | Bottom edge of vision panel measures 52" off of the floor surface. |

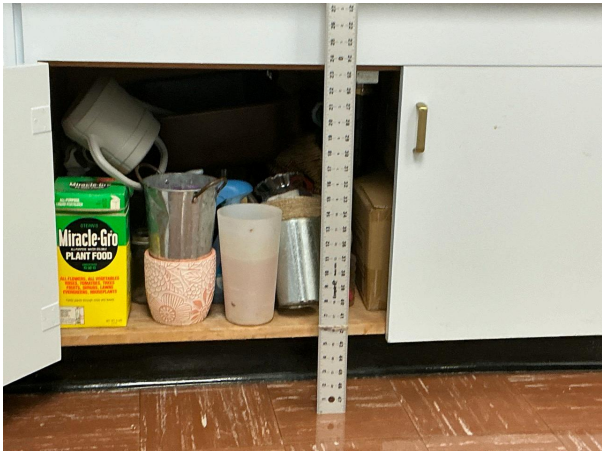
| <b>Site Conditions</b> | No knee or toe clearance is provided at sink due to cabinets. |

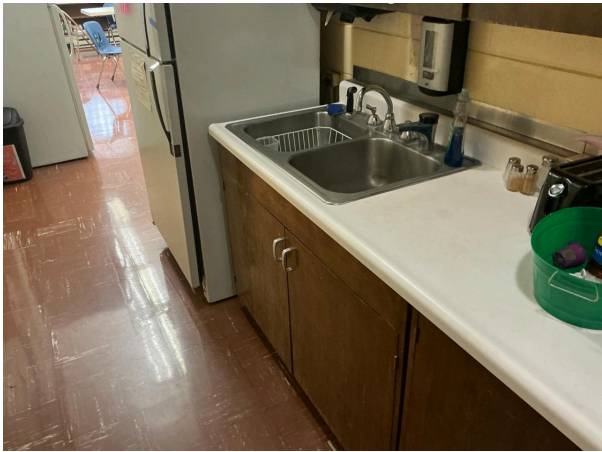
| <b>Site Conditions</b> | No knee or toe clearance is provided at sink due to cabinets. |
