# ACCESSIBILITY ASSESSMENT

January 8, 2025

## **ADA TITLE II ASSESSMENT**

Douglas Gardens Elementary School  
3680 Jasper Road  
Springfield, OR 97478

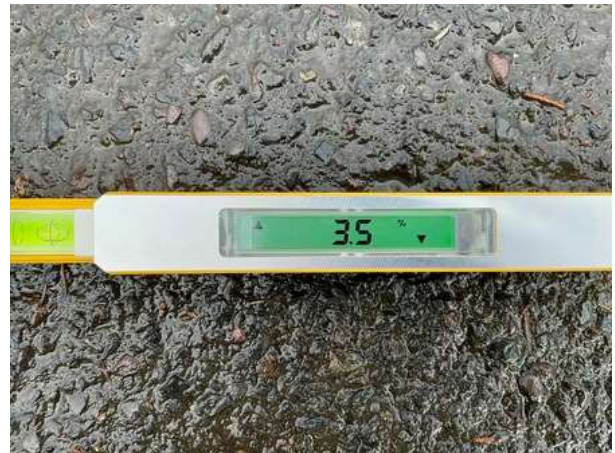
Photos for Barrier ID: AX528415

| Site Conditions | The van accessible aisle has a cross slope of 3.5%. |

Remove and replace with an adjacent access aisle that is at least 60" wide and has a slope of maximum 1:50 (2%) in all directions. [EXCEPTION: Slopes not steeper than 1:48 (2.08%) shall be permitted.] Changes in level are not permitted. Parking spaces and access aisles serving them shall be compliant. Access aisles shall be at the same level as the parking spaces they serve. Width measurements shall be made from the centerline of the markings. [EXCEPTION: Where parking spaces or access aisles are not adjacent to another parking space or access aisle, measurements shall be permitted to include the full width of the line defining the parking space or access aisle.] The quantity and order of magnitude cost estimate provided for this barrier are limited to the extent of the area identified as non-compliant. Additional costs that may be associated with removal of the barrier are not included.

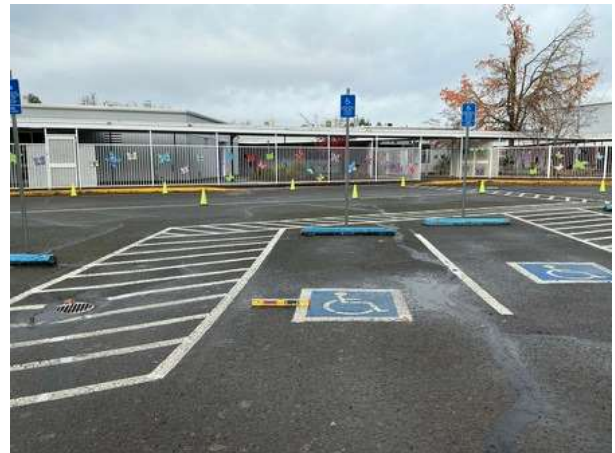
Photos for Barrier ID: AX528417

| <b>Site Conditions</b> | The standard accessible stall has a cross slope of 2.3%. |

Remove and replace with a van space which has a slope of maximum 1:50 (2%) in all directions. [EXCEPTION: Slopes not steeper than 1:48 (2.08%) shall be permitted.] Changes in level are not permitted. Parking spaces and access aisles serving them shall be compliant. Width measurements shall be made from the centerline of the markings. [EXCEPTION: Where parking spaces or access aisles are not adjacent to another parking space or access aisle, measurements shall be permitted to include the full width of the line defining the parking space or access aisle.] The quantity and order of magnitude cost estimate provided for this barrier are limited to the extent of the area identified as non-compliant. Additional costs that may be associated with removal of the barrier are not included.

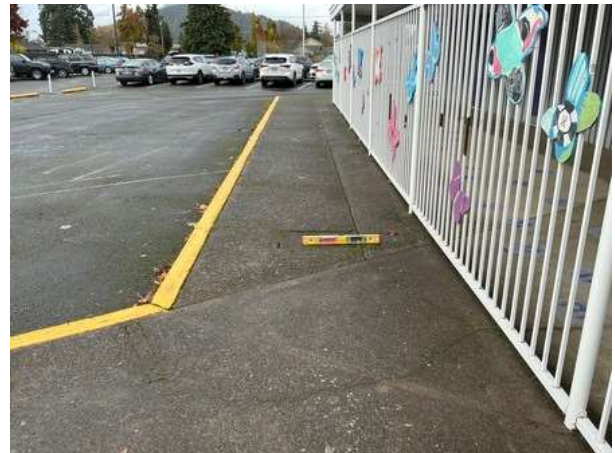
Photos for Barrier ID: AX528420

| Site Conditions | The accessible route has a cross slope of 2.7%. |

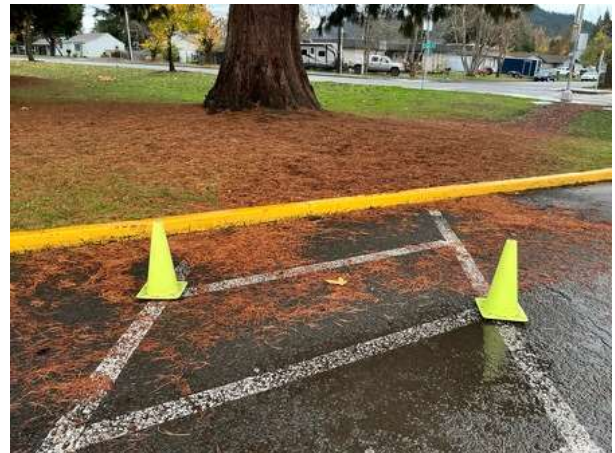
Photos for Barrier ID: AX528405

| <b>Site Conditions</b> | A curb ramp is not provided. |

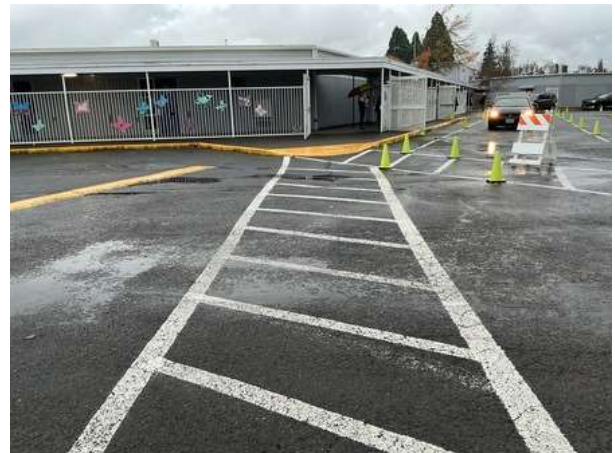
Photos for Barrier ID: AX528461

| <b>Site Conditions</b> | A curb ramp is not provided. |

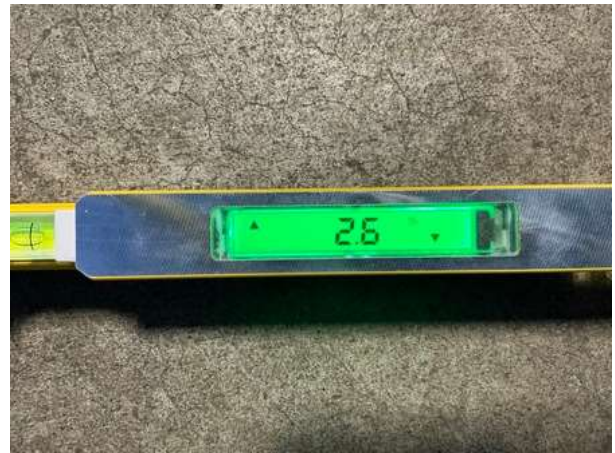
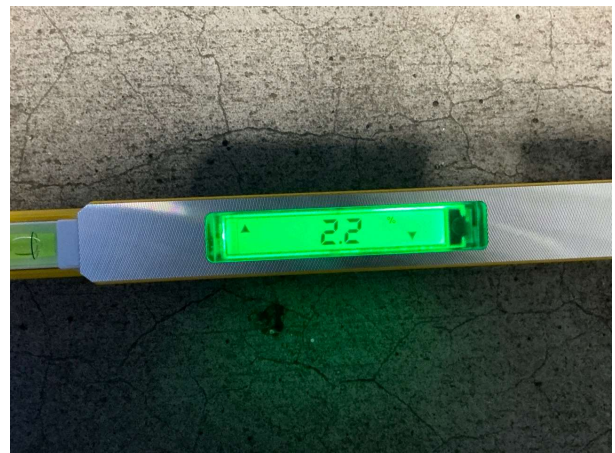
Photos for Barrier ID: AX528452

| <b>Site Conditions</b> | The accessible route has cross slopes from 2.2% to 2.6%. |

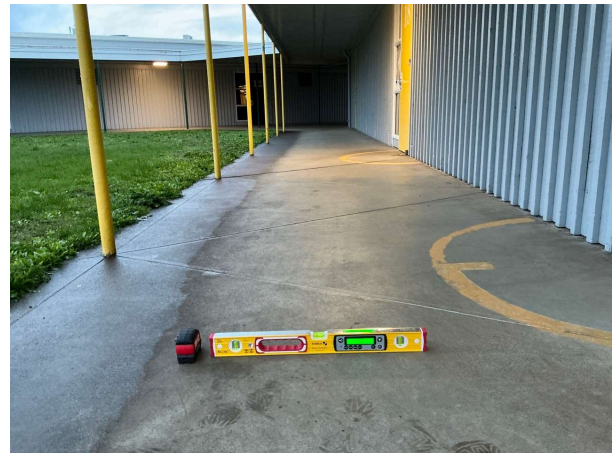
Photos for Barrier ID: AX528456

| Site Conditions | The accessible route has a cross slope of 2.3%. |
