# ACCESSIBILITY ASSESSMENT

**DATE OF REPORT:**  
March 4, 2025

## **ADA TITLE II ASSESSMENT**

Guy Lee Elementary School  
755 W Harlow Road  
Springfield, Oregon 97477

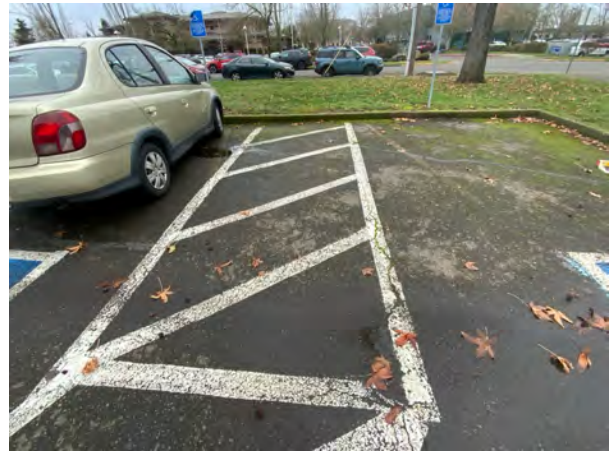
Photos for Barrier ID: AX545131

| <b>Site Conditions</b> | The access aisle contains a slope of 2.9%. |

Remove and replace with an adjacent access aisle that has a slope of maximum 1:50 (2%) in all directions. [EXCEPTION: Slopes not steeper than 1:48 (2.08%) shall be permitted.] Changes in level are not permitted. Parking spaces and access aisles serving them shall be compliant. Access aisles shall be at the same level as the parking spaces they serve. Measurements shall be made to the centerline of the stripe. Where accessible stalls and aisles are not adjacent to another stall or aisle, measurements shall be permitted to include the full width of the line defining the accessible parking space or aisle. The quantity and order of magnitude cost estimate provided for this barrier are limited to the extent of the area identified as non-compliant. Additional costs that may be associated with removal of the barrier are not included.

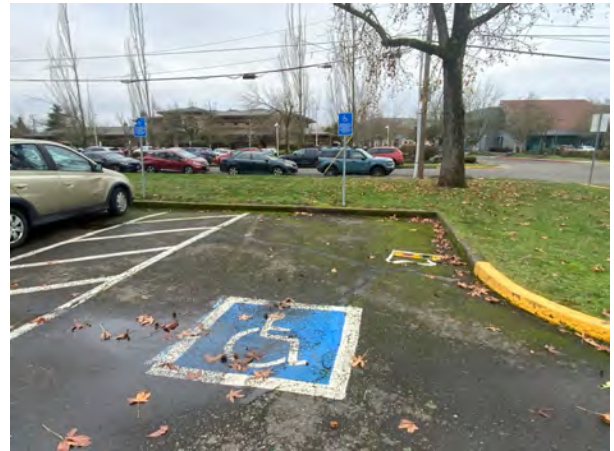
Photos for Barrier ID: AX545128

| <b>Site Conditions</b> | The bottom of the lowest sign is 63" above the parking surface. |

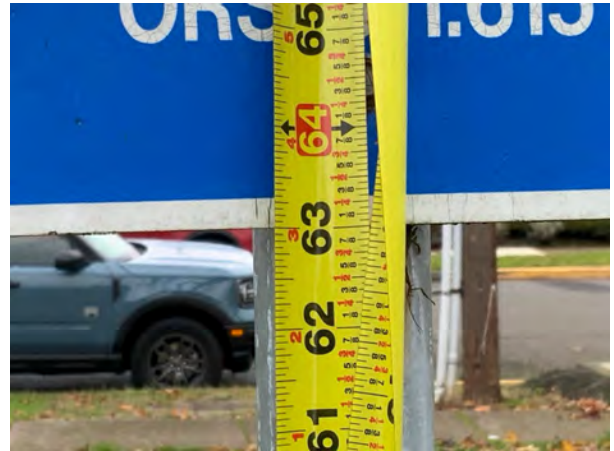
Photos for Barrier ID: AX545129

| Site Conditions | The signage does not include the "van accessible" designation. |

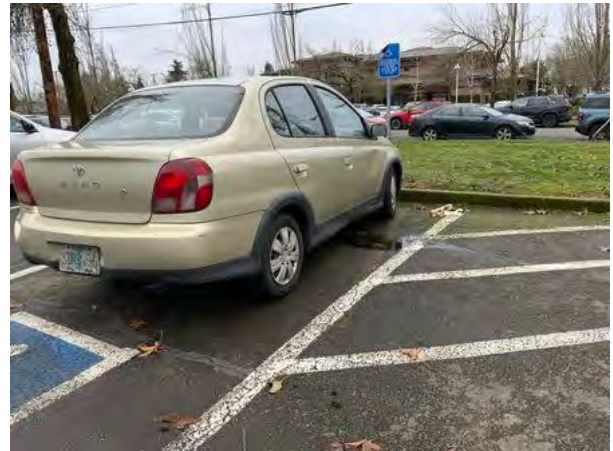
Photos for Barrier ID: AX545133

| The bottom of the lowest sign is 61 1/2” above the parking surface and is damaged. | | |

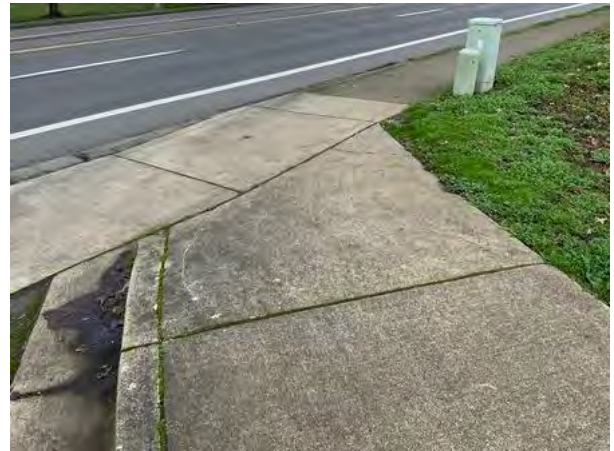
Photos for Barrier ID: AX545117

| Site Conditions | The parallel curb ramp bottom landing is 48" width. |

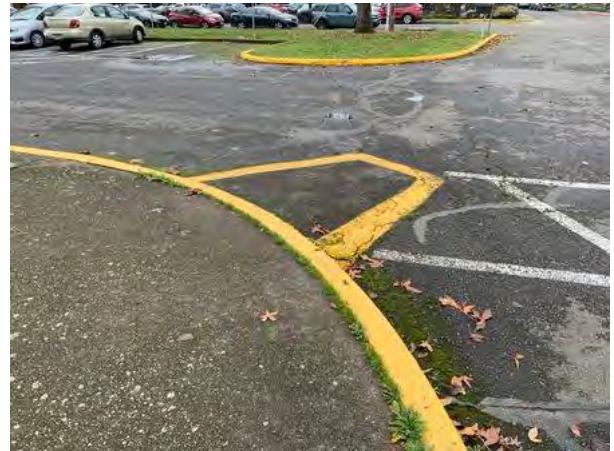
Photos for Barrier ID: AX545121

| Site Conditions | The curb ramp contains a running slope of 11.7% and projects into the street. | |

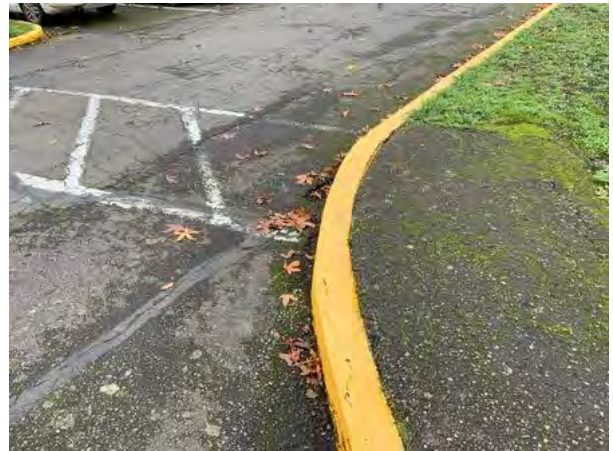
Photos for Barrier ID: AX545123

| <b>Site Conditions</b> | A curb ramp is not provided where the accessible route crosses a curb. |

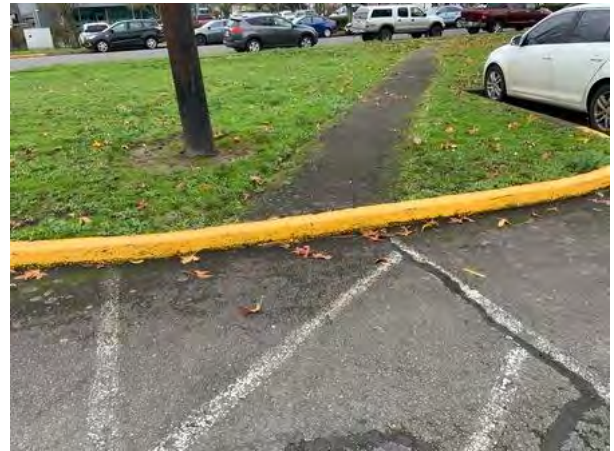
Photos for Barrier ID: AX545124

| <b>Site Conditions</b> | The accessible route has a cross slope of 5.3% for a length of 45' by 5' wide. |

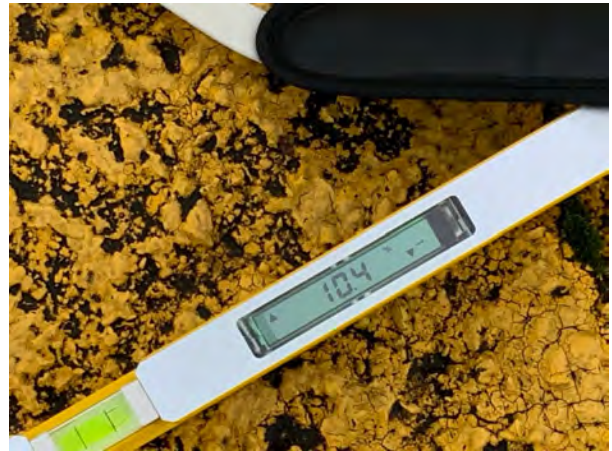
Photos for Barrier ID: AX545127

| <b>Site Conditions</b> | The curb ramp has a running slope of 9.2%. |

The curb ramp should be removed and replaced with a compliant curb ramp with no greater than the maximum allowable slopes of a ramp. Curb ramp runs shall have a running slope not steeper than 1:12 (8.33%). Cross slope of curb ramp runs shall not be steeper than 1:48. The running slope in new construction shall be 1:12 (8.33%) maximum. [EXCEPTION: In existing sites, buildings, and facilities built before 1/26/92, ramps and curb ramps shall be permitted to have running slopes steeper than 1:12 where such slopes are necessary due to space limitations. In facilities built before 1/26/92, the running slope can be 1:10 to 1:8 (10% to 12.5%) for a maximum rise of 3" OR 1:10 to 1:12 (8.3% to 10%) for a maximum rise of 6".] Where flares are provided, flare slopes shall not be greater than 1:10 (10%). [EXCEPTION: In alterations, where there is no landing at the top of curb ramps, curb ramp flares shall be provided and shall not be steeper than 1:12.]
