# ACCESSIBILITY ASSESSMENT

February 14, 2025

## **ADA TITLE II ASSESSMENT**

Mount Vernon Elementary School  
935 Filbert Lane  
Springfield, Oregon 97478

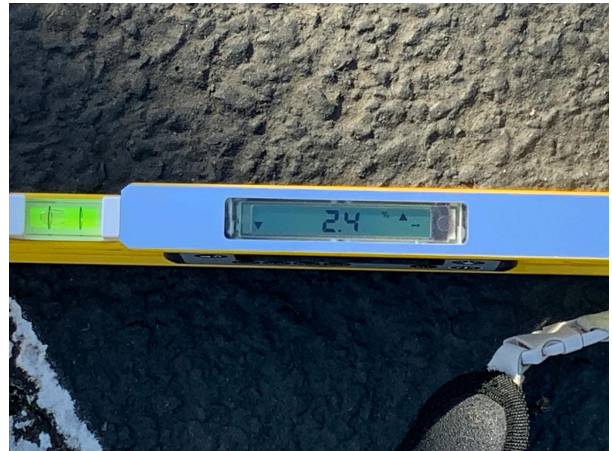
Photos for Barrier ID: AX553710

| Site Conditions | The van access aisle has a running slope of 2.4%. |

Remove and replace with an adjacent access aisle that has a slope of maximum 1:50 (2%) in all directions. [EXCEPTION: Slopes not steeper than 1:48 (2.08%) shall be permitted.] Changes in level are not permitted. Parking spaces and access aisles serving them shall be compliant. Access aisles shall be at the same level as the parking spaces they serve. Measurements shall be made to the centerline of the stripe. Where accessible stalls and aisles are not adjacent to another stall or aisle, measurements shall be permitted to include the full width of the line defining the accessible parking space or aisle. The quantity and order of magnitude cost estimate provided for this barrier are limited to the extent of the area identified as non-compliant. Additional costs that may be associated with removal of the barrier are not included.

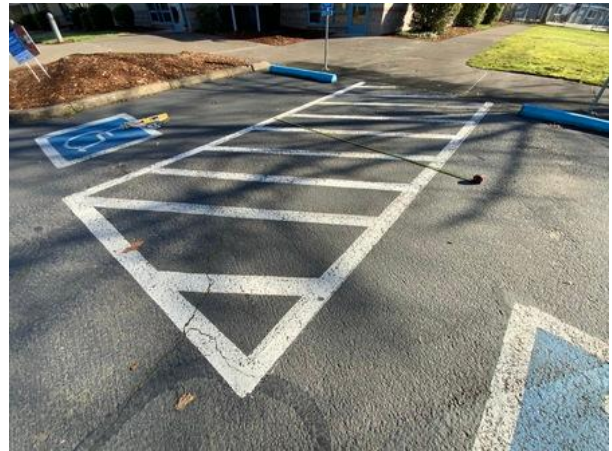
Photos for Barrier ID: AX553709

| <b>Site Conditions</b> | The access aisle is 94" wide. "No Parking" is missing from the access aisle. |

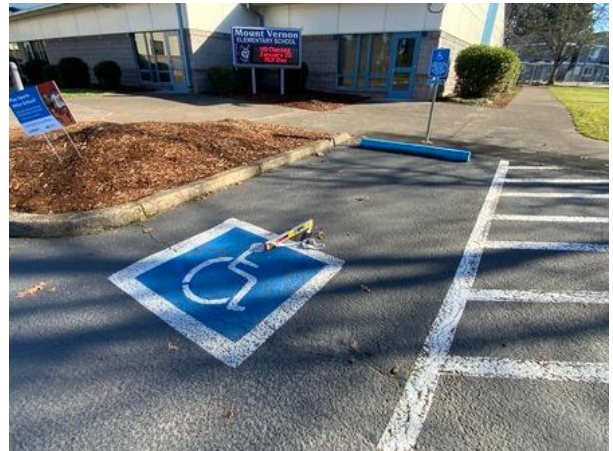
Photos for Barrier ID: AX553706

| <b>Site Conditions</b> | The van accessible parking space has a running slope of 2.7%. |

Remove and replace with a van space which has a slope of maximum 1:50 (2%) in all directions. [EXCEPTION: Slopes not steeper than 1:48 (2.08%) shall be permitted.] Changes in level are not permitted. Parking spaces and access aisles serving them shall be compliant. Width measurements shall be made from the centerline of the markings. [EXCEPTION: Where parking spaces or access aisles are not adjacent to another parking space or access aisle, measurements shall be permitted to include the full width of the line defining the parking space or access aisle.] The quantity and order of magnitude cost estimate provided for this barrier are limited to the extent of the area identified as non-compliant. Additional costs that may be associated with removal of the barrier are not included.

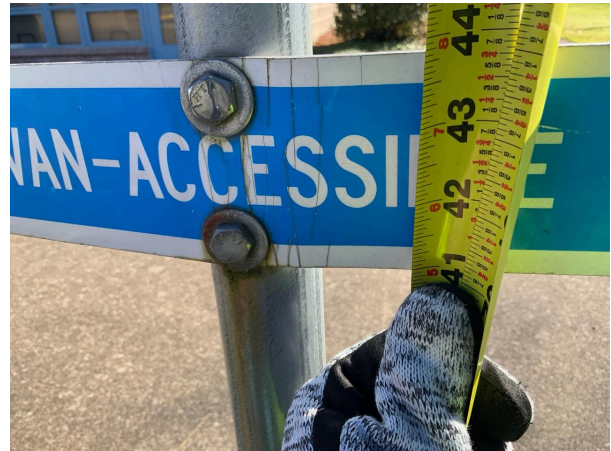
Photos for Barrier ID: AX553707

| <b>Site Conditions</b> | The bottom of the lowest sign is 41" above the parking surface. |

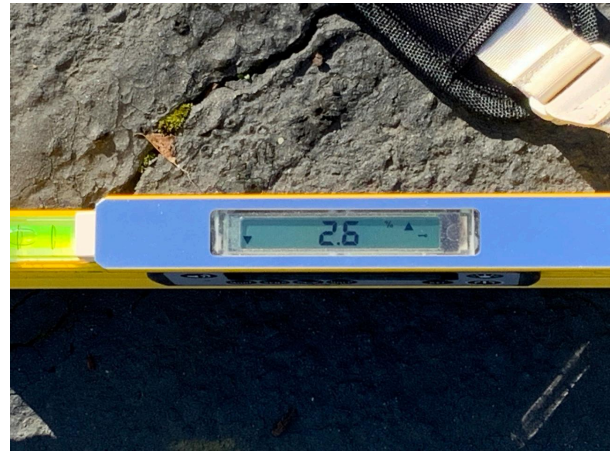
Photos for Barrier ID: AX553711

| <b>Site Conditions</b> | The accessible parking space has a running slope of 2.6%. |

Remove and replace with a parking space that has no more than 1:50 (2%) slope in all directions. [EXCEPTION: Slopes not steeper than 1:48 (2.08%) shall be permitted.] Changes in level are not permitted. Parking spaces and access aisles shall be level with surface slopes not exceeding 1:50 in all directions. Parking spaces and access aisles serving them shall be compliant. Access aisles shall be at the same level as the parking spaces they serve. The quantity and order of magnitude cost estimate provided for this barrier are limited to the extent of the area identified as non-compliant. Additional costs that may be associated with removal of the barrier are not included.

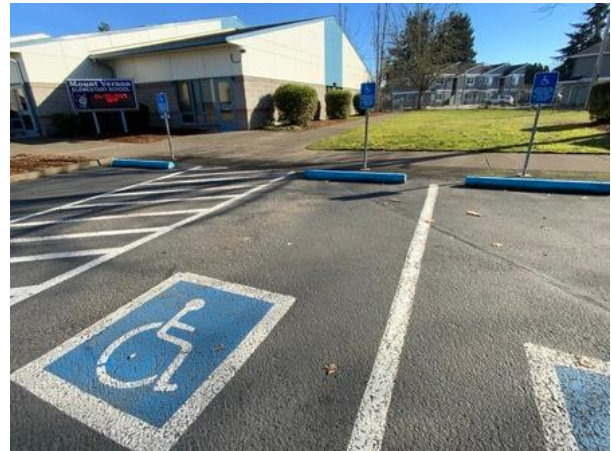
Photos for Barrier ID: AX553714

| <b>Site Conditions</b> | The bottom of the lowest sign is 45 1/2" above the parking surface. |

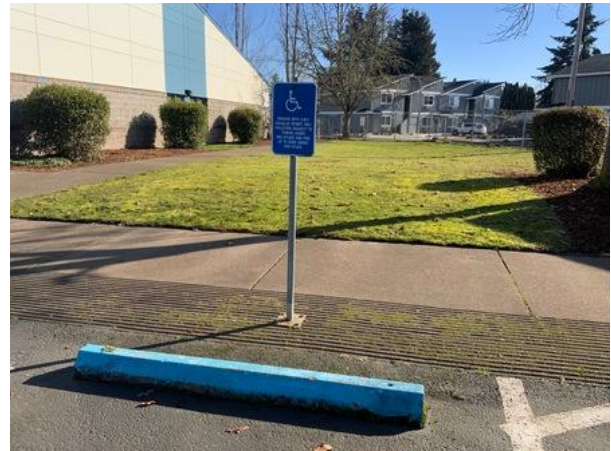
Photos for Barrier ID: AX553715

| <b>Site Conditions</b> | The bottom of the lowest sign is 45" above the parking surface. |

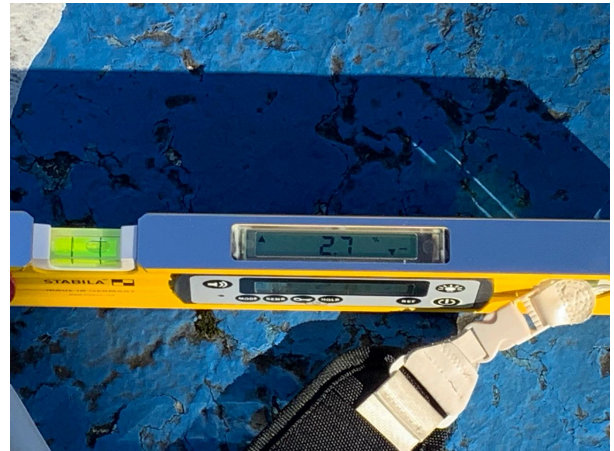
Photos for Barrier ID: AX553712

| Site Conditions | The accessible parking space has a running slope of 2.7%. |

Remove and replace with a parking space that has no more than 1:50 (2%) slope in all directions. [EXCEPTION: Slopes not steeper than 1:48 (2.08%) shall be permitted.] Changes in level are not permitted. Parking spaces and access aisles shall be level with surface slopes not exceeding 1:50 in all directions. Parking spaces and access aisles serving them shall be compliant. Access aisles shall be at the same level as the parking spaces they serve. The quantity and order of magnitude cost estimate provided for this barrier are limited to the extent of the area identified as non-compliant. Additional costs that may be associated with removal of the barrier are not included.

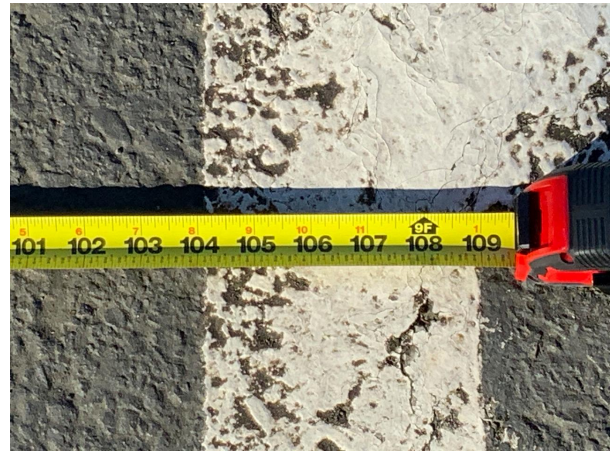
Photos for Barrier ID: AX553713

| <b>Site Conditions</b> | The accessible parking space is 106" wide. |

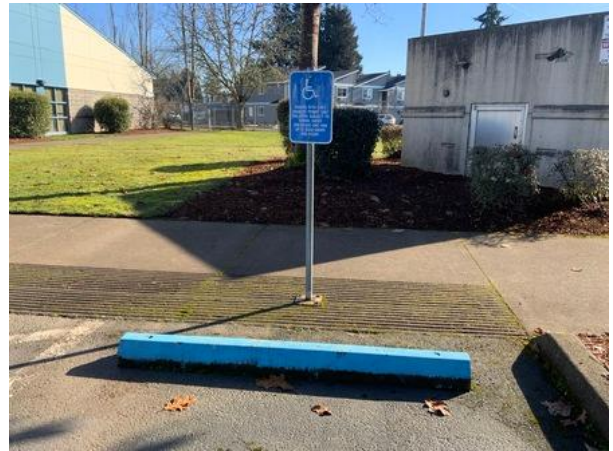
Photos for Barrier ID: AX553716

| <b>Site Conditions</b> | The bottom of the lowest sign is 44 1/2" above the parking surface. |

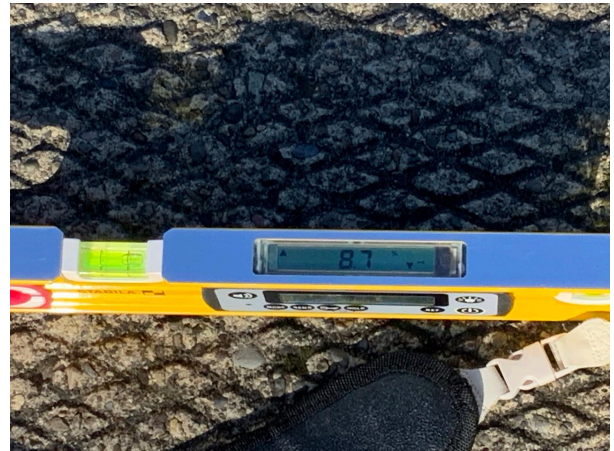
Photos for Barrier ID: AX553718

| <b>Site Conditions</b> | The curb ramp has a running slope of 8.7%. |

The curb ramp should be removed and replaced with a compliant curb ramp with no greater than the maximum allowable slopes of a ramp. Curb ramp runs shall have a running slope not steeper than 1:12 (8.33%). Cross slope of curb ramp runs shall not be steeper than 1:48. The running slope in new construction shall be 1:12 (8.33%) maximum. [EXCEPTION: In existing sites, buildings, and facilities built before 1/26/92, ramps and curb ramps shall be permitted to have running slopes steeper than 1:12 where such slopes are necessary due to space limitations. In facilities built before 1/26/92, the running slope can be 1:10 to 1:8 (10% to 12.5%) for a maximum rise of 3" OR 1:10 to 1:12 (8.3% to 10%) for a maximum rise of 6".] Where flares are provided, flare slopes shall not be greater than 1:10 (10%). [EXCEPTION: In alterations, where there is no landing at the top of curb ramps, curb ramp flares shall be provided and shall not be steeper than 1:12.]

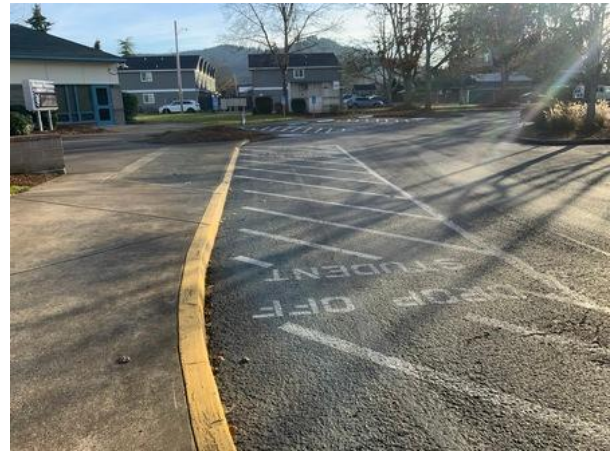
Photos for Barrier ID: AX553770

| <b>Site Conditions</b> | The access aisle has a slope of 2.2%. |

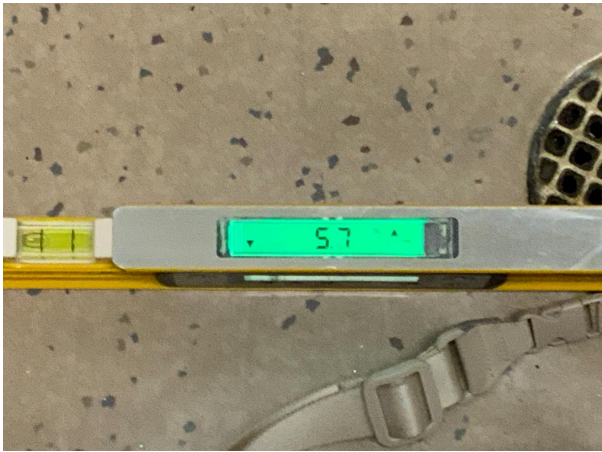
Photos for Barrier ID: AX553734

| Site Conditions | The clear space for the water closet has a slope of 5%. | |

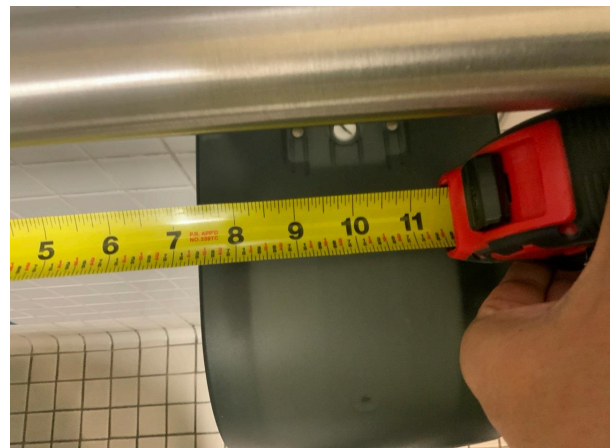
## Photos for Barrier ID: AX553755

| Site Conditions | The centerline of the toilet paper dispenser is 10" in front of the water closet. |
