# ACCESSIBILITY ASSESSMENT

**DATE OF REPORT:**  
March 4, 2025

## **ADA TITLE II ASSESSMENT**

Riverbend Elementary School  
320 51st Street  
Springfield, Oregon 97478

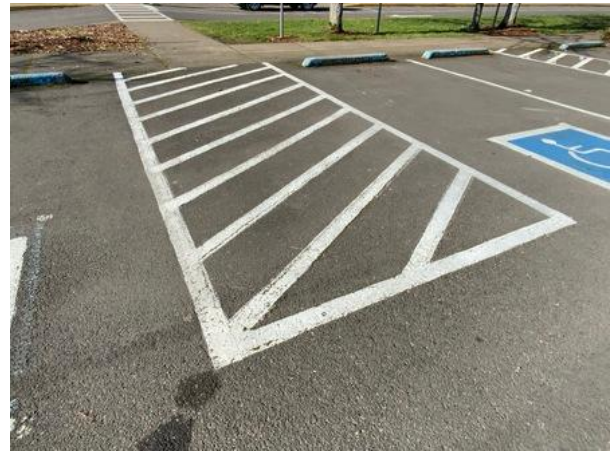
Photos for Barrier ID: AX555517

The diagonal striping on the van access aisle is 21" on center. The words "NO PARKING" are not provided on the surface of the van access aisle. The van access aisle is missing the accessible van access aisle signage.

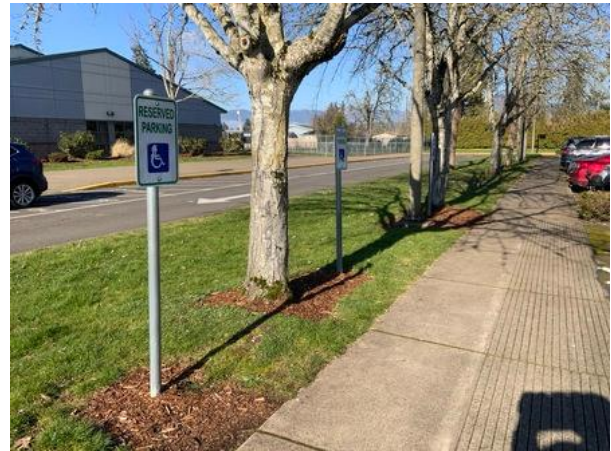
Photos for Barrier ID: AX555513

| <b>Site Conditions</b> | The bottom of the lowest sign is 47" above the parking surface. |

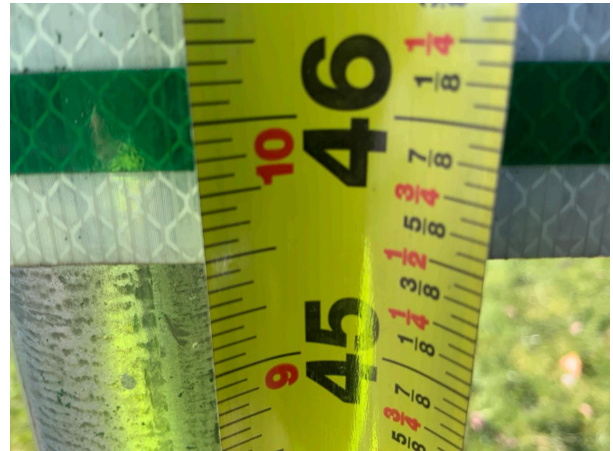
Photos for Barrier ID: AX555514

| <b>Site Conditions</b> | The bottom of the lowest sign is 45 1/2" above the parking surface. |

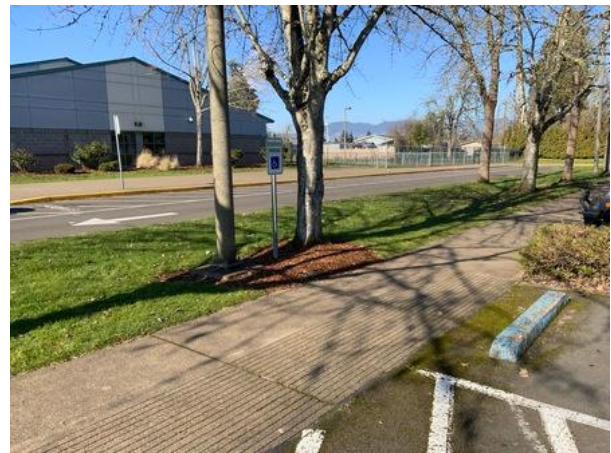
Photos for Barrier ID: AX555515

| <b>Site Conditions</b> | The bottom of the lowest sign is 43" above the parking surface. |

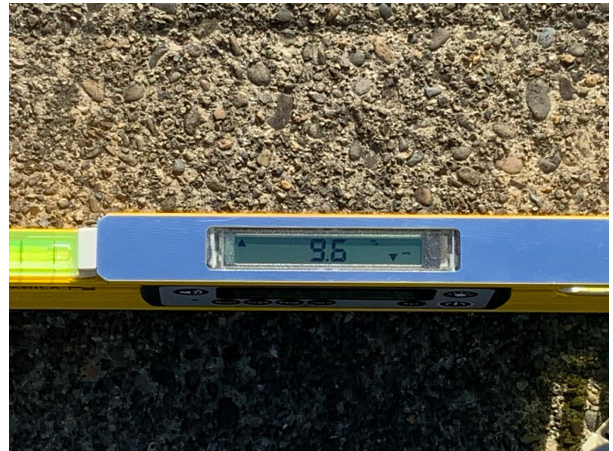
Photos for Barrier ID: AX555520

| <b>Site Conditions</b> | The curb ramp contains a running slope of 8.9% to 9.6%. |

The curb ramp should be removed and replaced with a compliant curb ramp with no greater than the maximum allowable slopes of a ramp. Curb ramp runs shall have a running slope not steeper than 1:12 (8.33%). Cross slope of curb ramp runs shall not be steeper than 1:48. The running slope in new construction shall be 1:12 (8.33%) maximum. [EXCEPTION: In existing sites, buildings, and facilities built before 1/26/92, ramps and curb ramps shall be permitted to have running slopes steeper than 1:12 where such slopes are necessary due to space limitations. In facilities built before 1/26/92, the running slope can be 1:10 to 1:8 (10% to 12.5%) for a maximum rise of 3" OR 1:10 to 1:12 (8.3% to 10%) for a maximum rise of 6".] Where flares are provided, flare slopes shall not be greater than 1:10 (10%). [EXCEPTION: In alterations, where there is no landing at the top of curb ramps, curb ramp flares shall be provided and shall not be steeper than 1:12.]

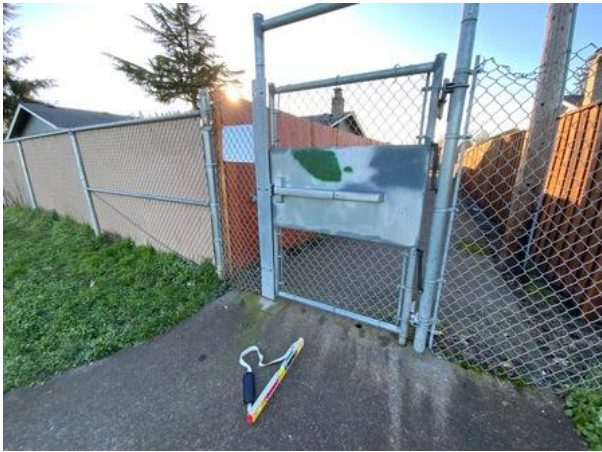
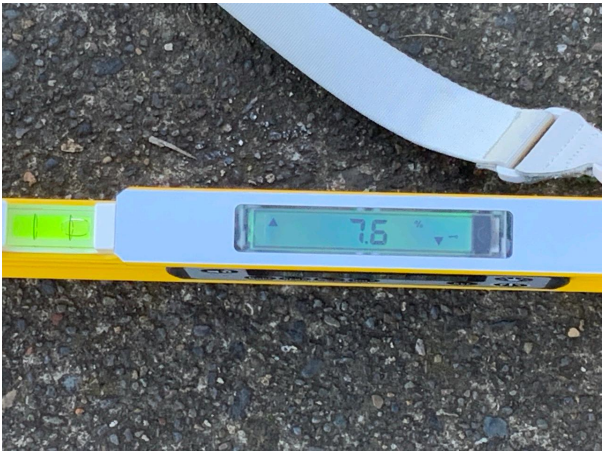
| Site Conditions | The maneuvering clearance at the accessible door has a slope of 7.6%. |

Remove and replace the surface within the required maneuvering clearance area so that the surface is level and clear with maximum slope 1:48 (2.08%) in any direction. The required depth of the maneuvering clearance is 48" minimum. The required side clearance is 12" minimum on the latch side of the door. Maneuvering clearance shall extend the full width of the doorway and the required latch side clearance. Floor or ground space within the required maneuvering clearance shall be maximum 1:48 (2.08%) slope. Changes in level are not permitted.

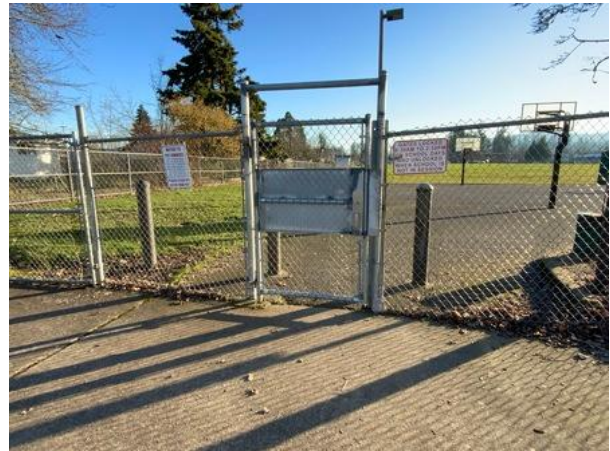
Photos for Barrier ID: AX555566

| Site Conditions | The opening force is 11 pounds. |

Adjust the closer/opener or replace with a door that requires no more 5 pounds of force for pushing or pulling the door open. The force for pushing or pulling open a door or gate other than fire doors shall be as follows: 1. Interior hinged doors and gates: 5 pounds (22.2 N) maximum. 2. Sliding or folding doors: 5 pounds (22.2 N) maximum. These forces do not apply to the force required to retract latch bolts or disengage other devices that hold the door or gate in a closed position. Note: Fire doors shall have a minimum opening force allowable by the appropriate administrative authority.

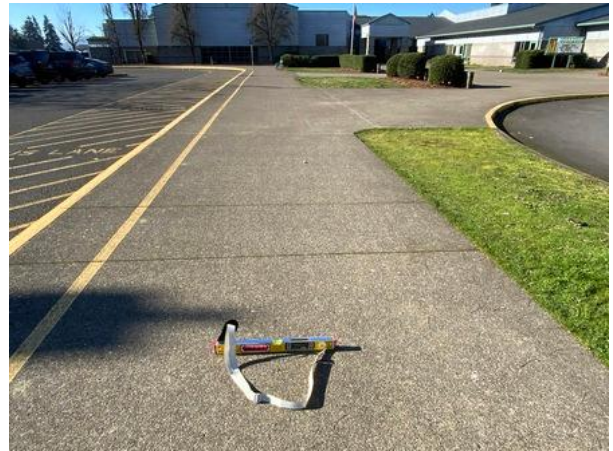
Photos for Barrier ID: AX555521

| <b>Site Conditions</b> | The accessible route has cross slopes of 2.4% for a length of 10' by 7' wide. |

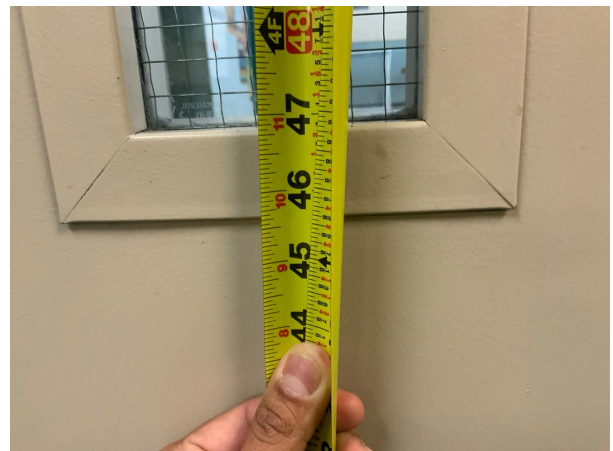
## Photos for Barrier ID: AX555543

| Site Conditions | The bottom of the entry door vision light is 47" above the finished floor. |

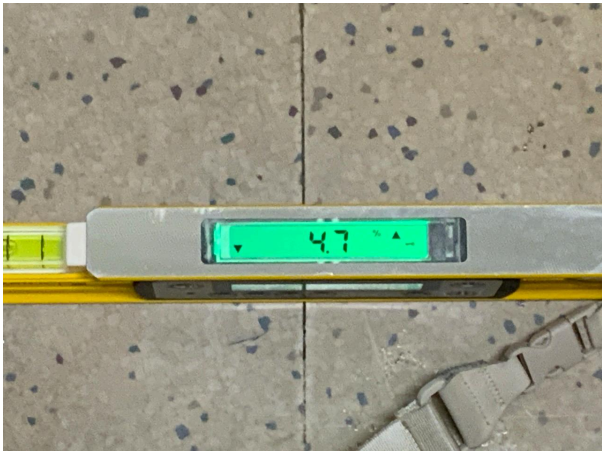
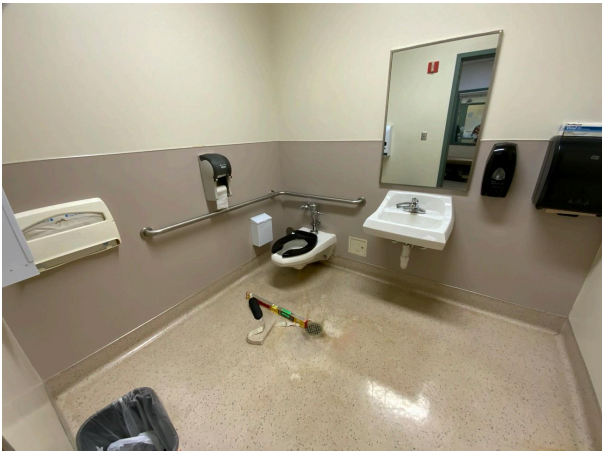
Photos for Barrier ID: AX555524

| Site Conditions | The floor surface contains a slope of 4.7%. | |

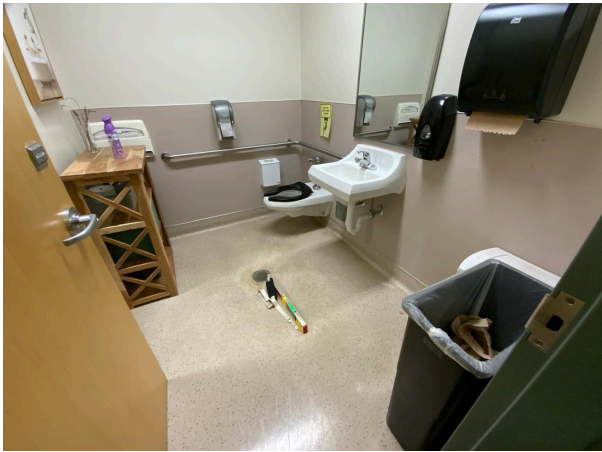
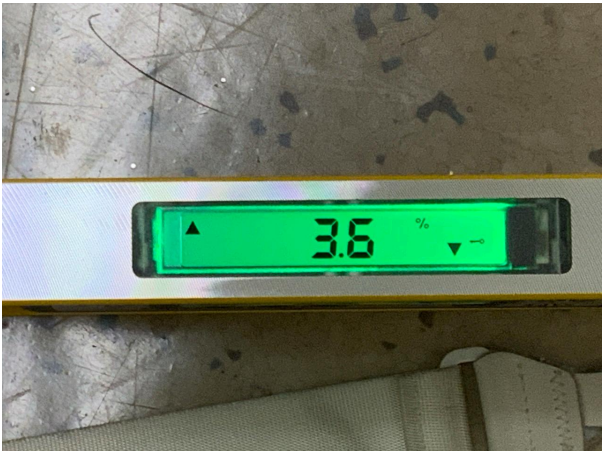
Photos for Barrier ID: AX555528

| Site Conditions | The floor surface contains a slope of 3.6%. | |
