# ACCESSIBILITY ASSESSMENT

February 24, 2025

## **ADA TITLE II ASSESSMENT**

Thurston Elementary School

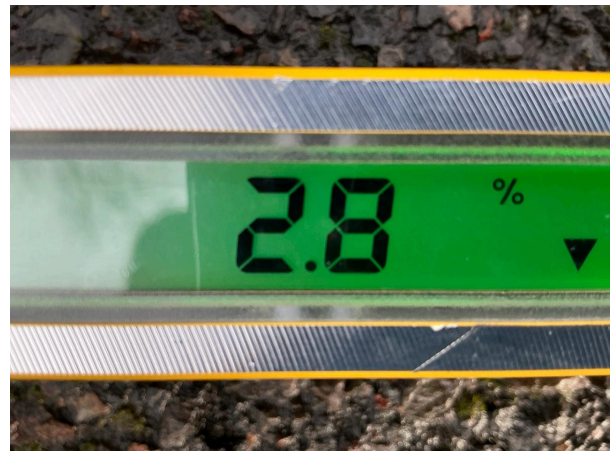
Photos for Barrier ID AX563276

| Site Conditions | The accessible parking space has a slope of 2.8%. |

Remove and replace with a van space which has a slope of maximum 1:50 (2%) in all directions. [EXCEPTION: Slopes not steeper than 1:48 (2.08%) shall be permitted.] Changes in level are not permitted. Parking spaces and access aisles serving them shall be compliant. Width measurements shall be made from the centerline of the markings. [EXCEPTION: Where parking spaces or access aisles are not adjacent to another parking space or access aisle, measurements shall be permitted to include the full width of the line defining the parking space or access aisle.] The quantity and order of magnitude cost estimate provided for this barrier are limited to the extent of the area identified as non-compliant. Additional costs that may be associated with removal of the barrier are not included.

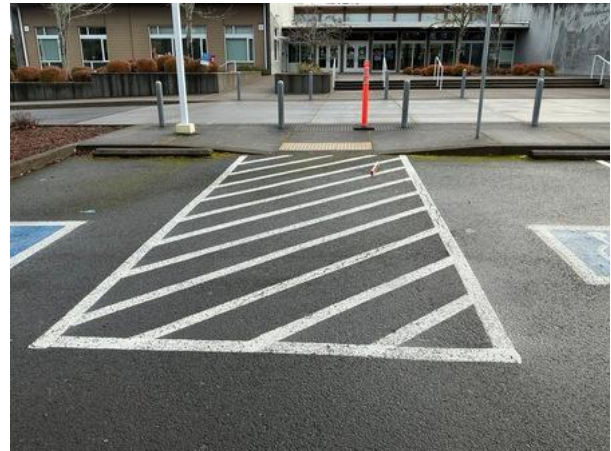
Photos for Barrier ID AX563277

| <b>Site Conditions</b> | The access aisle slope is 3.1%. |

Remove and replace with an adjacent access aisle that has a slope of maximum 1:50 (2%) in all directions. [EXCEPTION: Slopes not steeper than 1:48 (2.08%) shall be permitted.] Changes in level are not permitted. Parking spaces and access aisles serving them shall be compliant. Access aisles shall be at the same level as the parking spaces they serve. Measurements shall be made to the centerline of the stripe. Where accessible stalls and aisles are not adjacent to another stall or aisle, measurements shall be permitted to include the full width of the line defining the accessible parking space or aisle. The quantity and order of magnitude cost estimate provided for this barrier are limited to the extent of the area identified as non-compliant. Additional costs that may be associated with removal of the barrier are not included.

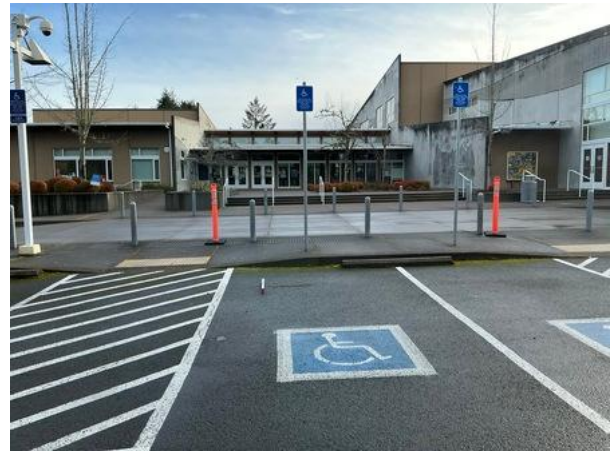
Photos for Barrier ID: AX563275

| <b>Site Conditions</b> | The accessible parking space has a slope of 2.6%. |

Remove and replace with a parking space that has no more than 1:50 (2%) slope in all directions. [EXCEPTION: Slopes not steeper than 1:48 (2.08%) shall be permitted.] Changes in level are not permitted. Parking spaces and access aisles shall be level with surface slopes not exceeding 1:50 in all directions. Parking spaces and access aisles serving them shall be compliant. Access aisles shall be at the same level as the parking spaces they serve. The quantity and order of magnitude cost estimate provided for this barrier are limited to the extent of the area identified as non-compliant. Additional costs that may be associated with removal of the barrier are not included.

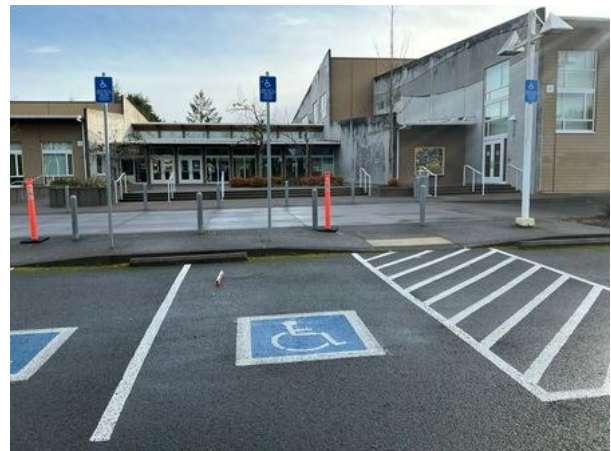
Photos for Barrier ID: AX563274

| <b>Site Conditions</b> | The accessible parking space has a slope of 2.6%. |

Remove and replace with a parking space that has no more than 1:50 (2%) slope in all directions. [EXCEPTION: Slopes not steeper than 1:48 (2.08%) shall be permitted.] Changes in level are not permitted. Parking spaces and access aisles shall be level with surface slopes not exceeding 1:50 in all directions. Parking spaces and access aisles serving them shall be compliant. Access aisles shall be at the same level as the parking spaces they serve. The quantity and order of magnitude cost estimate provided for this barrier are limited to the extent of the area identified as non-compliant. Additional costs that may be associated with removal of the barrier are not included.

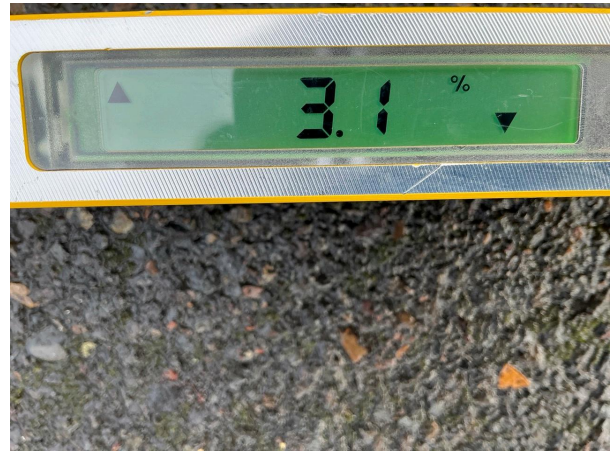
Photos for Barrier ID: AX563278

| <b>Site Conditions</b> | The access aisle slope is 3.1%. |

Remove and replace with an adjacent access aisle that is at least 60" wide and has a slope of maximum 1:50 (2%) in all directions. [EXCEPTION: Slopes not steeper than 1:48 (2.08%) shall be permitted.] Changes in level are not permitted. Parking spaces and access aisles serving them shall be compliant. Access aisles shall be at the same level as the parking spaces they serve. Width measurements shall be made from the centerline of the markings. [EXCEPTION: Where parking spaces or access aisles are not adjacent to another parking space or access aisle, measurements shall be permitted to include the full width of the line defining the parking space or access aisle.] The quantity and order of magnitude cost estimate provided for this barrier are limited to the extent of the area identified as non-compliant. Additional costs that may be associated with removal of the barrier are not included.

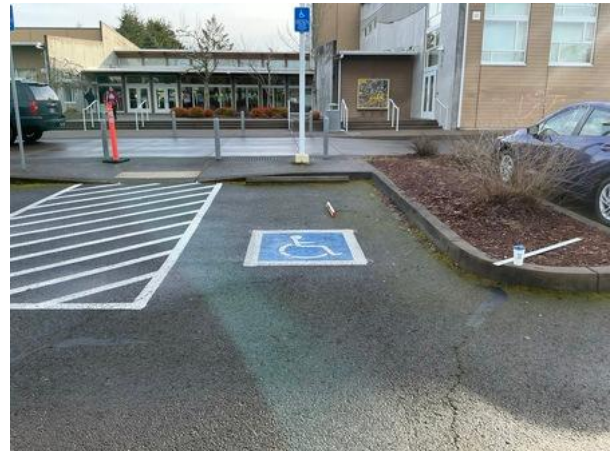
Photos for Barrier ID: AX563273

| <b>Site Conditions</b> | The accessible parking space has a slope of 3.7%. |

Remove and replace with a parking space that has no more than 1:50 (2%) slope in all directions. [EXCEPTION: Slopes not steeper than 1:48 (2.08%) shall be permitted.] Changes in level are not permitted. Parking spaces and access aisles shall be level with surface slopes not exceeding 1:50 in all directions. Parking spaces and access aisles serving them shall be compliant. Access aisles shall be at the same level as the parking spaces they serve. The quantity and order of magnitude cost estimate provided for this barrier are limited to the extent of the area identified as non-compliant. Additional costs that may be associated with removal of the barrier are not included.

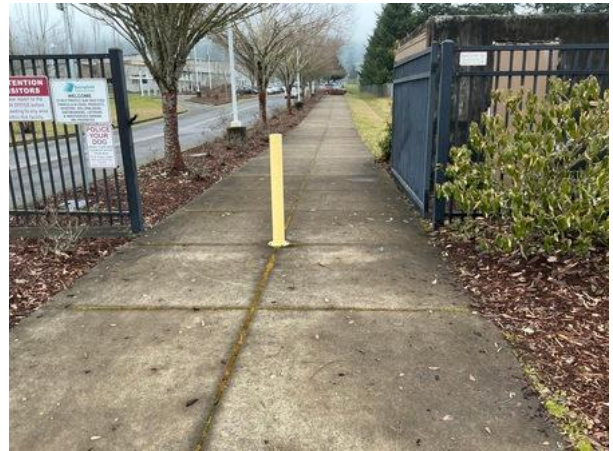
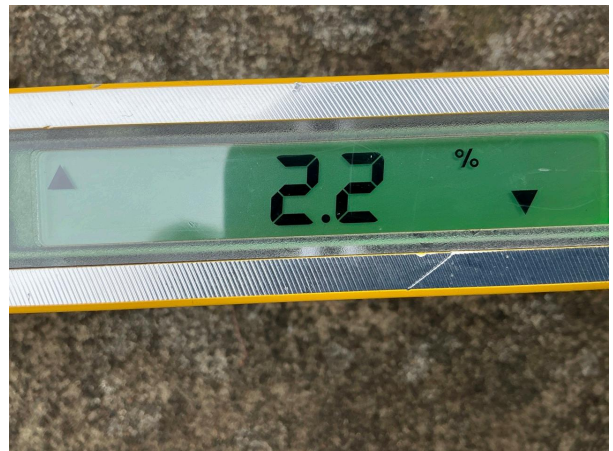
Photos for Barrier ID: AX563294

| <b>Site Conditions</b> | The exterior accessible route has cross slopes of 2.2%. |
