# ACCESSIBILITY ASSESSMENT

February 5, 2025

## **ADA TITLE II ASSESSMENT**

Walterville Elementary School

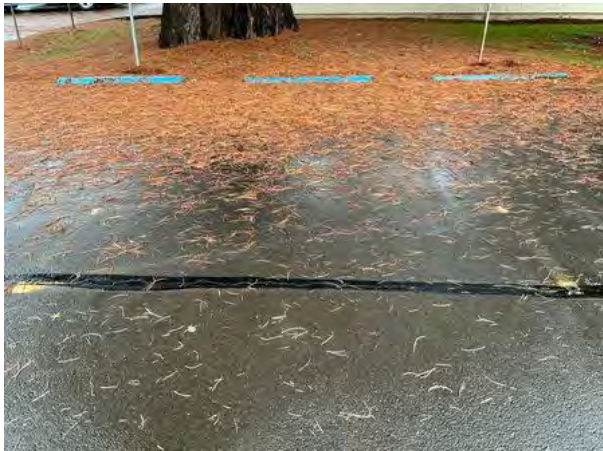
Photos for Barrier ID: AX525895

| Site Conditions | The access aisle is not striped. | |

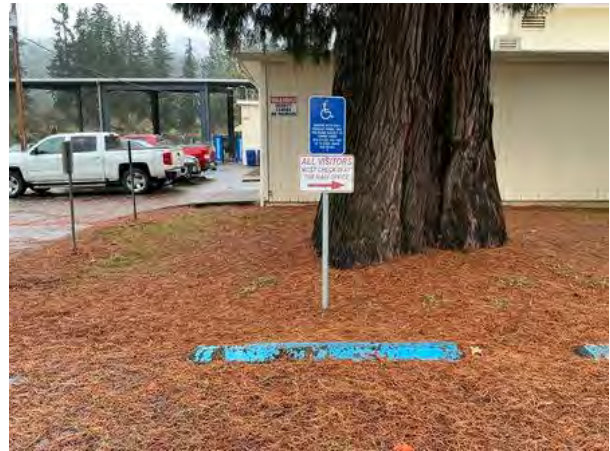
Photos for Barrier ID: AX525892

| <b>Site Conditions</b> | The signage is mounted 54-1/2 inches above the paving. |

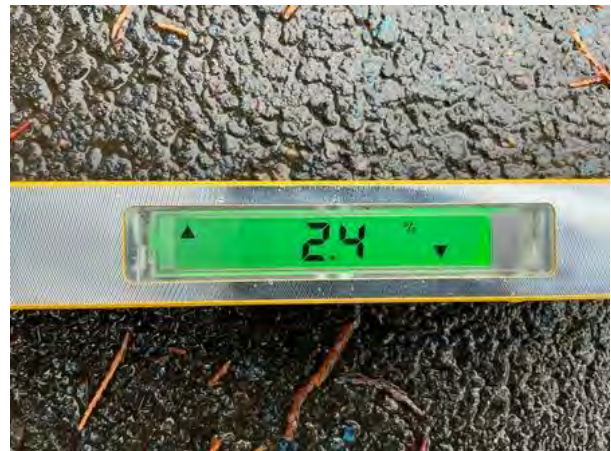
Photos for Barrier ID: AX525897

| Site Conditions | The accessible parking stall has a running slope of 2.4%. |

Remove and replace with a parking space that has no more than 1:50 (2%) slope in all directions. [EXCEPTION: Slopes not steeper than 1:48 (2.08%) shall be permitted.] Changes in level are not permitted. Parking spaces and access aisles shall be level with surface slopes not exceeding 1:50 in all directions. Parking spaces and access aisles serving them shall be compliant. Access aisles shall be at the same level as the parking spaces they serve. The quantity and order of magnitude cost estimate provided for this barrier are limited to the extent of the area identified as non-compliant. Additional costs that may be associated with removal of the barrier are not included.

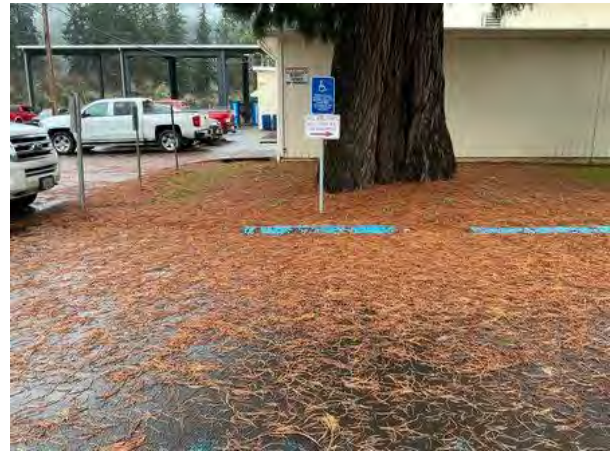
Photos for Barrier ID: AX525891

| <b>Site Conditions</b> | The accessible parking stall striping and ISA marking is faded. |

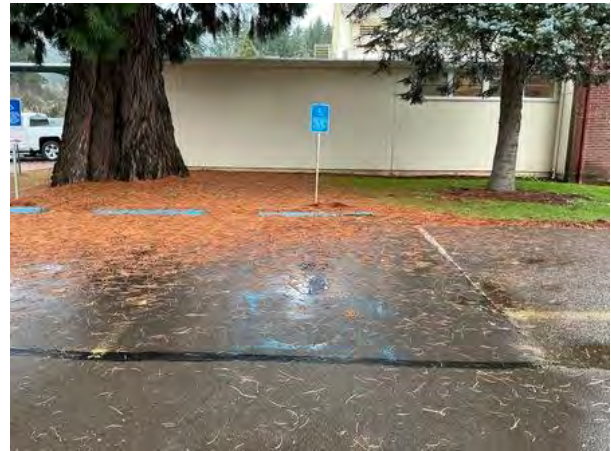
Photos for Barrier ID: AX525894

| <b>Site Conditions</b> | The accessible parking stall striping and ISA marking is faded. |

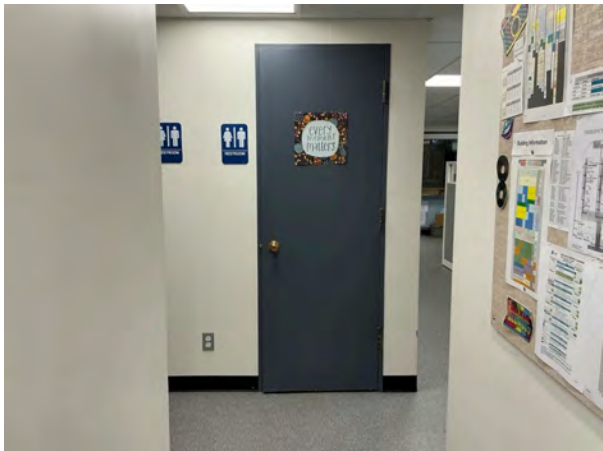
| Site Conditions | The clear width of the doors is 25 inches. | |

| Resolution | <p>Remove and replace with a door that has a minimum clear opening of 32". Door openings shall provide a clear width of 32" minimum. Clear openings of doorways with swinging doors shall be measured between the face of the door and the stop, with the door open 90 degrees. Openings more than 24" deep shall provide a clear opening of 36" minimum. There shall be no projections into the required clear opening width lower than 34" above the finish floor or ground. Projections into the clear opening width between 34" and 80" above the finish floor or ground shall not exceed 4". [EXCEPTIONS: 1. In alterations, a projection of 5/8" maximum into the required clear width shall be permitted for the latch side stop. 2. Door closers and door stops shall be permitted to be 78" minimum above the finish floor or ground.]</p> | |
