# ACCESSIBILITY ASSESSMENT

*February 4, 2025*

## **ADA TITLE II ASSESSMENT**

**Agnes Stewart Middle School**

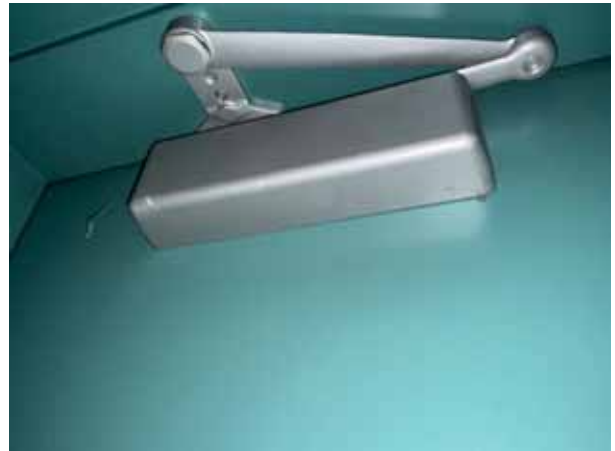
Photos for Barrier ID: AX556919

| Site Conditions | The opening force of the fire doors is 16 pounds. | |

| Adjust the closer/opener or replace with a door which requires no more force to open and close than the minimum allowable force required by the appropriate administrative authority. The force at the latch, the force to set the door in motion, and the force to fully open the door shall be the minimum allowable. These forces do not apply to the force required to retract latch bolts or disengage other devices that hold the door or gate in a closed position. | | |

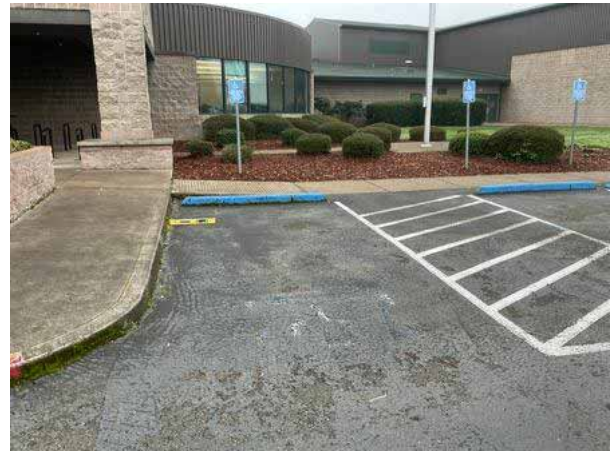
Photos for Barrier ID: AX556912

| <b>Site Conditions</b> | Accessible parking P1-A has a cross slope of 2.5%. |

Remove and replace with a parking space that has no more than 1:50 (2%) slope in all directions. [EXCEPTION: Slopes not steeper than 1:48 (2.08%) shall be permitted.] Changes in level are not permitted. Parking spaces and access aisles shall be level with surface slopes not exceeding 1:50 in all directions. Parking spaces and access aisles serving them shall be compliant. Access aisles shall be at the same level as the parking spaces they serve. The quantity and order of magnitude cost estimate provided for this barrier are limited to the extent of the area identified as non-compliant. Additional costs that may be associated with removal of the barrier are not included.

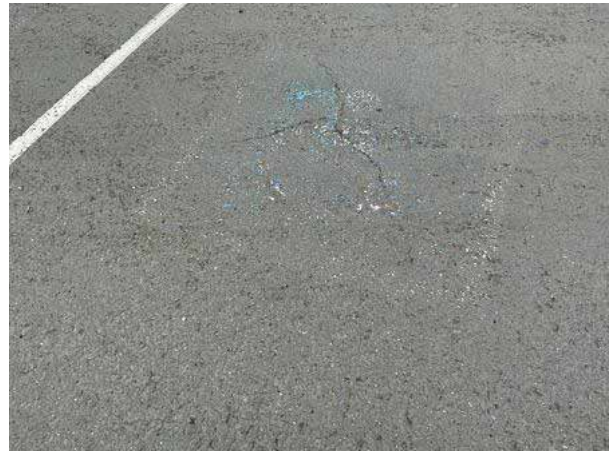
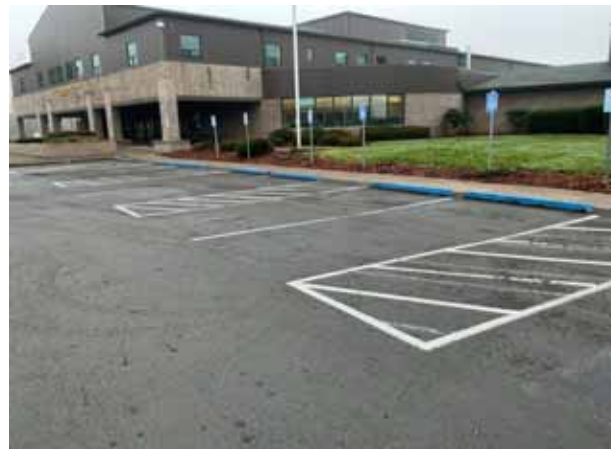
Photos for Barrier ID: AX556911

| <b>Site Conditions</b> | Accessible stall pavement markings are faded and illegible. |

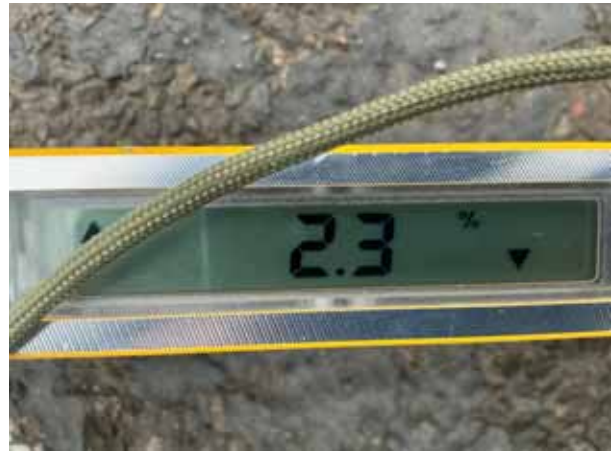
Photos for Barrier ID: AX556877

| <b>Site Conditions</b> | The cross slope of the access aisle is 2.3%. |

Remove and replace with an adjacent access aisle that has a slope of maximum 1:50 (2%) in all directions. [EXCEPTION: Slopes not steeper than 1:48 (2.08%) shall be permitted.] Changes in level are not permitted. Parking spaces and access aisles serving them shall be compliant. Access aisles shall be at the same level as the parking spaces they serve. Measurements shall be made to the centerline of the stripe. Where accessible stalls and aisles are not adjacent to another stall or aisle, measurements shall be permitted to include the full width of the line defining the accessible parking space or aisle. The quantity and order of magnitude cost estimate provided for this barrier are limited to the extent of the area identified as non-compliant. Additional costs that may be associated with removal of the barrier are not included.

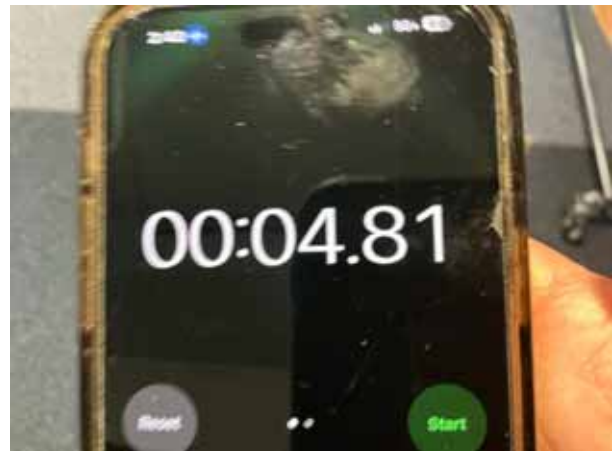
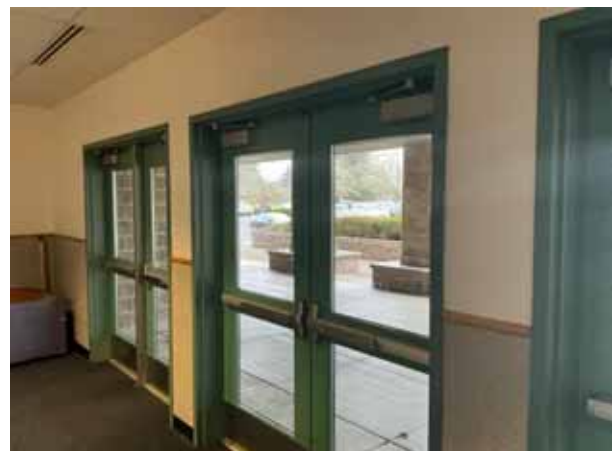
Photos for Barrier ID: AX556881

| Site Conditions | The opening force of the fire doors is 13 to 18 pounds. | |

| Adjust the closer/opener or replace with a door which requires no more force to open and close than the minimum allowable force required by the appropriate administrative authority. This barrier must be removed in conjunction with barrier ID 556881. The cost of this barrier removal is covered under ID 556881 and therefore, the cost of this ID is shown as \$0. The force at the latch, the force to set the door in motion, and the force to fully open the door shall be the minimum allowable. These forces do not apply to the force required to retract latch bolts or disengage other devices that hold the door or gate in a closed position. | | |

Adjust closer or remove and replace closer to ensure that the door has a closure time of at least 5 seconds within 12 degrees of the latch. This barrier must be removed in conjunction with barrier ID 556880. Door closers and gate closers shall be adjusted so that from an open position of 90 degrees, the time required to move the door to a position of 12 degrees from the latch is 5 seconds minimum.

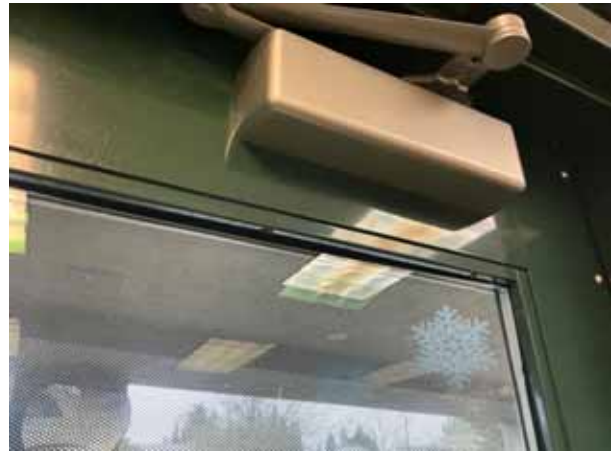
Photos for Barrier ID: AX556879

| Site Conditions | The opening force of the fire door is 14 pounds. | |

| Adjust the closer/opener or replace with a door which requires no more force to open and close than the minimum allowable force required by the appropriate administrative authority. The force at the latch, the force to set the door in motion, and the force to fully open the door shall be the minimum allowable. These forces do not apply to the force required to retract latch bolts or disengage other devices that hold the door or gate in a closed position. | | |

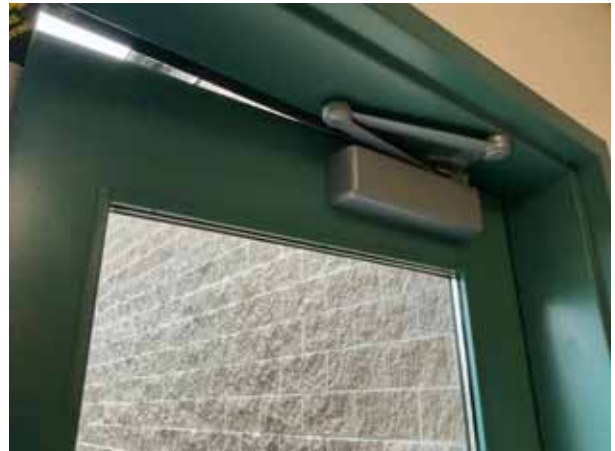
Photos for Barrier ID: AX556917

| Site Conditions | The opening force of the fire door is 14 pounds. | |

| Adjust the closer/opener or replace with a door which requires no more force to open and close than the minimum allowable force required by the appropriate administrative authority. The force at the latch, the force to set the door in motion, and the force to fully open the door shall be the minimum allowable. These forces do not apply to the force required to retract latch bolts or disengage other devices that hold the door or gate in a closed position. | | |

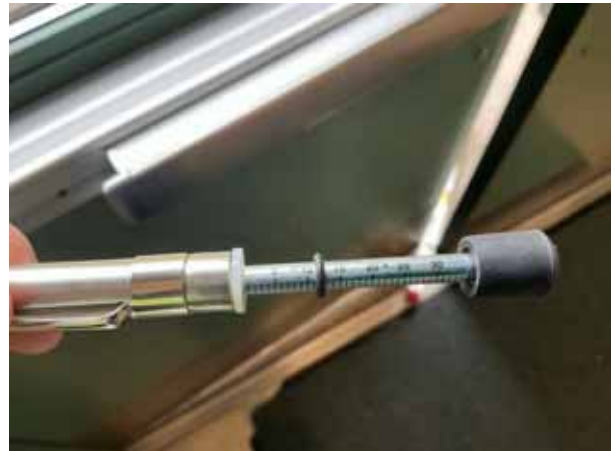
Photos for Barrier ID: AX556914

| Site Conditions | The opening force of the fire door is 12 pounds. | |

| Adjust the closer/opener or replace with a door which requires no more force to open and close than the minimum allowable force required by the appropriate administrative authority. This barrier must be removed in conjunction with barrier ID 556915. The cost of this barrier removal is covered under ID 556915 and therefore, the cost of this ID is shown as \$0. The force at the latch, the force to set the door in motion, and the force to fully open the door shall be the minimum allowable. These forces do not apply to the force required to retract latch bolts or disengage other devices that hold the door or gate in a closed position. | | |

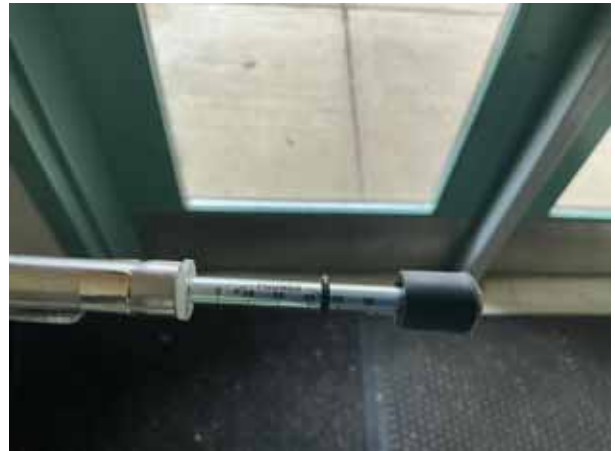
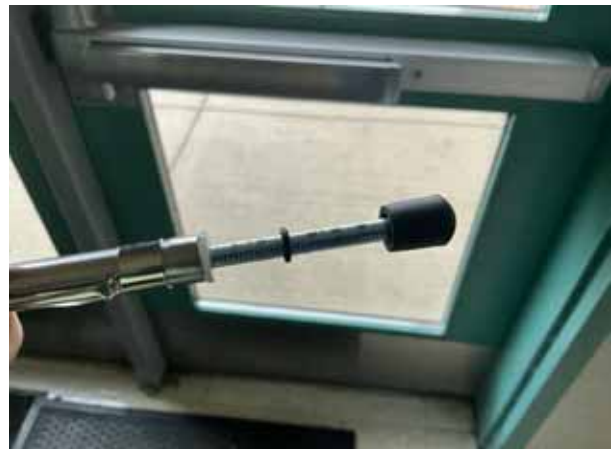
Photos for Barrier ID: AX556918

| Site Conditions | The opening force of the fire doors is 15 to 23 pounds. | |

| Adjust the closer/opener or replace with a door which requires no more force to open and close than the minimum allowable force required by the appropriate administrative authority. The force at the latch, the force to set the door in motion, and the force to fully open the door shall be the minimum allowable. These forces do not apply to the force required to retract latch bolts or disengage other devices that hold the door or gate in a closed position. | | |

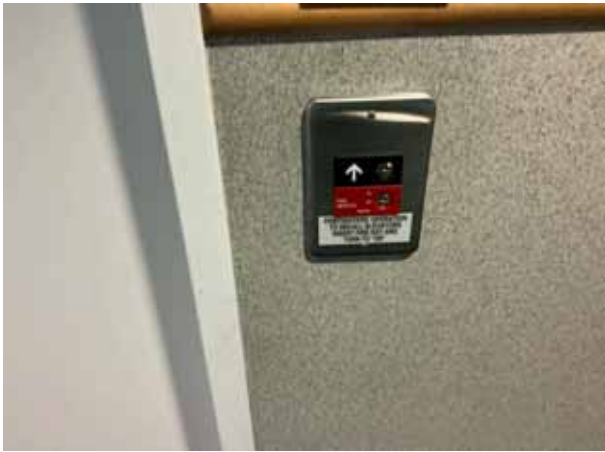
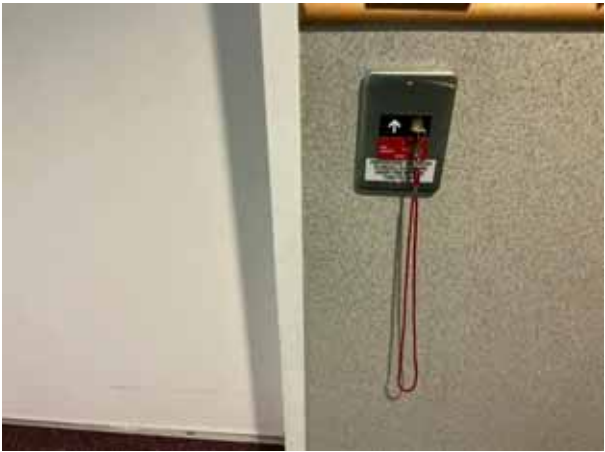
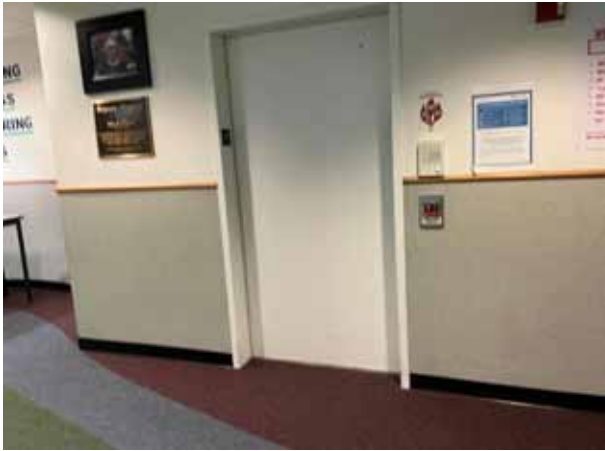
| Site Conditions | Elevator operation requires a key to operate. | |

| Resolution | Remove and replace with an automatic operation system. Elevator operation shall be automatic. | |

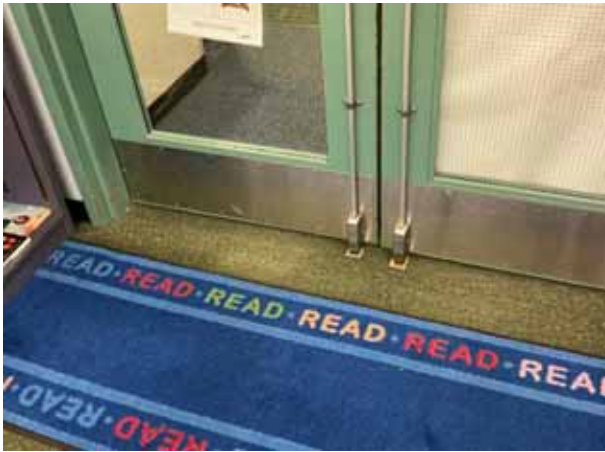
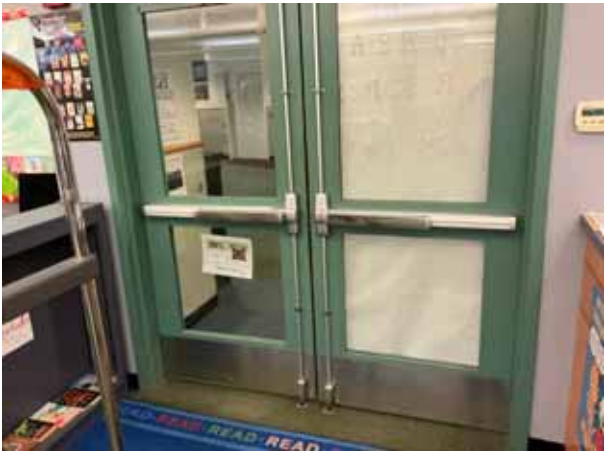
| Site Conditions | Door hardware is installed in the required smooth area of the doors. |

Modify or replace the door to provide a smooth surface on the door within 10 inches of the finish floor or ground for the full width of the door on the push side. Parts creating horizontal or vertical joints in these surfaces shall be within 1/16 inch of the same plane as the other and be free of sharp or abrasive edges. Cavities created by added kick plates shall be capped. Swinging door and gate surfaces within 10 inches of the finish floor or ground measured vertically shall have a smooth surface on the push side extending the full width of the door or gate. Parts creating horizontal or vertical joints in these surfaces shall be within 1/16 inch of the same plane as the other. Cavities created by added kick plates shall be capped. [EXCEPTIONS: 1. Sliding doors shall not be required to comply. 2. Tempered glass doors without stiles and having a bottom rail or shoe with the top leading edge tapered at 60 degrees minimum from the horizontal shall not be required to meet the 10 inch bottom smooth surface height requirement. 3. Doors and gates that do not extend to within 10 inches of the finish floor or ground shall not be required to comply. 4. Existing doors and gates without smooth surfaces within 10 inches of the finish floor or ground shall not be required to provide smooth surfaces provided that if added kick plates are installed, cavities created by such kick plates are capped.]

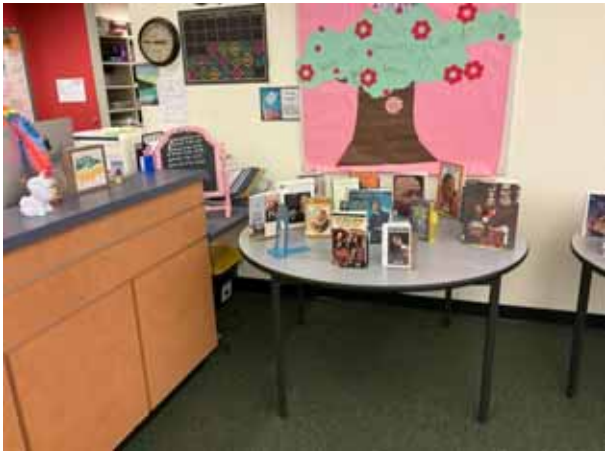
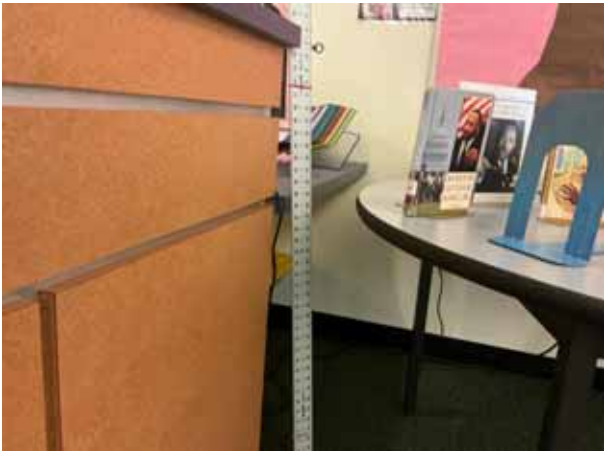
Photos for Barrier ID: AX556882

Site Conditions The accessible portion of the counter is blocked by items.

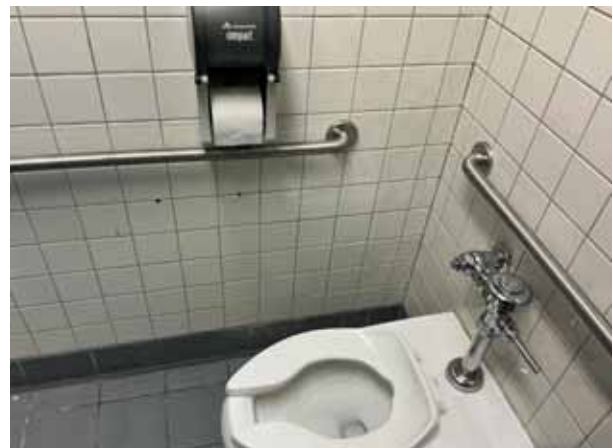
## Photos for Barrier ID: AX556889

| Site Conditions | The toilet paper dispenser is installed behind the rim of the toilet. |

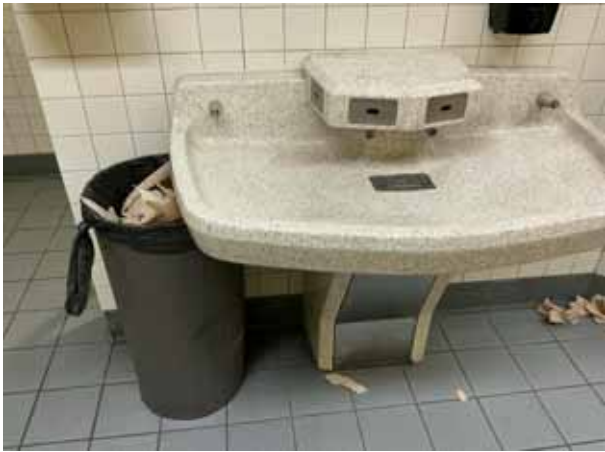
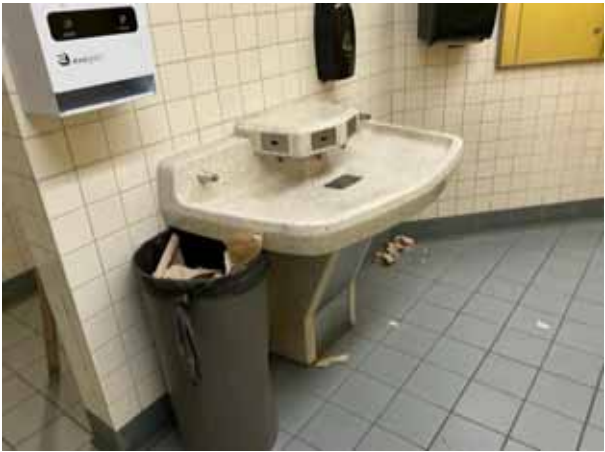
| Site Conditions | The trash can is in the required knee and toe clearance. |

Relocate trashcan or the lavatory to provide minimum 30" by minimum 48" clear floor space positioned for a forward approach to the lavatory. Compliant knee and toe clearance shall be provided. [EXCEPTIONS: 2. A lavatory in a toilet room or bathing facility for a single occupant accessed only through a private office and not for common use or public use shall not be required to provide knee and toe clearance. 3. In residential dwelling units, cabinetry shall be permitted under lavatories and kitchen sinks provided that all of the following conditions are met: (a) the cabinetry can be removed without removal or replacement of the fixture; (b) the finish floor extends under the cabinetry; and (c) the walls behind and surrounding the cabinetry are finished. 4. A knee clearance of 24" minimum above the finish floor or ground shall be permitted at lavatories and sinks used primarily by children 6 through 12 years where the rim or counter surface is 31" maximum above the finish floor or ground. 5. A parallel approach complying with 305 shall be permitted to lavatories and sinks used primarily by children 5 years and younger. 6. The dip of the overflow shall not be considered in determining knee and toe clearances. 7. No more than one bowl of a multi-bowl sink shall be required to provide knee and toe clearance.] Space under an element between 9" and 27" above the finish floor or ground shall be considered knee clearance and shall comply. Knee clearance shall extend 25" maximum under an element at 9" above the finish floor or ground. Floor or ground surfaces of a clear floor or ground space shall comply. Changes in level are not permitted. [EXCEPTION: Slopes not steeper than 1:48 shall be permitted.] The clear floor or ground space shall be 30" minimum by 48" minimum. One full unobstructed side of the clear floor or ground space shall adjoin an accessible route or adjoin another clear floor or ground space. Where a clear floor or ground space is located in an alcove or otherwise confined on all or part of three sides, additional maneuvering clearance shall be provided. Alcoves shall be 36" wide minimum where the depth exceeds 24". Alcoves shall be 60" wide minimum where the depth exceeds 15".
