# ACCESSIBILITY ASSESSMENT

December 10, 2024

## **ADA TITLE II ASSESSMENT**

Hamlin Middle School  
326 Centennial Boulevard  
Springfield, Oregon 97477

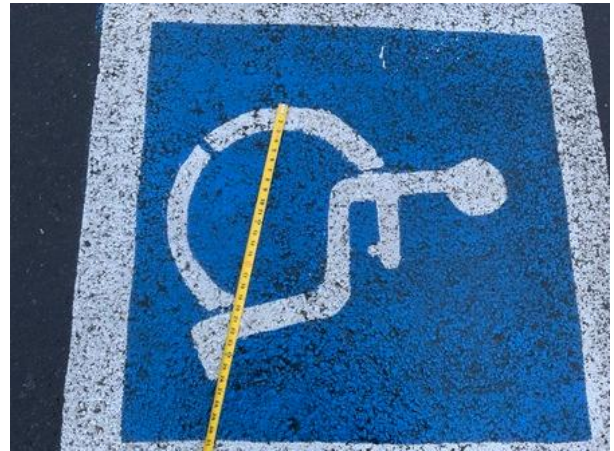
Photos for Barrier ID: AX527456

| Site Conditions | The pavement markings measure 32" in height and 26-1/2" in width. |

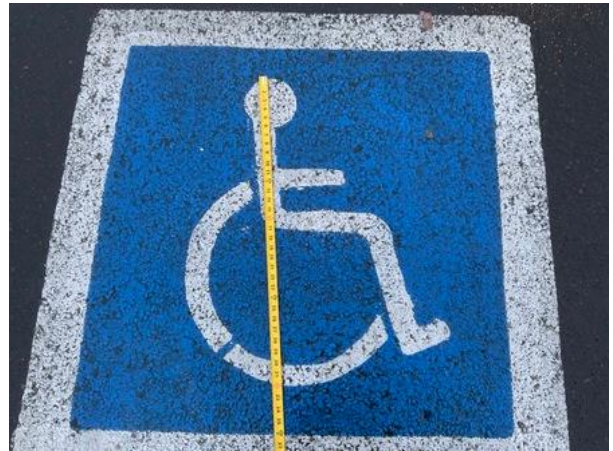
Photos for Barrier ID: AX527457

| Site Conditions | The pavement markings measure 32" in height and 26-1/2" in width. |

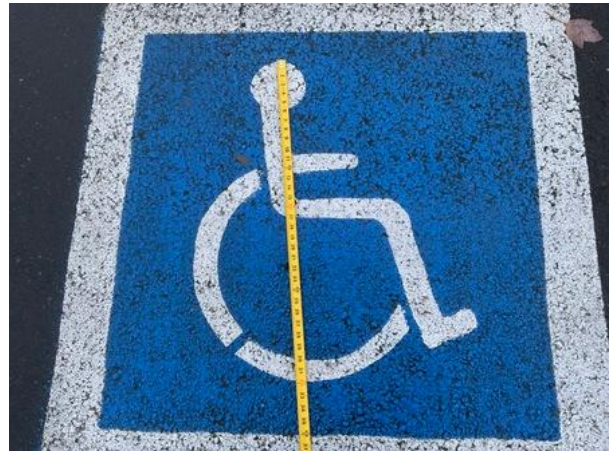
Photos for Barrier ID: AX527458

| Site Conditions | The pavement markings measure 32" in height and 26-1/2" in width. |

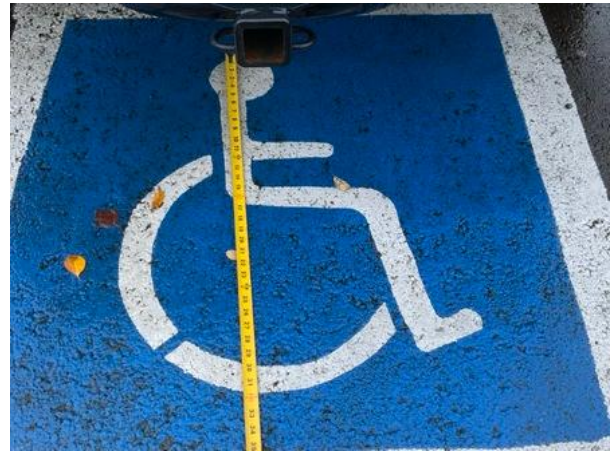
Photos for Barrier ID: AX527459

| Site Conditions | The pavement markings measure 32" in height and 26-1/2" in width. |

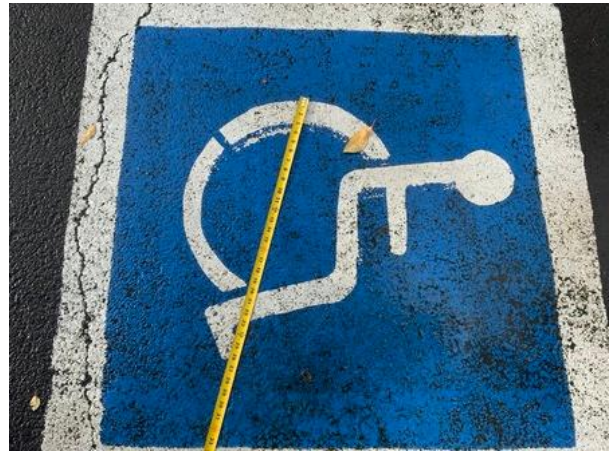
Photos for Barrier ID: AX527473

| Site Conditions | The pavement markings measure 32" in height and 26-1/2" in width. |

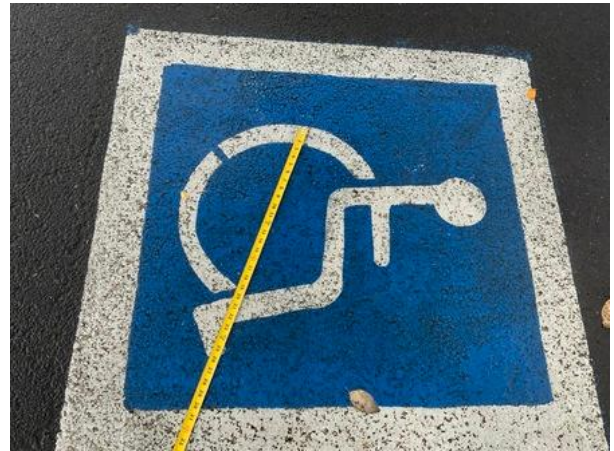
Photos for Barrier ID: AX527478

| Site Conditions | The pavement markings measure 32" in height and 26-1/2" in width. |

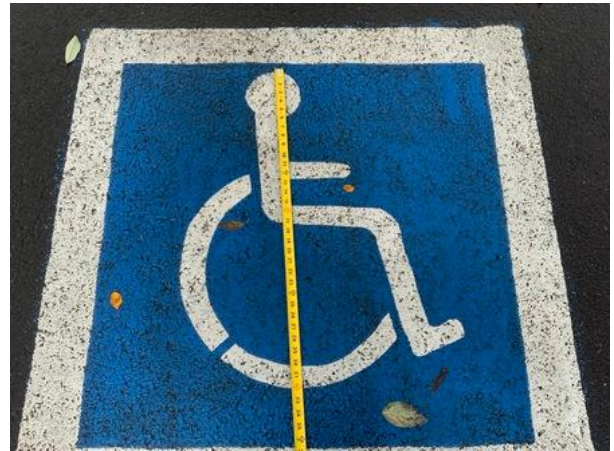
Photos for Barrier ID: AX527480

| Site Conditions | The pavement markings measure 32" in height and 26-1/2" in width. |
