# ACCESSIBILITY ASSESSMENT

February 25, 2025

## **ADA TITLE II ASSESSMENT**

Thurston Middle School  
6300 Thurston Road  
Springfield, OR 97478

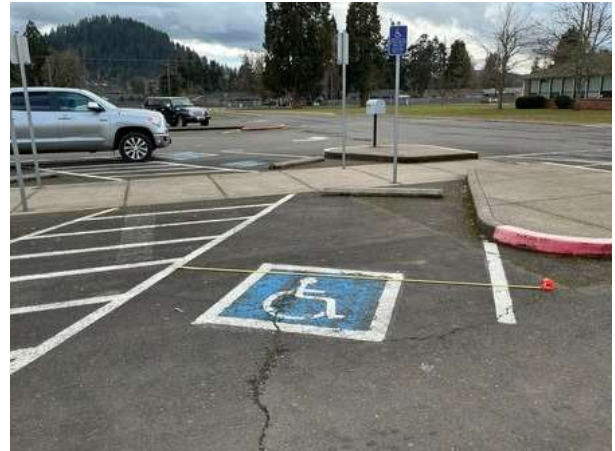
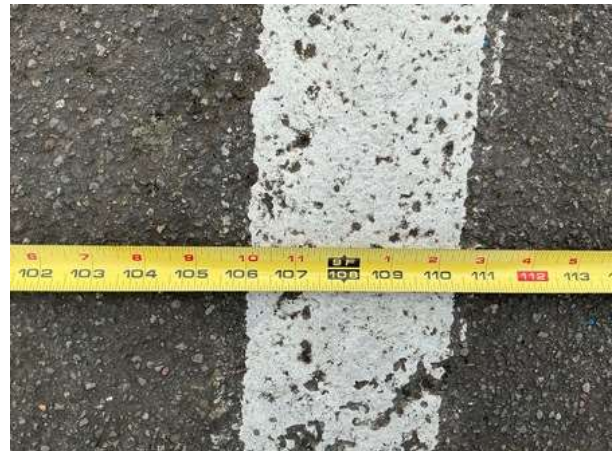
Photos for Barrier ID: AX563769

| <b>Site Conditions</b> | The accessible parking space has a slope of 2.3%. |

Remove and replace with a parking space that has no more than 1:50 (2%) slope in all directions. [EXCEPTION: Slopes not steeper than 1:48 (2.08%) shall be permitted.] Changes in level are not permitted. Parking spaces and access aisles shall be level with surface slopes not exceeding 1:50 in all directions. Parking spaces and access aisles serving them shall be compliant. Access aisles shall be at the same level as the parking spaces they serve. The quantity and order of magnitude cost estimate provided for this barrier are limited to the extent of the area identified as non-compliant. Additional costs that may be associated with removal of the barrier are not included.

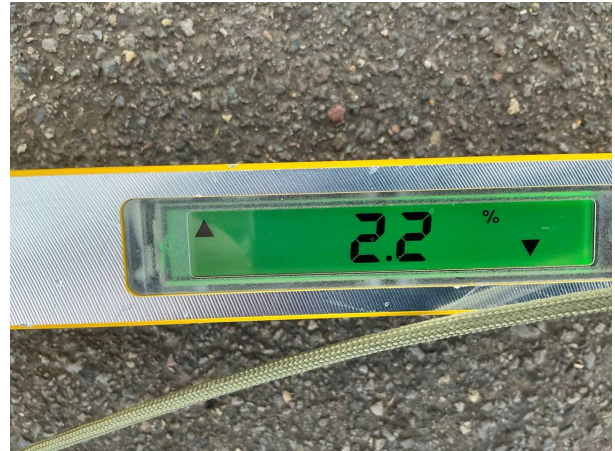
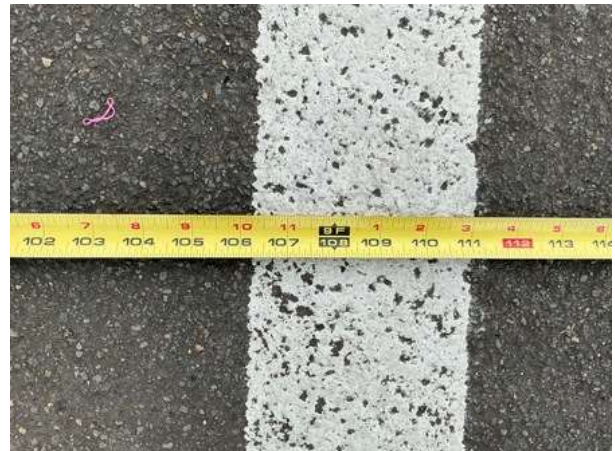
Photos for Barrier ID: AX563772

| <b>Site Conditions</b> | The slope of the van accessible parking space is 2.2%. |

Remove and replace with a parking space that has no more than 1:50 (2%) slope in all directions. [EXCEPTION: Slopes not steeper than 1:48 (2.08%) shall be permitted.] Changes in level are not permitted. Parking spaces and access aisles shall be level with surface slopes not exceeding 1:50 in all directions. Parking spaces and access aisles serving them shall be compliant. Access aisles shall be at the same level as the parking spaces they serve. The quantity and order of magnitude cost estimate provided for this barrier are limited to the extent of the area identified as non-compliant. Additional costs that may be associated with removal of the barrier are not included.

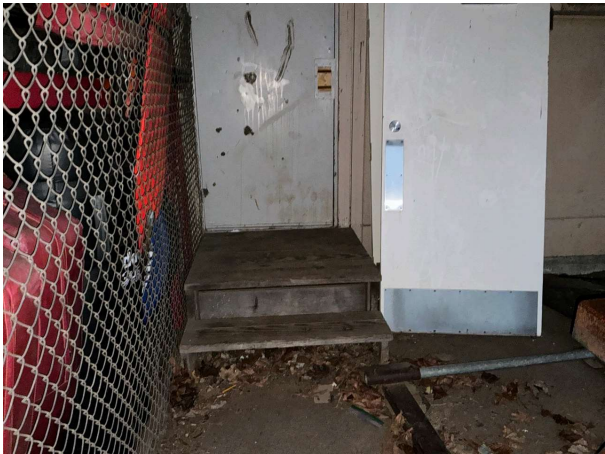
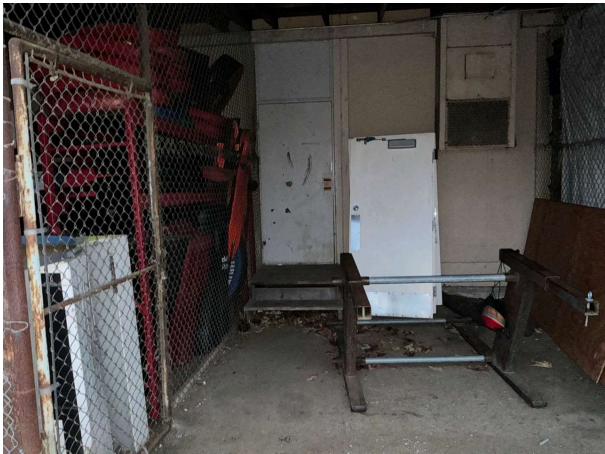
| Site Conditions | Stairs on accessible route have open risers. | |

| Resolution | Replace with compliant stairs that have closed risers. Open risers are not permitted. | |

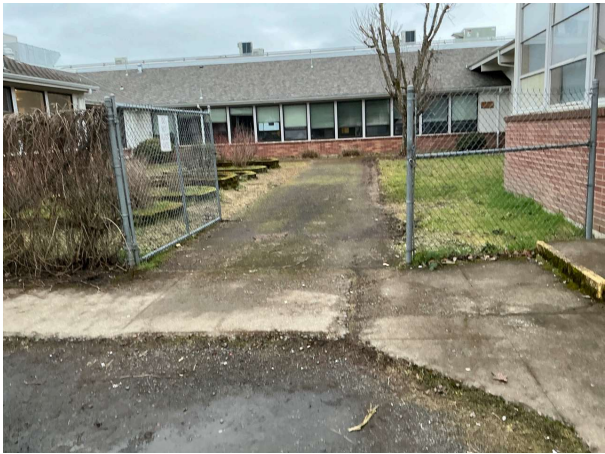
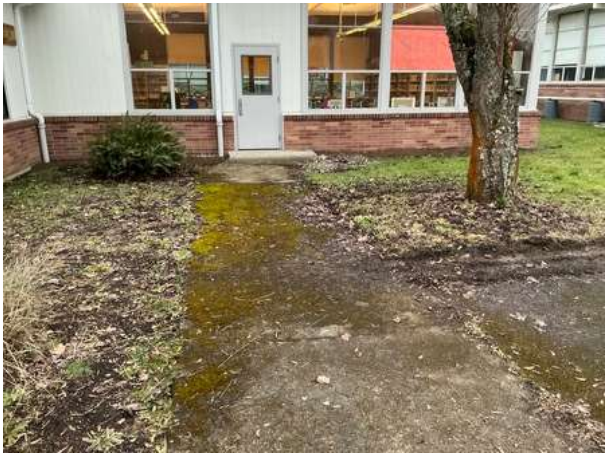
| Site Conditions | Ground surfaces on accessible pathway are not firm, stable and slip resistant. | |

| Resolution | Replace with a surface that is stable, firm and slip-resistant. Ground surfaces shall be stable, firm, and slip resistant. | |

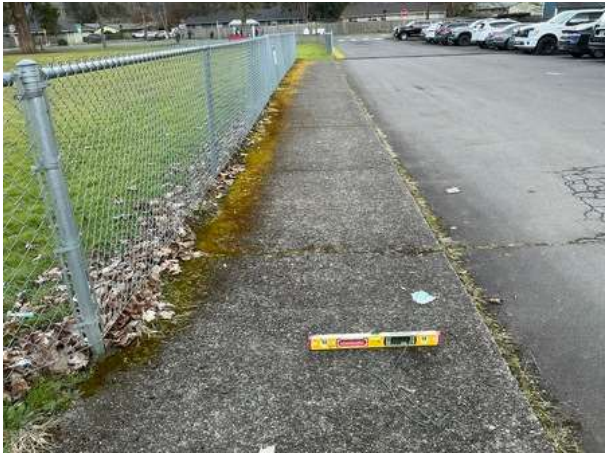
| Site Conditions | The accessible route has cross slopes of 2.2% to 2.6%. | |

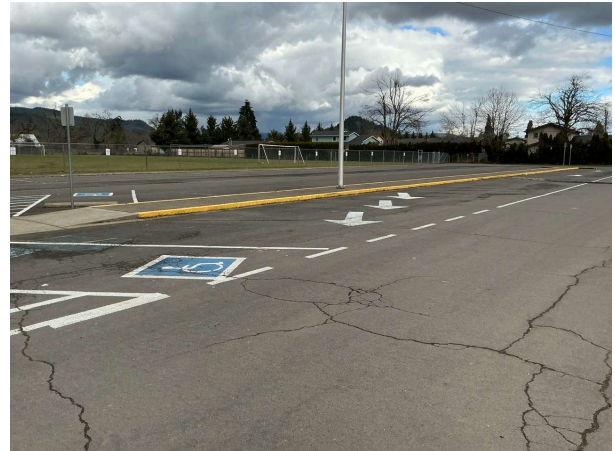
Photos for Barrier ID: AX563778

| <b>Site Conditions</b> | No compliant curb ramp is present in loading/unloading zone. |

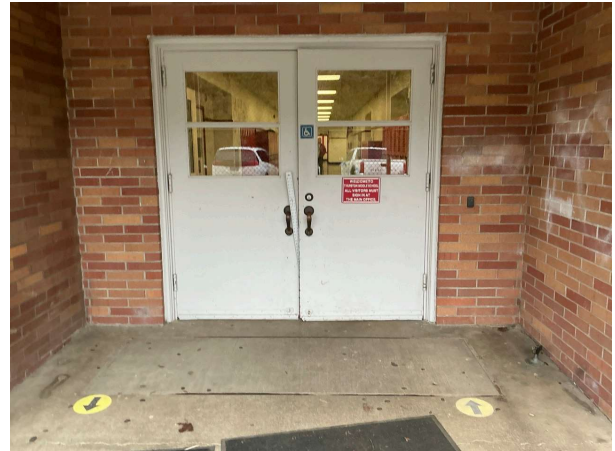
Photos for Barrier ID: AX563786

| Site Conditions | The hinged accessible exterior door requires 10 pounds of pressure to operate | |

| Resolution | Adjust the closer or replace with an exterior door that requires no more 8.5 pounds of force for pushing or pulling the door open. The opening force of doors along an accessible route shall be as follows: 1. Exterior doors: 8.5 pounds maximum (lbf) (37.8 N). 2. Interior doors: 5 pounds maximum (lbf) (22.2 N). 3. Stairway doors at pressurized stair enclosures: 15 pounds maximum (6.8 kg) at exterior doors. 4. Where environmental conditions require greater closing pressure, power-operated doors shall be used within the accessible route. [Exception: The force required to retract latch bolts or disengage other devices that hold the door or gate in a closed position shall not apply to panic hardware, delayed egress devices or fire-rated hardware.] | |
