# FACILITY CONDITION ASSESSMENT

**Oregon Department of Education**  
255 Capitol Street NE  
Salem, OR 97310  
Adam Krein

Thurston High School  
333 N 58<sup>th</sup> Street  
Springfield, OR 97478

October 20, 2025

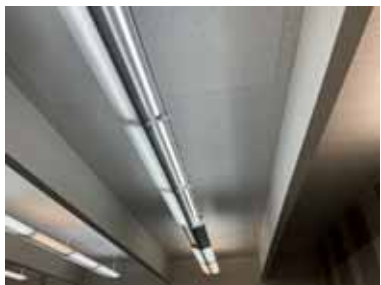
| | <div><div>Fire Suppression System</div><div>Full System Install/Retrofit, Medium Density/Complexity<br/>Thurston High School - 2<br/>Throughout Building</div></div> | <div><div>Plan Type:<br/>Retrofit/Adaptation</div><div>Cost Estimate: \$1,014,400</div></div> |
| | <div><div>Uniformat Code: D4010</div><div>Recommendation: <b>Renovate in 2029</b></div></div> | |

| Retrofit fire suppression system. - AssetCALC ID: 8707157 | | |

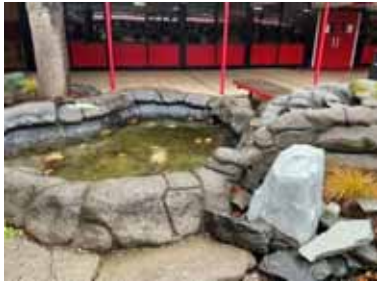
### Decorative Fountains in Poor condition.

Circulation Pump  
Site  
Site General

Fountain does not operate and is under a work order to be fixed. - AssetCALC ID: 8707167

Uniformat Code: G2060  
Recommendation: **Replace in 2025**
